Upper Lillooet Hydro Project

Weekly Environmental Monitoring Report #71

Reporting Period: August 30 – September 12, 2015

Upper Lillooet River Hydroelectric Facility (Water File No. 2002561, Water licence No. C130613), Boulder Creek Hydroelectric Facility (Water File No. 2003049, Water licence No. C129969) & Transmission Line (TX Line)

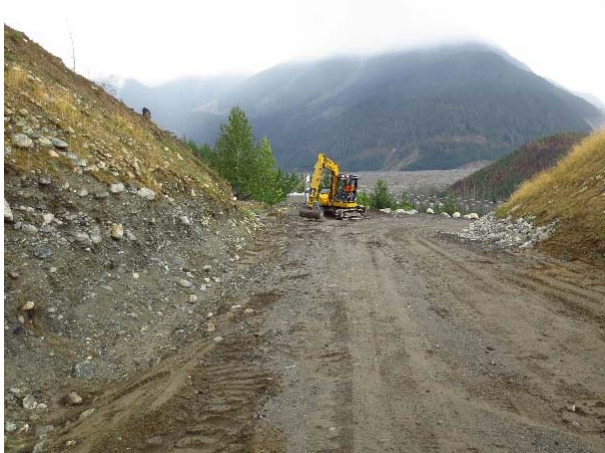
- Maintenance work on the camp access road (Photo 1).
- Scaling and danger tree removal at KM 41 on the Lillooet River FSR (Photo 3).
- Routine maintenance of construction equipment within the mechanic shop and fuel management continued at the KM 38 laydown.
- The electric fences surrounding the construction camp were maintained and operational throughout this reporting period.

Photo 1 – Maintenance work on camp access road (September 2, 2015).

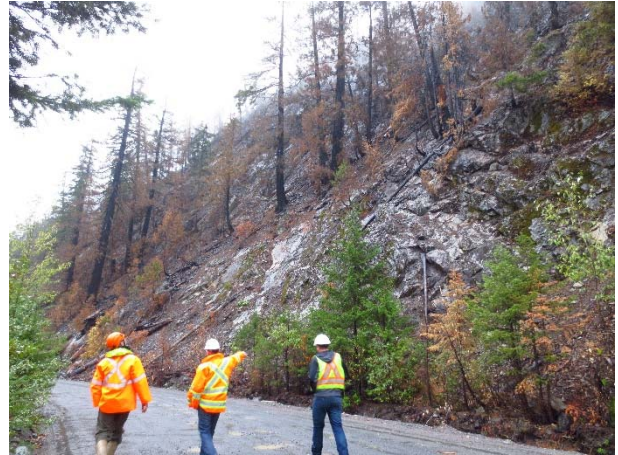
- On September 2, a kick-off meeting was held to discuss safety, environmental and engineering concerns for the KM 41 scaling and danger tree removal works (Photo 2).

Photo 2 – Kick-off meeting held for scaling and danger tree removal works at KM 41 on the Lillooet River FSR (September 2, 2015).

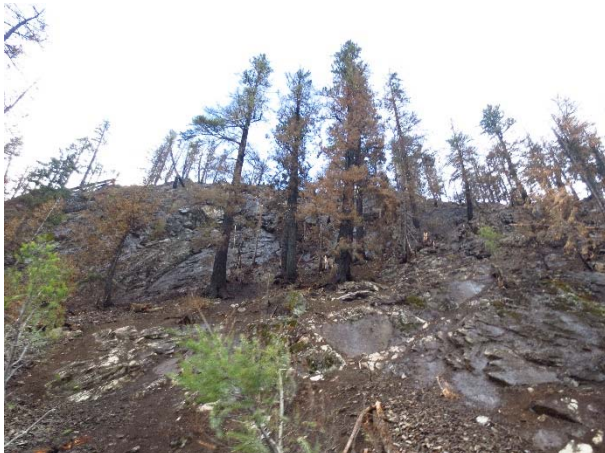
Photo 3 – Scaling and danger tree removal works at KM 41 of the Lillooet River FSR (September 3, 2015).

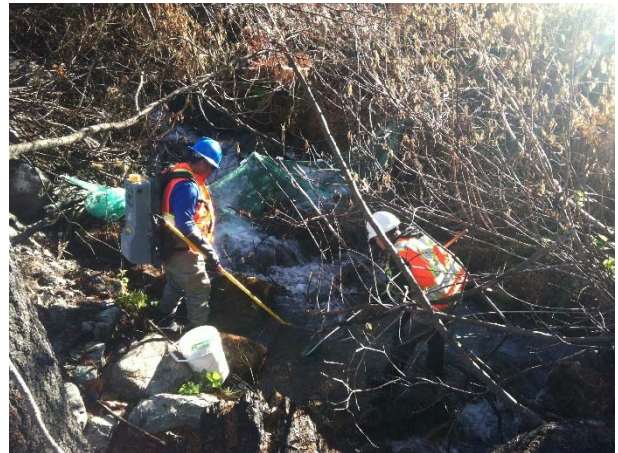
- On September 11 and 12, the IEM was present for a log box culvert removal and re-installation at a fish-bearing stream that crosses the magazine access road (stream 9a near KM 0.25 on the BDRHEF intake access road). An Ecofish crew conducted a fish salvage prior to works and during dewatering (Photo 4). Worksite isolation was achieved with a sandbag berm and pump method and works were completed in the absence of flowing water (Photo 5 and Photo 6). During the culvert installation works, three temporary pulses of suspended sediment were experienced downstream. One pulse occurred when the sandbag berm was built to create a sump within the isolated work area (Sept. 12, 09:42), a second pulse occurred when the old sill logs were removed (Sept. 11, 15:50) and a third pulse occurred when water was released to the culvert (Sept. 12, 11:07). The IEM conducted water sampling during works. See Section 5.6 for water quality results.

Photo 4 – Fish salvage conducted by Ecofish prior to installation of log box culvert (September 11, 2015).

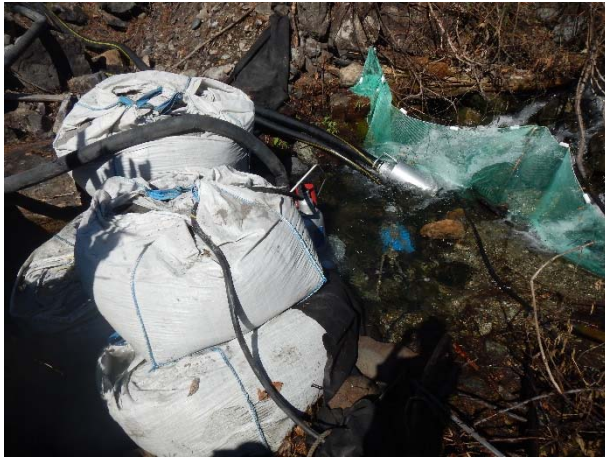
Photo 5 – Sandbag berm and pumps used to isolate box culvert work area from water (September 11, 2015).

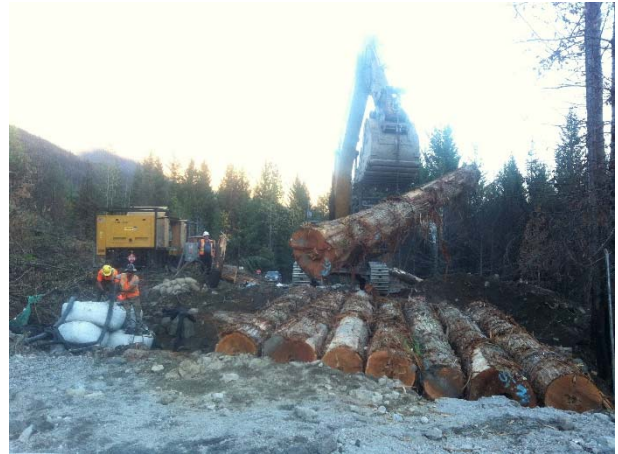
Photo 6 – Installation of the log box culvert on the magazine access road (September 12, 2015).

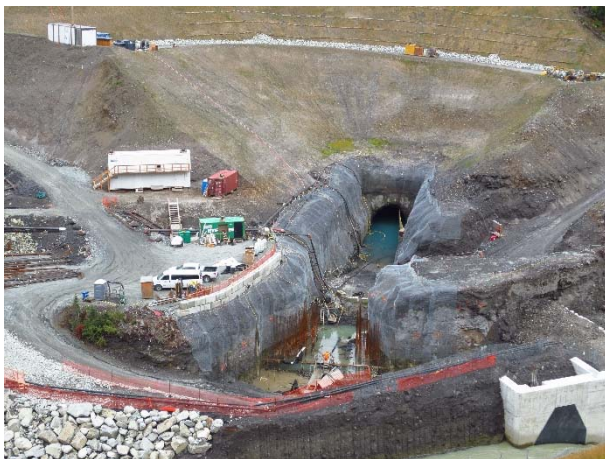
- Clean-up and site preparation work continued at the ULRHEF intake (Photo 7).
- Repairs to the tunnel ventilation and electrical systems commenced to allow for the re-activation of the tunneling activities at the upstream tunnel portal.
- Repair and installation of the ULREHF intake dewatering system (Photo 8 and Photo 9).

Photo 7 – Current conditions at the ULRHEF intake (September 2, 2015).

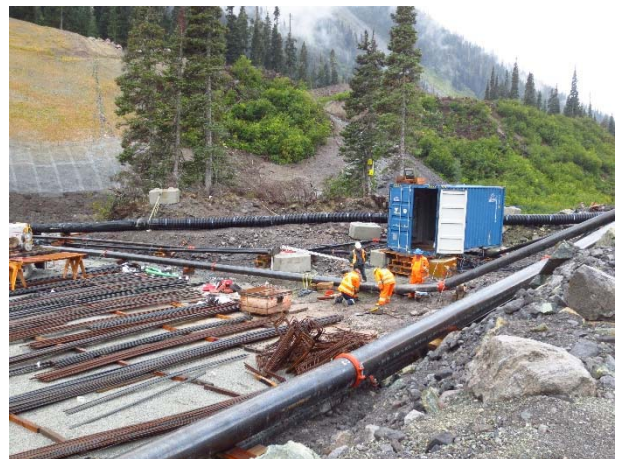
- The intake dewatering system was repaired and reconfigured during this reporting period (Photo 8). A sump box was installed at the entrance to the upstream tunnel portal to collect seepage water from the intake excavation and inside the tunnel (Photo 9). Clean seepage water was actively pumped directly to the Lillooet River throughout the reporting period (Photo 10).

Photo 8 – ULRHEF intake dewatering system repair works (September 2, 2015).

- All seepage water in the intake excavation and portal should be conveyed to the sediment basins unless approved for discharge directly to the Lillooet River by the IEM or CE environmental manager.
- The IEM recommends that the access roads and tributaries on the penstock alignment be monitored regularly to ensure that no ESC issues develop with the continued installation works and traffic.
- The ULRHEF powerhouse sump water should be monitored regularly. Alkaline or turbid water should be pumped to the settling ponds for treatment.

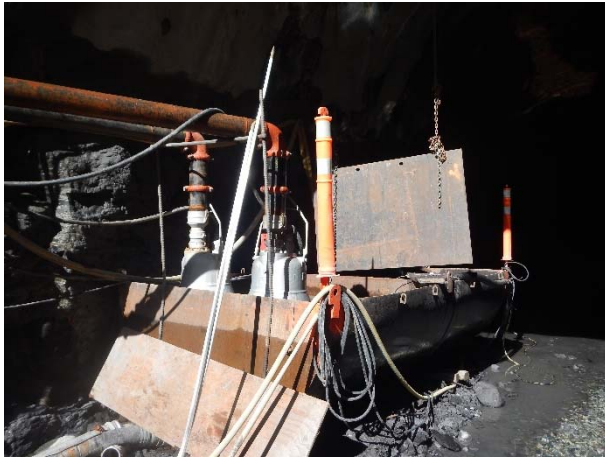
Photo 9 – Sump box and pumps installed at entrance to upstream tunnel portal (September 12, 2015).

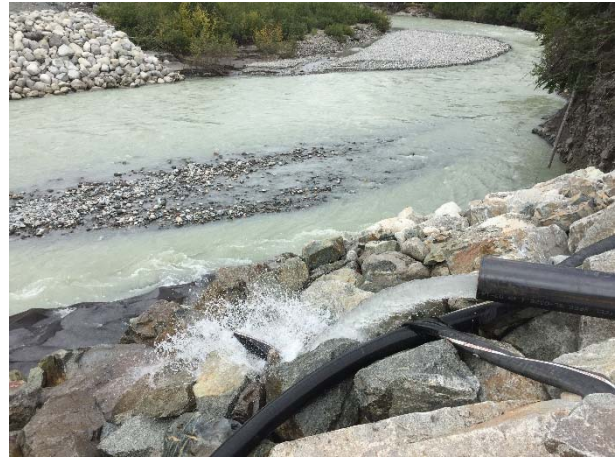
Photo 10 – Dewatering intake work area to Lillooet River (September 12, 2015).

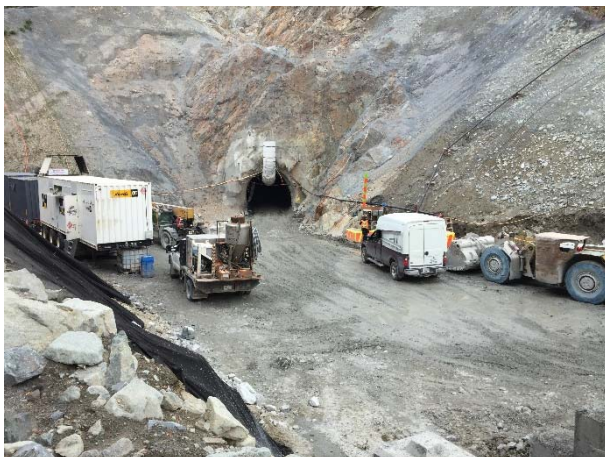
- Drilling, blasting, mucking and stabilization works within the tunnel (Photo 11).
- Dewatering to downstream tunnel portal settling ponds (Photo 12).

Photo 11 – Current conditions at the ULRHEF downstream tunnel portal (September 7, 2015).

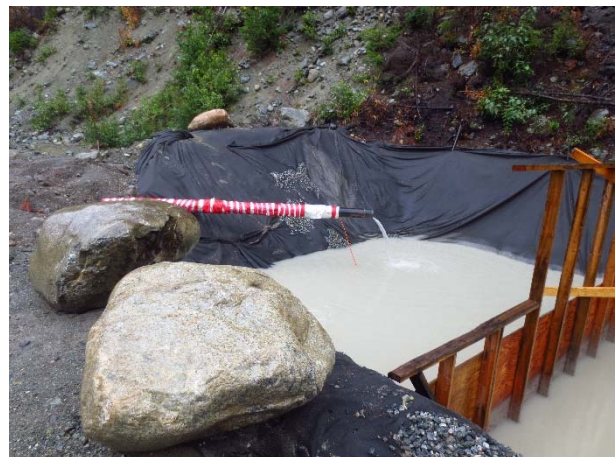
- Tunnelling works and dewatering to the downstream portal settling ponds continued during this reporting period. The settling pond water infiltrated to ground in the second cell with no discharge to the surrounding environment (Photo 12).

Photo 12 – ULRHEF downstream tunnel portal infiltration ponds (September 7, 2015).

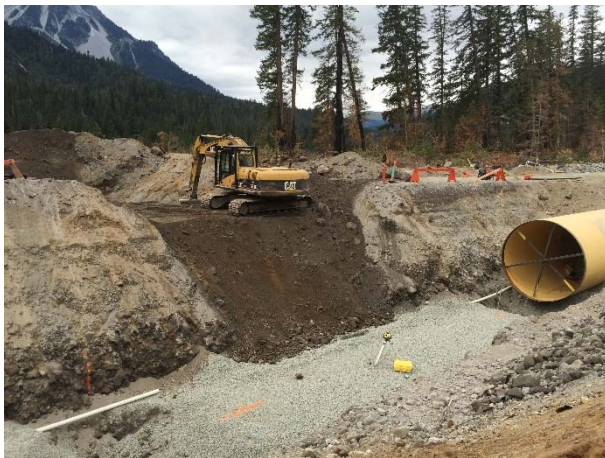
- Penstock excavation, installation and backfill continued from 3+300 to 3+900 (Photo 13).
- Penstock welding continued from 2+900 to 3+700 (Photo 14).

**Photo 13 – Penstock backfill works
(September 7, 2015).**

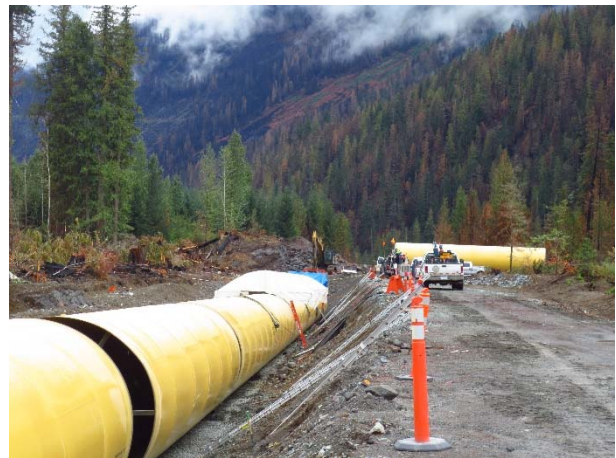
**Photo 14 – Penstock welding at 3+750
(September 2, 2015).**

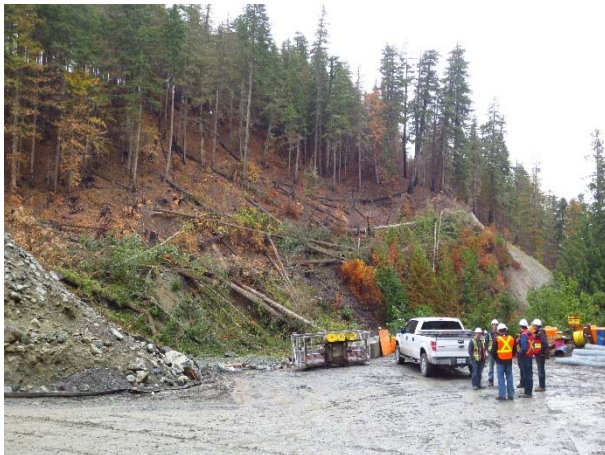
- On September 2, a kick-off meeting was held for the Truckwash Creek crossing clearing works. Site conditions, safety concerns and environmental issues were discussed (Photo 15).

**Photo 15 – Kick-off meeting for Truckwash Creek penstock
crossing clearing works (September 2, 2015).**

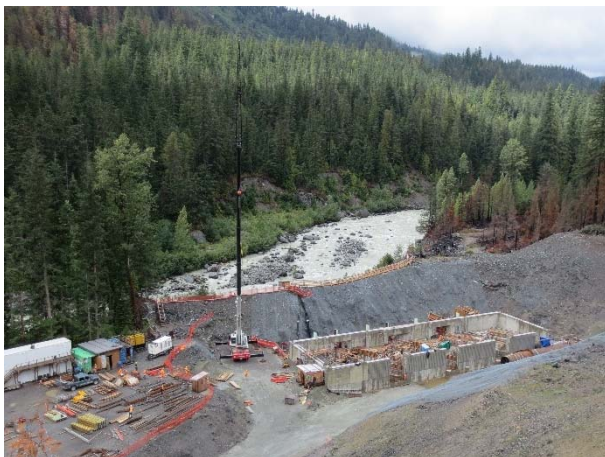
Photo 16 – Current conditions at the ULRHEF powerhouse (September 2, 2015).

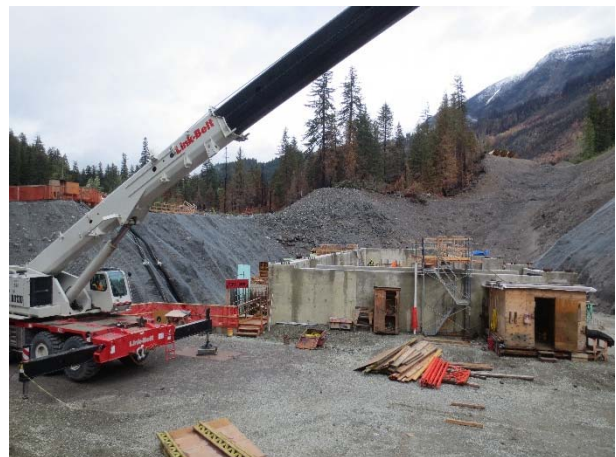
Photo 17 – Clean-up and site preparation at the ULRHEF powerhouse (September 2, 2015).

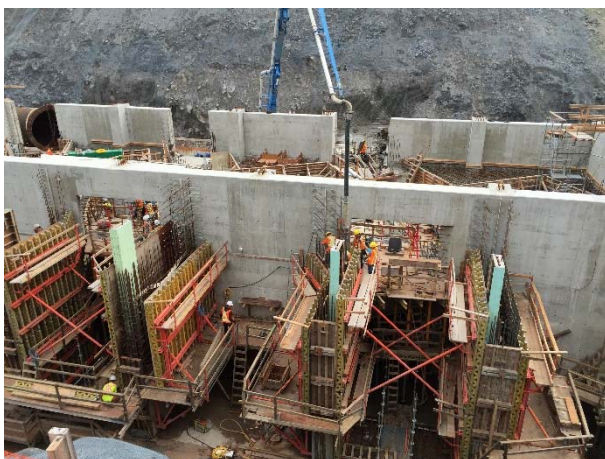
- On September 7, 11 and 12, the IEM was onsite to inspect the ULRHEF powerhouse during structural concrete pours (Photo 18). The IEM conducted water quality sampling of the powerhouse sump discharge (Photo 19). All water samples were measured to have a pH <9 and suitable for discharge to the surrounding environment as per the Surface Water Quality Protection Plan (see Section 5.6 for Water Quality Results).

Photo 18 – Concrete pour at ULRHEF powerhouse (September 7, 2015).

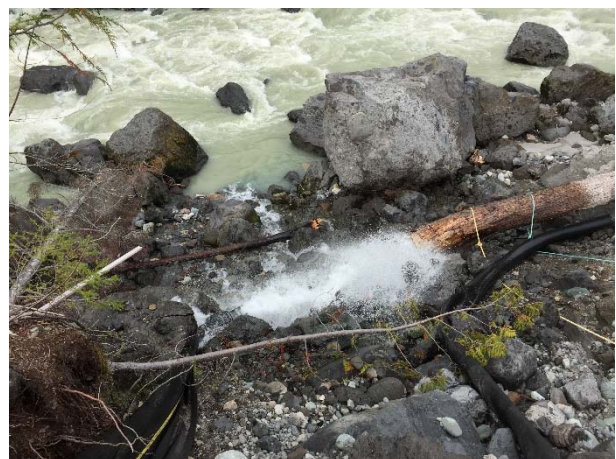
Photo 19 – Dewatering powerhouse sump to Lillooet River (September 7, 2015).

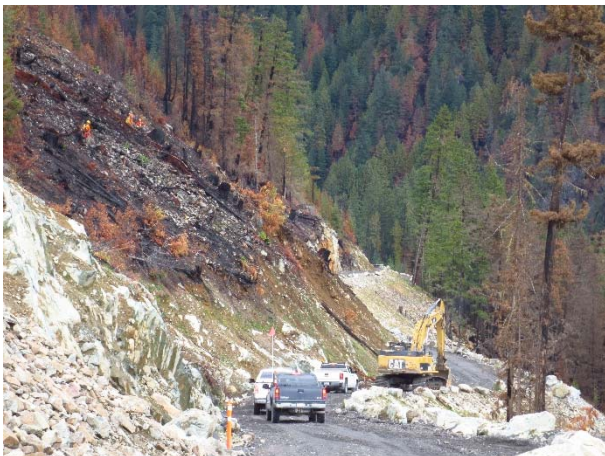
- Slope consolidation works were conducted upslope of the BDRHEF access road from KM 3.5 – 4.5 (Photo 20).
- Scaling and consolidation works on right bank above diversion tunnel.
- Excavation and blasting for ramp construction at BDRHEF intake (Photo 21).

Photo 20 – Slope consolidation works on BDRHEF intake access road (September 2, 2015).

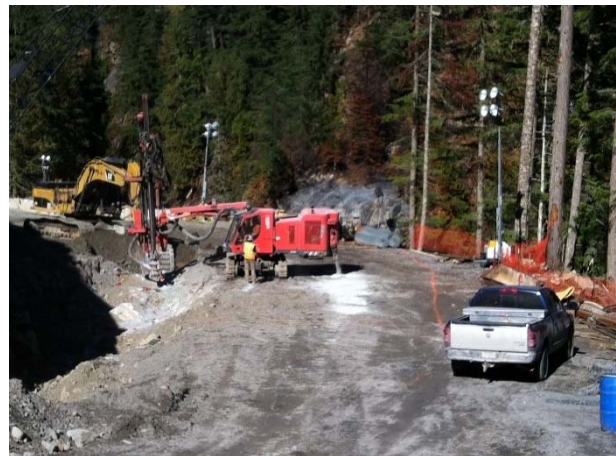
Photo 21 – Preparation for blasting and excavation of ramp at BDRHEF intake (September 10, 2015).

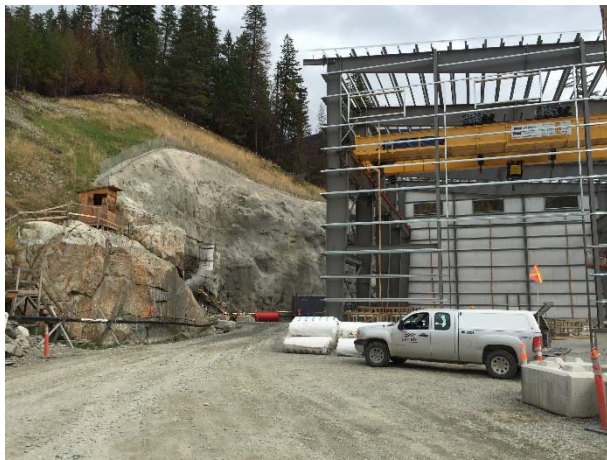
- Drilling, blasting, mucking and stabilization works re-commenced within the tunnel (Photo 22).
- Dewatering of the tunnel and powerhouse to the oil water separator and settling ponds continued (Photo 23).

Photo 22 – BDRHEF downstream portal entrance and powerhouse structure (September 7, 2015).

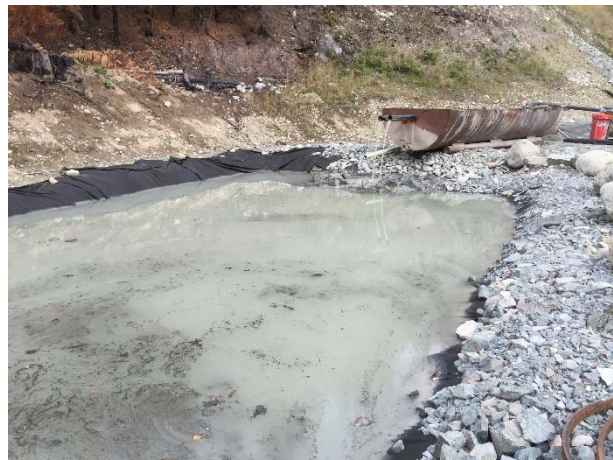
- All wastewater related to the BDRHEF tunnelling works continued to be contained and conveyed to the downstream portal settling ponds for treatment (Photo 23). The water in

the settling ponds continues to infiltrate to ground and has yet to reach the fourth cell.

Photo 23 – BDRHEF downstream portal settling ponds (September 7, 2015).

- All wastewater related to the BDRHEF tunnelling works should continue to be contained and conveyed to the downstream portal settling ponds for treatment. Regular inspections of the treatment ponds should be performed to ensure the necessary maintenance activities outlined in the work plan are performed.

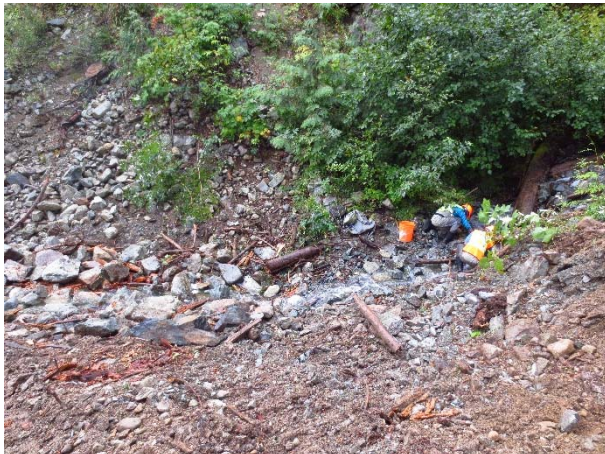
- On September 4, the IEM was present for a culvert installation at stream 272A in Segment 11. Stream 272A is an identified CTF watercourse. An Ecofish crew conducted a salvage prior to works and during dewatering (Photo 24). Worksite isolation was achieved with dam/sump and pump methods and works were completed in the absence of flowing water (Photo 25). During the culvert installation works, two pulses of suspended sediment were recorded downstream of the works which temporarily exceeded BCQWGs. The first pulse occurred during the installation of an earth berm installed to pool water and allow for the proper function of a diversion pump within the isolated work area (09:30) and a second

Photo 24 – Ecofish crew conduct Coastal Tailed Frog salvage prior to works at Stream 272A (September 4, 2015).

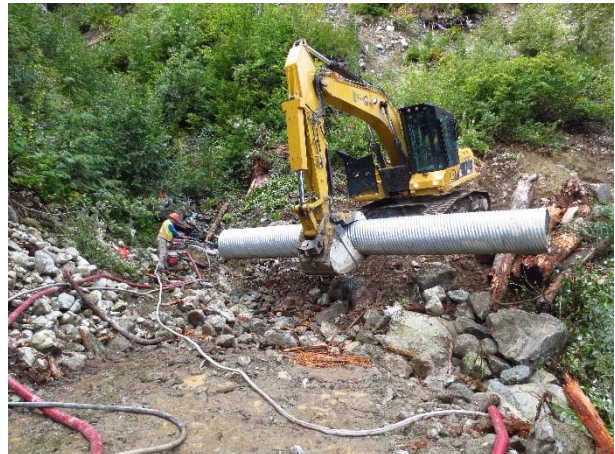
pulse occurred when water was released to the culvert (13:05). In both instances, the contractor worked diligently to reduce the amount of suspended sediment as quickly as possible. The IEM conducted water sampling during works. See Section 7.2 for water quality results.

Photo 25 – Culvert installation with isolation in place at Stream 272A (September 4, 2015).

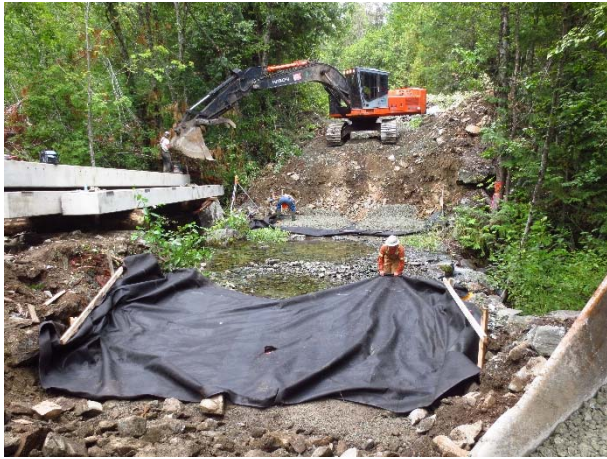
- The IEM was onsite to monitor permanent crossing/bridge construction works on the Miller Bench FSR at MB53, MB58 and MB59 (Photo 26, Photo 27 and Photo 28). The high water mark was clearly flagged at all crossings and works were completed in the dry with no effect on the surrounding watercourses. The IEM conducted water sampling during works and observed and measured no effect on downstream water quality.

Photo 26 – Preparation for installation of precast footings and steel columns at MB53 (September 1, 2015).

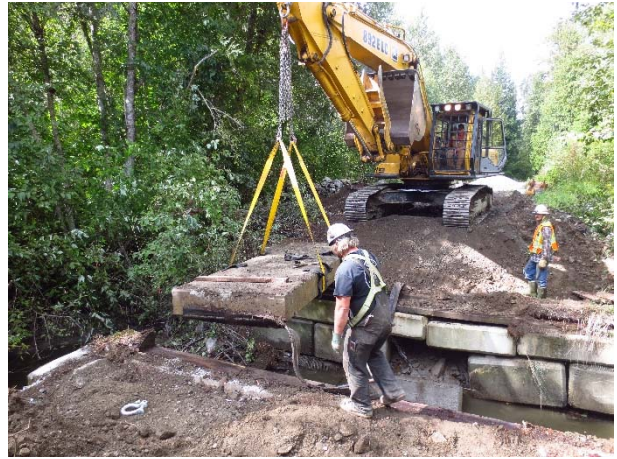
Photo 27 – Bridge installation works at MB59 (September 4, 2015).

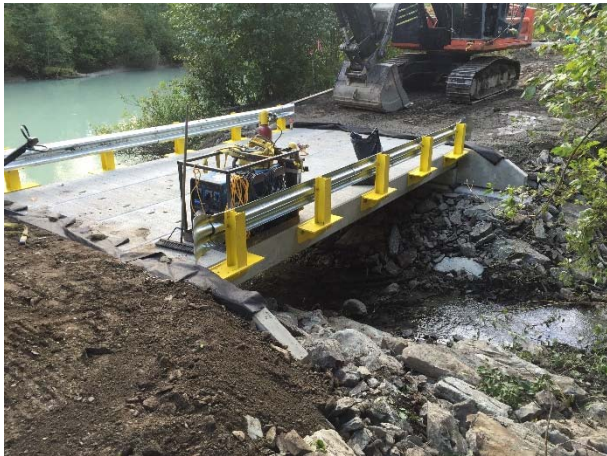
Photo 28 – Bridge installed at MB59 (September 7, 2015).
