Upper Lillooet Hydro Project

Weekly Environmental Monitoring Report #73

Reporting Period: September 27 – October 3, 2015

Upper Lillooet River Hydroelectric Facility (Water File No. 2002561, Water licence No. C130613), Boulder Creek Hydroelectric Facility (Water File No. 2003049, Water licence No. C129969) & Transmission Line (TX Line)

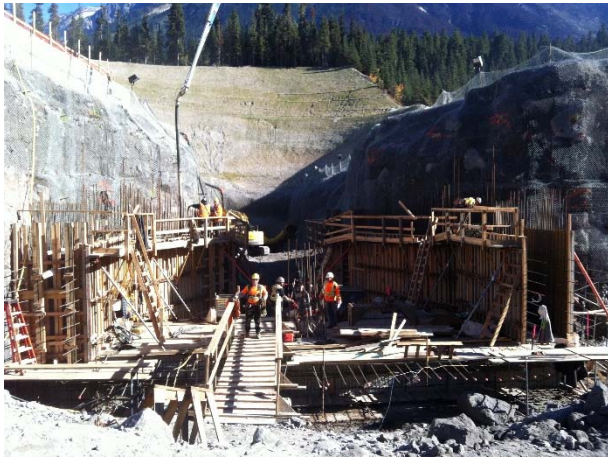
- Drilling, blasting and tunnel stabilization at the ULRHEF upstream portal.
- Rebar and formwork installation.
- Concrete pours for intake structure (Photo 1).
- Mud-slab concrete pour at sluiceway location.
- Dewatering to ULRHEF intake sediment basins.

Photo 1 – Concrete pour at the ULRHEF intake
(October 3, 2015).

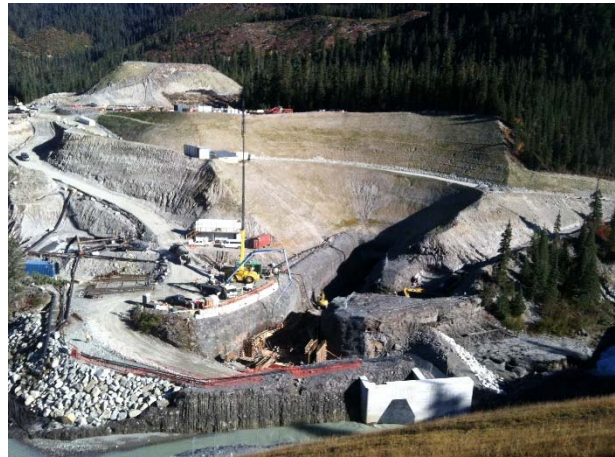
Photo 2 – Overview of the ULRHEF intake works area
(October 3, 2015).

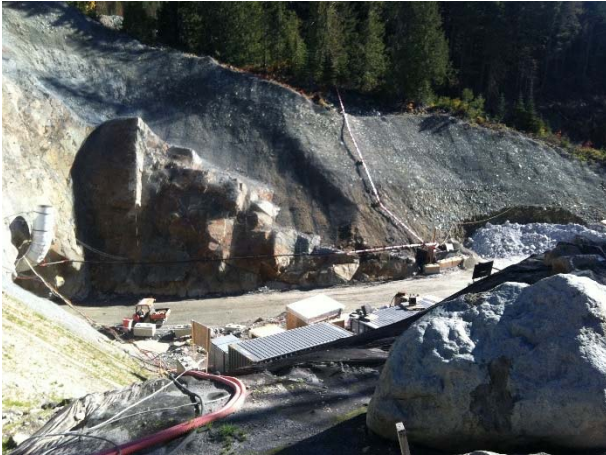
- Drilling, blasting, mucking and stabilization works within the tunnel (Photo 3).
- Dewatering to downstream tunnel portal settling ponds.
- Following the pre-work meeting on September 29, 2015, CE began falling trees and stripping and grubbing the new spoil area (SP-08) at KM 45 of the Lillooet River FSR.

Photo 3 – Current conditions at the ULRHEF downstream tunnel portal (October 3, 2015).

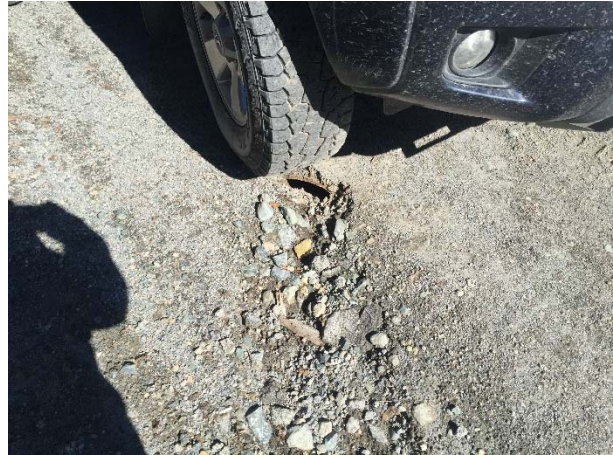
- The downstream portal infiltration ponds are nearing capacity, and the outlet from the ponds is currently buried and requires repair (Photo 4). Water has begun to seep from the base of the ponds into a vegetated area southwest of the ponds (within the OLTC; Photo 5). The IEM monitored the seepage flow from the ponds throughout the reporting period and confirmed that the water infiltrated to ground within the project area. Maintenance of the ponds is recommended to restore their infiltration capacity.

Photo 4 – Culvert outlet from the ULRHEF downstream tunnel portal infiltration ponds has been buried and requires repair. (September 29, 2015).

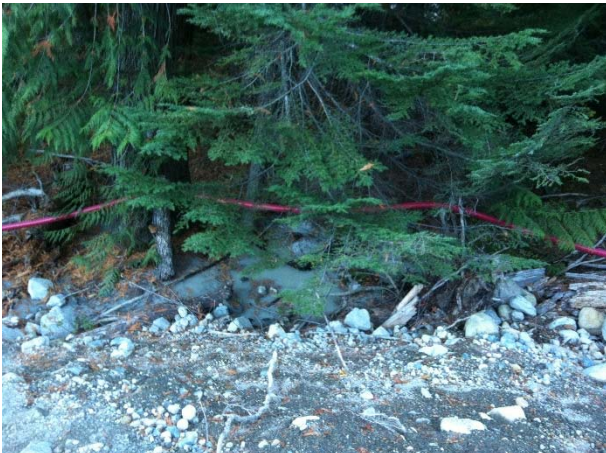
Photo 5 – ULRHEF downstream tunnel portal infiltration pond seepage (October 3, 2015).

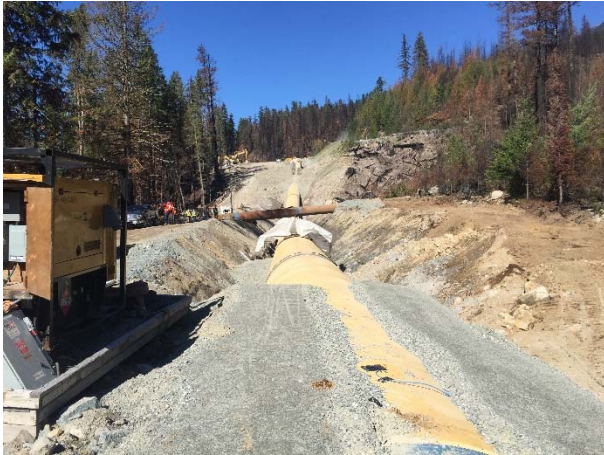
- Penstock excavation continued from 3+940 to 4+080, installation and backfill continued from 3+360 to 3+460 (Photo 6 & Photo 7).
- Penstock welding continued from 2+700 to 2+900.

Photo 6 – Penstock backfill works near ASTR-04 (September 29, 2015).

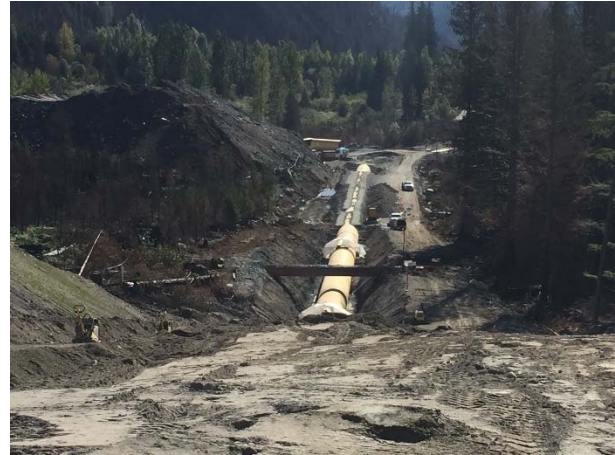
Photo 7 – Overview of active penstock work area; including welding and backfill placement (September 29, 2015).

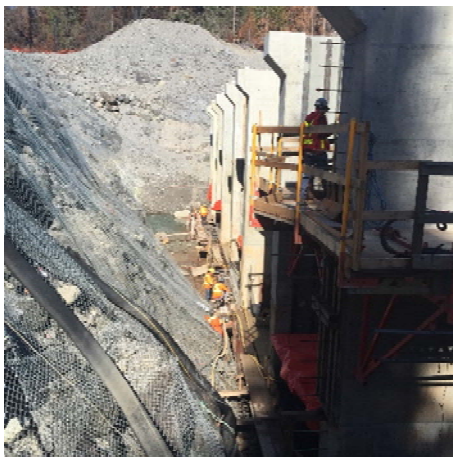
- Formwork and rebar installation (Photo 8).
- Structural concrete pour on September 27 and 29.
- Manifold installation works continued throughout the reporting period (Photo 9).

Photo 8 – Current conditions at the tailrace of the ULRHEF powerhouse (September 29, 2015).

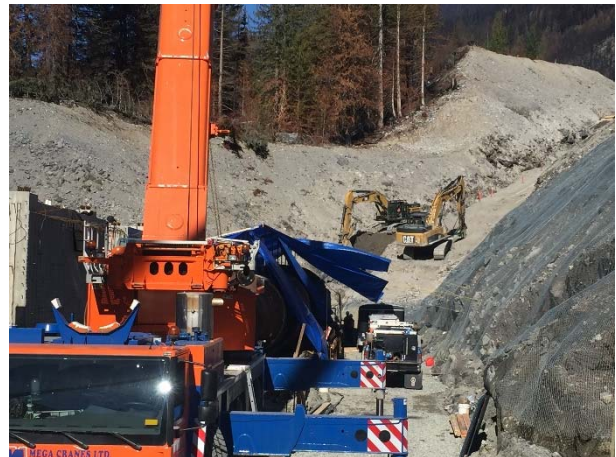
Photo 9 – Installation of the manifold continued during this reporting period (September 29, 2015).

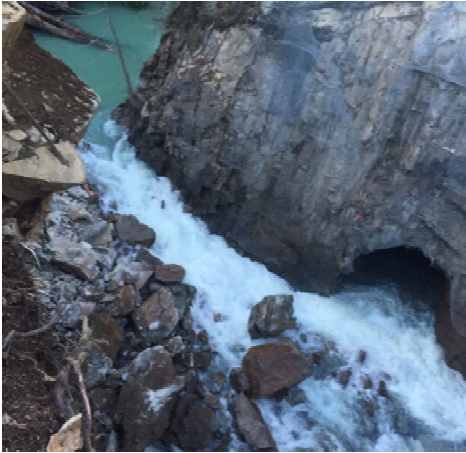
- CE completed all reasonable mitigation measure to reduce the amount of blast rock lost to the river during each blast at the Boulder intake crane pad; however blast rock did enter the river during some of the blasts. The IEM was onsite to monitor water quality following each blast and no visible water quality impacts were observed. The IEM has determined that the blast rock lost to the creek did not cause environmental impact or concern for the following reasons:

- No visual impacts to water quality were observed (water quality was not able to be sampled due to access limitations), and,
 - All the rock will be removed during construction of the intake structure.

Photo 10 – Material lost during blasting for the excavation of the access ramp at BDRHEF intake. Water quality remained visually unaffected immediately after the blast. (September 27, 2015).

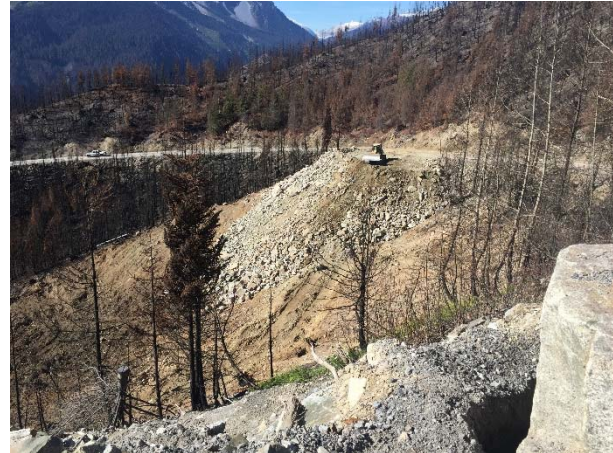
Photo 11 – Spoil area used to place blast rock generated from the intake access ramp excavation. (September 29, 2015).

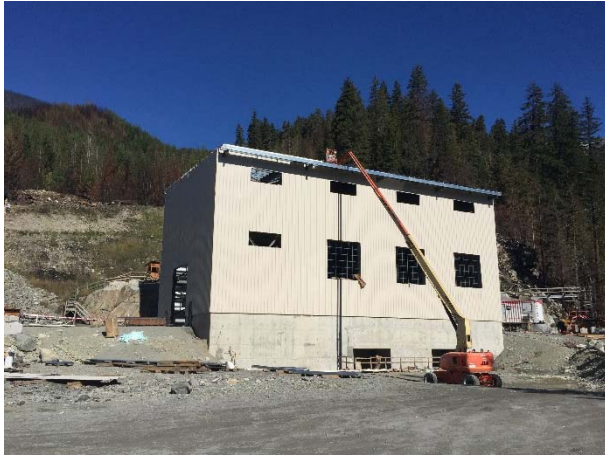
Photo 12 – BDRHEF powerhouse structure
(September 29, 2015).

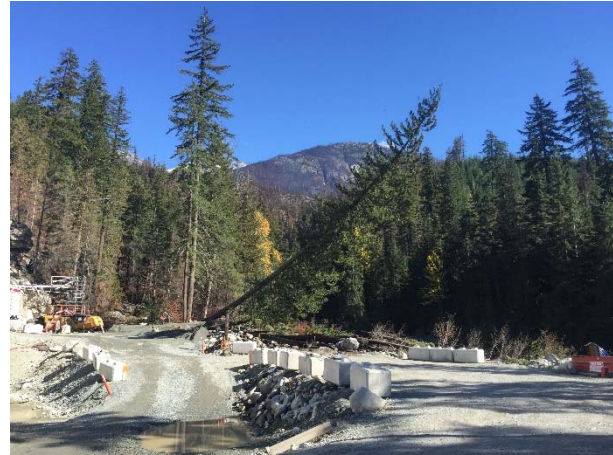
- The IEM was onsite on September 29, to oversee falling activities within the Boulder Creek RVMA, identified OGMA, and suitable SPOW habitat. The IEM verified that clearing boundaries were flagged and reviewed by the fallers prior to completing the works.
- All wastewater related to the BDRHEF tunnelling works continued to be contained and conveyed to the downstream portal settling ponds for treatment. The water in the settling ponds has reached the fourth cell, and continues to infiltrate to ground.

Photo 13 – Falling within the footprint of the Boulder Creek diversion berm and within the Boulder Creek RVMA was monitored by the IEM (September 30, 2015).

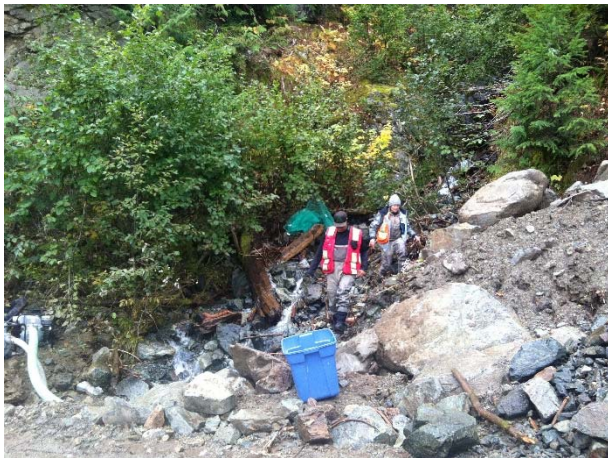
Photo 14 – Installing CTF isolation netting and conducting CTF salvage prior to starting the stream 272a culvert removal works in Segment 11. (October 2, 2015).

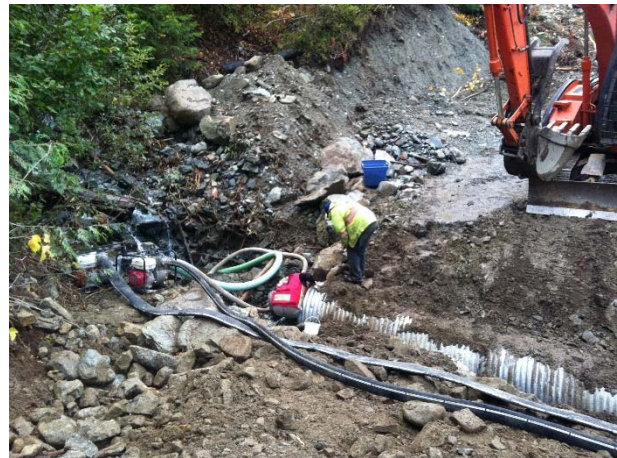
Photo 15 – Pumps and hoses installed to dry work area during the 272a culvert removal. Once the culvert was dry it was assessed for CTF presence (October 2, 2015)

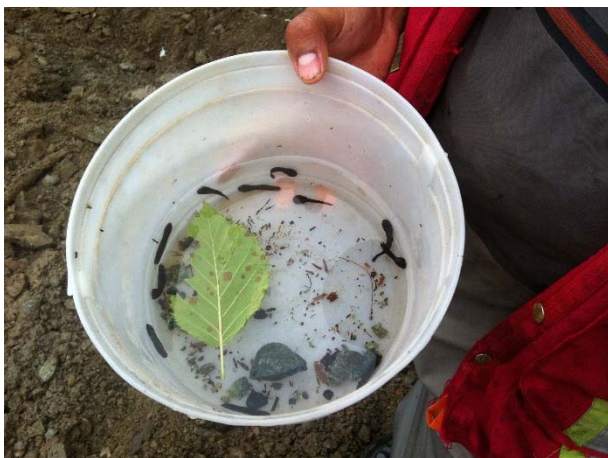
Photo 16 – CTF captured and relocated upstream of stream 272a culvert removal works. (October 2, 2015)

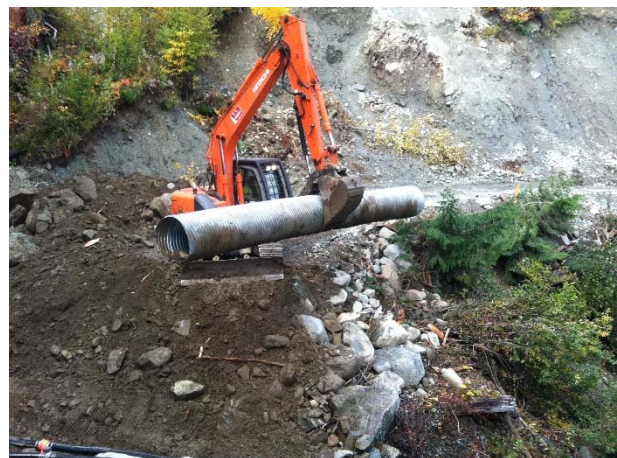
Photo 17 – Removal of stream 272a culvert completed in the dry. (October 2, 2015).

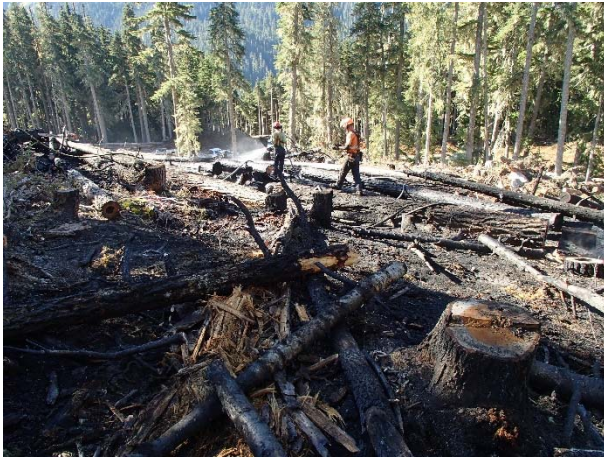
- On September 30, a small fire (Photo 18, Photo 19) ignited during blasting works associated with the reactivation of the ULHP TX Line access road in Segment 13 that accesses structure 308 (referred to as Road 306A or Road 308). A blast cap landed in a pile of dead cedar following blast detonation and ignited the very dry material. A helicopter responded immediately and extinguished the fire with water buckets. A guard was dug around the smoldering pile of debris with an excavator and a fire watch was held to ensure it did not flare up. The BC Wildfire service, and INX were notified of the fire immediately and the appropriate level of response was initiated in a timely manner.

Photo 18 – Wetting down hot spots after a fire was accidentally started from blasting activities associated with Road 306 in Segment 13 (October 1, 2015).

Incident description: A blast was set off using handi-dets and safety fuse. It is suspected that a handi-det from the blast caused some dry cedar to ignite which quickly spread to the surrounding debris and standing timber.

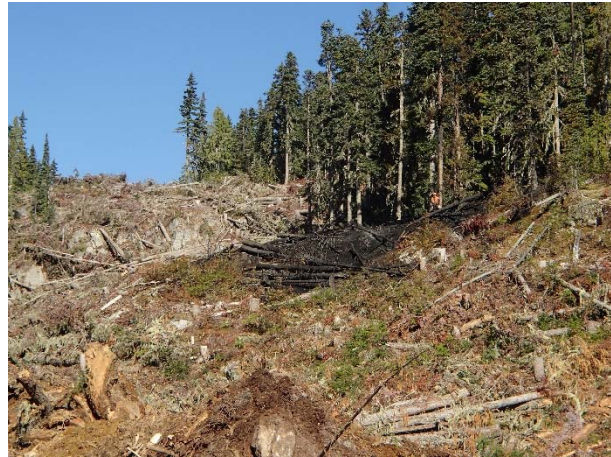
Photo 19 – Overview of the area burned in Segment 13 (October 1, 2015)
