Upper Lillooet Hydro Project

Weekly Environmental Monitoring Report #74

Reporting Period: October 4 – October 10, 2015

Upper Lillooet River Hydroelectric Facility (Water File No. 2002561, Water licence No. C130613), Boulder Creek Hydroelectric Facility (Water File No. 2003049, Water licence No. C129969) & Transmission Line (TX Line)

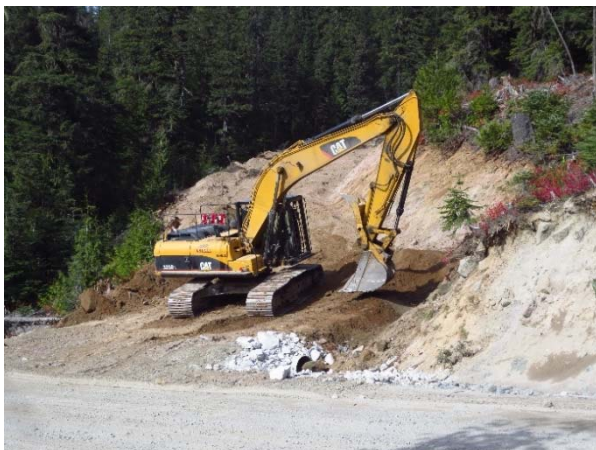
- Ditch installation at the KM 45 spoil area access road (Photo 1).
- Stripping and grubbing of the permanent PAG rock storage area (Photo 2). Organic material and woody debris will remain onsite for future restoration works.
- Routine maintenance of construction equipment within the mechanic shop and fuel management continued at the KM 38 laydown. All hazardous substance materials (waste oil, contaminated soil, used oil/hydraulic fluid containers, etc.) were stored temporarily for off-site disposal in a designated area at the laydown (Photo 3). The materials were all well contained and protected from the weather.
- The electric fences surrounding the construction camp were maintained and operational throughout this reporting period.

Photo 1 – Ditching access road to KM 45 spoil pile (October 5, 2015).

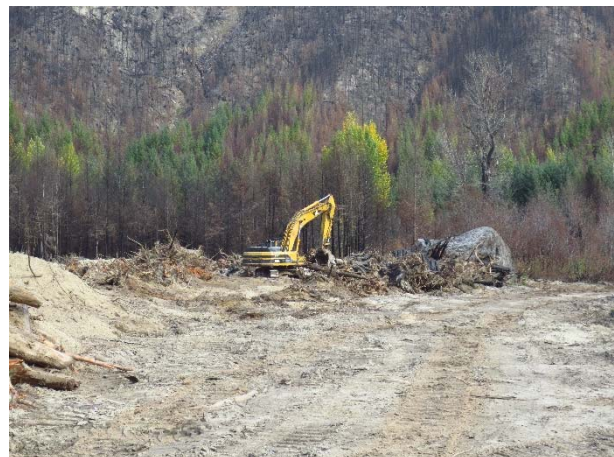
Photo 2 – Stripping and grubbing of the PAG rock storage area (October 6, 2015).

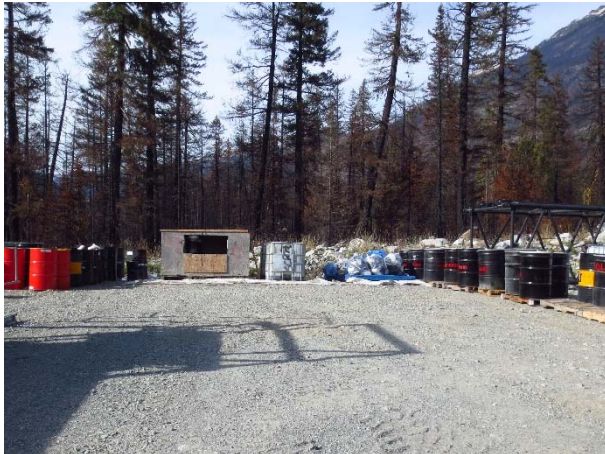
Photo 3 – Waste product storage area at KM 38 laydown (October 5, 2015).

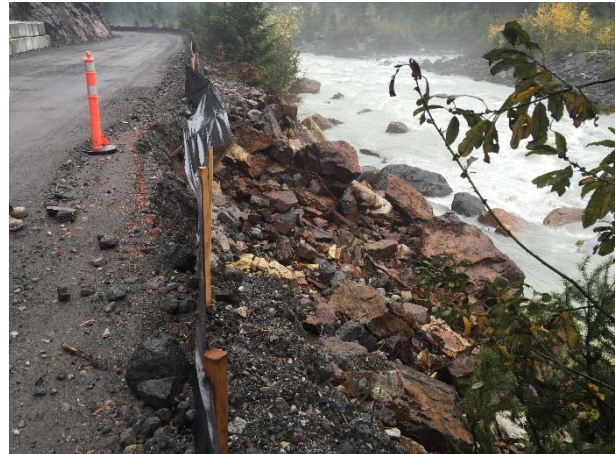
- On October 8, the IEM assessed road conditions between KM 41 and 41.2 on the Lillooet River FSR (Photo 4). From the assessment, it is apparent that bank stabilization, ditching, and culvert installation works will be required to improve drainage and stabilize the road edge in this section of the FSR due to implementation of post-wildfire landslide assessment rock scaling requirement of the KM 40.5 to KM 41.2 slope. The IEM determined that the works would be able to be completed above the high water mark of the Lillooet River. Works are scheduled for the week of October 25 – 31.

Photo 4 – Road stabilization works required at KM 41 on the Lillooet River FSR (October 8, 2015).

- All seepage water in the intake excavation and portal should be conveyed to the sediment basins unless approved for discharge directly to the Lillooet River by the IEM or CE environmental manager.
- The IEM recommends that the access roads and tributaries on the penstock alignment be monitored regularly to ensure that no ESC issues develop with the continued installation works and traffic.
- Maintenance of the downstream portal infiltration ponds is required to restore their function and ensure continued adherence to the Surface Water Quality Management Plan.
- The ULRHEF powerhouse sump water should be monitored regularly. Alkaline or turbid water should be pumped to the settling ponds for treatment.

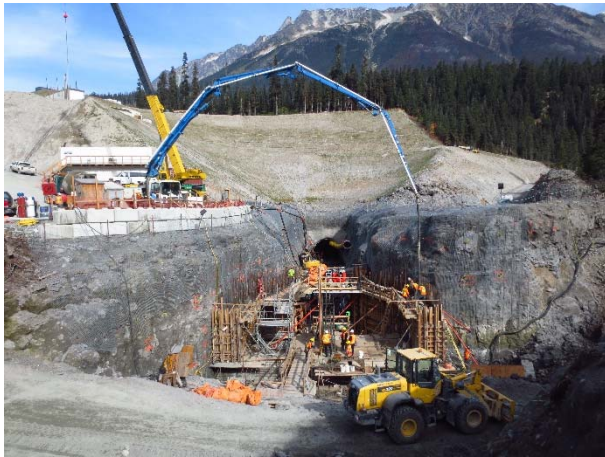
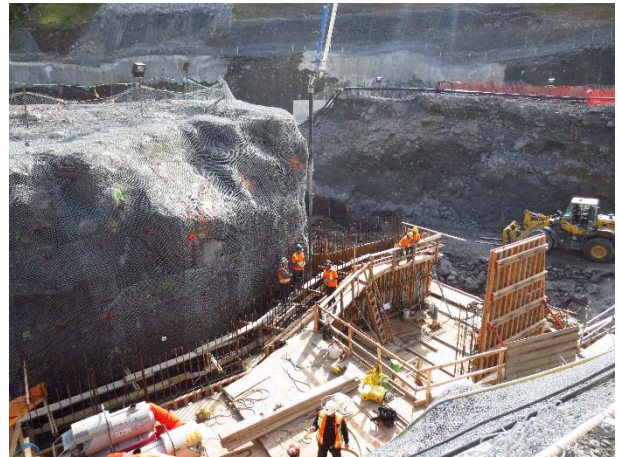
- Drilling, blasting and tunnel stabilization at the ULRHEF upstream portal.
- Rebar and formwork installation.
- Concrete pours for intake structure (Photo 5 Photo 6).
- Excavation and mud-slab concrete pour at sluiceway location (Photo 7).
- Dewatering to ULRHEF intake sediment basins (Photo 8 and Photo 9).

Photo 5 – Concrete pour at the ULRHEF intake (October 7, 2015).

Photo 6 – Concrete pour at the ULRHEF intake (October 7, 2015).

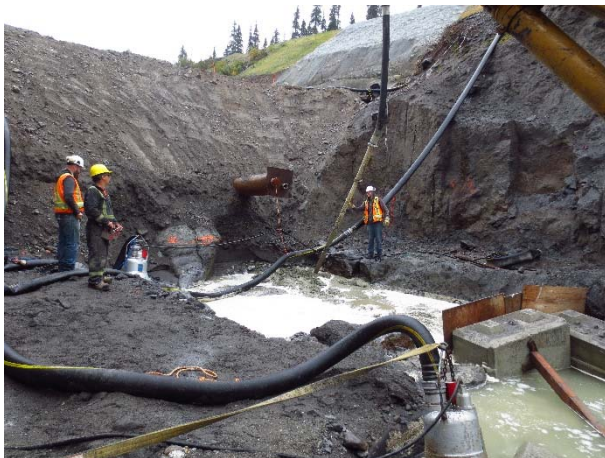
Photo 7 – Concrete pour at ULRHEF intake sluiceway location (October 8, 2015).

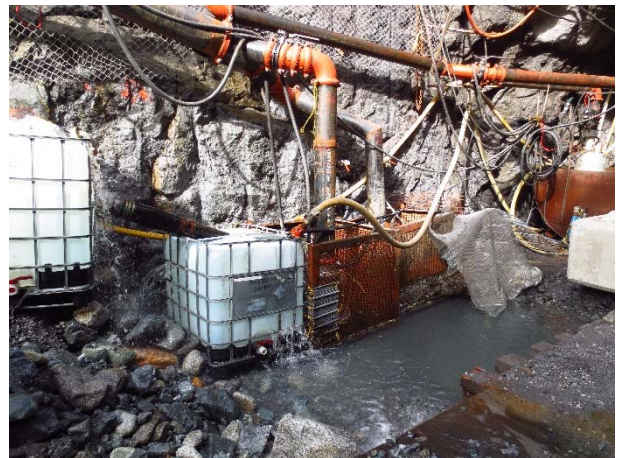
- All turbid or alkaline water resulting from activities at the ULRHEF intake or upstream tunnel portal is pumped to the ULRHEF intake sediment basins (Photo 8 and Photo 9). A dedicated CE crewmember is present to monitor the pumps within the intake work area and tunnel portal during active construction works. This person has the responsibility of directing all turbid or alkaline water to the sediment ponds and must verify with CE environmental staff or the IEM prior to directing any water to the Lillooet River. All water in the intake sediment basins infiltrated to ground during this reporting period. The water has reached the last sediment basin cell (Photo 9).

Photo 8 – ULRHEF upstream tunnel portal sump (October 5, 2015).

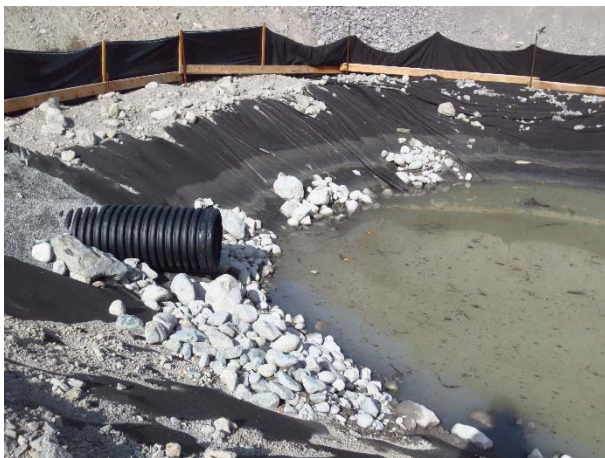
Photo 9 – ULRHEF intake sediment basin outlet pipe (October 5, 2015).

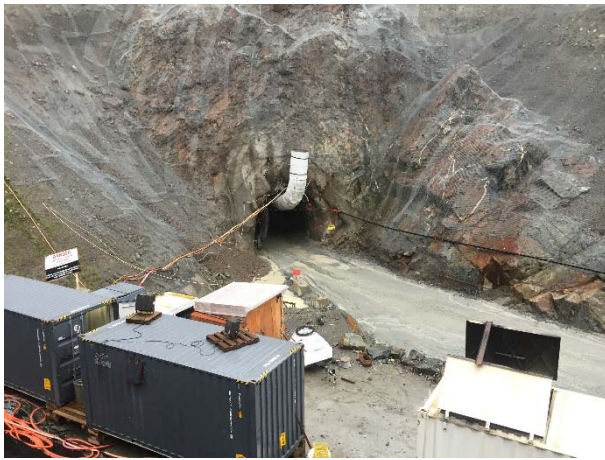
- Drilling, blasting, mucking and stabilization works within the tunnel (Photo 10).
- Dewatering to downstream tunnel portal settling ponds (Photo 11).

Photo 10 – Current conditions at the ULRHEF downstream tunnel portal (October 8, 2015).

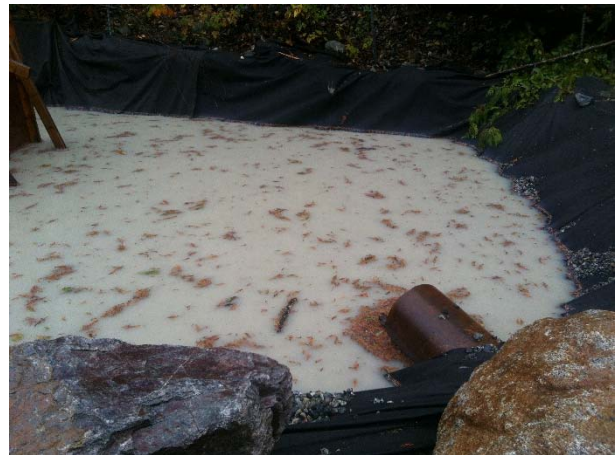
- The downstream portal infiltration ponds reached capacity and water began discharging to a vegetated area southwest of the ponds during this reporting period (Photo 11 and Photo 12). The IEM monitored the seepage flow from the ponds throughout the reporting period and confirmed that the water infiltrated in the vegetated area and was not discharged to the surrounding environment.

Photo 11 – ULRHEF downstream tunnel portal infiltration ponds (October 10, 2015).

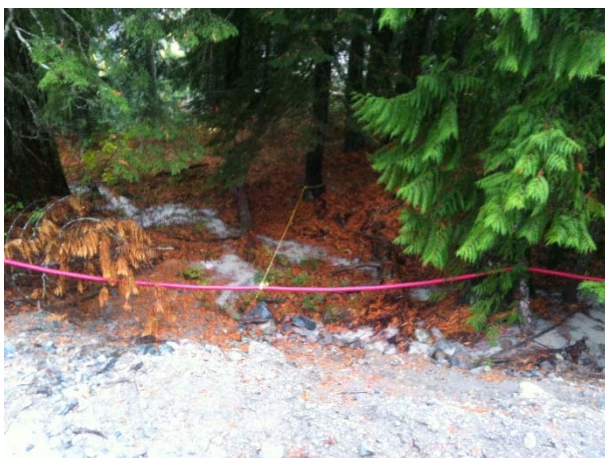
Photo 12 – ULRHEF downstream tunnel portal infiltration pond seepage (October 10, 2015).

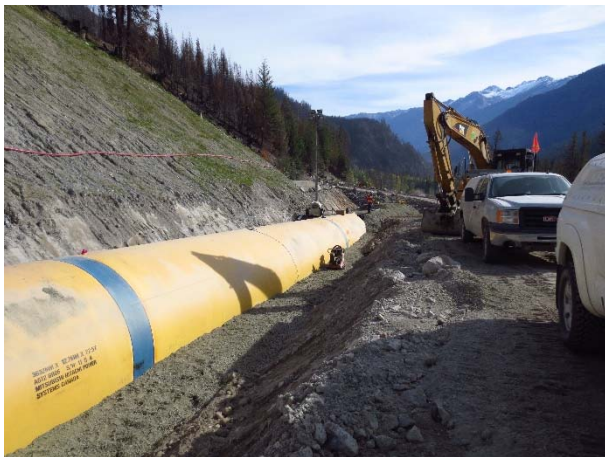
- Penstock excavation, installation and backfill continued from 3+300 to 3+900 (Photo 13).
- Penstock welding continued from 2+900 to 3+700 (Photo 14).

Photo 13 – Penstock backfill works
(October 5, 2015).

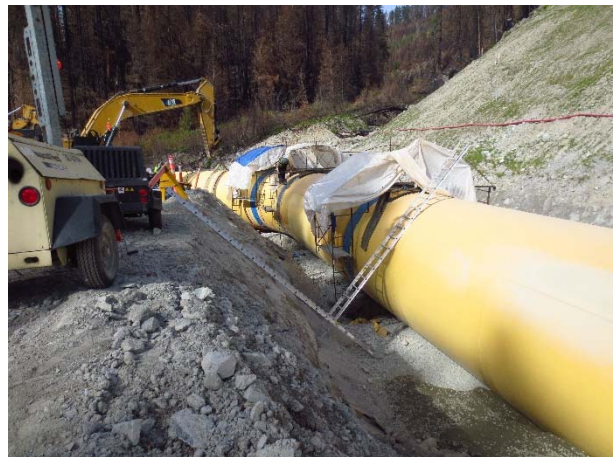
Photo 14 – Penstock welding near 3+500
(October 5, 2015).

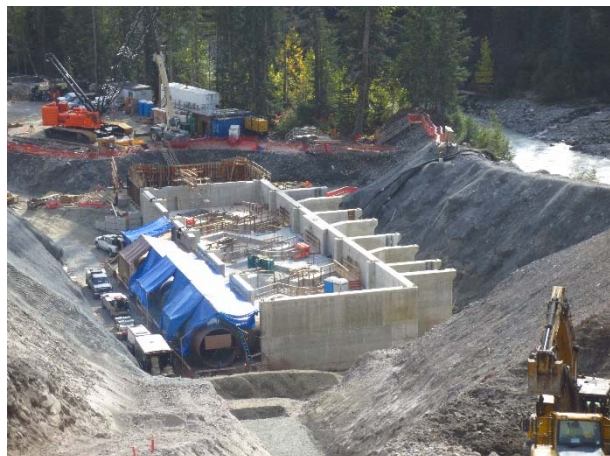
- Formwork and rebar installation (Photo 15).
- Structural concrete pour on October 6 (Photo 16).

Photo 15 – Current conditions at the ULRHEF powerhouse (October 6, 2015).

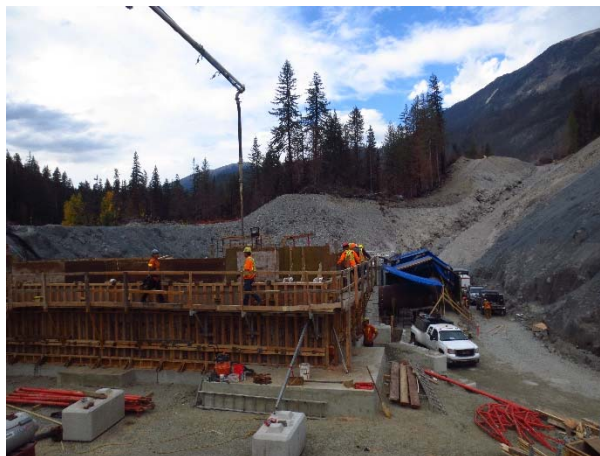
- On October 6, the IEM was onsite to inspect the ULRHEF powerhouse during a concrete pour. The IEM conducted water quality sampling of the powerhouse sump discharge. All water samples were measured to have a pH <9 and suitable for discharge to the surrounding environment as per the Surface Water Quality Protection Plan. See Section 4.6 Water Quality Results.

Photo 16 – Structural concrete pour at the ULRHEF powerhouse (October 6, 2015).

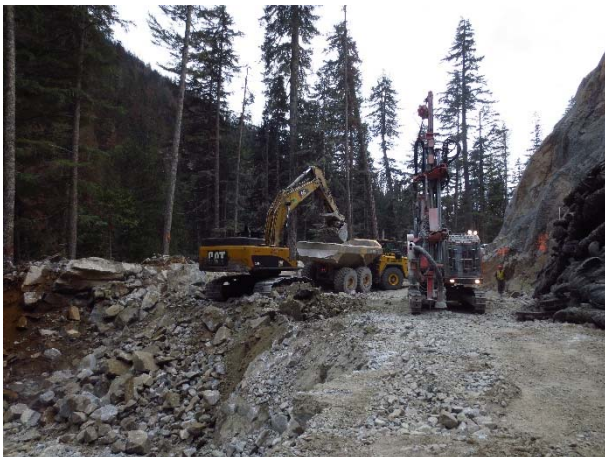
- Drilling, blasting and excavation for access ramp construction at BDRHEF intake (Photo 17).
- Rock consolidation works on the right bank at the intake (Photo 18).

Photo 17 – Excavation for access ramp at BDRHEF intake (October 6, 2015).

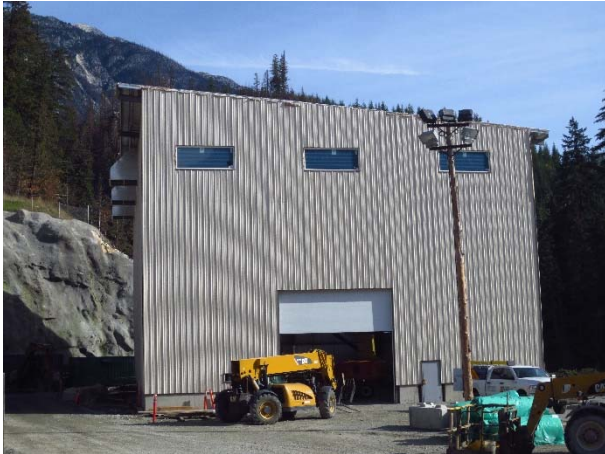
- BDRHEF powerhouse superstructure construction (Photo 19).
- Drilling, blasting, mucking and stabilization works within the tunnel.
- Dewatering of the tunnel and powerhouse to the oil water separator and settling ponds continued.

Photo 19 – BDRHEF powerhouse structure (October 5, 2015).

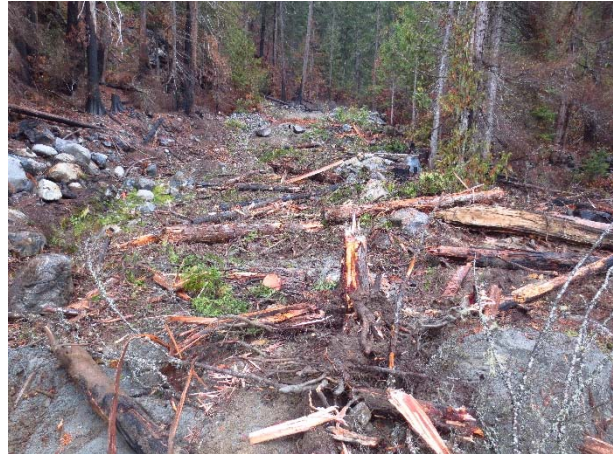
- Access road northeast of BDRHEF powerhouse was deactivated during this reporting period (Photo 20). The existing road surface was de-compacted with an excavator and organic material and coarse woody debris was placed to promote revegetation.
- The fish exclusion boxes were re-installed for the pump intakes in Boulder Creek near the BDRHEF tunnel portal (Photo 21).

Photo 20 – Deactivated access road northeast of BDRHEF powerhouse (October 8, 2015).

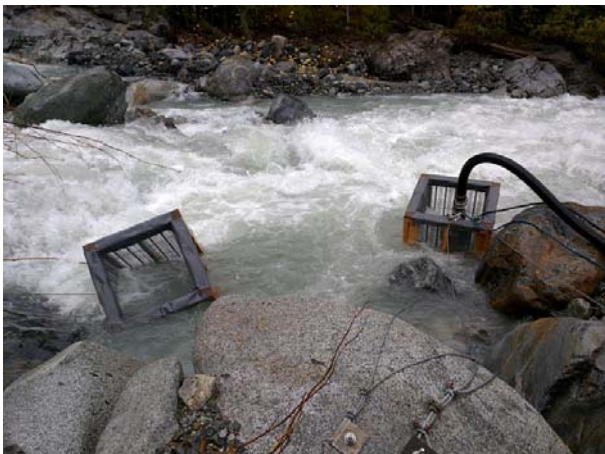
Photo 21 – Fish exclusion boxes re-installed on pump intakes in Boulder Creek (October 9, 2015).
