Upper Lillooet Hydro Project

Weekly Environmental Monitoring Report #77

Reporting Period: October 25 – October 31, 2015

Upper Lillooet River Hydroelectric Facility (Water File No. 2002561, Water licence No. C130613), Boulder Creek Hydroelectric Facility (Water File No. 2003049, Water licence No. C129969) & Transmission Line (TX Line)

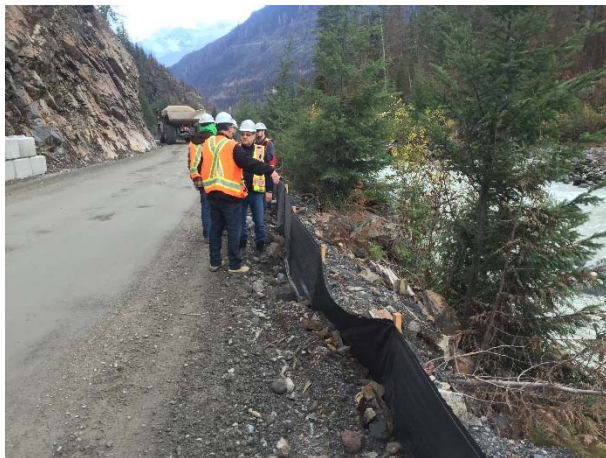
Photo 1 – Kick-off meeting held at KM 41.1 prior to road repairs (October 26, 2015).

- On October 26, a kick-off meeting was held for the bank stabilization, ditching, and culvert installation works at KM 41 – 41.2 on the Lillooet River FSR (Photo 1). The IEM and CE discussed work methods for repairs within 15m of the Lillooet River. On October 26 and 27, repairs were completed above the high water mark of the Lillooet River and silt fencing was reinstalled on road edge following completion (Photo 2 and Photo 3). The works improved drainage, stabilized the road edge and completed recommended mitigation measures to close ITM item *ULR #28* (see Section 9.0).

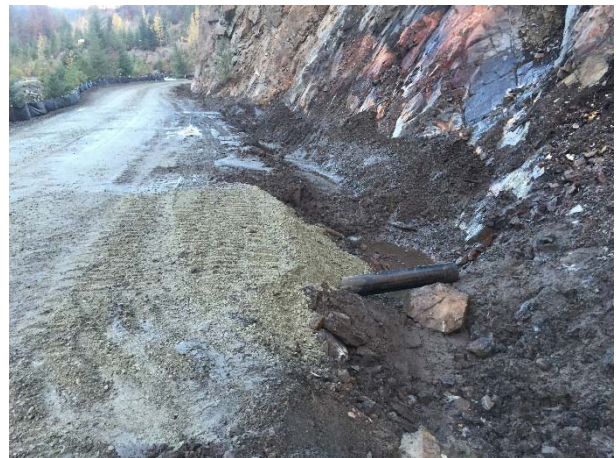
Photo 2 – Culvert installed at KM 41.1 on the Lillooet River FSR (October 27, 2015).

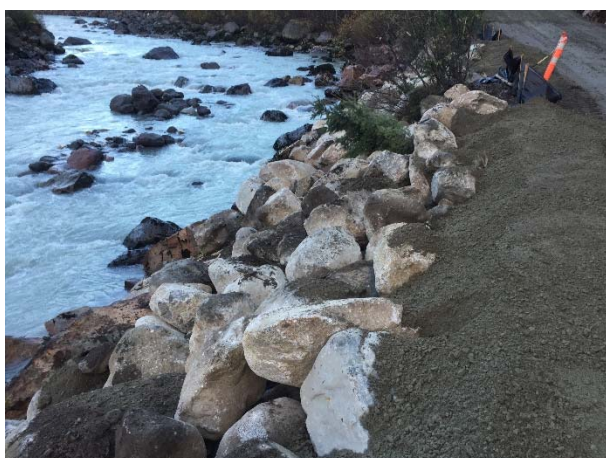
Photo 3 – Road edge repaired and armoured at KM 41.1 on the Lillooet River FSR (October 27, 2015).

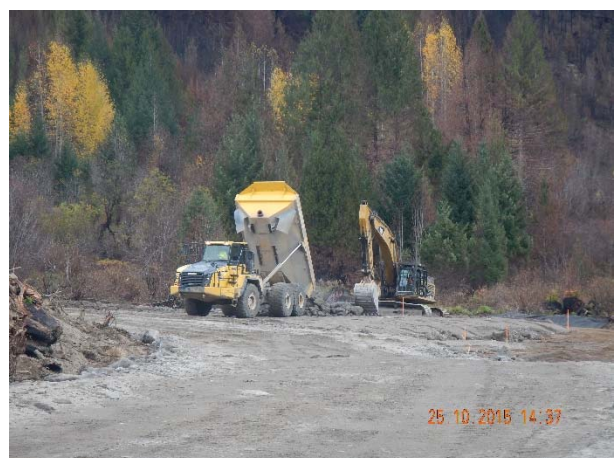
Photo 4 – Construction of PAG stockpile area at KM 41.75 on the Lillooet River FSR (October 25, 2015).

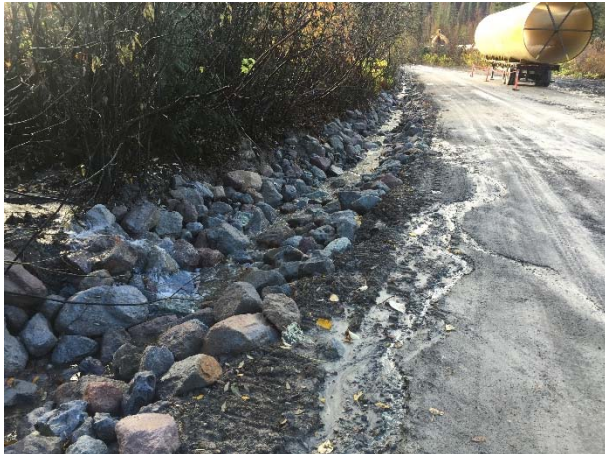
- An armoured ditch was installed at KM 42.5 on the Lillooet River FSR during this reporting period (Photo 5). The ditch has eliminated runoff on the road during rain events and completed recommended mitigation measures to close ITM item *ULR #29* (see Section 9.0).

Photo 5 – Armoured ditch installed at KM 42.5 on the Lillooet River FSR (October 30, 2015).

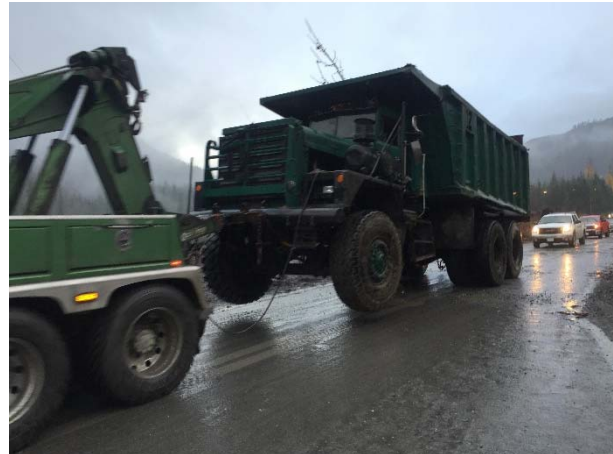
- On October 31, an excavator and tow trucks were used to remove the pumice truck from the slope at KM 45.25 on the Lillooet River FSR (Photo 6).

Photo 6 – Pumice truck removed from KM 45.25 on the Lillooet River FSR and towed off site (October 31, 2015).

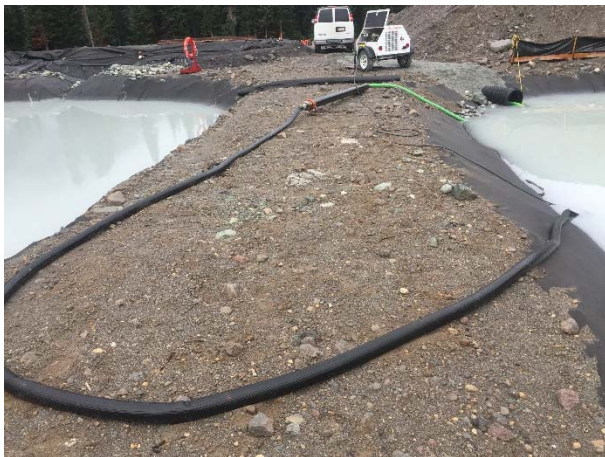
- On October 28, CE's environmental management team installed a flocculant injection system at the ULRHEF intake sediment basins (Photo 11; ITM ULR#34). The system was installed in the last cell before the lower basins to ensure sediment basin discharge remained within project water quality guidelines. On October 29, the IEM conducted water quality sampling upstream and downstream of the injection system. The system was observed to reduce turbidity from 72.0 NTU (11:07; fourth cell in upper basins) to 25.3 NTU (11:03; lower

basins). The flocculant system installation completed recommended mitigation measures to close ITM item ULR #34 (see Section 9.0).

Photo 11 – Flocculant injection system installed at ULRHEF intake sediment basins (October 28, 2015).

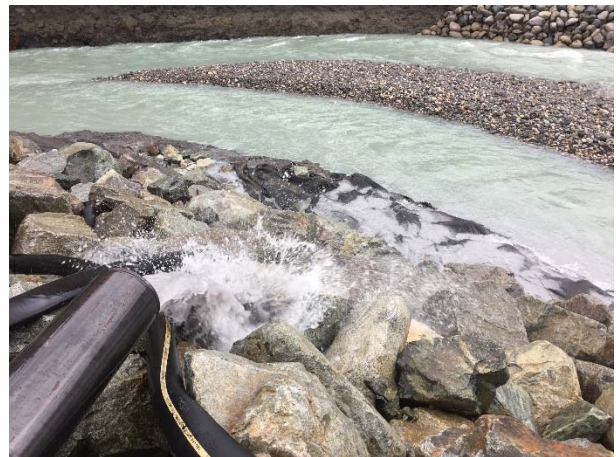
- On October 28, the IEM was onsite to monitor water quality during a blast in the ULRHEF upstream tunnel. Following the blast, the IEM observed that the tunnel sump pumps had not been diverted to the sediment basins and that turbid water was being discharged to the Lillooet River (Photo 12). The IEM notified CE crews and the tunnel seepage water was immediately diverted to the sediment basins. The turbid discharge persisted for less than 4 minutes and no visual change to downstream water quality was observed by the IEM downstream of the input. Please see Section 4.6 for results and sampling locations. The CE crew member in charge of the sump and sediment basin pumps routinely diverted the tunnel water to the basins 15 – 20 minutes following a blast. The increased volume of seepage in the tunnel following the October 28 blast caused turbid water to reach the sump at the portal entrance in less time than during previous blasts. CE's environmental team will ensure that all tunnel-dewatering pumps are diverted to the sediment basins and the IEM is informed prior to all blasting at the ULRHEF intake.

Photo 12 – Turbid water discharged to the Lillooet River following blast (October 28, 2015).

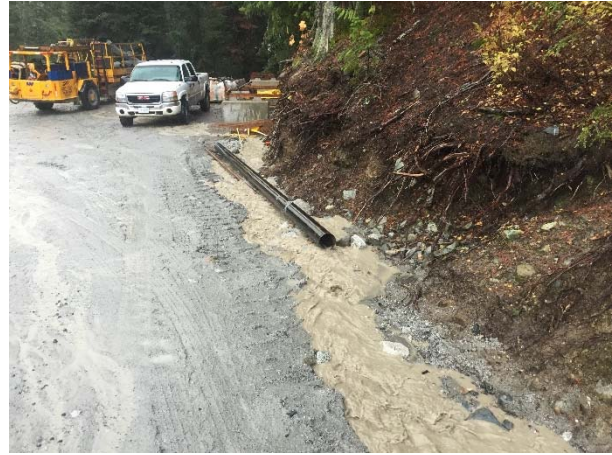
- On October 31, the IEM observed turbid runoff on the downstream portal access road and at portal laydown area during a significant rain event (Photo 14 and Photo 15). The IEM identified the source of the runoff at KM 45 on the Lillooet River FSR. An infilled ditch-line caused water to run over the road surface to KM 44.75 and drain down the slope to the downstream portal access road. The IEM also identified the need for a drainage path at the bottom of the access road to prevent water from fanning out into the laydown area. The IEM notified CE's environmental management team of the observed drainage deficiencies.

Photo 14 – Turbid runoff in ditch on ULRHEF downstream portal access road (October 31, 2015).

- All seepage water in the intake excavation and portal should be conveyed to the sediment basins unless approved for discharge directly to the Lillooet River by the IEM or CE environmental manager.
- The IEM recommends that the access roads and tributaries on the penstock alignment be monitored regularly to ensure that no ESC issues develop with the continued installation works and traffic.
- The ULRHEF powerhouse sump water should be monitored regularly. Alkaline or turbid water should be pumped to the settling ponds for treatment.
- Environmental issues and recommendations associated with FAM#05 should be addressed in a timely manner. Refer to the ITM for outstanding items as of the end of this reporting period.

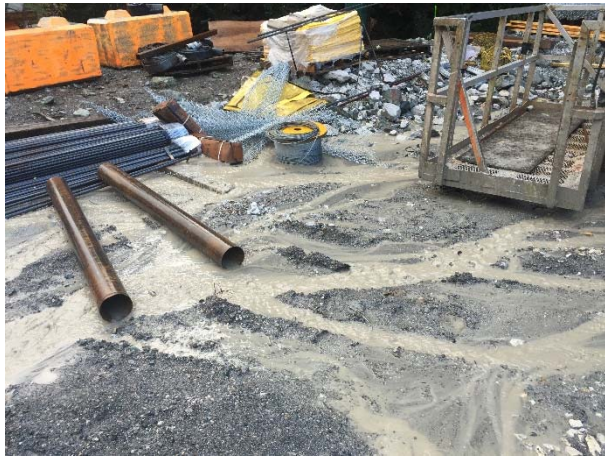
Photo 15 – Turbid runoff fanning out in laydown area at bottom of downstream portal access road (October 31, 2015).

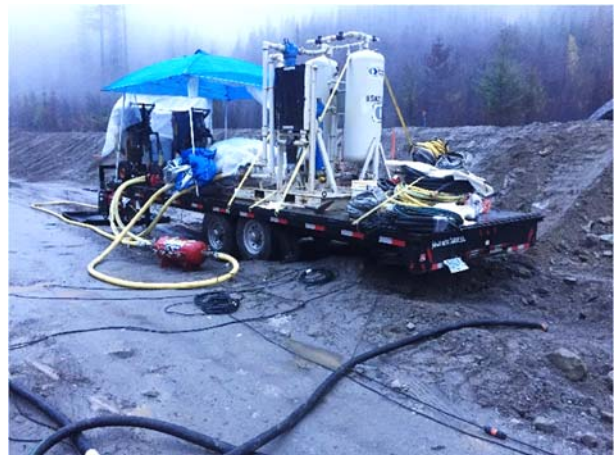
- On October 29, a kick-off meeting was held for the penstock lining works at 3+500 on the penstock alignment (Photo 19). It was agreed that all sand-blasted waste material related to the lining activities would be bagged, stored at the KM 38 laydown and hauled offsite to an appropriate waste facility.

Photo 19 – Penstock lining equipment at 3+500 on the penstock alignment (October 29, 2015).

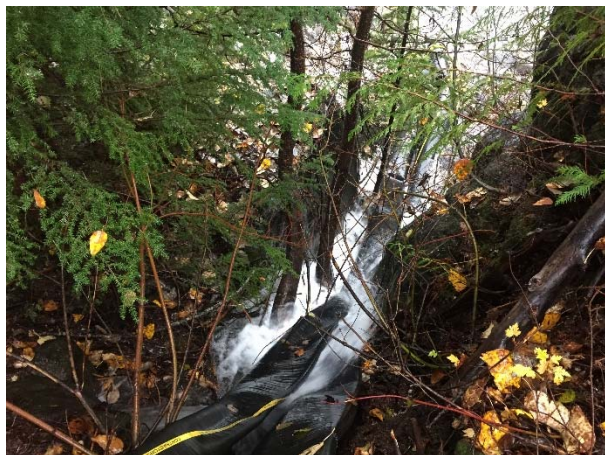
Photo 22 – Dewatering seepage water from the ULRHEF powerhouse sump to the Lillooet River (October 31, 2015).

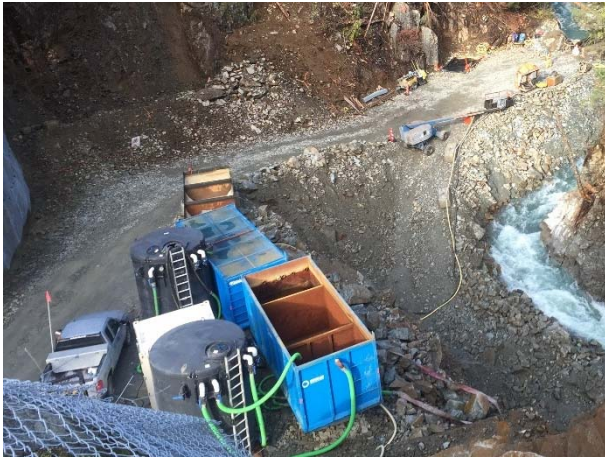
- All wastewater related to diversion tunneling activities is pumped to an active water treatment system installed at the bottom of the intake access ramp (Photo 27 and Photo 28). The IEM and CE's environmental management team will routinely sample the system discharge to Boulder Creek. No water discharged from the active treatment system during this reporting period.

Photo 27 – Active water treatment system at BDRHEF intake (October 29, 2015).

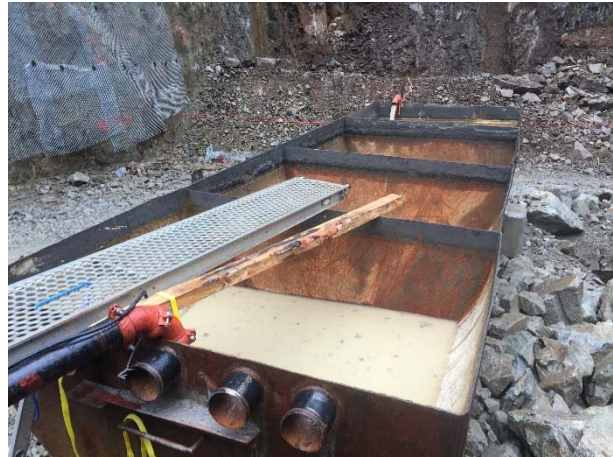
Photo 28 – Tunneling wastewater pumped to active water treatment system (October 29, 2015).

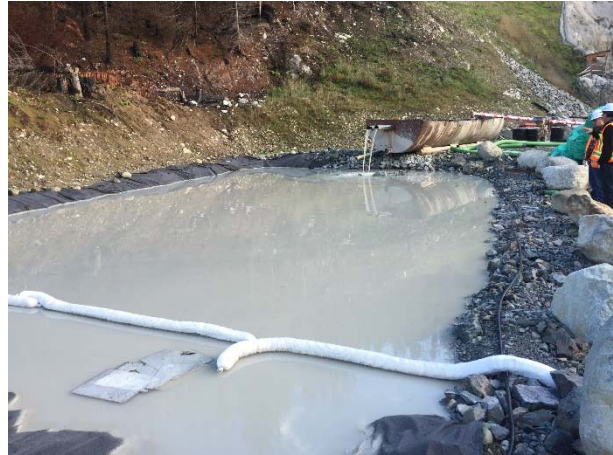
- All wastewater related to the BDRHEF tunnelling works continued to be contained and conveyed to the downstream portal settling ponds for treatment (Photo 30). The water in the settling ponds continues to infiltrate to ground.

Photo 30 – BDRHEF tunnel portal settling ponds (October 27, 2015).

- All wastewater related to the BDRHEF tunnelling works should continue to be contained and conveyed to the downstream portal settling ponds for treatment. Regular inspections of the treatment ponds should be performed to ensure the necessary maintenance activities outlined in the work plan are performed.
- Environmental issues and recommendations associated with FAM#05 should be addressed in a timely manner. Refer to the ITM for outstanding items as of the end of this reporting period.

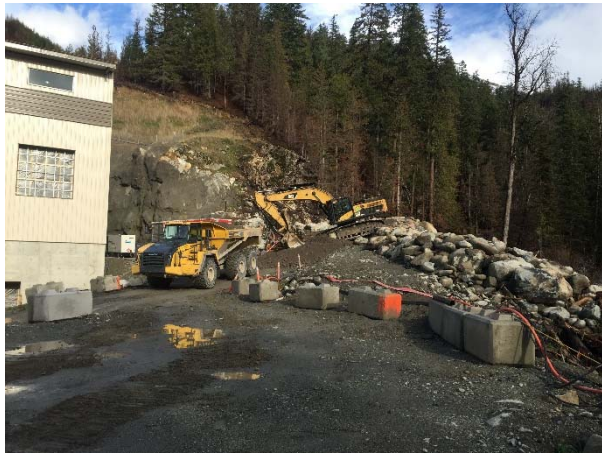
Photo 31 – Modification works on BDRHEF powerhouse debris flood protection berm (October 30, 2015).

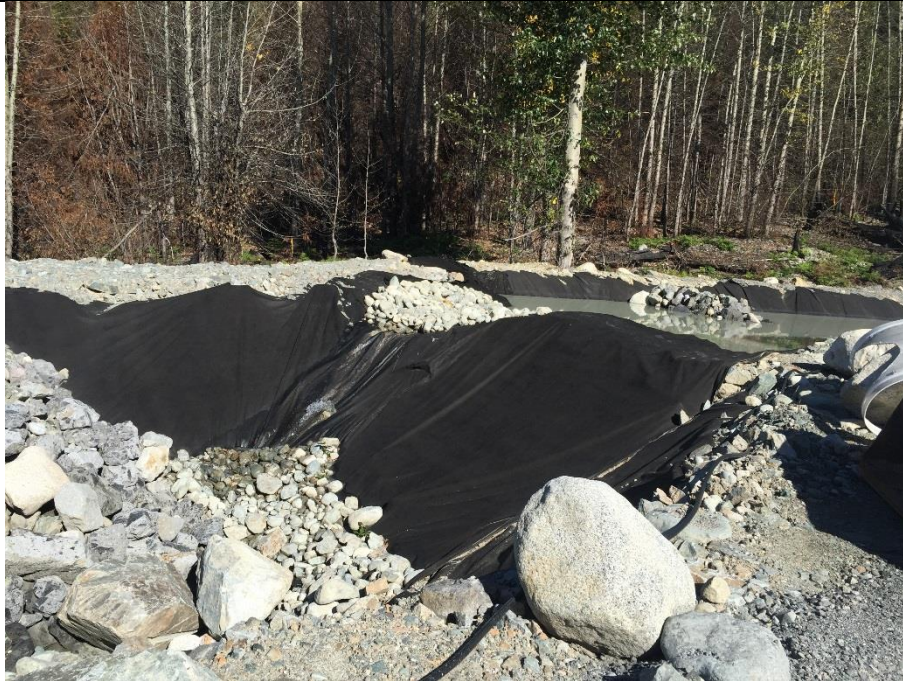
BDR#25. Water from the fourth cell of the water treatment ponds is seeping out of the edge of the pond, flows over an active haul path, and along the edge of the powerhouse access road before infiltrating to ground

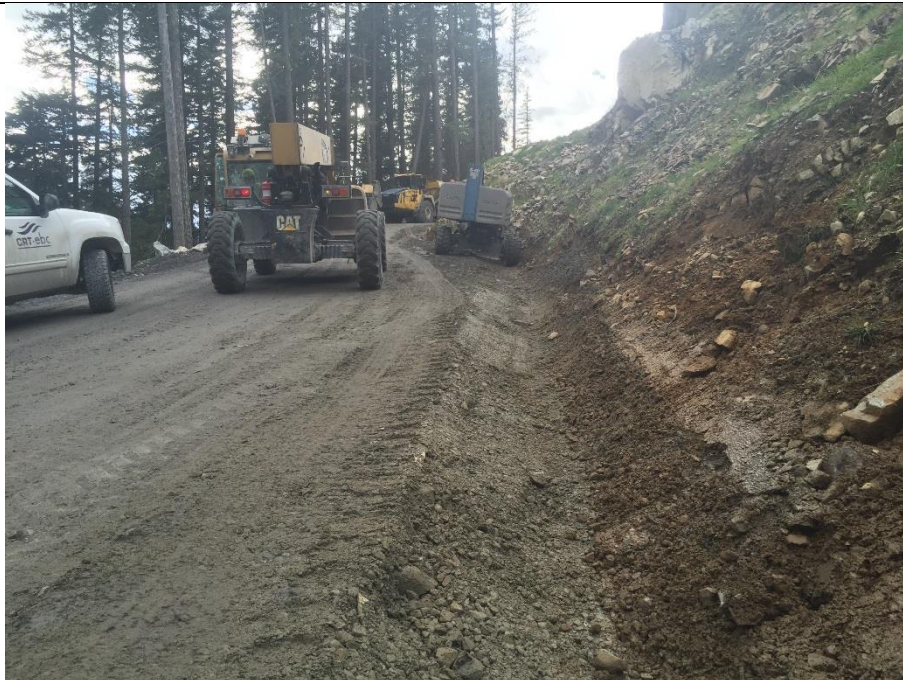
ULR#26. Ditch installation has started along the Boulder intake access road between 4 – 5KM. Ditches should continue to be installed along this section of road and all culvert inlets should be inspected and maintained as required. Note: Equipment should not park in the ditch lines.

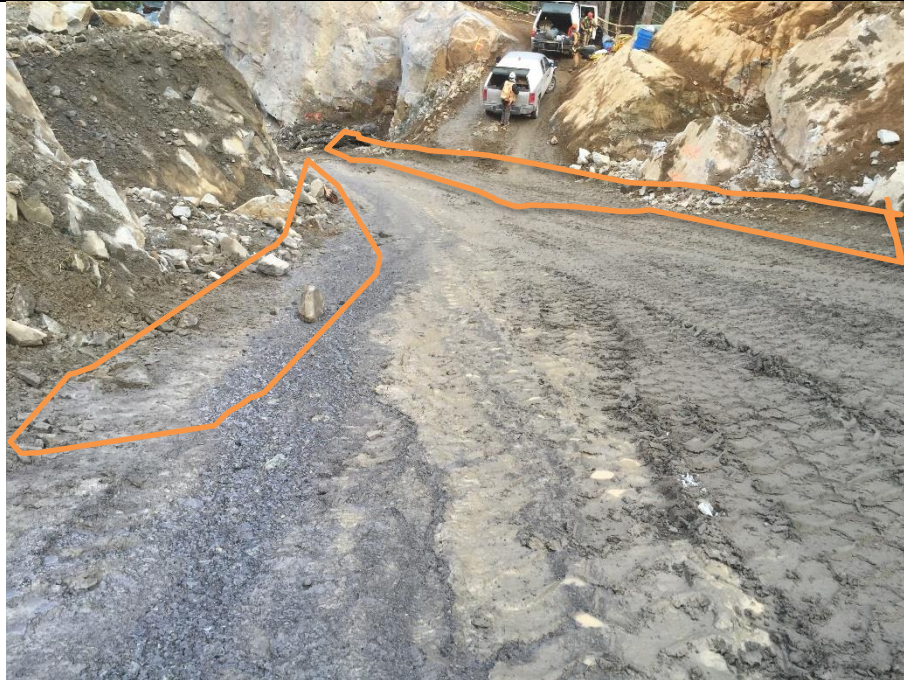
BDR#27. Ditches outlined in the work plan have not been installed and sediment/sediment laden water are flowing over the running surface along the length of the ramp

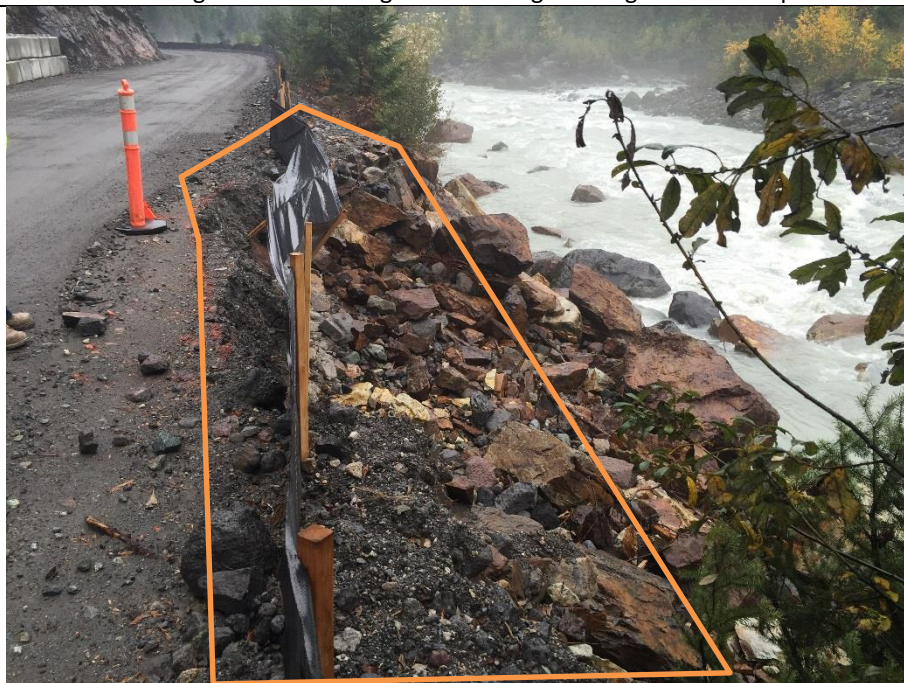
ULR#28. The road edge eroded significantly during scaling activities and during the last major rain event and requires bank stabilization (above the HWM), ditch installation/maintenance, and silt fence repair.

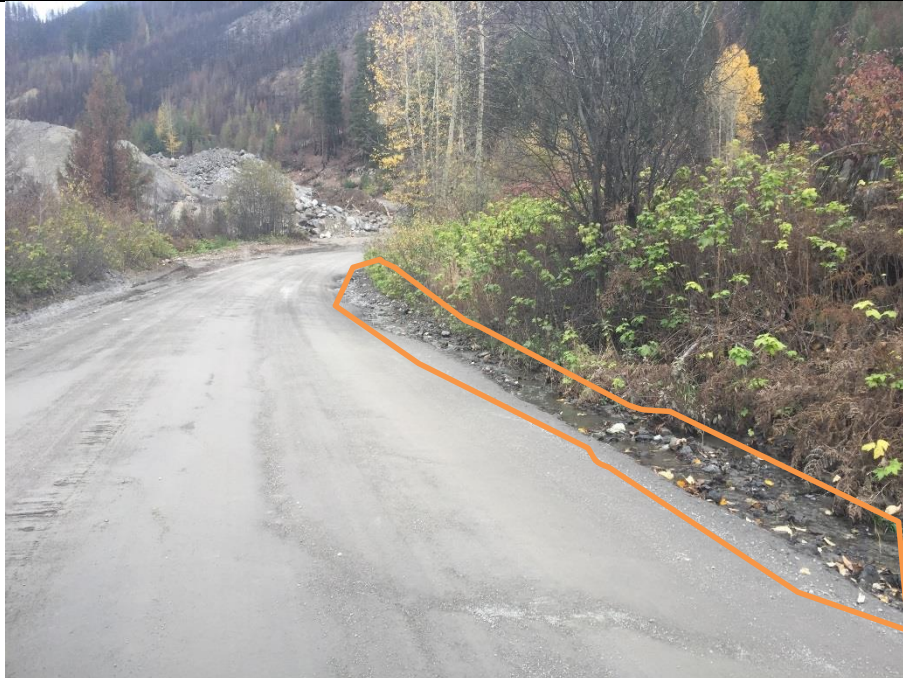
ULR#29. Water in the ditch line is eroding the road edge

ULR#29	OPEN	Lillooet River FSR ~ KM42 – KM42.5	Water in the ditch line is eroding the road edge	Formalize and armour the ditch line to protect the road edge from further erosion	October 26, 2015	November 7, 2015		
ULR#30	OPEN	ASTR04 – Haul road crossing	The silt fence on the downstream side of the WBC/road has failed. Runoff from the surface of the haul road is not conveyed in a ditch. As a result flows concentrate in this location, which led to the silt fence failure.	1. Repair the haul road drainage to direct water away from ASTR04 2. Remove failed silt fence ensuring material does not enter ASTR04, and replace it.	October 26, 2015	November 7, 2015

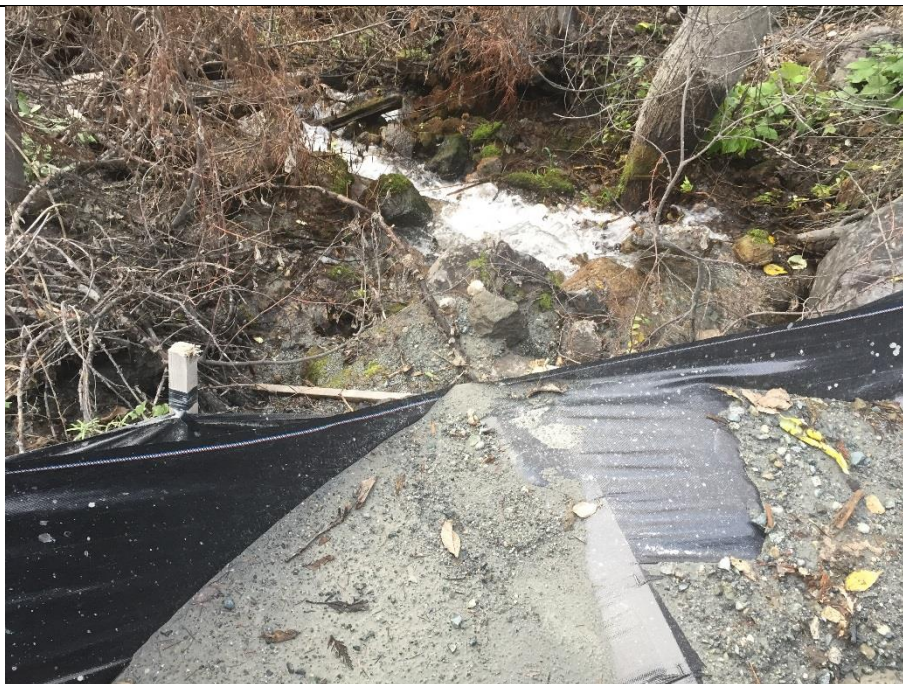
ULR#30. The silt fence on the downstream side of the WBC/road at ASTRO4 has failed. Runoff from the surface of the haul road is not conveyed in a ditch. As a result flows concentrate in this location, which led to the silt fence failure.

ID No.	Status	Location	Issue Description	Action Taken/Recommended	Date of Identification	Targeted Date for Completion	Date Completed
ULR#30	OPEN	ASTR04 – Haul road crossing	The silt fence on the downstream side of the WBC/road has failed. Runoff from the surface of the haul road is not conveyed in a ditch. As a result, flows concentrate in this location, which led to the silt fence failure.	<ol style="list-style-type: none"> 1. Repair the haul road drainage to direct water away from ASTR04 2. Remove failed silt fence ensuring material does not enter ASTR04, and replace it. 	Oct. 26, 2015	Nov. 7, 2015	
ULR#31	OPEN	ULRHEF- Downstream Tunnel Portal access road drainage ditches	Ditches are not collecting and transporting road runoff as intended due to the road grading along the lower ULRHEF tunnel portal access road and infilling of the ditch line.	<ol style="list-style-type: none"> 1. Clean out ditch line and re-grade road to convey water to the ditch line 2. Ensure water from the laydown area is drained/conveyed into the re-established ditch line. 	Oct. 26, 2015	Nov. 7, 2015

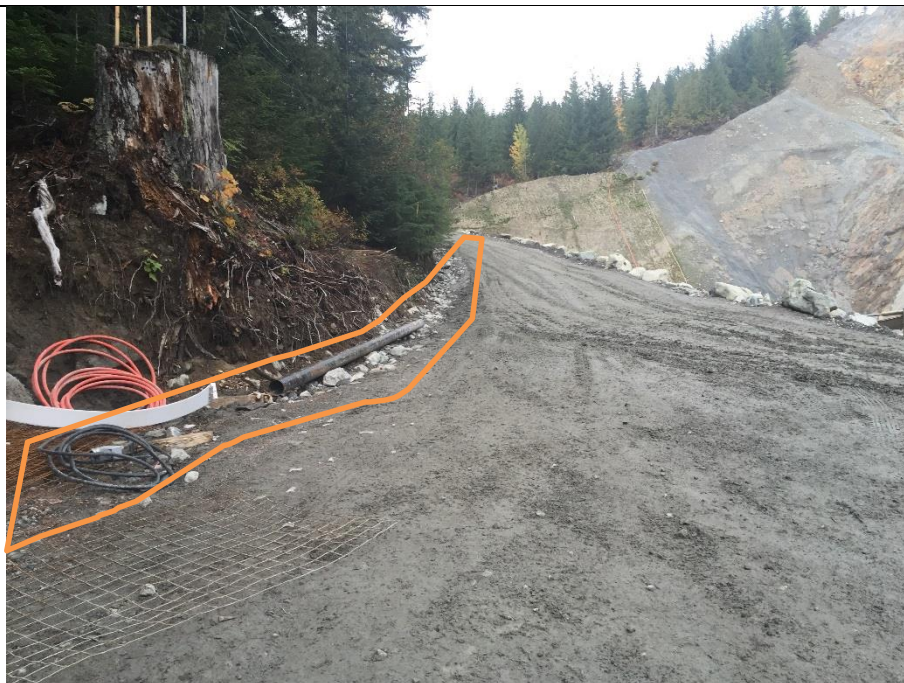
ULR#31. Ditches are not collecting and transporting road runoff as intended due to the road grading along the lower ULRHEF tunnel portal access road and infilling of the ditch line. Surface runoff is not conveyed in ditch lines and discharges sediment laden water directly to Truckwash Creek during rain events.

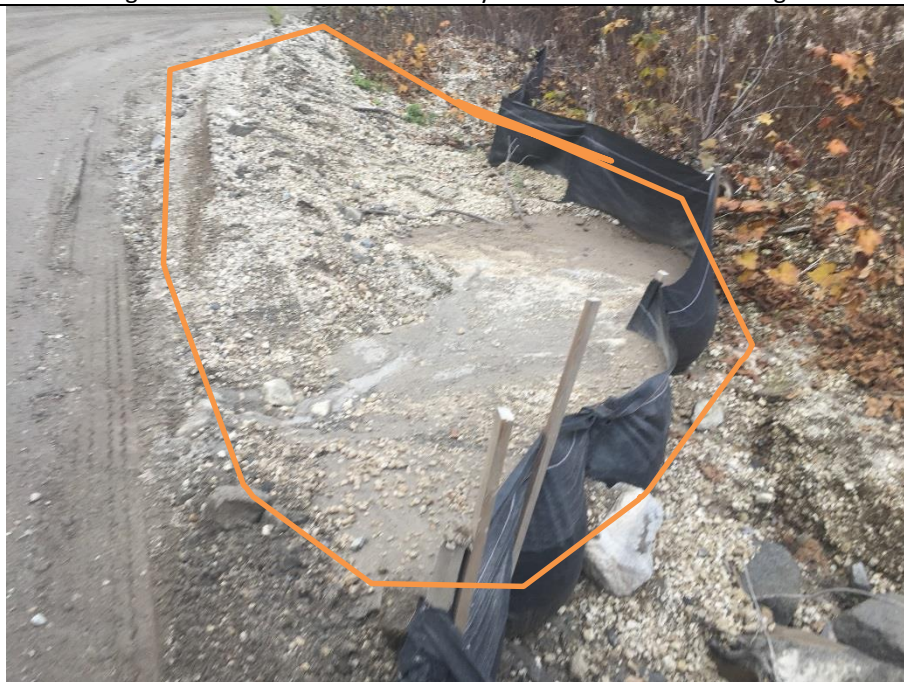
ULR#32. The silt fence on the upstream side of the second WBC is 95% infilled with sediment and has previously failed (KM48 of the Lillooet River FSR).

ULR#32	CLOSED	Lillooet River FSR – KM48	The silt fence on the upstream side of the second WBC is 95% infilled with sediment and has previously failed.	Removed the sediment accumulation captured by the silt fence and replace the silt fence.	Oct. 26, 2015	Nov. 7, 2015	Oct. 30, 2015
ULR#33	CLOSED	River Right – ULRHEF intake	Infilled ditches require maintenance	<ol style="list-style-type: none"> 1. Clean-out the ditch above the river right cut slope to prevent further riling 2. Remove material that has infilled the ditch in sections along the access road 	Oct. 26, 2015	Nov. 7, 2015	Oct. 26, 2015
ULR#34	CLOSED	ULRHEF intake – Water treatment ponds	The flocculant treatment component of the water treatment ponds are not currently installed	Install flocculant treatment component of the ponds as outlined in the work plan to prevent further exceedances of BCWQGs when water discharges to the Lillooet River. Note: Turbidity of the discharge temporarily exceeded BCWQGs on Oct. 25, 2015.	Oct. 25, 2015	Nov. 7, 2015	Oct. 28, 2015

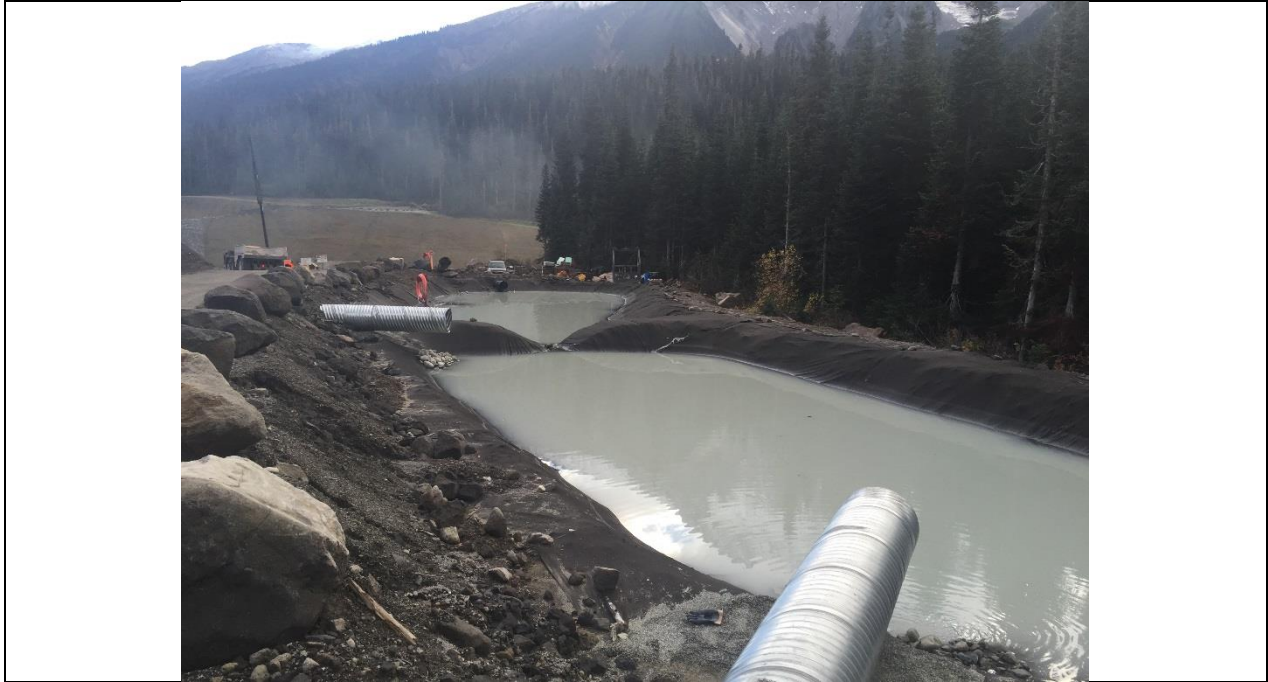
ULR#34. The flocculant and pH treatment components of the water treatment ponds are not currently installed

ULR#34	OPEN	ULRHEF intake – Water treatment ponds	The flocculant and pH treatment components of the water treatment ponds are not currently installed	Install the pH and flocculant treatment components of the ponds as outlined in the work plan to prevent further exceedances of BCWQGs when water discharges to the Lillooet River. Note: Turbidity of the discharge temporarily exceeded BCWQGs on October 25, 2015.	October 25, 2015	November 7, 2015
