Upper Lillooet Hydro Project

Weekly Environmental Monitoring Report #79

Reporting Period: November 8 – November 14, 2015

Upper Lillooet River Hydroelectric Facility (Water File No. 2002561, Water licence No. C130613), Boulder Creek Hydroelectric Facility (Water File No. 2003049, Water licence No. C129969) & Transmission Line (TX Line)

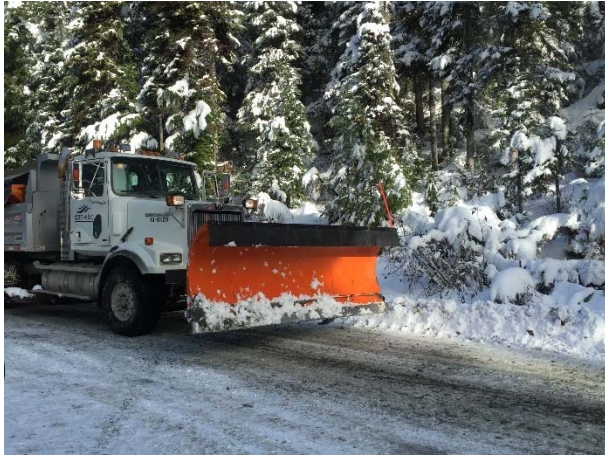
Photo 1 – Snow plowing on the Lillooet River FSR (November 11, 2015).

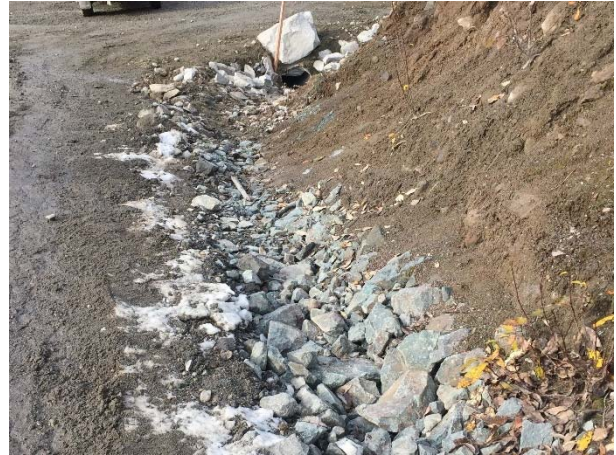
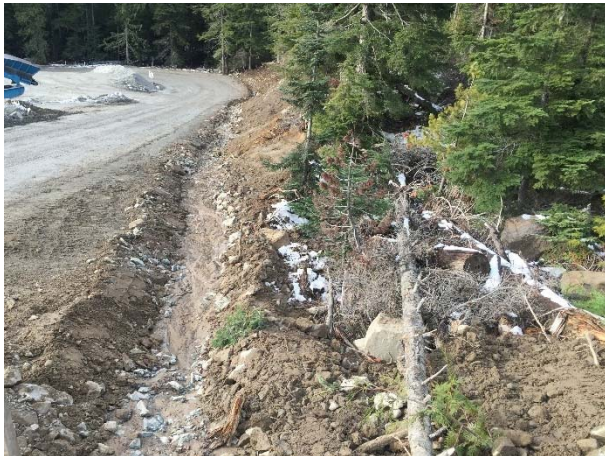
- On November 10, a culvert was installed at the bottom of the KM 45 spoil area access road and ditching was completed below the culvert to KM 44.9 on the Lillooet River FSR (Photo 2 and Photo 3). The maintenance works mark the completion of recommended mitigation measures for ITM item *ULR#35* (see Section 9.0).

Photo 2 – Ditching completed and culvert installed at KM 45 on the Lillooet River FSR (November 11, 2015).

Photo 3 – Ditching completed at KM 45 on the Lillooet River FSR (November 11, 2015).

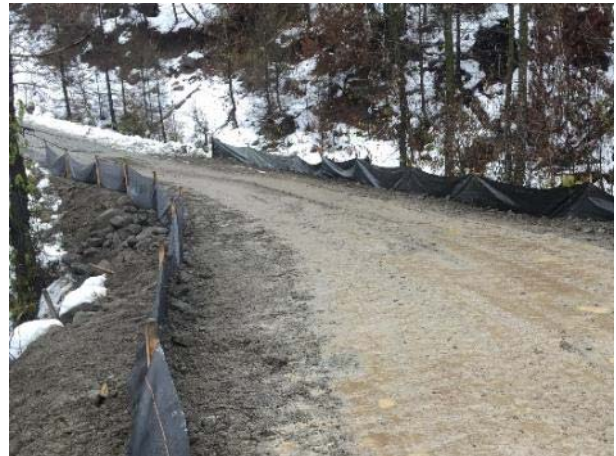
- On November 13, the haul road (Truckwash 2 access road) crossing at ASTRO4 was lifted and re-graded (Photo 4). Following works, CE reinstalled silt fencing along the road edge. The IEM inspected the area on November 14 and observed that the works had caused some road-building material to fall towards the downstream side of the culvert crossing; however, an inspection of lower slope was not possible at the time due to poor access. The IEM determined that the road maintenance works have improved road drainage and mark the completion of recommended mitigation measures for ITM item *ULR#30* (see Section 9.0). The IEM has requested that CE attend a follow-up inspection of the area to verify that material used to raise the haul road are stable and have not contributed sediment to ASTRO4 (ITM item *ULR#39*; see Section 9.0).

Photo 4 – Road lifted and silt fence re-installed on the haul road ASTR04 crossing (November 14, 2015).

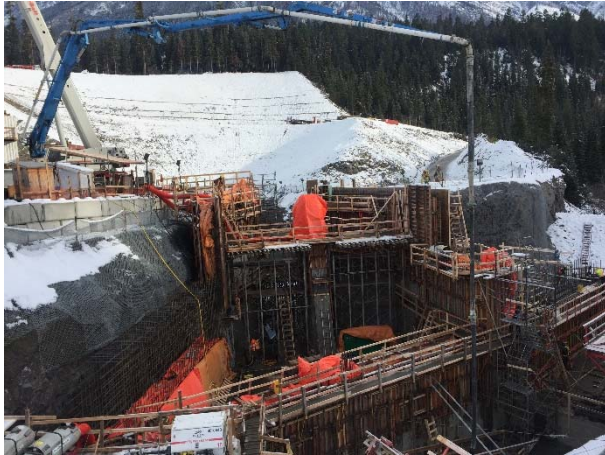
Photo 5 – Concrete pour at the ULRHEF intake (November 11, 2015).

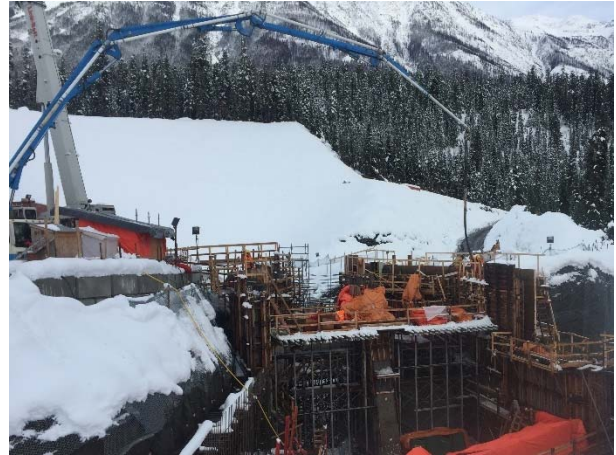
Photo 6 – Concrete pour at the ULRHEF intake (November 13, 2015).

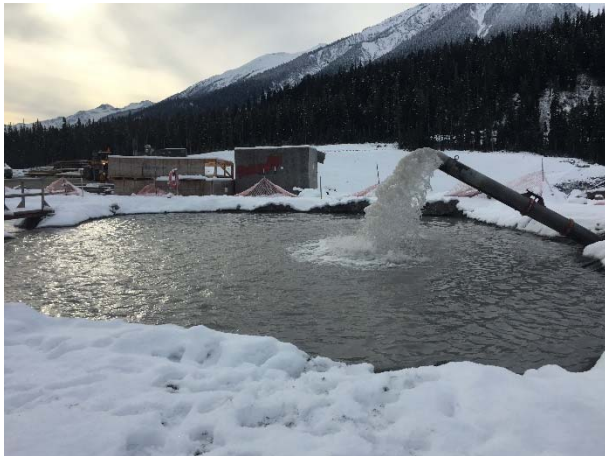
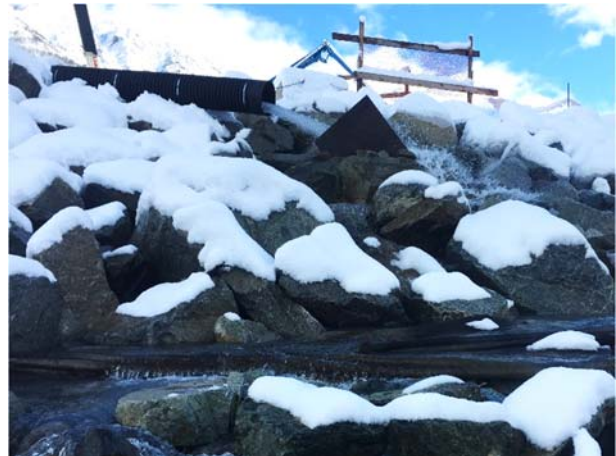
- All turbid or alkaline water resulting from activities at the ULRHEF intake or upstream tunnel portal is pumped to the ULRHEF intake sediment basins (Photo 7 and Photo 8). A dedicated CE crewmember is present to monitor the pumps within the intake work area and tunnel portal during active construction works. This person has the responsibility of directing all turbid or alkaline water to the sediment ponds and must verify with CE environmental staff or the IEM prior to directing any water to the Lillooet River.

Photo 7 – First cell of ULRHEF intake sediment basins (November 11, 2015).

Photo 8 – ULRHEF intake sediment basin outlet pipe at Lillooet River (November 11, 2015).

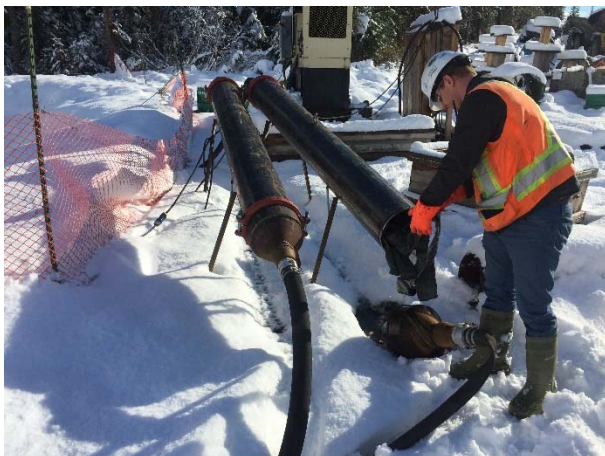
- The flocculant injection system at the intake sediment basins was observed to be operational during this reporting period and CE's environmental management team regularly maintained the system (Photo 9). The IEM conducted regular water quality sampling at the ULRHEF intake sediment basin discharge location. Please see Section 4.6 Water Quality Results for this reporting period's data.

Photo 9 – Flocculant injection system refilled by CE's environmental management team at ULRHEF intake sediment basins (November 11, 2015).

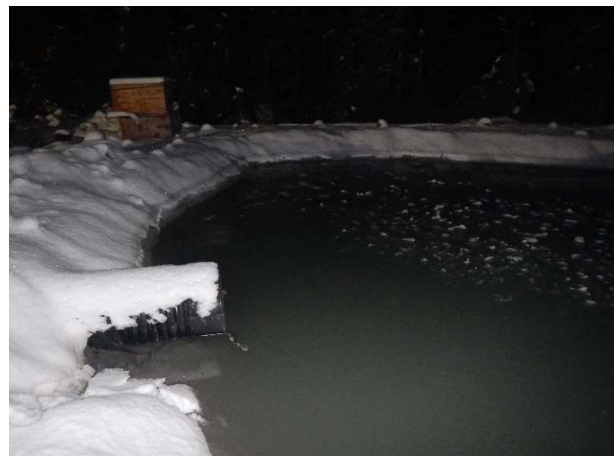
- On November 8, the IEM was at the ULRHEF intake to conduct water quality monitoring following probe-hole grouting in the upstream tunnel. Upon arriving at the intake, the IEM observed that the sediment basins were at capacity (Photo 10) and that tunnel seepage water was being pumped directly to the Lillooet River without pH mitigation (CO₂ injection). The IEM took samples of the direct discharge to the river and the discharge from the sediment basins. Both samples did not meet project water quality guidelines (>pH 9). The IEM informed the pump operator and the tunnel water was diverted to the sediment basins. The IEM contacted CE's environmental management team and they immediately travelled to the intake and ensured that the pH injection system was operating and that water discharging from the ponds was within project guidelines. The discharged elevated pH water ranged from a pH of 9.1 – 9.7 and was unlikely to have any impact on aquatic organisms in the Lillooet River due to the small volume of discharge in relation to flows in the Lillooet River. Despite this, the discharge of elevated pH water is in direct violation of the CEMP and Surface Water Quality Management Plan and is therefore considered a project related environmental incident. On November 9, the IEM requested that CE prepare an Environmental Incident Report (2015-11-08-EIR-017). Please see Section 4.6 Water Quality Results for water quality data related to the incident.

Photo 10 – Last cell of ULRHEF intake sediment basins full and discharging to Lillooet River following grouting in tunnel (November 8, 2015).

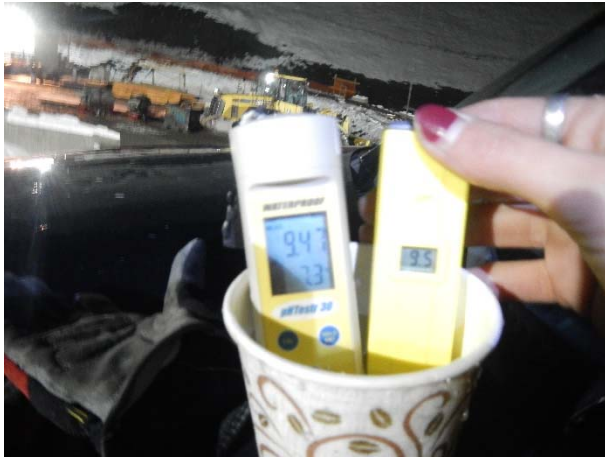
Photo 11 – pH sampling at ULRHEF intake sediment basins following grouting in tunnel (November 8, 2015).

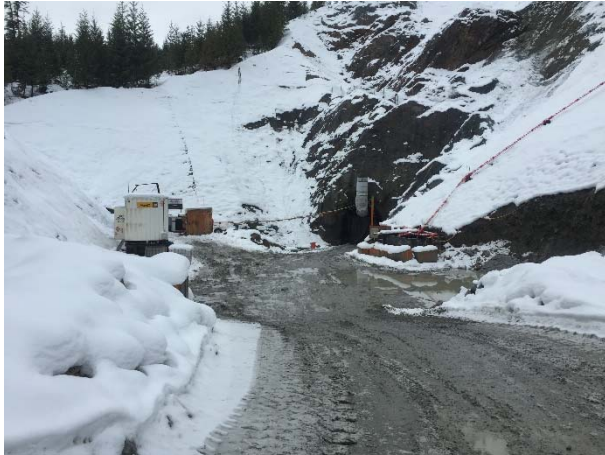
Photo 12 – Current conditions at the ULRHEF downstream tunnel portal (November 14, 2015).

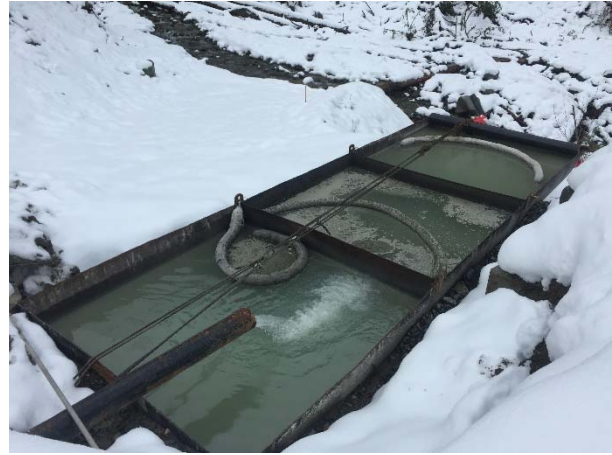
Photo 13 – Oil-water separator at ULRHEF downstream portal (November 14, 2015).

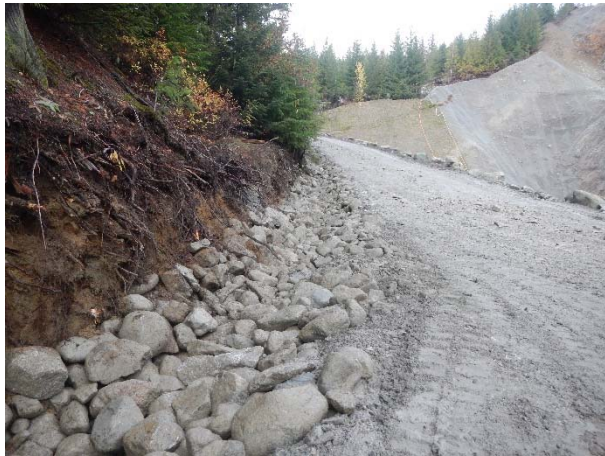
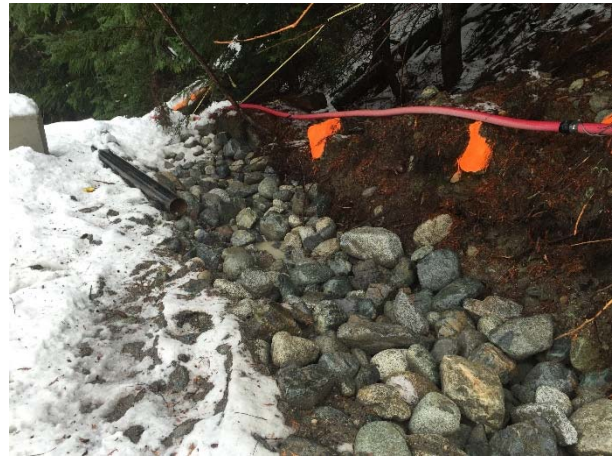
- All tunnel seepage water was pumped to the downstream tunnel portal infiltration ponds. The ponds were observed to be slowly filling throughout the reporting period with no discharge to the surrounding environment.
- On November 8, CE completed ditch maintenance at the bottom of the downstream portal access road (Photo 14 and Photo 15). The maintenance works will prevent runoff from entering the laydown area and satisfies completion of the recommended mitigation measures for ITM item *ULR#31* (see Section 9.0).

Photo 14 – Ditch maintenance and rock lining completed on downstream portal access road (November 8, 2015).

Photo 15 – Ditch maintenance and rock lining completed on downstream portal access road (November 14, 2015).

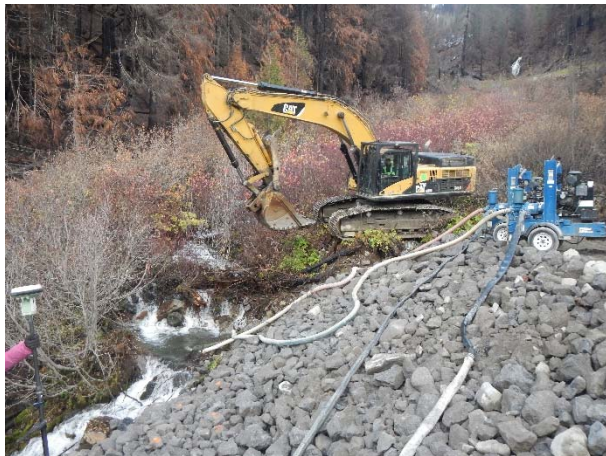
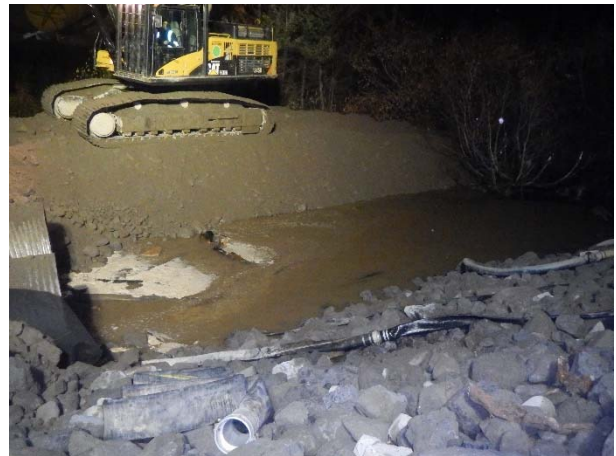
- On November 8, the IEM was present to monitor over-drain construction at ASTR03 (Photo 16 to Photo 21). CE installed an active diversion utilizing two 4” pumps and one 6” pump to

Photo 16 – Pump installation for active diversion at ASTR03 overdrain construction (November 8, 2015).

Photo 17 – Berm constructed to introduce flows to over-drain culverts (November 8, 2015).

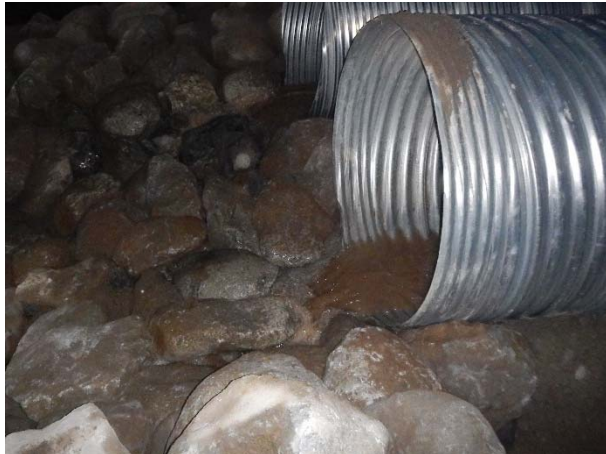
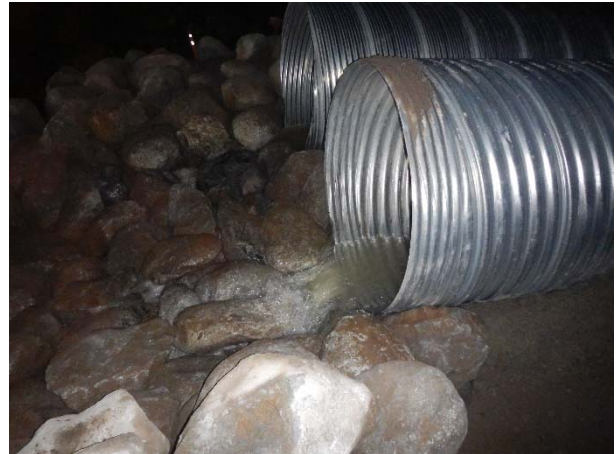
divert the watercourse and allow for the construction of a berm to direct flows into the installed over-drain culverts. During works, sediment was introduced to the watercourse due to water piping through the over-drain bedding material and unforeseen erosion of the slope at the outlet of the culverts. CE will assess the long-term stability of this slope in the spring; however, it is currently no longer eroding and considered stable. The IEM conducted water quality sampling and remained in close contact with the site superintendent throughout works. The IEM requested that crews slow the pace of works when high ranges of turbidity were measured downstream of the work area. Please see Section 4.6 Water Quality Results for over-drain construction water quality data.

Photo 18 – Turbid flows through over-drain culverts following construction of ASTR03 over-drain berm (November 8, 2015).

Photo 19 – Flows clearing of sediment following completion of over-drain works (November 8, 2015).

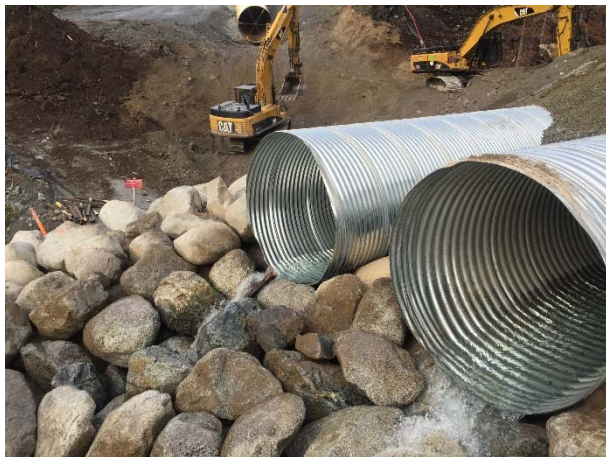
Photo 20 – ASTR03 over-drain with penstock crossing construction in background (November 10, 2015).

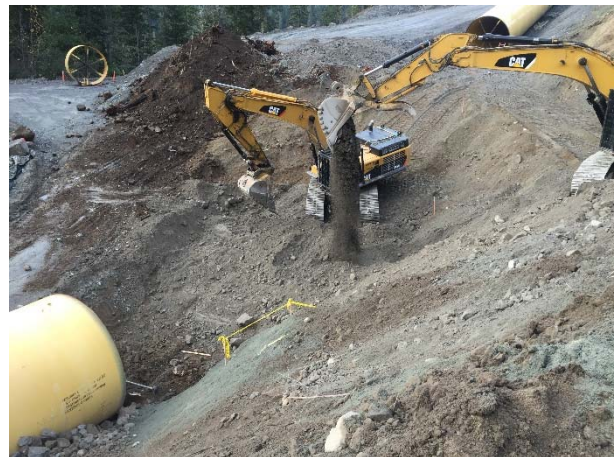
Photo 21 – ASTR03 penstock crossing construction (November 10, 2015).

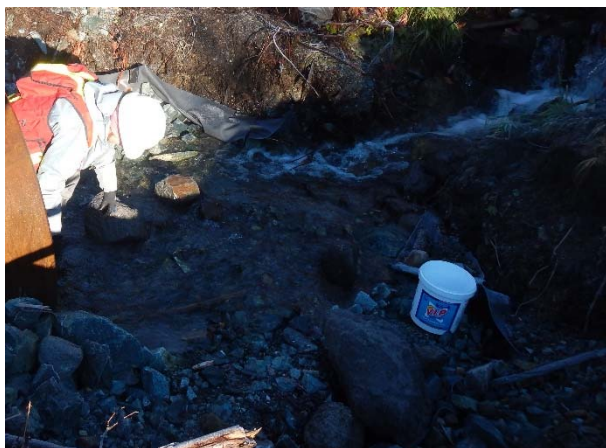
Photo 22 – Ecofish conducts CTF salvage upstream of ASTR04 culvert (November 9, 2015).

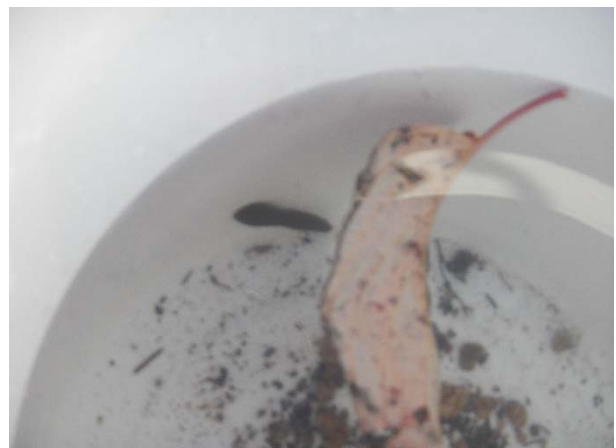
Photo 23 – CTF tadpole captured in ASTR04 and relocated outside of the active work area (November 9, 2015).

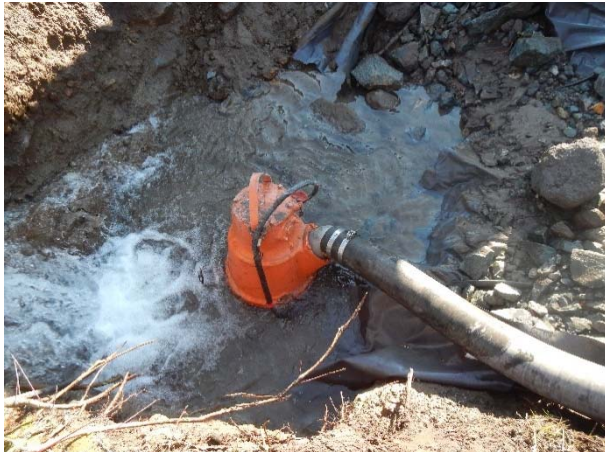
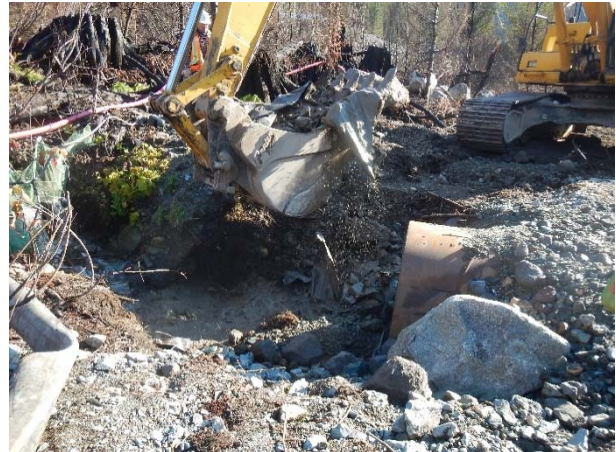
- On November 9, the IEM was present for the removal of the culvert at ASTR04 and installation of an active diversion (sump and 6" pump) to prepare the site for over-drain construction and final watercourse reclamation works. ASTR04 is an identified CTF watercourse. An Ecofish crew conducted an amphibian salvage prior to works and during dewatering (Photo 22 and Photo 23). Three CTF tadpoles were captured, held in sanitized buckets of cold creek-water and relocated outside of the active work-area. The IEM was onsite to monitor works and conduct water quality sampling during the culvert removal and diversion installation. During the excavation of an upstream sump and pump installation, a pulse of suspended sediment was recorded downstream of the works which temporarily exceeded BCWQGs. The water was measured at over 1000 NTU 45m downstream and was observed to quickly (<5 minutes) clear to within ~25 NTU over background. Downstream water quality returned to within 8 NTU of background within 25 minutes. Please see Section 4.6 for water quality sampling results.

Photo 24 – 6” pump installed for ASTRO4 diversion (November 9, 2015).

Photo 25 – Culvert removal at ASTRO4 with active diversion in place (November 9, 2015).

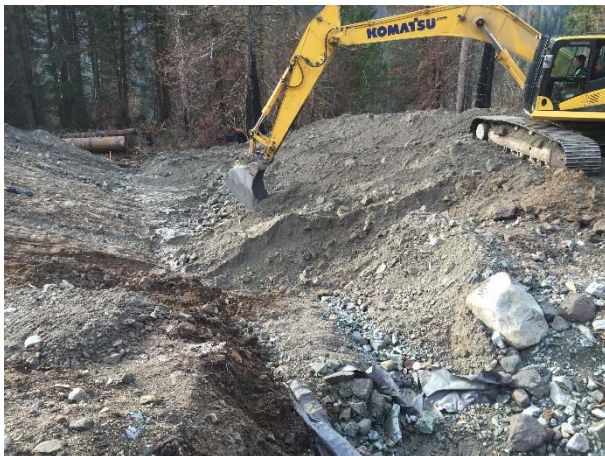
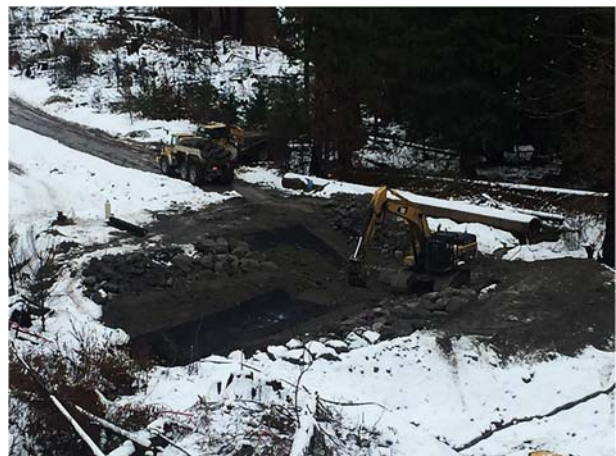
Photo 26 – ASTRO4 overdrain construction with active diversion in place (November 10, 2015).

Photo 27 – ASTRO4 overdrain construction with active diversion in place (November 14, 2015).

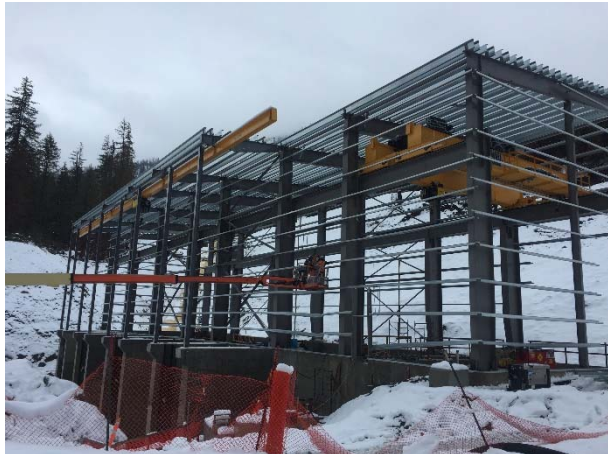
Photo 28 – Current conditions at the ULRHEF powerhouse (November 14, 2015).

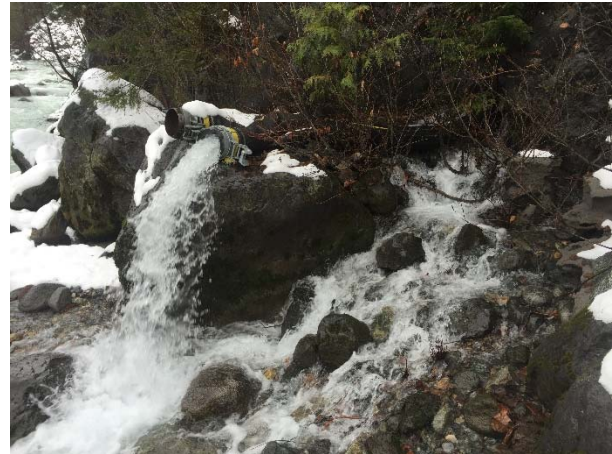
Photo 29 – Dewatering seepage water from the ULRHEF powerhouse sump to the Lillooet River (November 14, 2015).

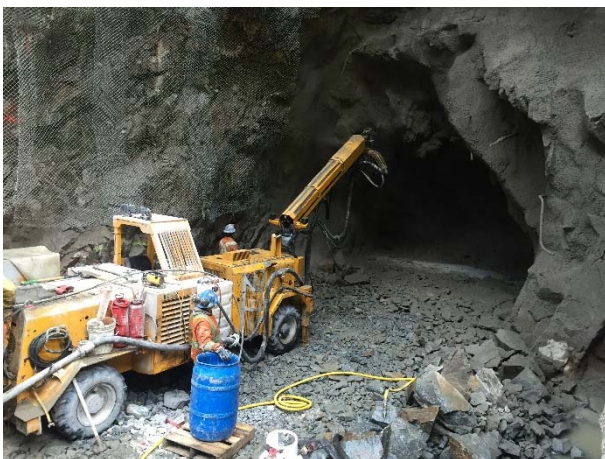
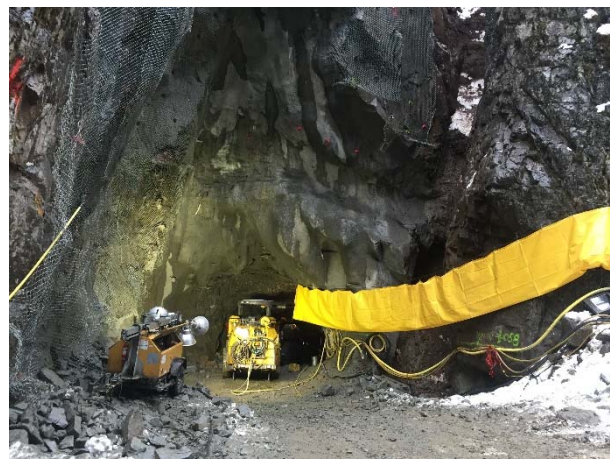
Photo 30 – Drilling at BDRHEF intake diversion tunnel (November 10, 2015).

Photo 31 – Drilling at BDRHEF intake diversion tunnel (November 14, 2015).

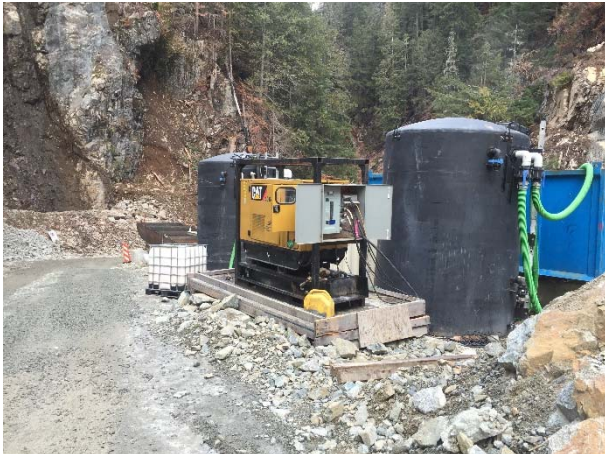
- All wastewater related to diversion tunneling activities was pumped to an active treatment system installed at the bottom of the intake access ramp (Photo 32). The IEM and CE's environmental management team routinely sampled the system discharge to Boulder Creek. Please see Section 5.3 for water quality data.
- On November 9, CE completed road capping and ditch installation on the BDRHEF intake access ramp (Photo 33 and Photo 34). The maintenance works will prevent runoff from entering the work area and mark the completion of recommended mitigation measures for ITM item *BDR#27* (see Section 9.0).

Photo 32 – Active water treatment system at BDRHEF intake (November 10, 2015).

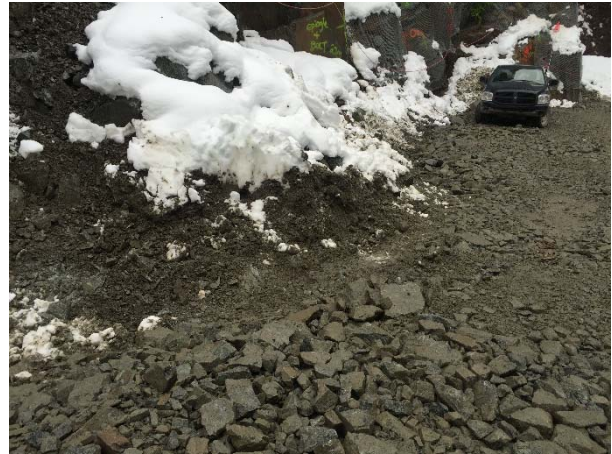
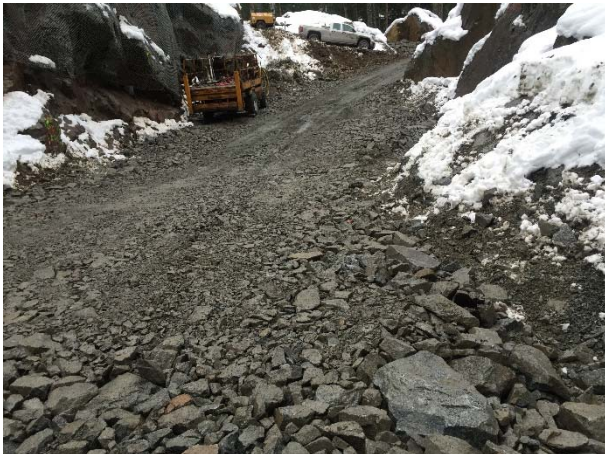
Photo 33 – Road capping and ditching installed on BDRHEF intake access ramp (November 10, 2015).

Photo 34 – Road capping and ditching installed on BDRHEF intake access ramp (November 10, 2015).

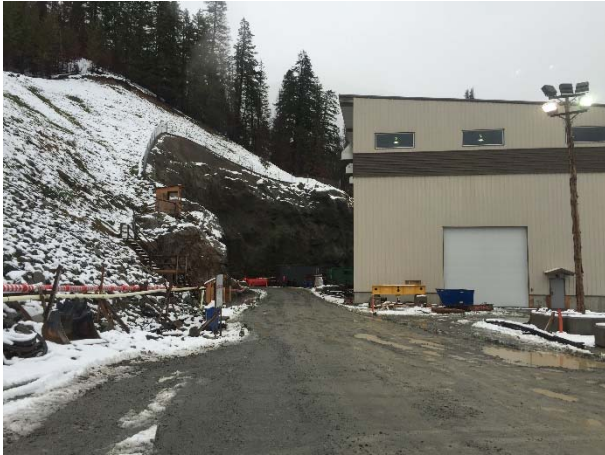
Photo 35 – BDRHEF tunnel portal and powerhouse structure (November 14, 2015).

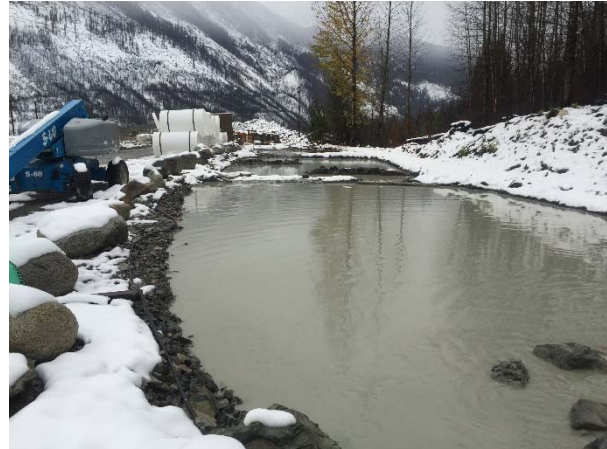
- All wastewater related to the BDRHEF tunnelling works continued to be contained and conveyed to the downstream portal settling ponds for treatment (Photo 36).

Photo 36 – BDRHEF tunnel portal settling ponds (November 14, 2015).
