Upper Lillooet Hydro Project

Weekly Environmental Monitoring Report #81

Reporting Period: November 22 – November 28, 2015

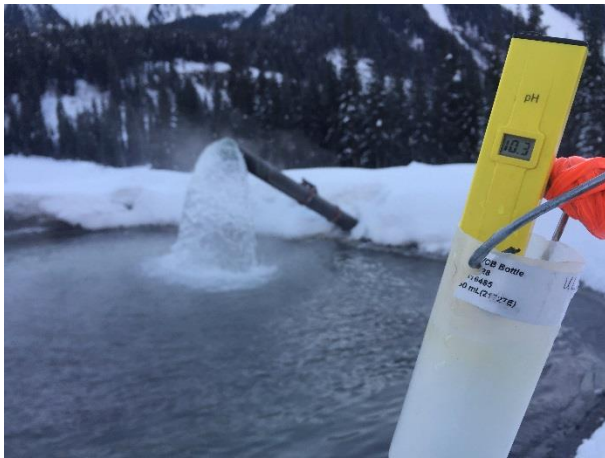
- All turbid or alkaline water resulting from activities at the ULRHEF upstream tunnel portal is pumped directly to the ULRHEF intake sediment basins (Photo 1).

Photo 1 – Alkaline water pumped to ULRHEF intake sediment basins during grout injection (November 28, 2015).

- Additional water treatment measures should be installed at the ULRHEF intake sediment basins to treat high pH water resulting from grouting activities.
- All seepage water in the intake excavation and portal should be conveyed to the sediment basins unless approved for discharge directly to the Lillooet River by the IEM or CE environmental manager.
- The ULRHEF powerhouse sump water should be monitored regularly. Alkaline or turbid water should be pumped to the settling ponds for treatment.

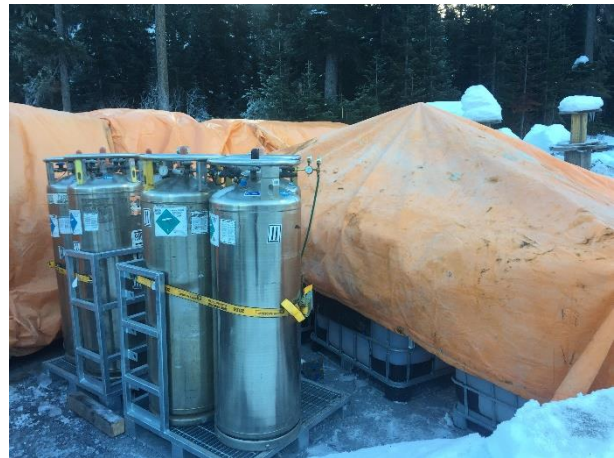
Photo 2 – Active water treatment system with CO₂ tanks at ULRHEF intake (November 28, 2015).

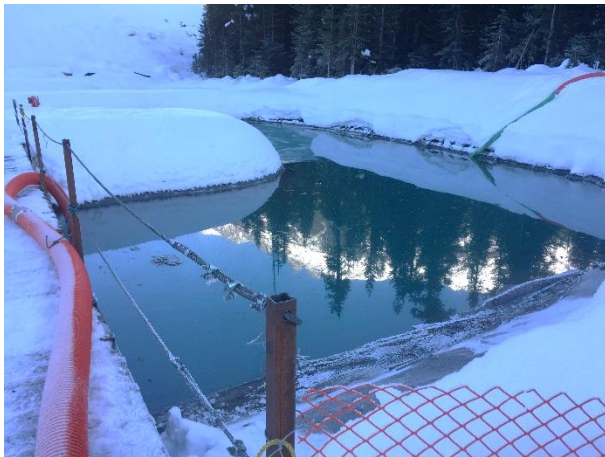
Photo 3 – Orange hose (foreground) conveying water to CO₂ treatment system and hose (background) pumping water through diffuser pipe and back to ponds (November 28, 2015).

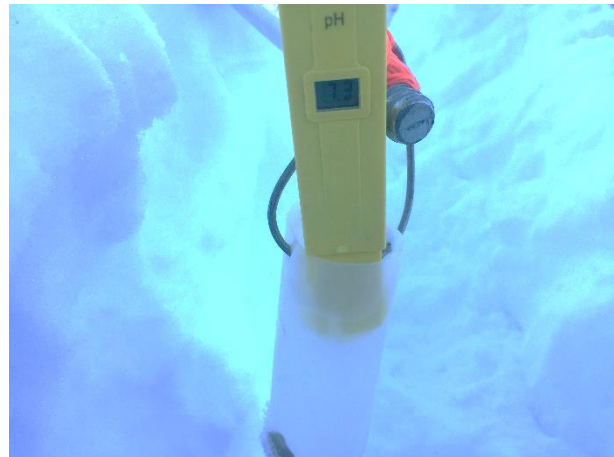
Photo 4 – pH sampling at the compliance point downstream of the ULRHEF intake sediment basins outlet (November 28, 2015).

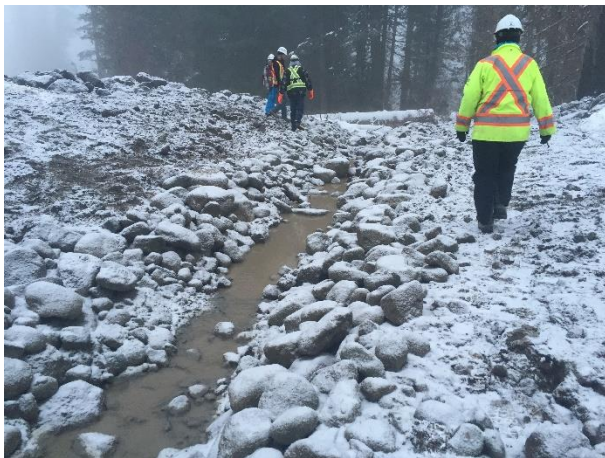
- On November 23, CE began of ASTR-04 over-drain following hand placement of CTF microhabitat structures under the direction of Ecofish (QP). Initially CE placed a 2" bypass pump to divert clean water through the constructed channel, while continuing to bypass the majority of flow around the constructed channel with a 6" pump (Photo 5). Once the flow in the newly watered channel was visibly clear and connected downstream, CE began installing the impermeable geo-membrane and backfilling of the sump. Once half of the backfill was placed, the 6" pump was removed (flow was maintained with the 2" bypass pump) and the last half of the backfill placement occurred simultaneously (Photo 6). Once the backfill placement was complete and natural flow restored, water quality began to improve in the newly constructed channel (Photo 7); however, at 10:00 sub-surface flow was noticed on stream right near the downstream end of the constructed channel (Photo 8).

Photo 5 – Initial re-watering of ASTR-04 overdrain by bypass pump to permit working on the placement of an impermeable geotextile membrane and backfilling to grade (November 23, 2015).

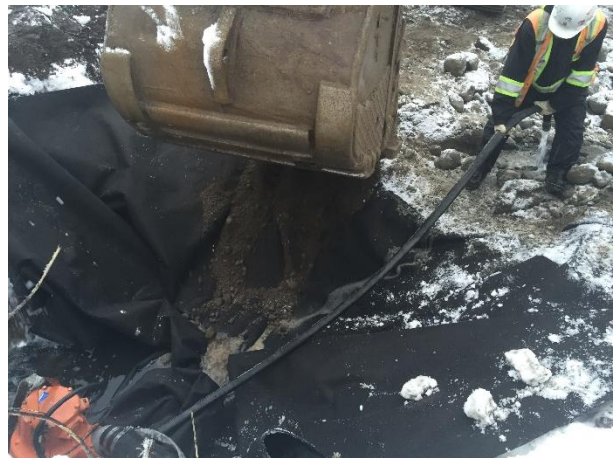
Photo 6 – Placement of impermeable geotextile membrane and backfill of the existing bypass sump while continuing to bypass the majority of flows (November 23, 2015).

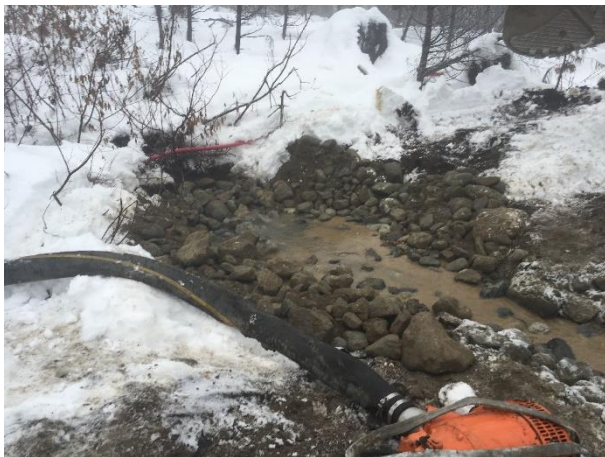
Photo 7 – Backfill of sump completed and natural flows restored to ASTR-04 (November 23, 2015).

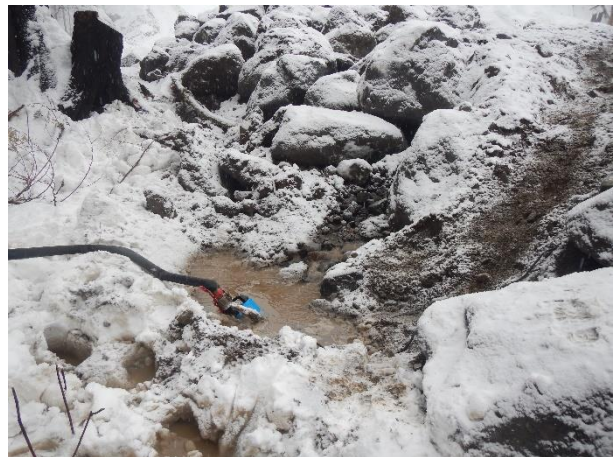
- Once subsurface flow was discovered, CE placed a 2" pump to divert the turbid flow to vegetation and began to discuss options to eliminate the subsurface flow. In consultation with SES and INX, CE determined that the installation of the impermeable geotextile membrane at the upstream end of the channel was ineffective and needed to be enlarged.

- Water quality was monitored by the IEM throughout work activity and communication between the CE crew and IEM occurred during each step of the work. Turbidity exceeded BCWQGs for approximately nine hours on November 23. The prolonged period of high turbidity occurred because the initial placement of the impermeable membrane failed to achieve a watertight seal, which created the subsequent subsurface flows observed. To stop

Photo 8 – Seepage noticed at downstream end of reconstructed channel indicative of sub-surface flows (November 23, 2015).

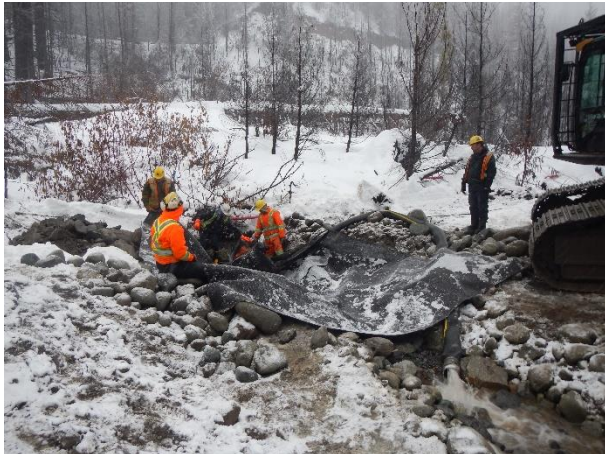
- The 6" pump was replaced to divert clean water around the work area through the newly constructed channel while CE excavated the upstream section and placed additional membrane to ensure an effective seal (Photo 9). Again, once half of the backfill was placed, the 6" pump was removed and the second half of the backfill was placed simultaneously. Once the backfill placement was complete for the second time natural flow was restored. Water quality began to improve in the newly constructed channel (Photo 10) and subsurface flow was reduced. The IEM recommends that an inspection occur in the spring to ensure that all subsurface flow has been eliminated.

Photo 9 – Replacement of impermeable geotextile membrane to prevent subsurface flow (November 23, 2015).

subsurface flow and prevent undermining of the ASTR-04 over-drain CE notified the IEM that re-working of the impermeable membrane was required as quickly as possible to prevent further damages. CE worked directly with the IEM to mitigate further damage to ASTR-04 to the extent possible and the secondary placement of impermeable membrane was successful in eliminating the majority of subsurface flow. Near the end of the day, it was evident that water quality was showing a trend toward returning to within BCWQGs; therefore, the IEM made the decision to return to site the following morning to verify that water quality had improved. The IEM returned on the morning of November 24, and verified that subsurface flow had reduced and that turbidity levels had returned to within BCQWGs. Please see Appendix A for detailed water quality sampling data.

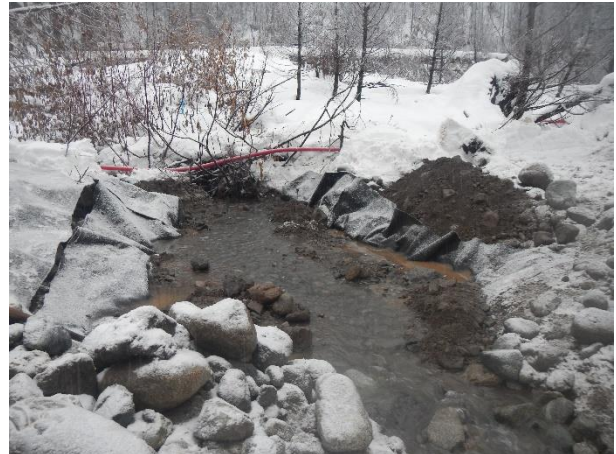
Photo 10 – Natural flows restored following membrane replacement and sump backfill (November 23, 2015).

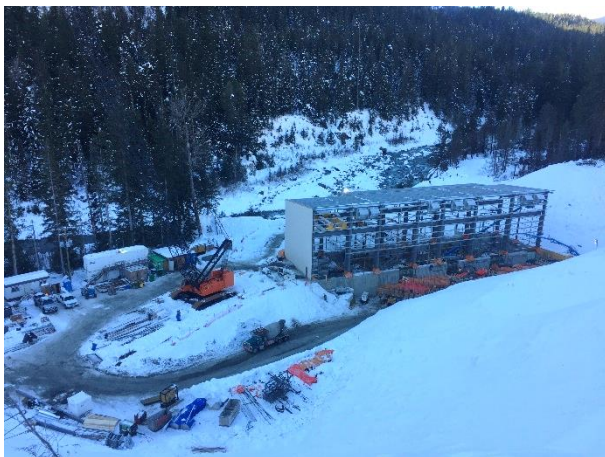
Photo 11 – Current conditions at the ULRHEF powerhouse (November 26, 2015).

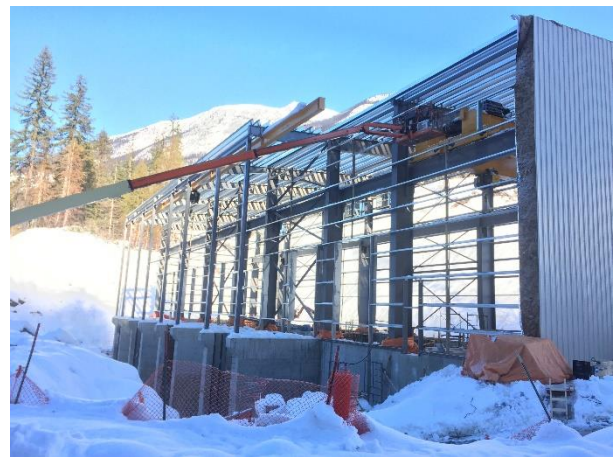
Photo 12 – Current conditions at the ULRHEF powerhouse (November 27, 2015).

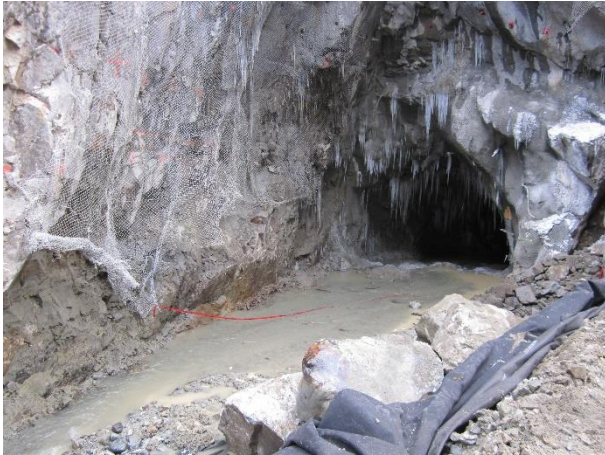
Photo 13 – Upstream cofferdam with geomembrane and rock armouring (November 22, 2015).

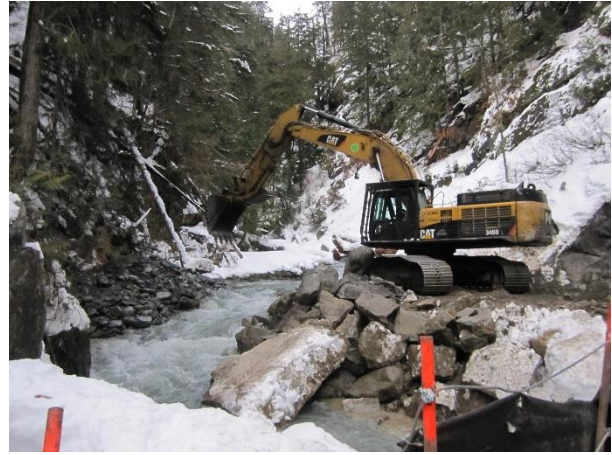
- On November 22 and 23, diversion and upstream cofferdam instream works continued at the BDRHEF intake.
- Works began at 9:30 on November 22 with the excavation of a trench and geomembrane anchoring at the diversion tunnel entrance for the upstream cofferdam (Photo 13). The trench excavation caused two pulses of turbidity downstream which quickly (<40 minutes) cleared to within 8 NTU of background levels. The turbidity observed at the mixing zone station (15m downstream of the diversion tunnel) equated to a temporary (<30 minutes) pulse with a peak of 21.5 NTU at the compliance station (240m upstream of the powerhouse).
- Beginning at 11:50, diversion pad removal and berm construction required that an excavator (equipped with biodegradable hydraulic oil) work instream for brief periods causing intermittent downstream turbidity (Photo 14). At 16:20, the excavator removed the upstream

Photo 14 – Excavator equipped with biodegradable hydraulic oil removing upstream end of diversion channel (November 22, 2015).

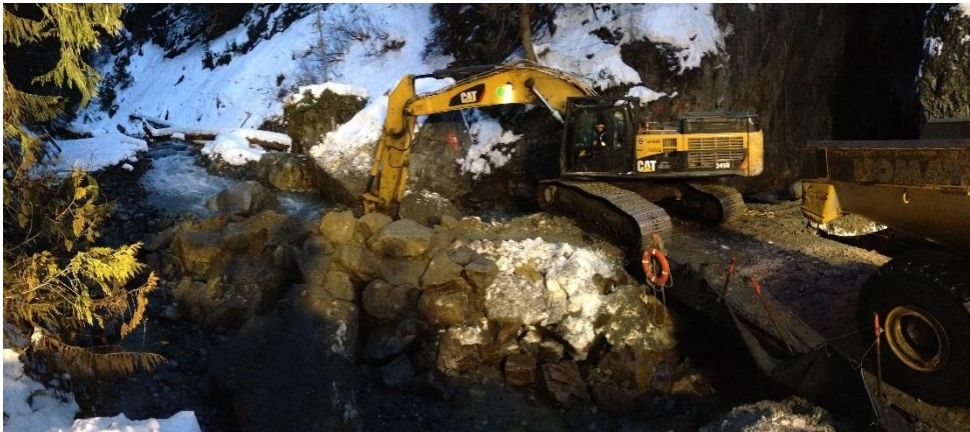
plug to redirect the majority of flow into the diversion tunnel (Photo 15 to Photo 17). The plug removal caused a spike of turbidity at the mixing zone of 776 NTU which resulted in peak of 145 NTU at the compliance station (18:10). Instream works were completed at 16:55. Turbidity at the mixing zone station returned to within 8 NTU of background levels by 17:10 and at the compliance station by 19:20.

Photo 15 – Upstream cofferdam with excavator removing plug releasing majority of creek flow to diversion tunnel (November 22, 2015).

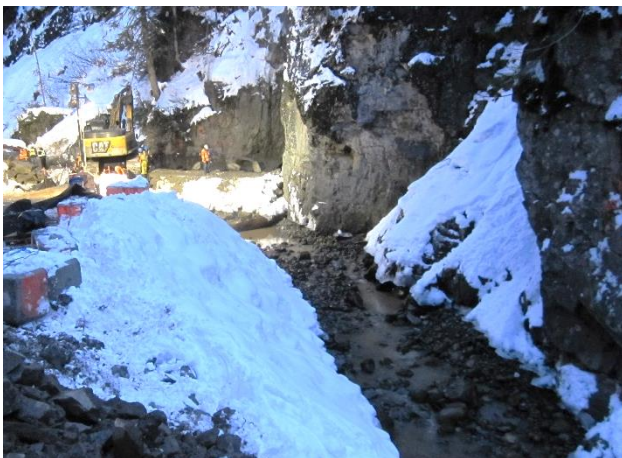
Photo 16 – View looking upstream at dewatered creek channel following plug removal and diversion of flow (November 22, 2015).

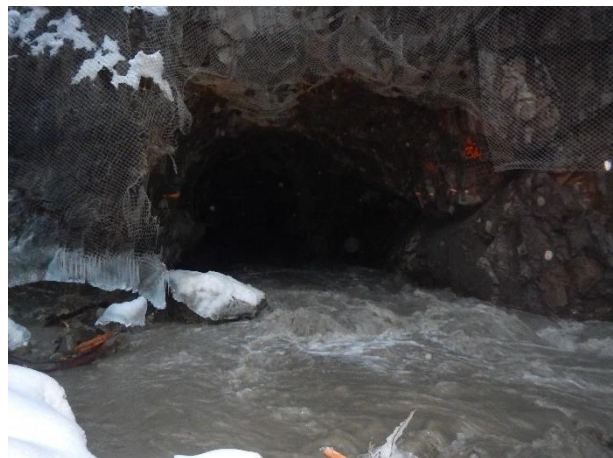
Photo 17 – Diversion tunnel exit following plug removal and creek diversion (November 22, 2015).

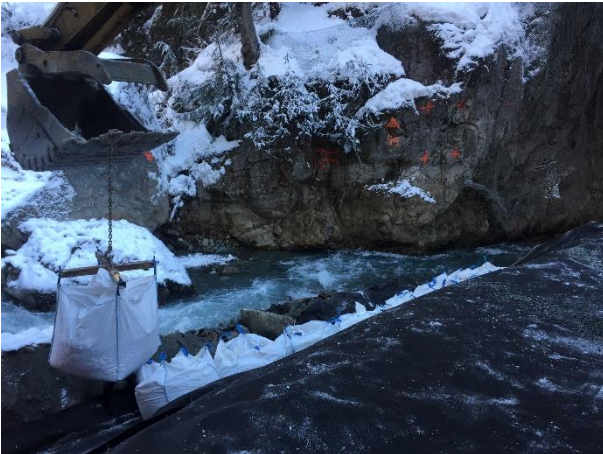
- On November 23, the final instream works for the upstream cofferdam were completed. Beginning at 8:40, an excavator dug a trench on the upstream side of the cofferdam to prepare the key (Photo 18). The excavation caused a pulse of turbidity measured in the mixing zone which quickly (<10 minutes) cleared to within 8 NTU of background levels. The works had no effect on water quality at the compliance station.

Photo 18 – Excavator placing mega-bags in trench for upstream cofferdam construction (November 24, 2015).

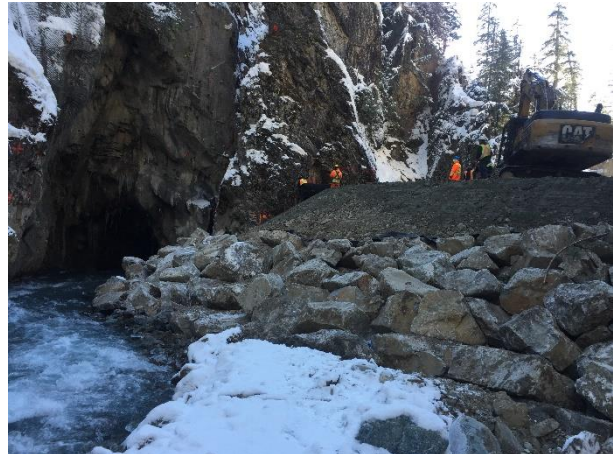
Photo 19 – The upstream cofferdam near completion with rock armouring (November 25, 2015).

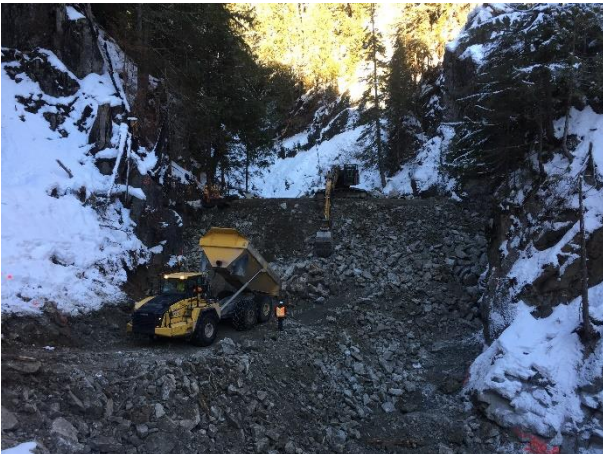
Photo 20 – Final stage of upstream cofferdam construction (November 26, 2015).

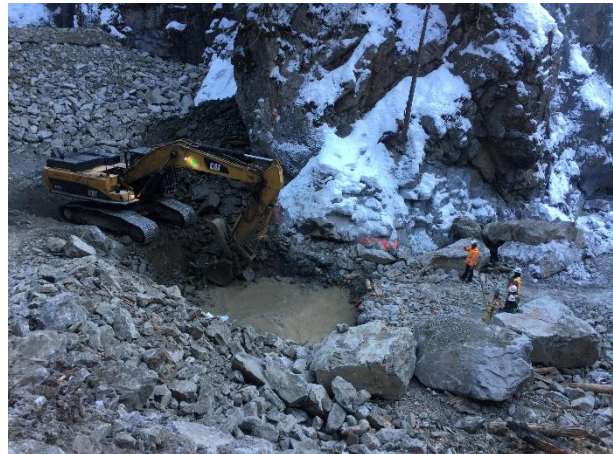
Photo 21 – Test pit below upstream cofferdam to assess bedrock conditions (November 27, 2015).

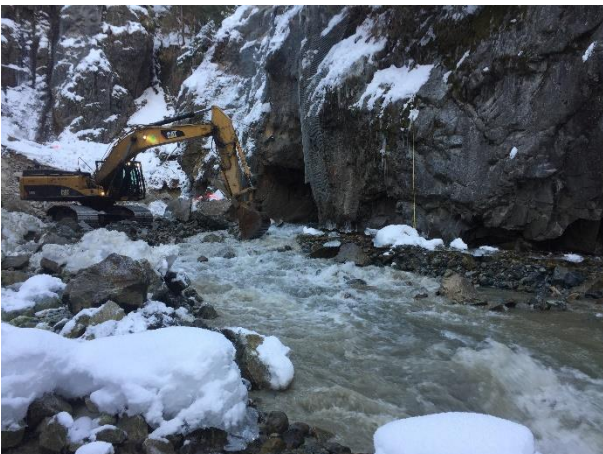
- On November 28, BDRHEF intake downstream cofferdam construction commenced (Photo 22). The works required the excavator to work instream to redirect flows towards the left bank of Boulder Creek to prepare the cofferdam site. Instream works caused intermittent pulses of turbidity measured at the mixing zone station. At 8:40, the IEM requested that CE slow the pace of works to reduce the intensity of the turbid pulse observed downstream. Downstream turbidity persisted for 40 minutes before returning to within 8 NTU of background levels at the mixing zone. Peak turbidity at the mixing zone was recorded to be 749 AU and equated to a peak of 55.4 NTU at the compliance station. The remaining cofferdam construction was conducted above the high water mark and did not have an effect on water quality (Photo 23).

Photo 22 – Instream works for downstream cofferdam construction (November 28, 2015).

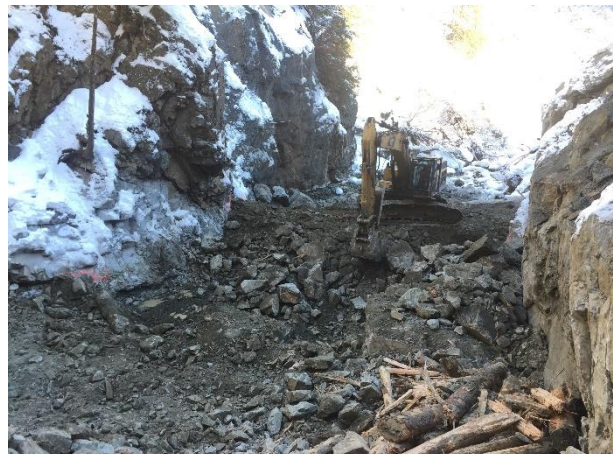
Photo 23 – Final stage of downstream cofferdam construction (November 28, 2015).

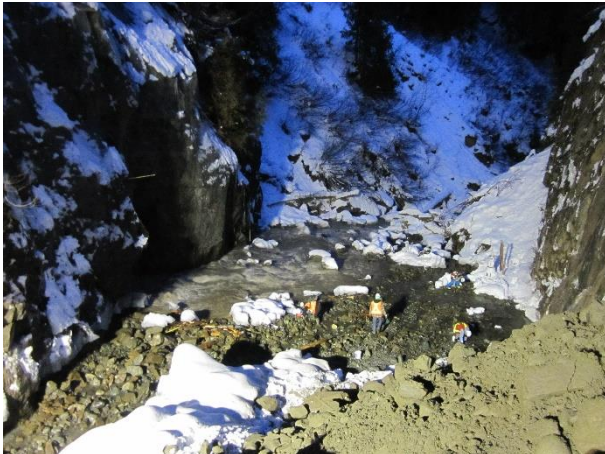
- On November 22 at 16:30, Ecofish crews conducted a Coastal Tailed Frog salvage in the dewatered section of Boulder Creek following diversion of the majority of flow to the tunnel (Photo 24). No frogs or tadpoles were found during the salvage.

Photo 24 – Ecofish conducting a Coastal Tailed Frog salvage in dewatered creek channel (November 22, 2015).

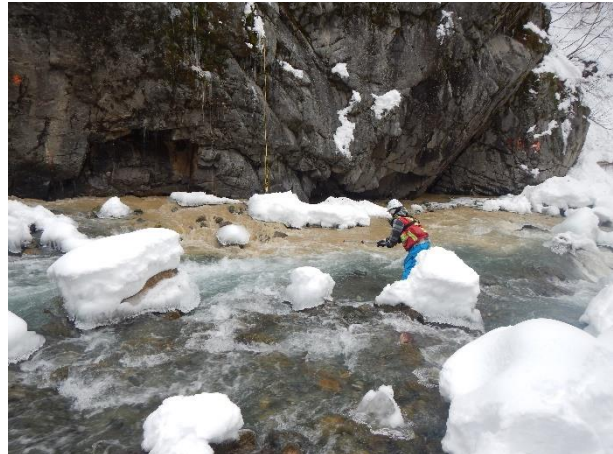
Photo 25 – The IEM conducting water quality sampling downstream of the diversion tunnel in the mixing zone during diversion (November 22, 2015).

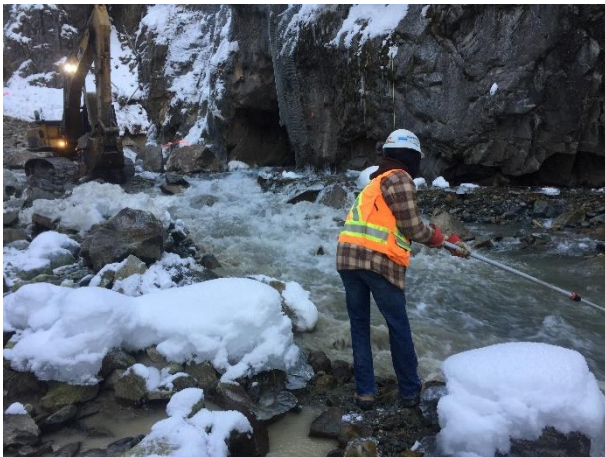
Photo 26 – Water quality sampling downstream of the diversion tunnel during downstream cofferdam construction (November 28, 2015).

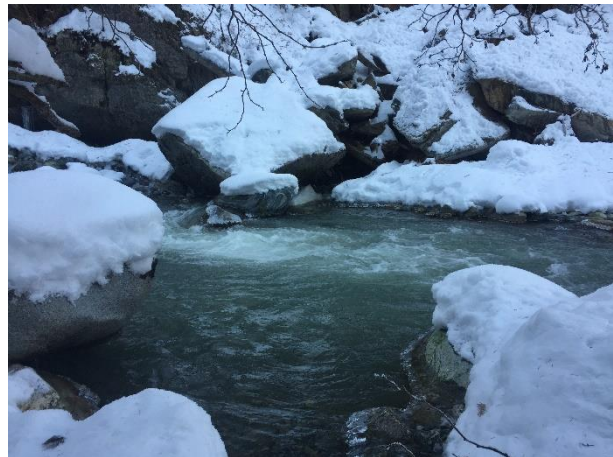
Photo 27 – Flows clearing in Boulder Creek at the water quality compliance station following downstream cofferdam construction (November 28, 2015).

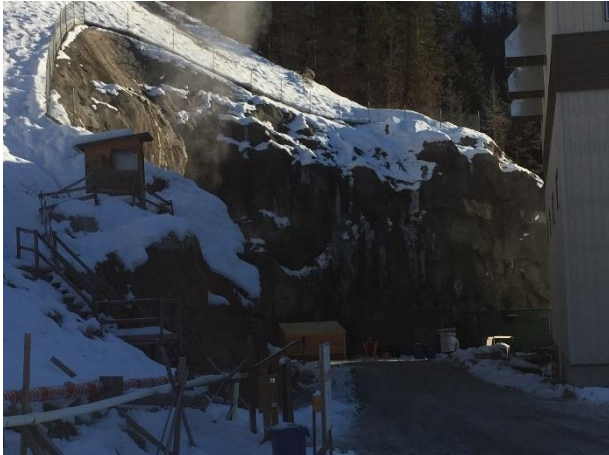
Photo 28 – BDRHEF tunnel portal closed during this reporting period due to blasting restrictions (November 27, 2015).

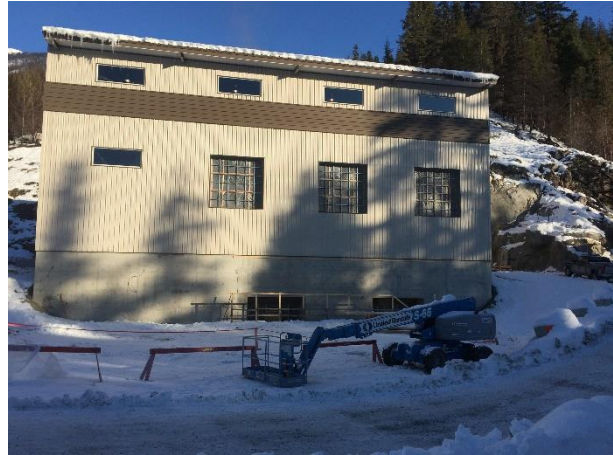
Photo 29 – BDRHEF powerhouse structure (November 27, 2015).

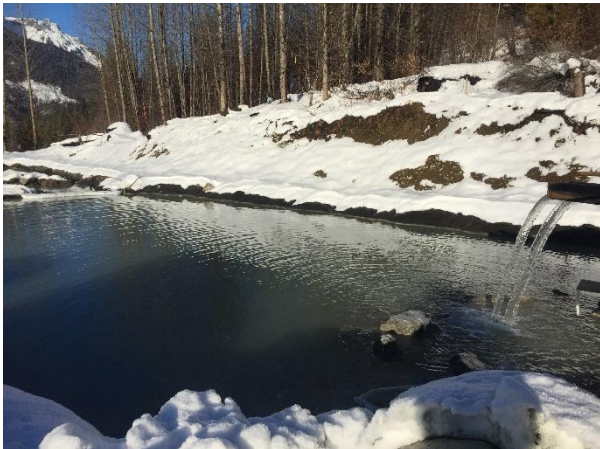
- All wastewater related to the BDRHEF tunnelling works continued to be contained and conveyed to the downstream portal settling ponds for treatment (Photo 30).

Photo 30 – BDRHEF tunnel portal settling ponds (November 27, 2015).
