# Upper Lillooet Hydro Project

## Weekly Environmental Monitoring Report #82

Reporting Period: November 29 – December 5, 2015

Upper Lillooet River Hydroelectric Facility (Water File No. 2002561, Water licence No. C130613), Boulder Creek Hydroelectric Facility (Water File No. 2003049, Water licence No. C129969) & Transmission Line (TX Line)

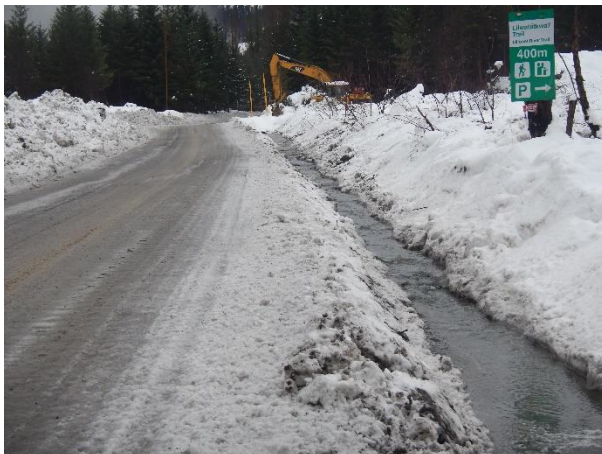
Photo 1 – Maintenance of ditch at KM42 of the Lillooet River FSR (December 4, 2015)

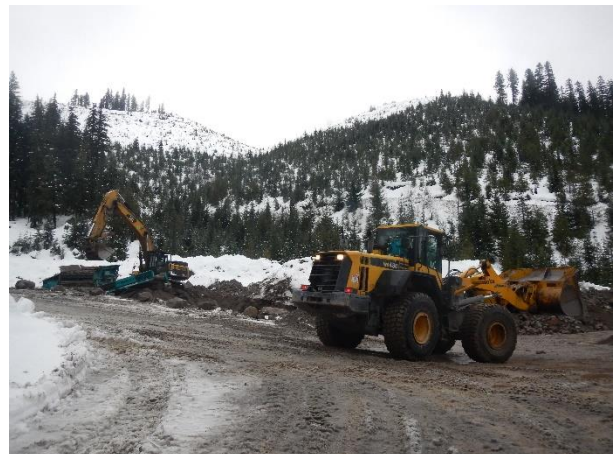
- Routine maintenance of construction equipment within the mechanic shop and fuel management continued at the KM 38 laydown. All hazardous substance materials (waste oil, contaminated soil, used oil/hydraulic fluid containers, etc.) were stored temporarily for off-site disposal in a designated area at the laydown. The materials were all well contained and protected from the weather.
- The electric fences surrounding the construction camp were maintained and operational throughout this reporting period.
- Road maintenance and snow removal on the Lillooet River FSR and site access roads continued (Photo 1).
- Spoil pile at KM45 of the Lillooet River FSR was used as a laydown area for sand generation and stockpiling (Photo 2).

Photo 2 – Screening material at the spoil pile located at KM45 of the Lillooet River FSR. Screened material was stockpiled and used to sand the FSR (December 4, 2015).

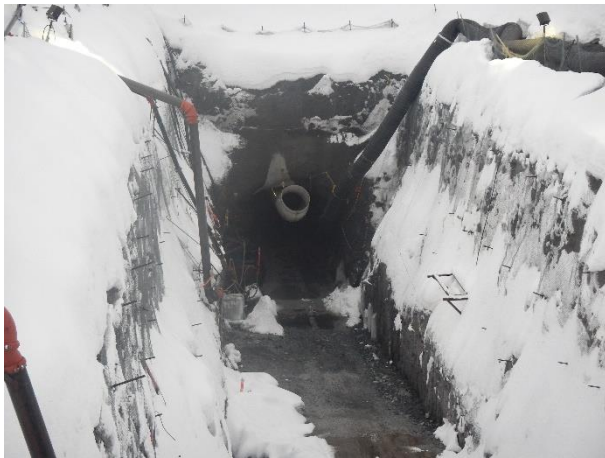
- Drilling, tunnel stabilization and grout injection at the ULRHEF upstream tunnel (Photo 3).
- Dewatering to ULRHEF intake sediment basins.
- ULRHEF intake shutdown for winter (Photo 4).

Photo 3 – ULRHEF upstream tunnel portal (December 2, 2015).

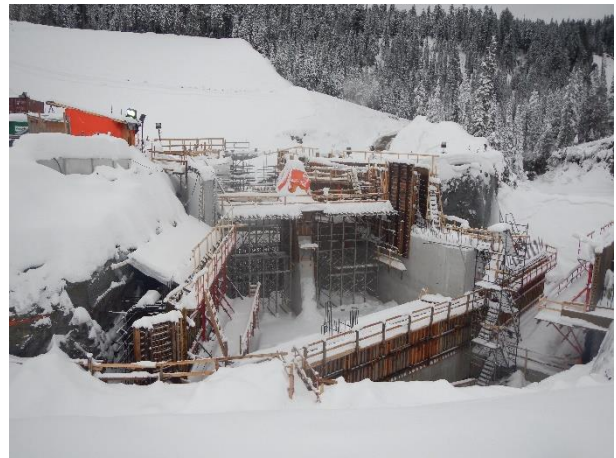
Photo 4 – ULRHEF intake shutdown for winter (December 2, 2015).

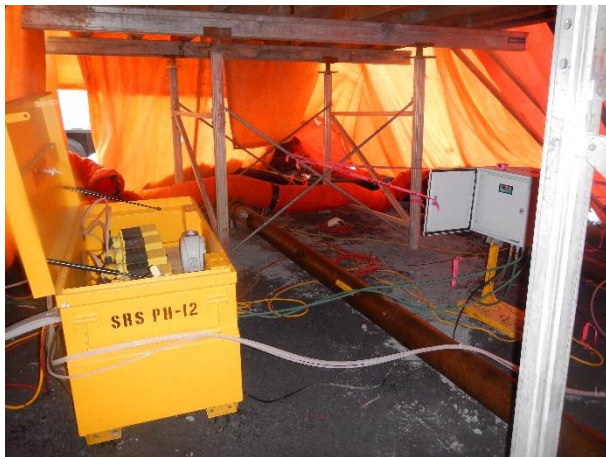
- The flocculent injection system at the intake sediment basins was observed to be operational during this reporting period and CE's environmental management team regularly maintained the system (Photo 5). The IEM conducted regular turbidity sampling at the ULRHEF intake sediment basin discharge location. Please see Section 4.6 Water Quality Results for this reporting period's data.

Photo 5 – Primary Sumas water treatment system near Pond 2 of ULRHEF intake basins (December 4, 2015).

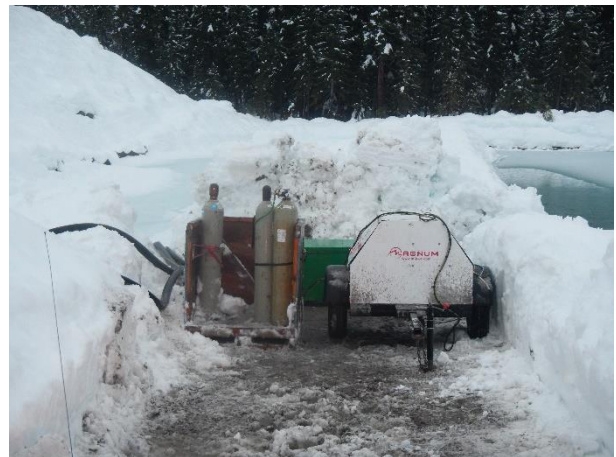
- During grout injection works in the ULRHEF tunnel on November 29 and December 3, 2015, the pH of water discharging to the Lillooet River approached close to pH = 9.0 (See Section 4.6 for detailed water quality sampling results). This prompted the IEM to recommend improvement to the water treatment system and development of a protocol for preventing and/or stopping the discharge of high pH water in the event the an exceedance of pH = 9.0 was recorded (See the attached FAM #7 and ITM ULR#40 for further details). CE responded to the IEM's request by:

Photo 6 - Secondary Sumas water treatment system at Pond 5 of ULRHEF intake basins (December 4, 2015).

- Adding another back-up CO<sub>2</sub> injection system to pond #5 (for a total of three injection systems; Photo 6);
  - Constructing warming tents to prevent the CO<sub>2</sub> injection lines and regulators from freezing; and,

- By developing a protocol for recirculation of the water in the ponds in the event of elevated pH at the discharge location.
- The above response provided by CE addressed the intent of FAM #7 and marked the closure of ITM ULR#40.

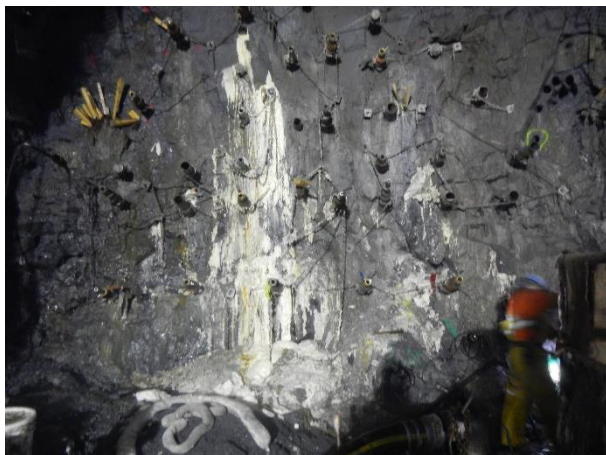
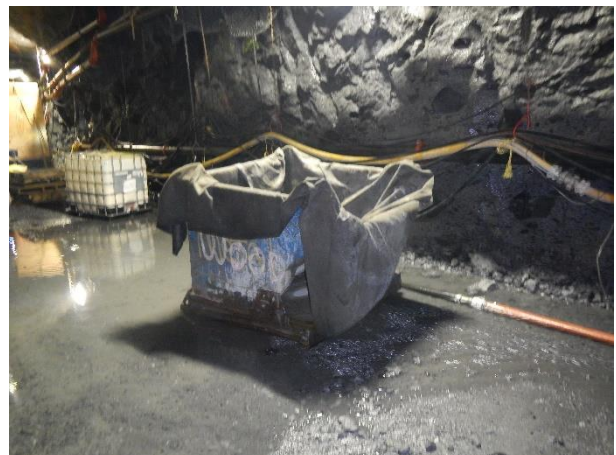
- Inside the ULRHEF tunnel at the face, the excess grout is dumped into bins which are left to cure and are then emptied when hardened (Photo 7 and Photo 8). This limits the amount of high pH-laden grout water that would normally enter the pumps and need to be treated.

Photo 7 – Grouting at the face of ULRHEF upstream tunnel portal (December 5, 2015).

Photo 8 – Geotextile-lined bins used in the tunnel to dispose of excess grout (December 5, 2015).

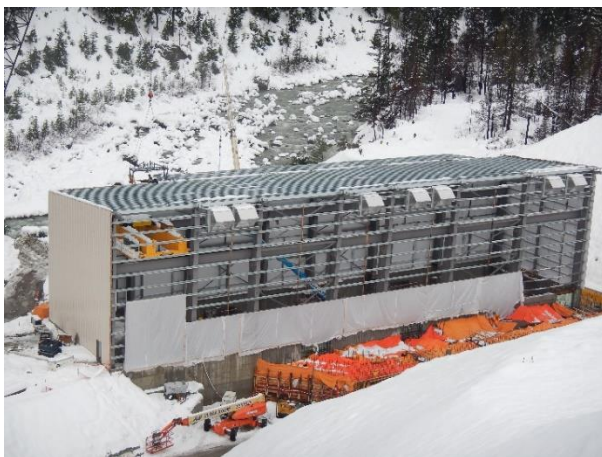
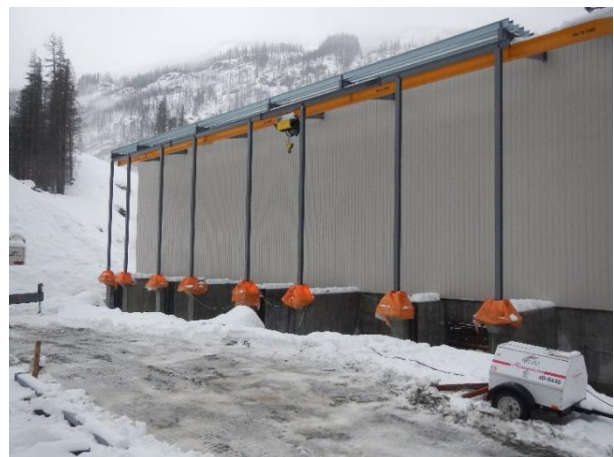
- Superstructure construction (Photo 9 & Photo 10).
- Dewatering to the Lillooet River.

Photo 9 – Current conditions at the ULRHEF powerhouse (December 4, 2015).

Photo 10 – Current conditions at the ULRHEF powerhouse (December 4, 2015).

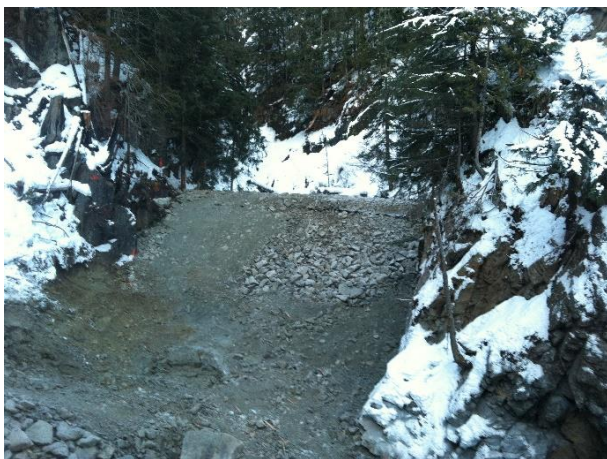
- All equipment was removed from the BDRHEF intake and the site closed for the winter on November 30, 2015. The gate at 3.3KM of the BDRHEF intake access road is locked and will remain closed until May 1, 2016.
- The upstream cofferdam and a temporary downstream cofferdam were both completed during the previous reporting period (Photo 11 & Photo 12). A permanent downstream cofferdam will be constructed in the spring.

**Photo 11 – Upstream cofferdam at BDRHEF Intake (November 30, 2015).**

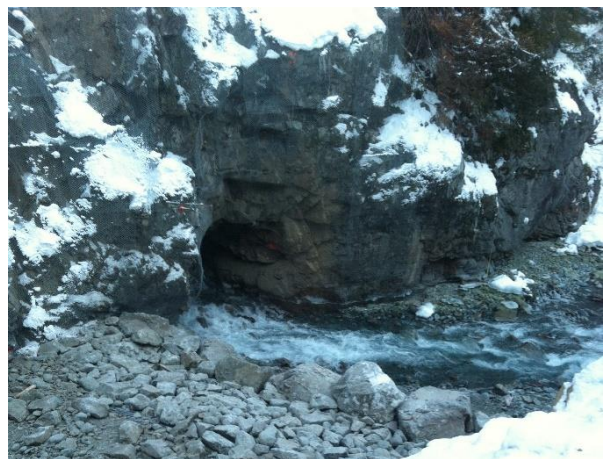
**Photo 12 – Partial downstream cofferdam constructed at BDRHEF Intake (November 30, 2015).**
