# Upper Lillooet Hydro Project

## Weekly Environmental Monitoring Report #85

Reporting Period: January 3 – 16, 2016

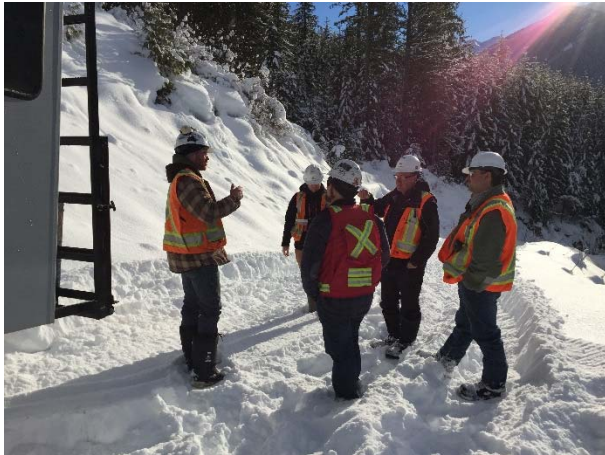
Photo 1 – Pre-work meeting conducted onsite at the sand borrow pit near KM36 of the Lillooet River FSR prior to beginning works (January 8, 2016).

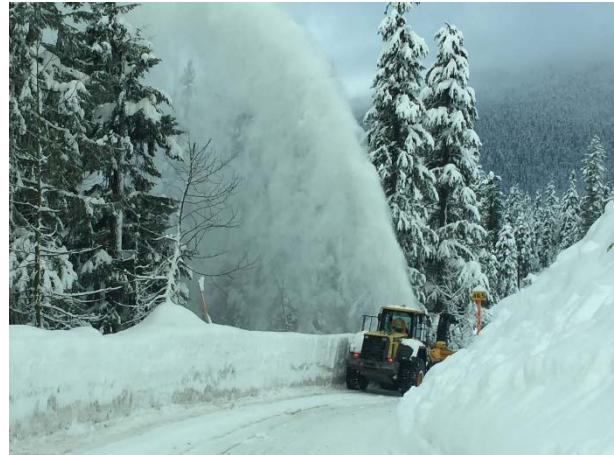
- Snow removal on the Lillooet River FSR and site access roads continued (Photo 2).

Photo 2 – Snow blowing flowing snowfall near KM47 of the Lillooet River FSR (January 13, 2016).

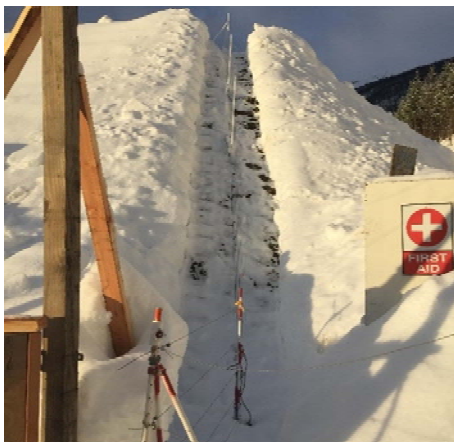
- Snow management around the waste compactor, electric fences, and construction camp facilities was performed to maintain their operation following heavy snowfall during this reporting period (Photo 3 & Photo 4). CE continues to remove snow and repair the electric fence following each snowfall.

Photo 3 – Electric fences were snow free and operational during this reporting period (January 6, 2016).

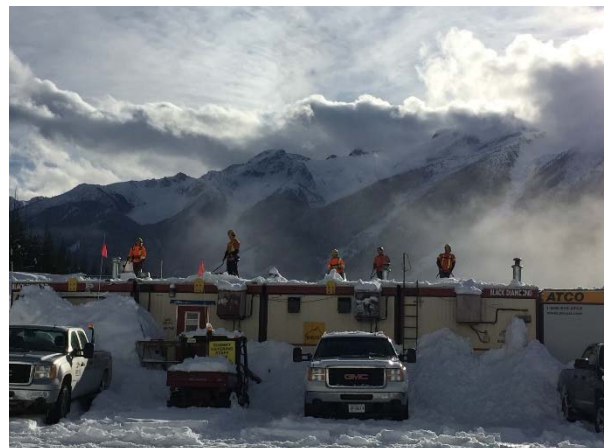
Photo 4 – Removing snow from the roofs at the ULHP camp following heavy snowfall (January 13).

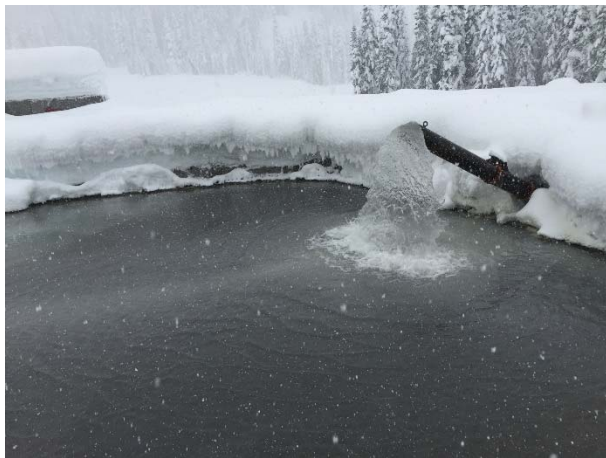
- Dewatering to ULRHEF intake sediment basins (Photo 5).

- During all grout injection work in the tunnel, seepage and process water was directed to the ULRHEF intake sediment basins for treatment (Photo 5). Prior to works, CE's environmental management team activated the CO<sub>2</sub> injection component of the water treatment system and prepared the flocculant injection system to be used if necessary.
- The IEM was at the ULRHEF intake to conduct water quality monitoring during active grout injection in the upstream tunnel. During works, the IEM conducted sampling in the treatment basins, in the cells downstream of the treatment systems (Photo 5) and at the outlet to the Lillooet River (Photo 6), when water leaving the system was close to pH 9. Water treatment was successful and water quality remained within Project guidelines (pH 6.5 – 9) during grouting works. Please see Section 4.5 Water Quality Results.

Photo 5 – Water being directed to the first cell of the of the ULRHEF sediment basins during tunnel grouting (January 12, 2016).

- All seepage water in the intake excavation and portal should be conveyed to the sediment basins unless approved for discharge directly to the Lillooet River by the IEM or CE environmental manager.
- CE should develop a long-term plan to address water treatment at the ULRHEF downstream tunnel heading now that infiltration capacity in the ponds has reduced and water discharging

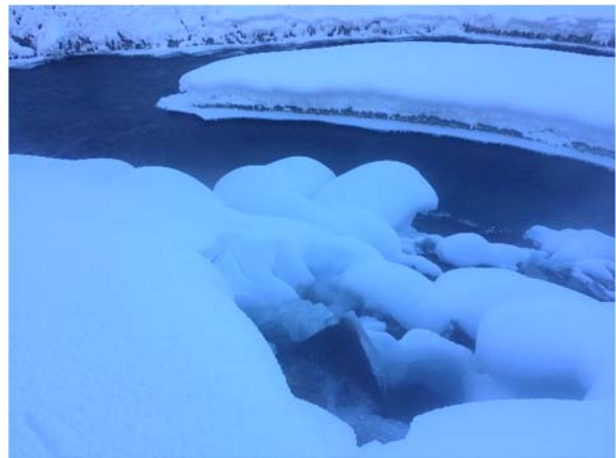
Photo 6 – Water discharging to the Lillooet River from the ULRHEF sediment basins (January 9, 2016).

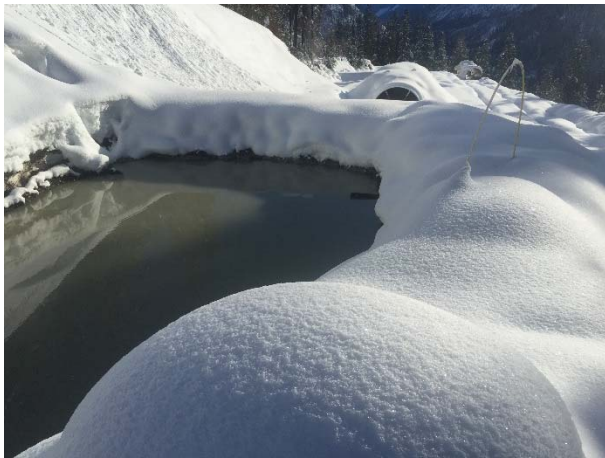
- During an inspection on January 8, the IEM noted that water was discharging from the infiltration ponds through the outlet pipe and flowing along the toe of the penstock fill slope through a vegetated area (Photo 7). The IEM hiked along the flow path and found that the water was no longer infiltrating to ground and was discharging offsite, over a ledge that was inaccessible. The water was discharging offsite at 77 NTU and above BCWQGs for discharge to surface water; however, as water was discharging to vegetation and unlikely to have reached a watercourse via surface connection, the discharge is not considered to have had an impact on surface water quality or aquatic life. The IEM requested that CE prevent

the water discharging from the primary infiltration ponds as this water flows along the toe of the penstock fill before flowing over the edge of a steep embankment. By allowing discharge from the infiltration ponds, particularly once the snow begins to melt, the potential exists for erosion and sediment transport offsite towards the Lillooet River Trail. CE responded the following morning (January 9), by repairing the piping and valves to the discharge pipe that will direct water to a second set of infiltration ponds temporarily (Photo 8). By directing water between the two sets of ponds, CE can manage the infiltration rates to prevent the water from discharging offsite (Photo 9). CE is working on developing a more permanent solution in this area now that the infiltration capacity of the primary treatment ponds has slowed.

**Photo 7 – Water discharging from the primary infiltration ponds at the ULRHEF downstream tunnel is no longer infiltrating in a vegetated area and is flowing over a steep bank at the toe of the penstock fill (January 8, 2016).**

off-site does not meet surface water quality guidelines and poses an ESC risk to downstream areas. In the short term, CE should closely monitor the infiltration rates in both sets of treatment ponds to prevent offsite discharge of surface water.

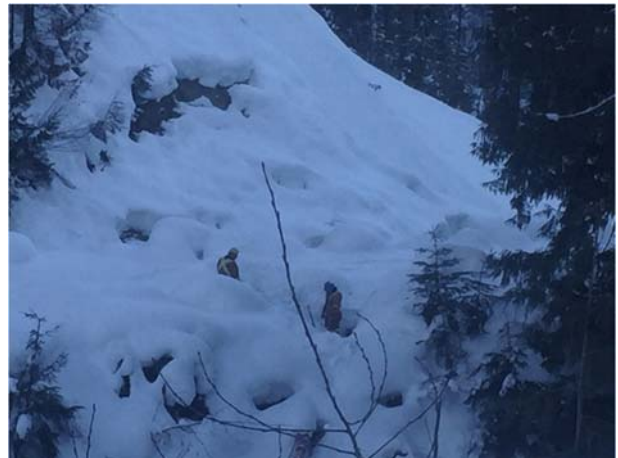
**Photo 8 – Repairing the piping system at the primary ULRHEF downstream tunnel infiltration ponds so water can be direct to the second set of infiltration ponds (January 9, 2015).**

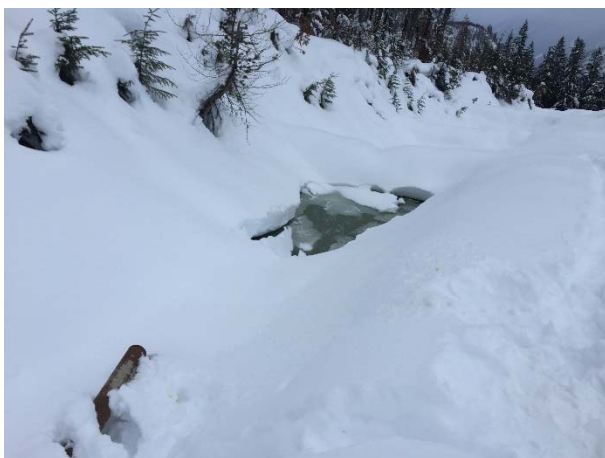
**Photo 9 –ULRHEF downstream tunnel seepage and process water being directed to the second set of infiltration ponds (January 11, 2016).**

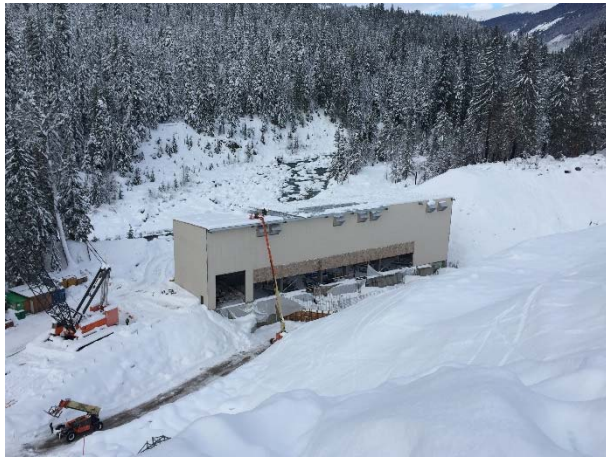
- Superstructure construction (Photo 10 and Photo 11Photo 11).
- Dewatering to Lillooet River.

Photo 10 – ULRHEF powerhouse construction (January 7, 2016).

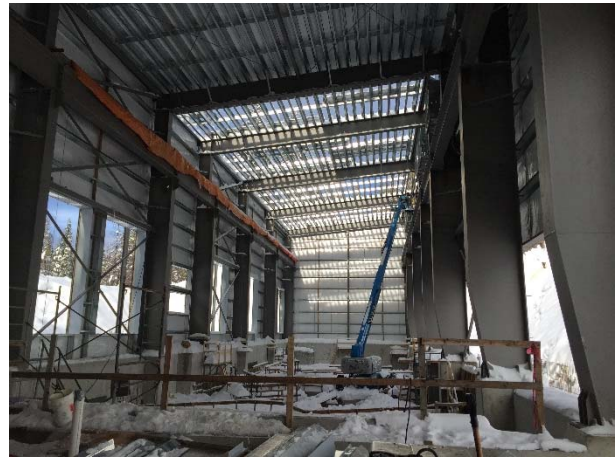
Photo 11 – ULRHEF powerhouse construction (January 13, 2016).

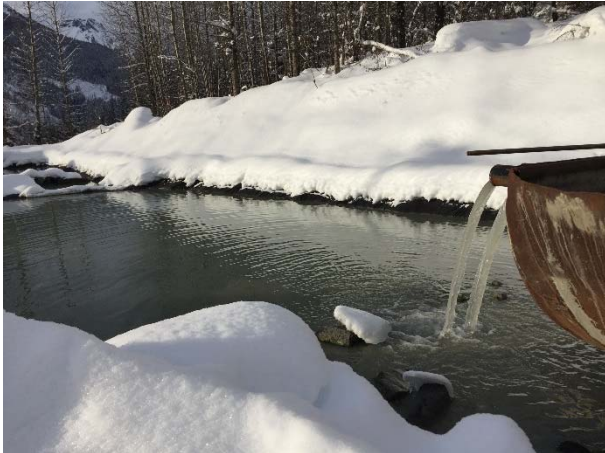
- Drilling, blasting and tunnel stabilization in the downstream tunnel portal.
- BDRHEF powerhouse mechanical and electrical component installation.
- Dewatering of the tunnel and powerhouse to the oil water separator and settling ponds continued (Photo 12).

- All wastewater related to the BDRHEF tunnelling works continued to be contained and conveyed to the downstream portal settling ponds for treatment (Photo 12).

Photo 12 – BDRHEF downstream portal settling ponds (January 6, 2016).

- All wastewater related to the BDRHEF tunnelling works should continue to be contained and conveyed to the downstream portal settling ponds for treatment. Regular inspections of the treatment ponds should be performed to ensure the necessary maintenance activities outlined in the work plan are performed.

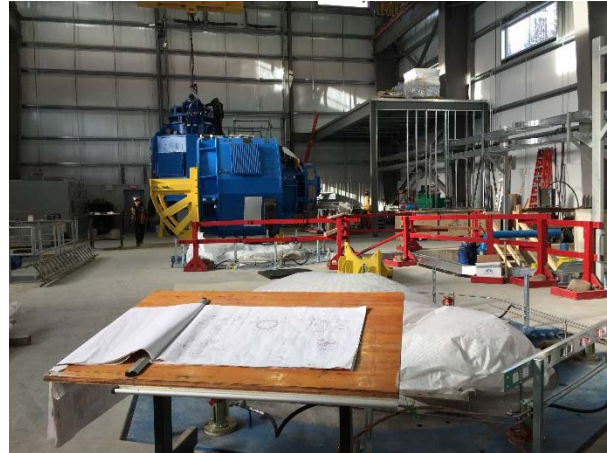
Photo 13 – Preparing the generators for installation inside the BDRHEF powerhouse. (January 13, 2016).
