# Upper Lillooet Hydro Project

## Weekly Environmental Monitoring Report #87

Reporting Period: January 31 – February 13, 2016

Upper Lillooet River Hydroelectric Facility (Water File No. 2002561, Water licence No. C130613), Boulder Creek Hydroelectric Facility (Water File No. 2003049, Water licence No. C129969) & Transmission Line (TX Line)

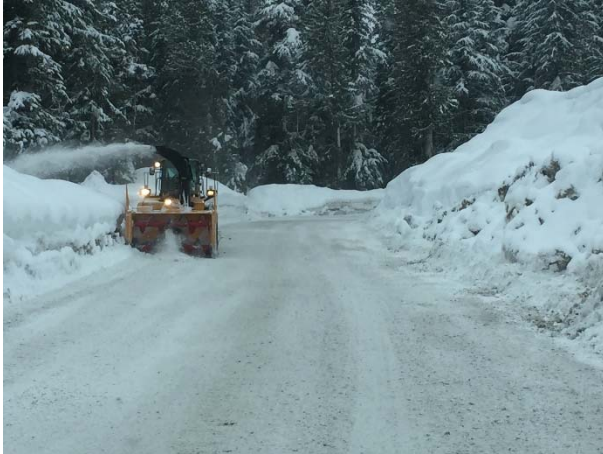
Photo 1 – Snow removal on the Lillooet River FSR  
(February 4, 2016).

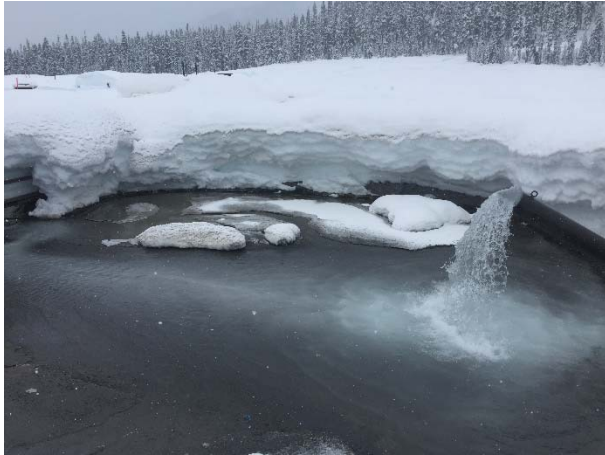
- During grout injection and tunnel excavation rounds in the upstream tunnel, all seepage water was directed to the ULRHEF intake sediment basins for treatment (Photo 2). CE's environmental management team ensured that the active treatment system was functioning and well maintained.
- The IEM visited the ULRHEF intake daily to conduct water quality monitoring during grout injection and tunnel excavation works. During works, the IEM conducted sampling in the cells downstream of the treatment system and at the outlet to the Lillooet River. The water treatment was successful and water quality remained within project guidelines (pH 6.5 – 9; and, <8NTU over background) throughout the monitoring period. Please see Section 4.5 Water Quality Results.

Photo 2 – The first cell of the ULRHEF sediment basins during tunnel grouting (February 3, 2015).

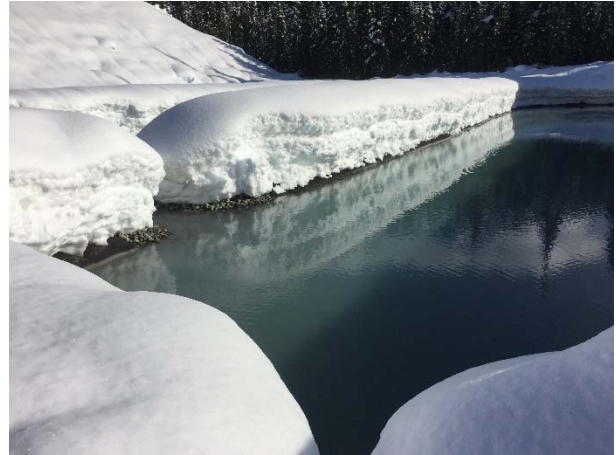
Photo 3 – The second cell of the ULRHEF sediment basins following a blast in the tunnel; water was visibly clear downstream of treatment system (February 8, 2015).

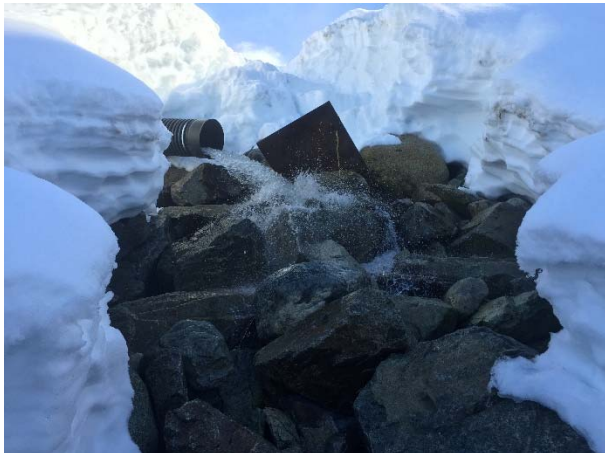
Photo 4 – Discharge from ULRHEF sediment basins to Lillooet River during mucking in the tunnel (February 8, 2015).

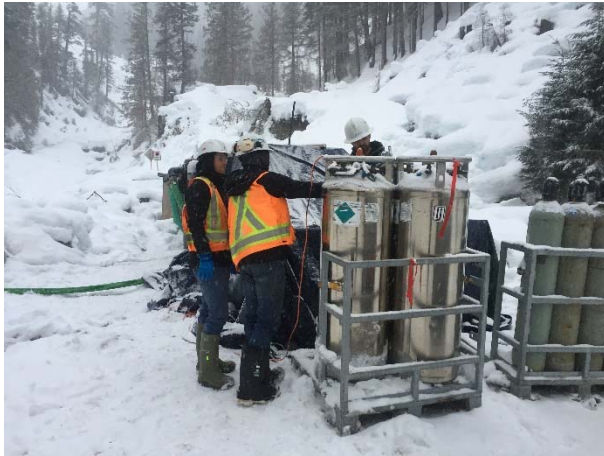
- On January 31, water discharging from the water treatment system temporarily exceeded BCWQGs for turbidity (NTU = 68.3; See Section 4.5). Upon identification of the exceedance CE directed water back to the infiltration ponds until the system was repaired on February 3, 2016 (Photos 5 and 6). The cause was identified as a clogged sand filter, which rendered sand filtration ineffective. The filters were cleaned and once the system was operational, CE directed treated water (within BCWQGs) back to Truckwash Creek.

- On February 4, the IEM observed that the system was not functioning properly once again and CE's environmental management team diverted water from the treatment system back to the lower ponds. On February 8, the water treatment system supplier installed two additional settling tanks and reconfigured the system. Water discharging from the reconfigured treatment system was tested and confirmed to be within BCWQGs prior to discharging water directly to Truckwash Creek. The water treatment system remained operational and functioned as intended for the remainder of the reporting period. Please see Section 4.5 for Water Quality Results.

Photo 5 – Installation of active water treatment system at the downstream tunnel infiltration ponds (February 3, 2016).

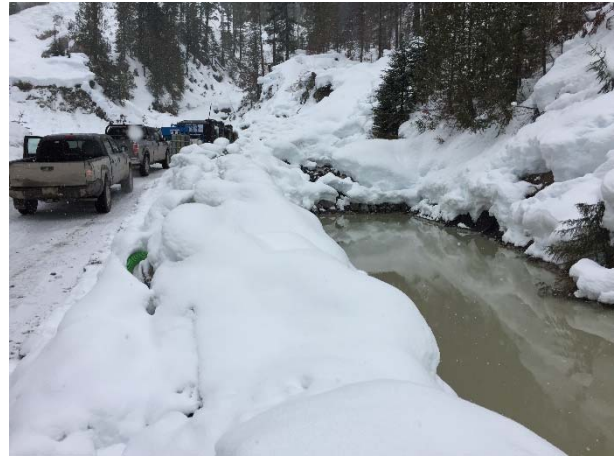
Photo 6 – ULRHEF downstream tunnel infiltration ponds (February 3, 2016).

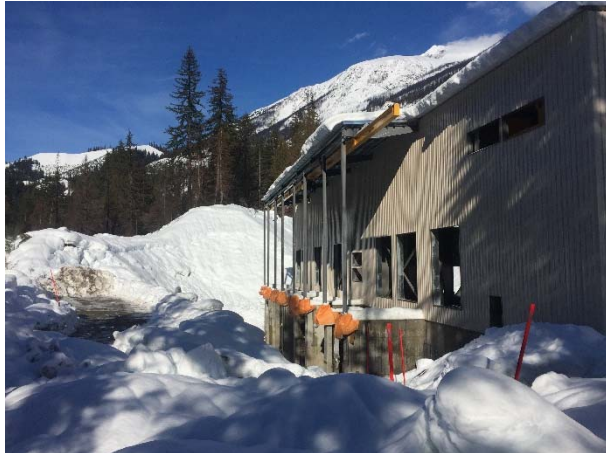
- No construction activities are currently occurring at the powerhouse (Photo 7); dewatering to Lillooet River continues (Photo 8).

**Photo 7 – Current conditions at the ULRHEF powerhouse (February 8, 2016).**

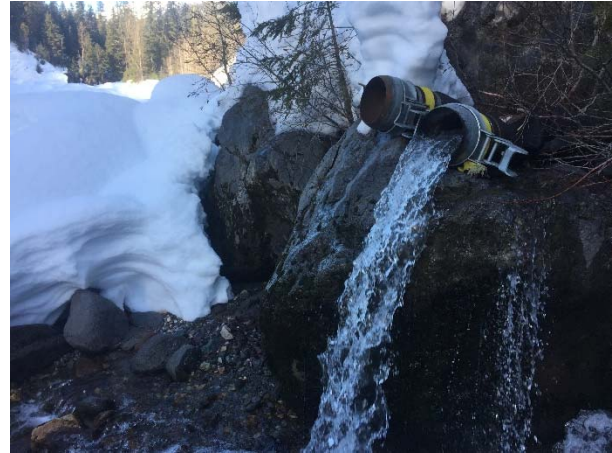
**Photo 8 – ULRHEF powerhouse seepage water dewatered to the Lillooet River (February 8, 2016).**

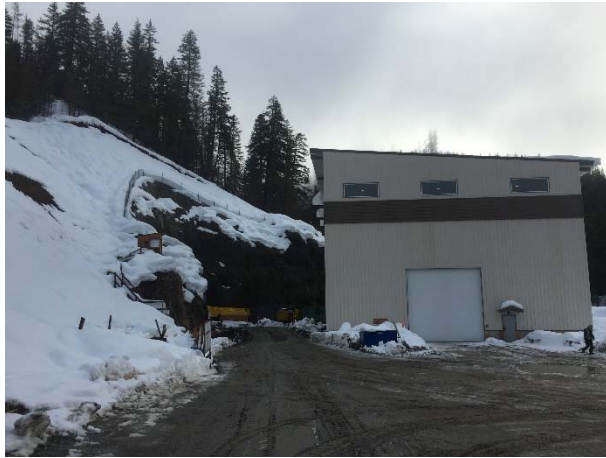
Photo 9 – Current conditions at the BDRHEF tunnel portal and powerhouse (February 9, 2016).

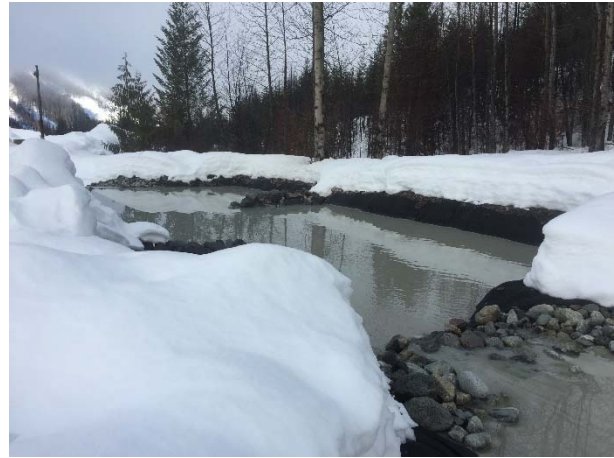
- All wastewater related to the BDRHEF tunnelling works continued to be contained and conveyed to the downstream portal settling ponds for treatment (Photo 10).

Photo 10 – BDRHEF downstream portal settling ponds (February 9, 2016).
