Upper Lillooet Hydro Project

Weekly Environmental Monitoring Report #89

Reporting Period: February 28 – March 12, 2016

Upper Lillooet River Hydroelectric Facility (Water File No. 2002561, Water licence No. C130613), Boulder Creek Hydroelectric Facility (Water File No. 2003049, Water licence No. C129969) & Transmission Line (TX Line)

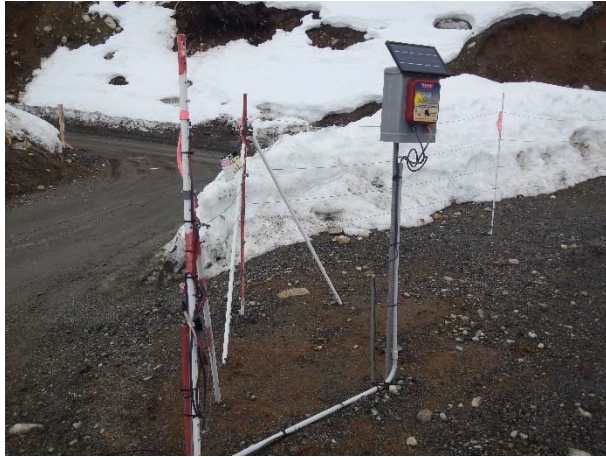
Photo 1 – Electric fence on Pad 1 (March 8, 2016).

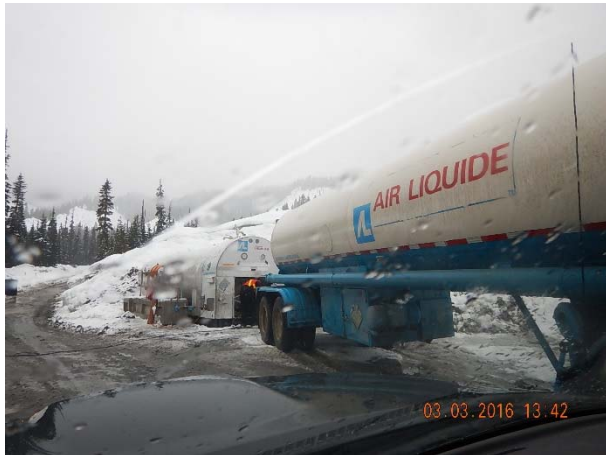
- During canopy tube installation, drilling, grout injection, and blasting all seepage water was directed to the ULRHEF intake sediment basins for treatment (Photo 3). CE's environmental management team ensured that the active treatment system was functioning as intended and stocked with required water treatment chemical.
- The IEM visited the ULRHEF intake daily to conduct water quality monitoring during grout injection. During works, the IEM conducted sampling in the cells downstream of the treatment system and at the outlet to the Lillooet River. The water treatment was successful and water quality remained within project guidelines (pH 6.5 – 9; and, <8NTU over background) throughout the monitoring period. Please see Section 4.5 Water Quality Results.

Photo 3 – Delivery of the bulk CO₂ system to support the water treatment system at the ULRHEF intake (March 3, 2016).

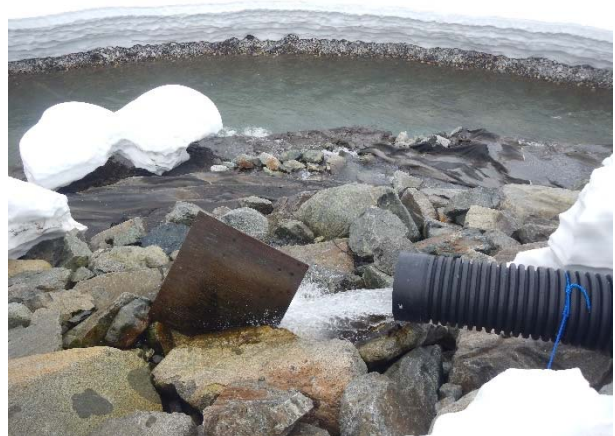
Photo 4 – Discharge from ULRHEF sediment basins to Lillooet River during canopy tube installation (drilling) in the tunnel (March 8, 2016).

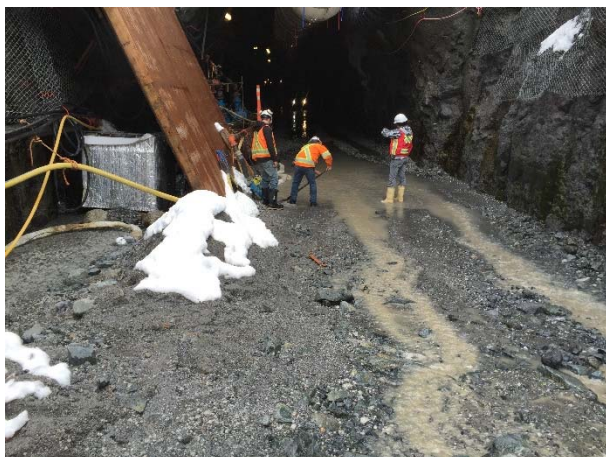
- On March 11, 2016 increased road runoff and traffic associated with tunnel mucking contributed turbid water to the clean water sump that pumps water directly to the Lillooet River. The IEM recorded a temporary exceedance of BCWQGs as a result of these works and notified CE of the problem (See Section 4.5 for water quality results). CE responded by working to better isolate the road runoff from the clean water sump (Photo 5).

Photo 5 – Working to isolate turbid road runoff from the clean water sump. The turbid runoff resulted in a temporary exceedance of BCWQGs in the Lillooet River (March 11, 2016).

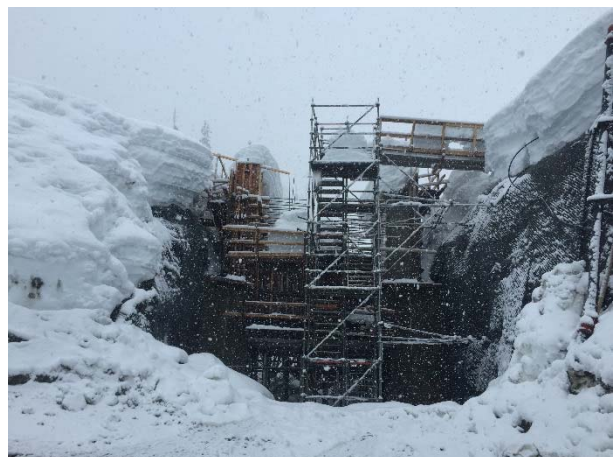
- Consolidation of class 4CT material began following the pre-work meeting conducted on March 3, 2016. Works included canopy tube drilling and grout injection operations, followed by the first round of drilling and blasting in class 4CT material on March 10, 2016.
- Delivery and setup of the bulk CO₂ system at the ULRHEF intake setting ponds occurred on March 3, 2016 (Photo 3).
- Dewatering to ULRHEF intake sediment basins (Photo 3 - Photo 5).
- Intake structure construction had not yet resumed as of March 12, 2016 (Photo 6).

Photo 6 – ULRHEF intake structure work remains on hold (Mach 12, 2016).

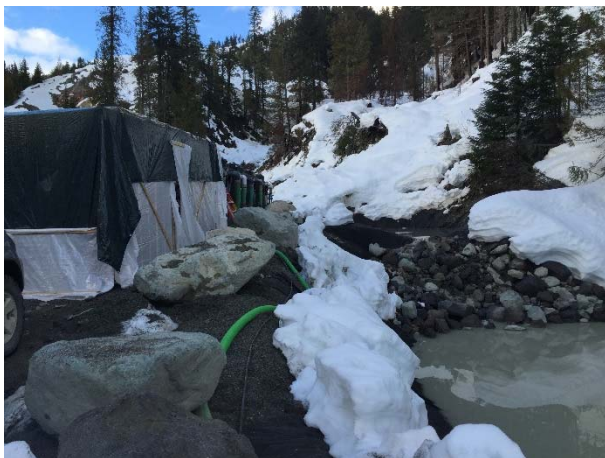
- On March 4, 8, and 10, the IEM observed that the system was not treating all of the process water emanating from the lower tunnel, and that excess water was discharging from the ponds above BCWQGs (Photo 7; Photo 8; see section 4.5 for water quality results). CE should assess the capacity of the treatment system to prevent discharging water from the ponds. Water discharging from the ponds risks causing offsite erosion of the Lillooet River trail as previously outlined in FAM#8 distributed on January 18, 2016 prior to the installation of the water treatment system. This issue will be tracked as ITM *ULR#46*.

Photo 7 – Active water treatment system at the downstream tunnel infiltration ponds (March 7, 2016).

- All water from the ULRHEF upstream tunnel heading should be conveyed to the sediment basins for treatment. CE should perform regular monitoring to ensure that the water treatment system is functioning as intended and that discharge to the Lillooet River continues to meet BCWQGs.
- CE should be regularly monitoring the downstream tunnel water treatment system to ensure it is functioning as intended and that discharge into Truckwash Creek continues to meet

BCWQGs. The water treatment system capacity should be assessed to prevent discharging process water above BCWQGs offsite (ITM ULR#46).

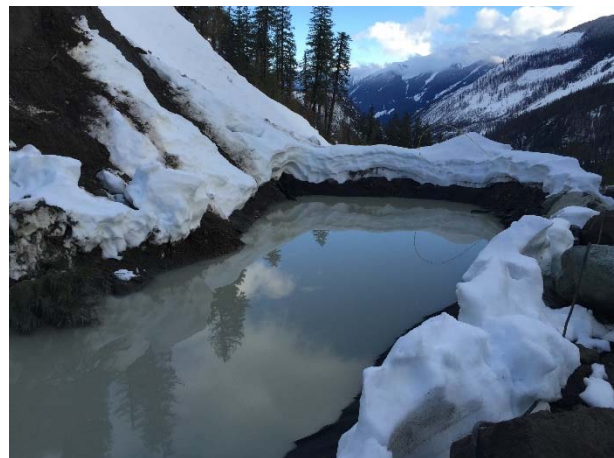
Photo 8 – ULRHEF downstream tunnel infiltration ponds continue to outlet despite the treatment system being active (March 7, 2016).

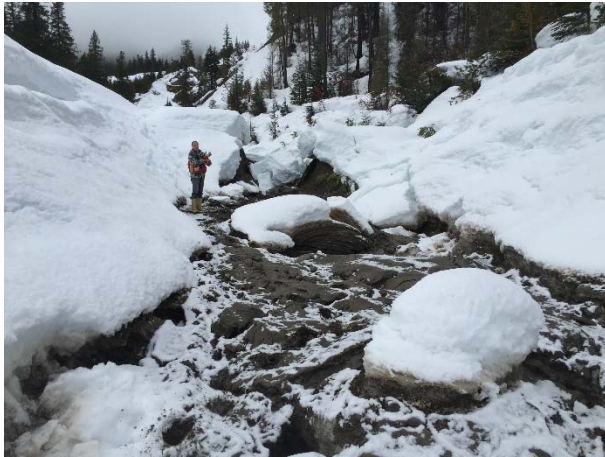
- On March 12, CE informed the IEM and INX that a small slide of snow and material caused the failure of the outside wall of one of the sediment ponds located adjacent to the penstock alignment (Photo 9). The ponds were not in use at the time; however, they contained some water, which flowed through the collapsed wall towards stream ASTR-03. It appears from initial inspection that the water did not reach the watercourse and no environmental damage was caused by the event.

Photo 9 – Failure of the outside wall of the sediment pond caused by a small snow and debris slide into the pond (March 12, 2016).

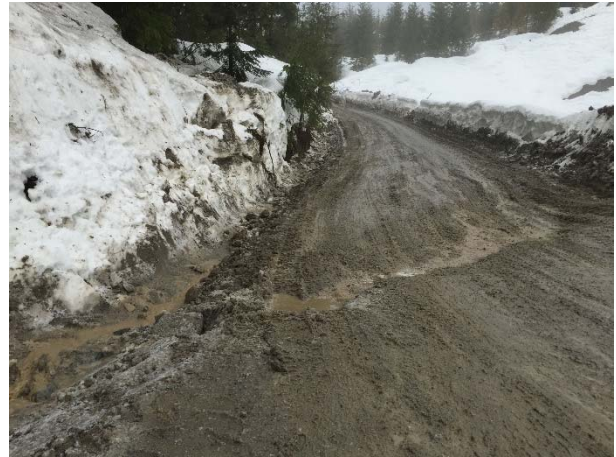
- On March 6, CE installed a cross ditch across the downstream tunnel portal access road to convey road runoff to the ditch (Photo 10). The ditch line outlet should be examined to ensure it is infiltrating to ground and not causing offsite erosion within the Mountain Goat replacement area.

Photo 10 – Cross-ditching installed to direct road runoff to the ditch line (March 6, 2016).

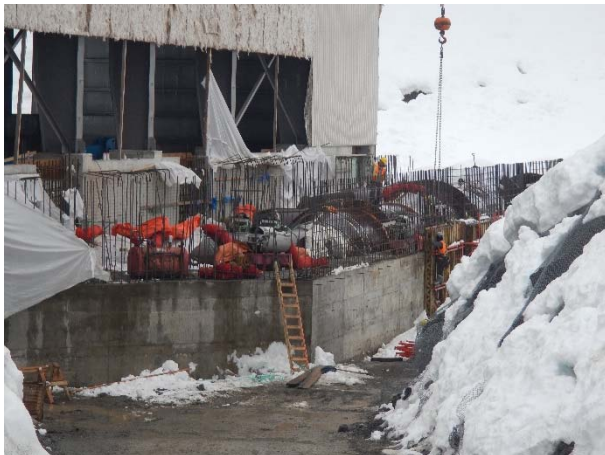
- Construction activities resumed with snow and formwork removal at the ULRHEF powerhouse (Photo 11); dewatering to Lillooet River continues.

Photo 11 – Current conditions at the ULRHEF powerhouse (March 8, 2016).

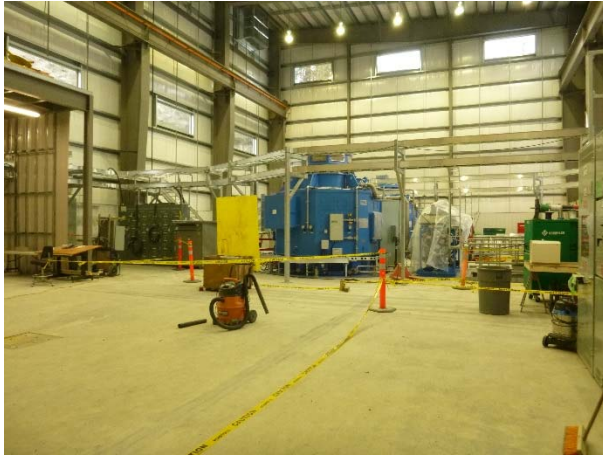
- Drilling, blasting and tunnel stabilization in the downstream tunnel portal (Photo 13).
- BDRHEF powerhouse electrical component installation (Photo 12).
- Dewatering of the tunnel and powerhouse to the oil water separator and settling ponds continued (Photo 13).

Photo 12 – Current conditions inside the BDRHEF powerhouse (March 6, 2016).

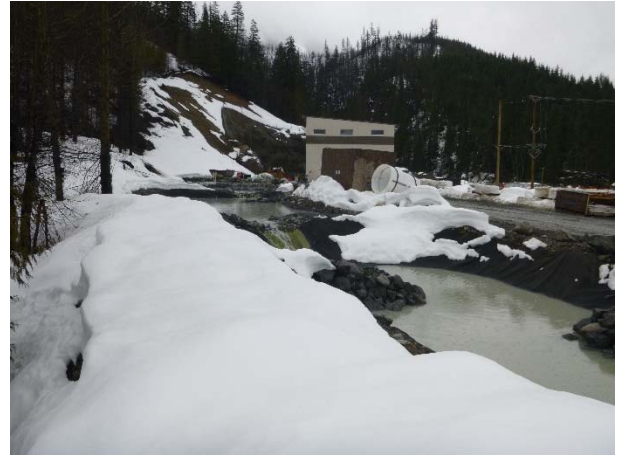
- All wastewater related to the BDRHEF tunnelling works continues to be conveyed to the downstream portal settling ponds for treatment (Photo 13). Water discharging from the sediment ponds empties to the perimeter ditch surrounding the spoil pile and continues to infiltrate to ground prior to reaching surface waters.

Photo 13 – BDRHEF downstream tunnel portal, powerhouse, and settling ponds (March 6, 2016).

- All wastewater related to the BDRHEF tunnelling works should continue to be contained and conveyed to the downstream portal settling ponds for treatment. Regular inspections of the treatment ponds should be performed to ensure the necessary maintenance activities outlined in the work plan are performed.
