Upper Lillooet Hydro Project

Weekly Environmental Monitoring Report #90

Reporting Period: March 13 – March 26, 2016

Upper Lillooet River Hydroelectric Facility (Water File No. 2002561, Water licence No. C130613), Boulder Creek Hydroelectric Facility (Water File No. 2003049, Water licence No. C129969) & Transmission Line (TX Line)

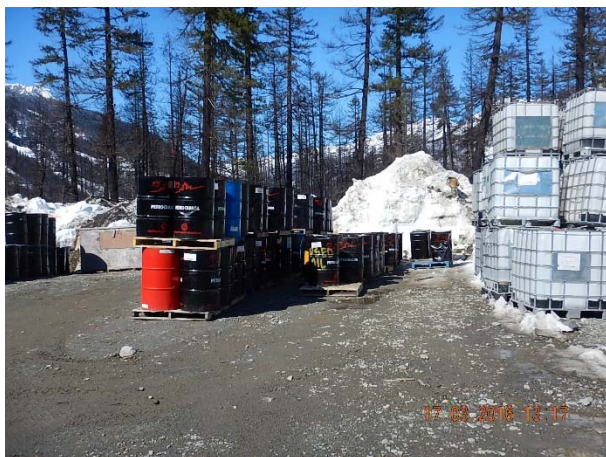
Photo 1 – Hazardous materials stored at the KM38 laydown stored temporarily prior to off-site disposal (March 17, 2016).

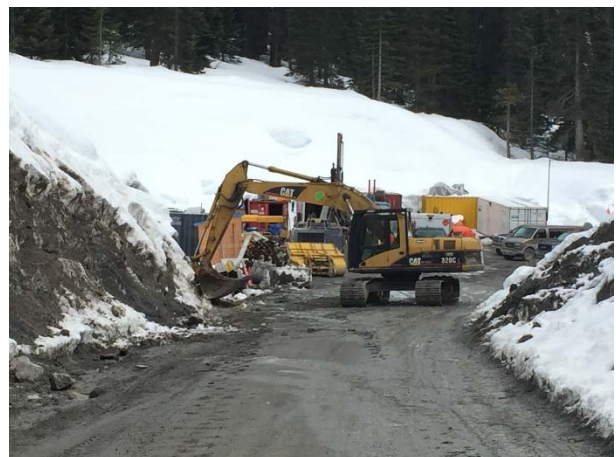
- Ditch armoring remains outstanding at KM49 of the Lillooet River FSR. On March 16, the IEM issued FAM#10 after road drainage discharging to the Lillooet River was over-range on the turbidity meter. This issue has been tracked as ITM ULR#43 since February 19, 2016. Repairs are required to prevent turbid runoff from discharging to the Lillooet and causing temporary exceedance of BCWQGs. CE responded to FAM#10 on March 18, indicating that the following repairs will be installed:

Photo 2 – Snow removal and ditch maintenance near KM49 of the Lillooet River FSR (March 19, 2016).

- The ditch will end in a sump near where a new culvert was installed a week ago. The ditch will have check dams (when clean angular rock becomes available).

- A second sump will be dug prior to the outlet to the Lillooet River. It was discussed that if water in the sump is discharging above BCWQGs a pump will be installed to direct sediment laden water to a vegetated area for infiltration.

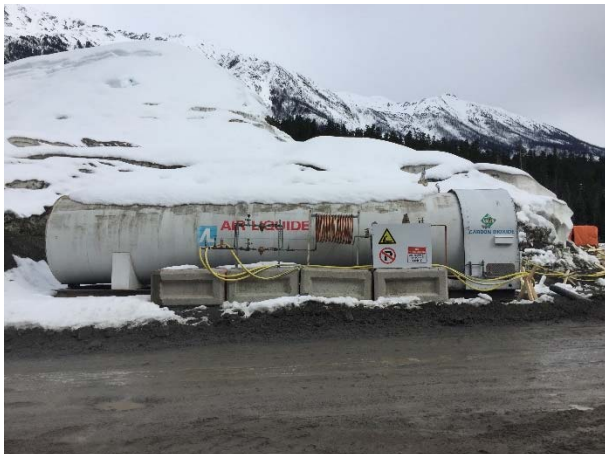
Photo 3 – Installation of the bulk CO₂ system to support the water treatment system at the ULRHEF intake was completed and active as of March 19, 2016.

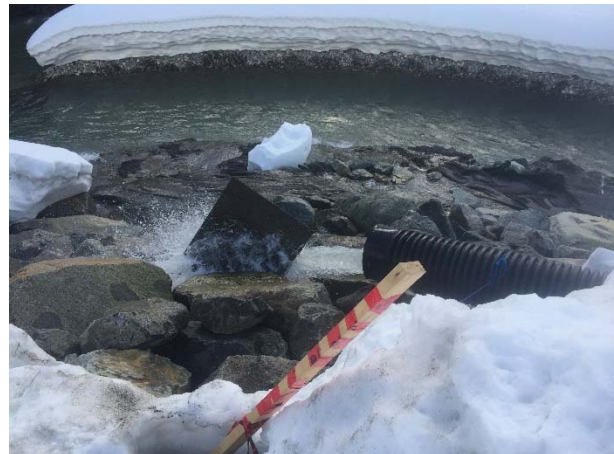
- During canopy tube installation, drilling, grout injection, and blasting all seepage water was directed to the ULRHEF intake sediment basins for treatment (Photo 3 & Photo 6). CE's environmental management team ensured that the active treatment system was functioning as intended and stocked with required water treatment chemical.
- The IEM visited the ULRHEF intake daily to conduct water quality monitoring during grout injection. During works, the IEM conducted sampling in the cells downstream of the treatment system and at the outlet to the Lillooet River. The water treatment was successful and water quality remained within project guidelines (pH 6.5 – 9; and, <8NTU over background) throughout the monitoring period. Water quality sampling data is available upon request.

Photo 4 – Discharge from ULRHEF sediment basins to Lillooet River during canopy tube installation (drilling) in the tunnel (March 22, 2016).

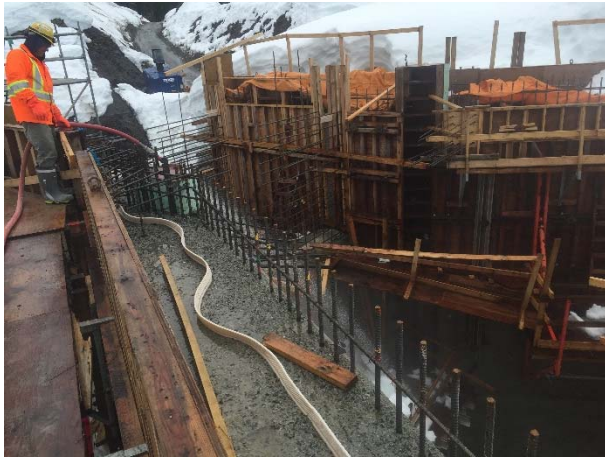
Photo 5 – Spraying hot water to melt snow at the ULRHEF intake structure (March 23, 2016).

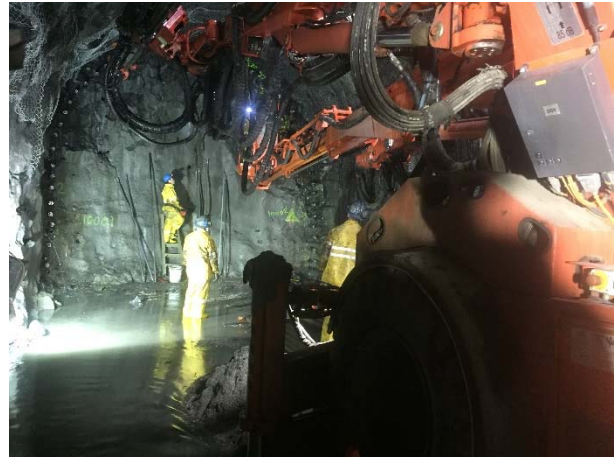
Photo 6 – Canopy tube installation; a component of the umbrella support system being installed within the ULRHEF upstream tunnel (March 23, 2016).

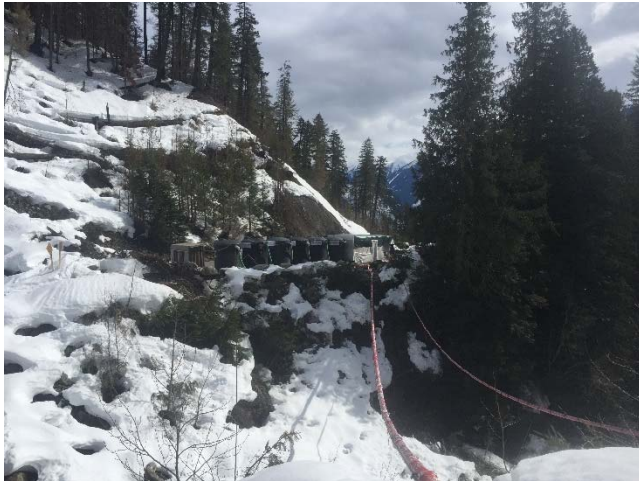
- The IEM conducted regular inspections of the active water treatment system and found that water discharging to Truckwash Creek was within BCWQGs during all inspections (Photo 7). Water quality data is available upon request.

Photo 7 – Active water treatment system at the downstream tunnel infiltration ponds (March 22, 2016).

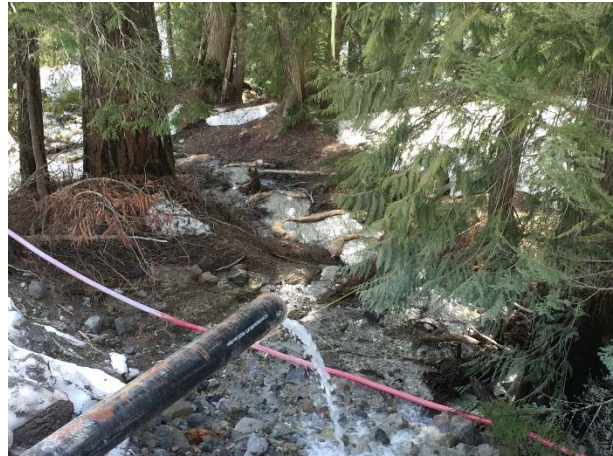
- On March 14, 16-17, 20-23 and 25, the IEM observed that process water was bypassing the active water treatment system and was discharging from the ponds above BCWQGs (Photo 8). This issue was first identified and tracked as ITM *ULR#46*. With the increased volume of water, the situation appears to have worsened. The IEM acknowledges that CE has been attempting to find a solution to treating the excess water (CE proposed to discharge excess water to the penstock sub-drain or disperse it along the top of the penstock fill slope with a diffusion pipe; however, both options were deemed to present too high a risk and were denied by the Design Engineer). As the situation had not improved during the reporting period the IEM issued FAM#11 on March 24, 2016 to address the outstanding concern (ITM *ULR#49*). CE has indicated that they are sourcing a larger capacity treatment system capable of handling the increased amount of process water from the downstream tunnel portal.

Photo 8 – Water continues to discharge from the ULRHEF downstream tunnel infiltration ponds despite the treatment system being active. The IEM is under the understanding that an upgraded water treatment system is on order (March 26, 2016).

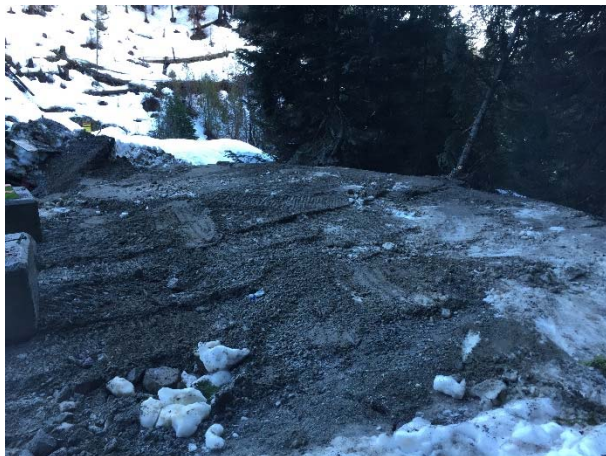
- On March 24, the IEM discovered that CE might have pushed debris and snow beyond the work area limits and into the mountain goat UWR replacement area adjacent to the ULRHEF lower tunnel laydown. FAM#11 was prepared to highlight the IEM's concern and to request that CE assess whether any material was placed within the mountain goat UWR replacement area (*ULR#49*). CE attempted to remove as much material as possible and placed lock blocks to prevent further encroachment (March 25; Photo 9). CE will provide an assessment of any damaged caused to the area that may influence its use as suitable UWR replacement

area. The assessment will be completed once the snow fully melts. This issue will be tracked in the recommendation section until it is completed.

Photo 9 – Some of the snow and material was removed that was pushed into the UWR mountain goat replacement area. CE will assess the area and develop a reclamation plan if necessary once the snow has melted (ULR #49; March 25, 2016).

- Once the snow in the area melts, CE should assess whether deposited material within the mountain goat UWR replacement area has compromised the suitability of the potentially impacted area and undertake any remedial actions recommended by the QP (ITM *ULR#49*; FAM#11).

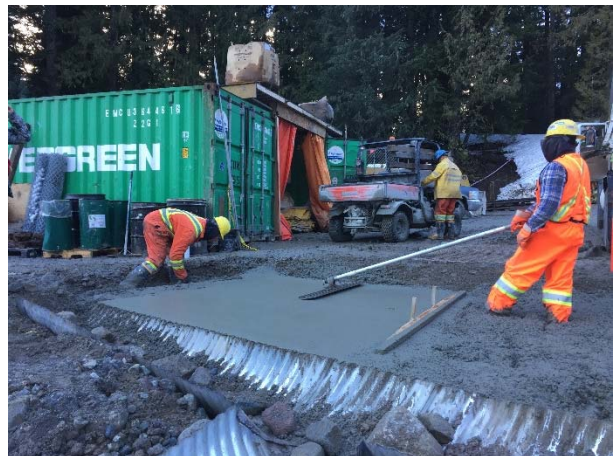
- On March 25, CE installed a concrete pad in front of culvert that is intended to intercept road and work site runoff and direct it to the active water treatment system. The fix was implemented to prevent the culvert from undermining (Photo 10; ULR#43).

Photo 10 – CE installed a concrete pad in front of culvert that is intended to intercept road and work site runoff and direct it to the active water treatment system (ULR#43; March 25, 2016).

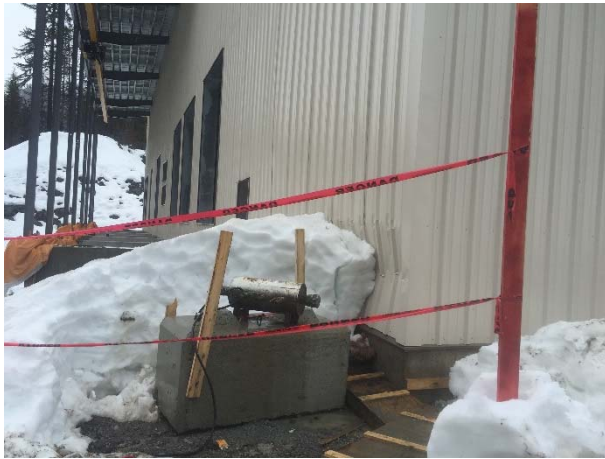
- Some damage to the outside of the powerhouse was observed, which was caused by snow falling from the roof (Photo 11).
- Construction activities resumed with snow removal, formwork installation and manifold structure concrete pours at the ULRHEF powerhouse (Photo 12); dewatering to Lillooet River continues.

Photo 11 – Minor snow damage resulting from snow sliding off the roof of the ULRHEF powerhouse (March 23, 2016).

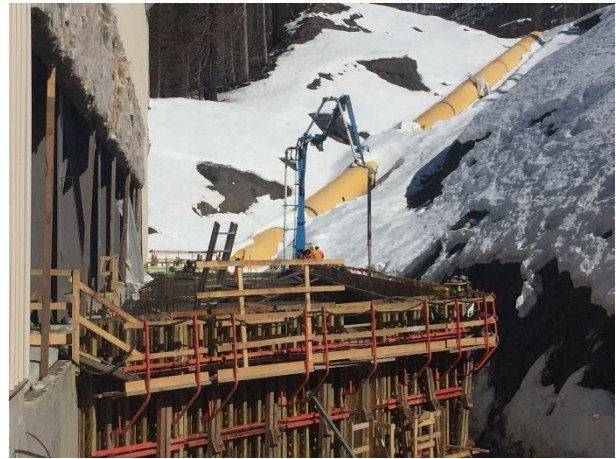
Photo 12 – Concrete pour for the powerhouse manifold (March 25, 2016).

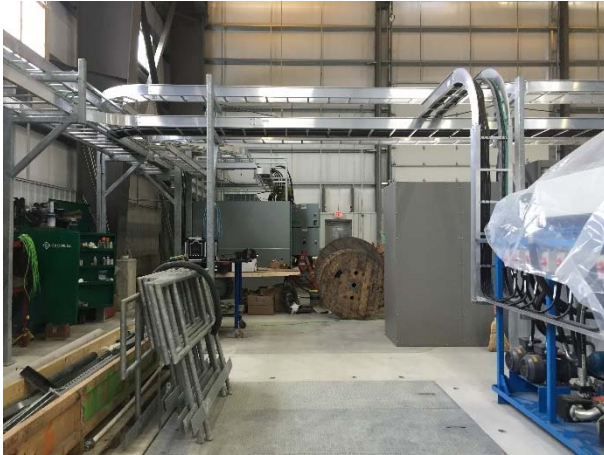
Photo 13 – Conditions inside the powerhouse (March 24, 2016).

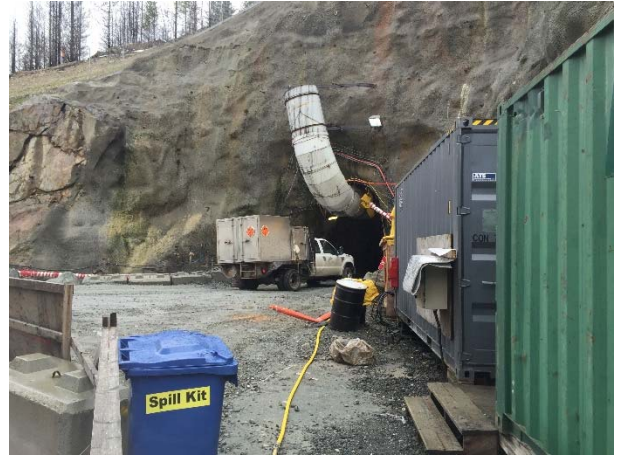
Photo 14 – BDRHEF downstream tunnel portal (March 24, 2016).

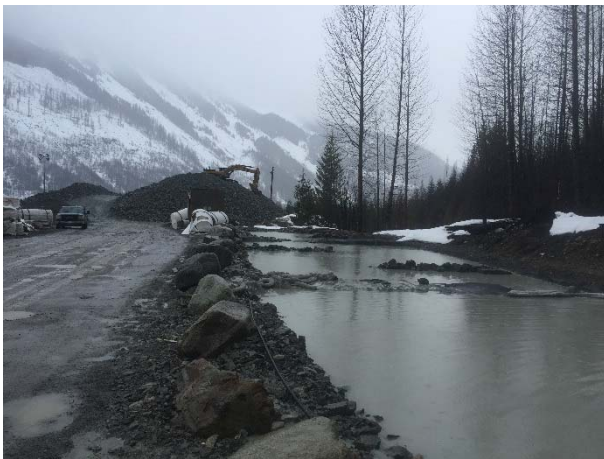
- All wastewater related to the BDRHEF tunnelling works continues to be conveyed to the downstream portal settling ponds for treatment (Photo 15). Water discharging from the sediment ponds empties to the perimeter ditch surrounding the spoil pile and continues to infiltrate to ground prior to reaching surface waters.

Photo 15 – BDRHEF sediment ponds (March 23, 2016).

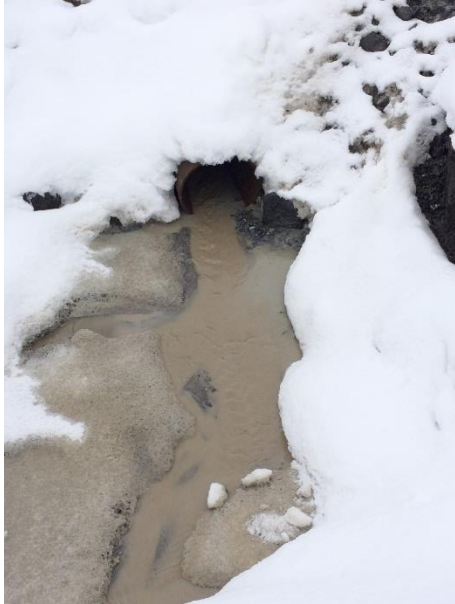
Photo 1 – Site discharge at KM49 being directed to the Lillooet River was over-range on the 2020we turbidity meter yesterday. (March 15, 2016)

1. Provide a plan to address the turbid discharge to the Lillooet River at KM49. The IEM recommends that CE armour ditches with clean angular rock and install velocity checks at spacing and configurations appropriate to the grade of the ditch line to settle suspended sediment and meet BCWQG criteria for turbidity.
2. Provide a plan to address the turbid discharge being conveyed offsite (through mountain goat replacement habitat and directly to Truckwash Creek) from the ditch lines along the ULRHEF lower tunnel portal access road. The IEM recommends that CE armour ditches with clean angular rock and install velocity checks at spacing and configurations appropriate to the grade of the ditch line to settle suspended sediment and meet BCWQG criteria for turbidity.

The implementation of the requested plans should be installed immediately to prevent continued exceedance of surface water quality parameters for the turbidity of site discharge.

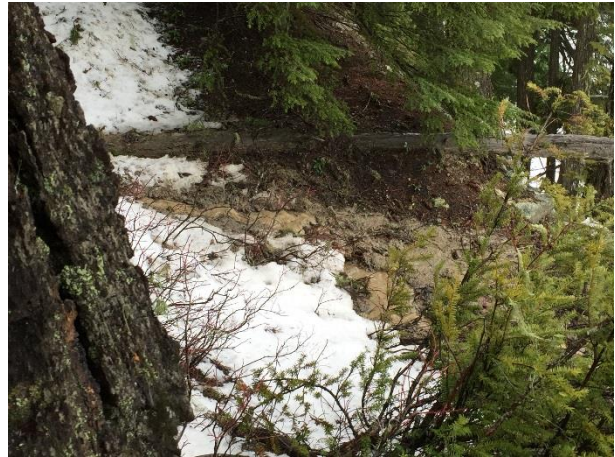
Photo 2 – Turbid water flowing through mountain goat replacement area flows over the edge of a cliff and directly into Truckwash Creek. Turbidity of Truckwash Creek downstream of this input measured 1202AU on March 14, 2016 when background was below 8 NTU.

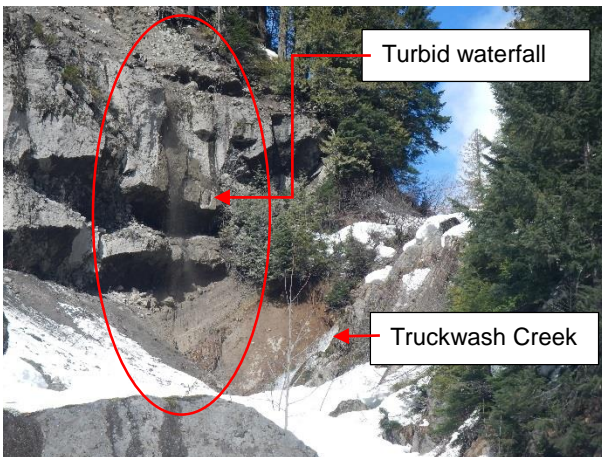
Photo 3 – Turbid site runoff flowing over the edge of a cliff directly to Truckwash Creek.

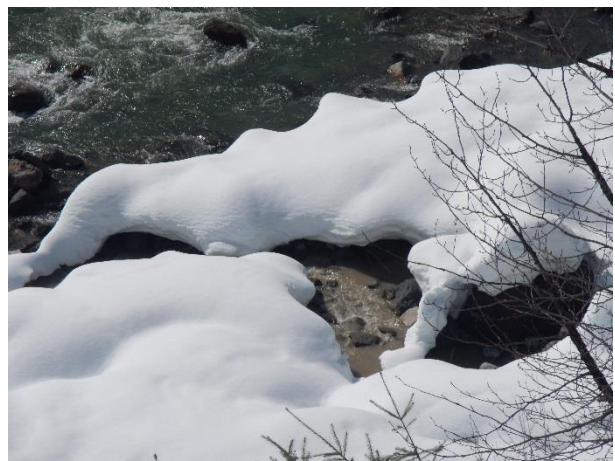
Photo 4 – Confluence of Truckwash Creek and the Lillooet River downstream of the Truckwash Creek pedestrian bridge.

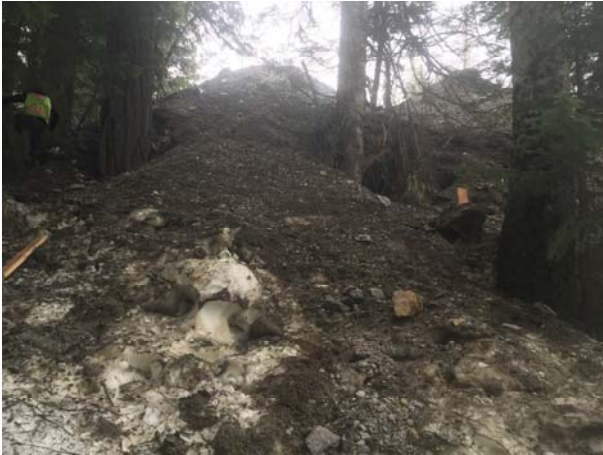
1. It appears that CE may have pushed debris and snow beyond the work area limits and into the mountain goat UWR replacement area adjacent to the ULRHEF lower tunnel laydown.

Photo 1 – Material deposited appears to be outside of the project area and within mountain goat UWR replacement area. (March 23, 2016)

1. Please assess whether any material has been deposited within the mountain goat UWR replacement area. If there has been an encroachment, please ensure this material is removed and provided an assessment of any damaged caused to the area that may impact its use as suitable UWR replacement area.

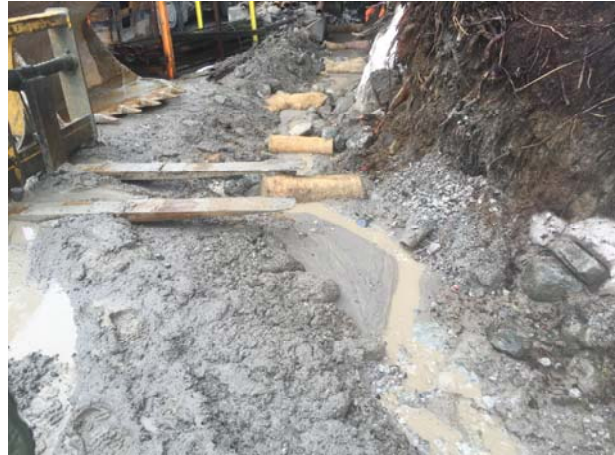
2. Turbid water continues to transport sediment into the mountain goat UWR replacement area which ultimately ends up in Truckwash Creek. In response to the IEMs concerns in this area CE has indicated that they will perform the necessary repairs once they are able to generate and process clean crushed rock to armour ditch lines upslope of the discharge location. The temporary ditch work that CE has completed (see photos) is not functioning to ensure water quality meets the objective of the surface water quality protection plan.

Photo 2 – Measures installed by CE to treat turbid water in the ditch line are not functioning as intended. Please ensure all water from this ditch line is directed to the water treatment system until material required to fix the ditch line is available. (March 23, 2016)

2. Please prevent sediment laden water from discharging to Truckwash Creek through the the mountain goat UWR replacement area. Direct this water to the active water treatment system until work to armour the ditch line is performed and WQ flowing through it meets surface water quality objectives. All turbid water from the work area requires treatment prior to discharging to Truckwash Creek.

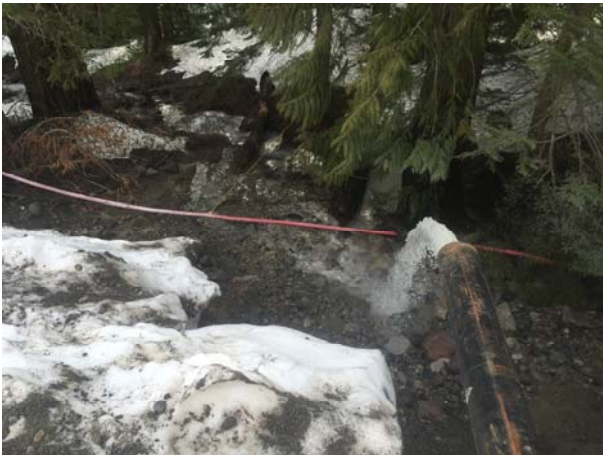
Photo 3 – Turbid discharge that is not able to be fully captured by the active water treatment system at Truckwash Creek is being directed offsite, over the edge of a cliff, and ultimately connects to the Lillooet River. The discharge presents an ESC risk to downstream areas and exceeds BCWQGs for pH and turbidity. Please install appropriate ESC and pH mitigation measures until a large capacity water treatment system is installed. (March 23, 2016)

3. The installation of a new system should be treated as a top priority. Until this new water treatment system is installed and functioning the IEM acknowledges that some turbid water will be continuously discharging from the treatment ponds. As this water reaches the Lillooet River via surface connection, please ensure that a CO2 diffuser is installed to treat the pH of water prior to discharging off-site. Additionally, please perform all measures possible to treat turbidity in the discharge water. The IEM suggests installing Curlex wattles (not matting) as check dams along the drainage path at the base of the penstock fill slope. The check dam spacing should be determined according to the grade of the drainage path.
