Upper Lillooet Hydro Project

Weekly Environmental Monitoring Report #91

Reporting Period: March 27 – April 9, 2016

Upper Lillooet River Hydroelectric Facility (Water File No. 2002561, Water licence No. C130613), Boulder Creek Hydroelectric Facility (Water File No. 2003049, Water licence No. C129969) & Transmission Line (TX Line)

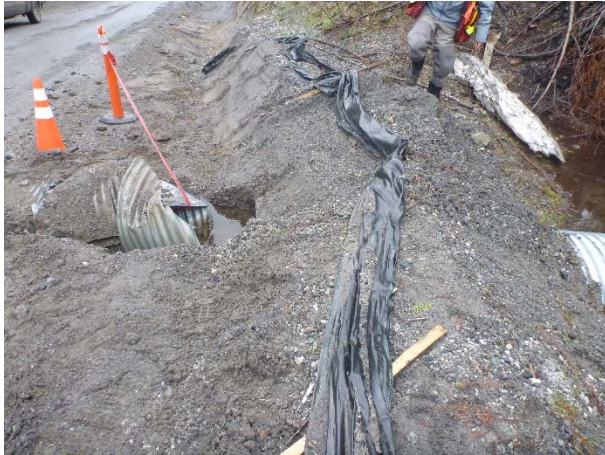
Photo 1 – Damaged culvert at KM43 of the Lillooet River FSR (April 7, 2016).

- On April 6, the damaged culvert at KM43 of the Lillooet River FSR was repaired. Ecofish installed isolation netting and conducted a CTF salvage prior to beginning the repair work; no individuals were observed. The IEM monitored construction activities and conducted WQ during culvert replacement (Photo 1 to Photo 4). Short periods of elevated turbidity were observed during diversion pump installation, culvert removal, replacement and dewatering. Exceedances are highlighted in Section 4.5 Water Quality Results. Turbidity exceedance at the downstream monitoring location lasted no longer than 30 minutes and no environmental issues were observed over the course of these works.

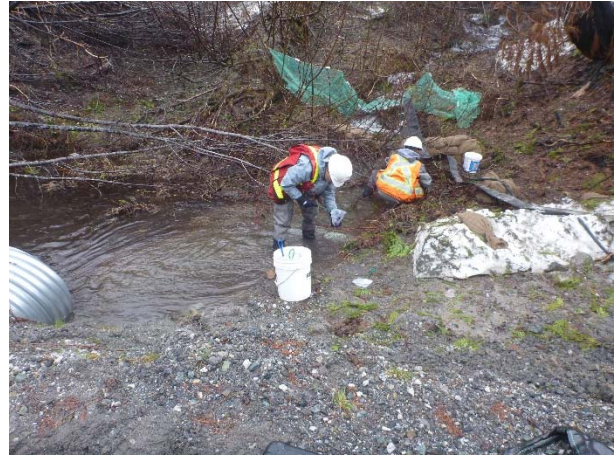
Photo 2 – CTF salvage prior to culvert repair at KM43 of the Lillooet River FSR (April 7, 2016).

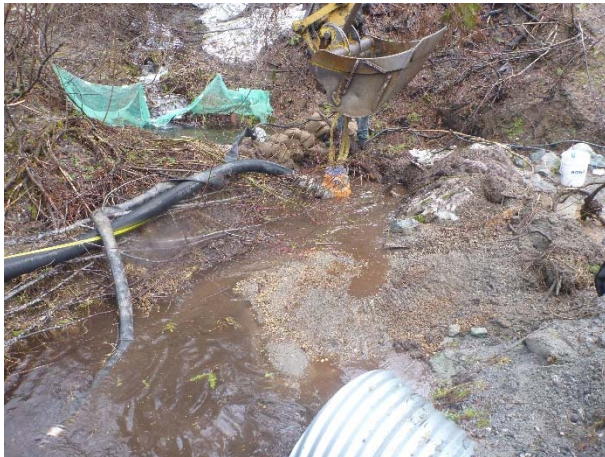
Photo 3 – Turbid water associated with the placement of diversion pump at KM43 (April 7, 2016).

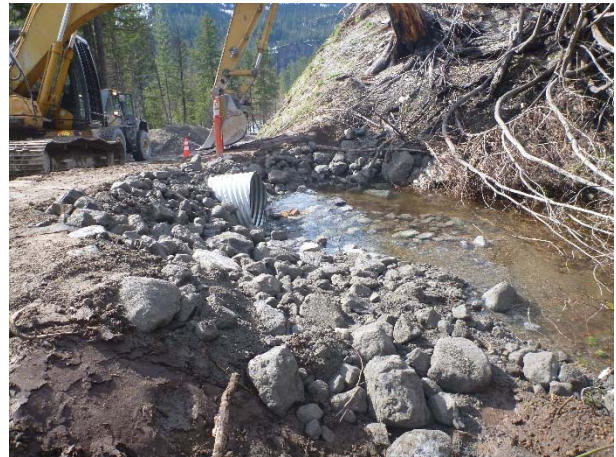
Photo 4 – KM43 culvert repair completed (April 7, 2016).

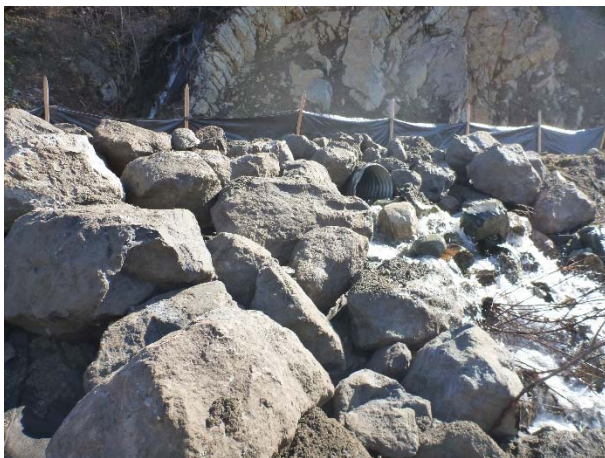
- On April 7, the IEM monitored the armouring of the culvert outlet of ASTR-03 at KM43.3 of Lillooet River FSR (Photo 5). All work was conducted outside of the wetted channel, no WQ exceedances were observed and there were no environmental incidents associated with these works. Please see Section 4.5 for water quality sampling results.

Photo 5 – Armouring of culvert outlet on ASTR-03 (April 7, 2016).

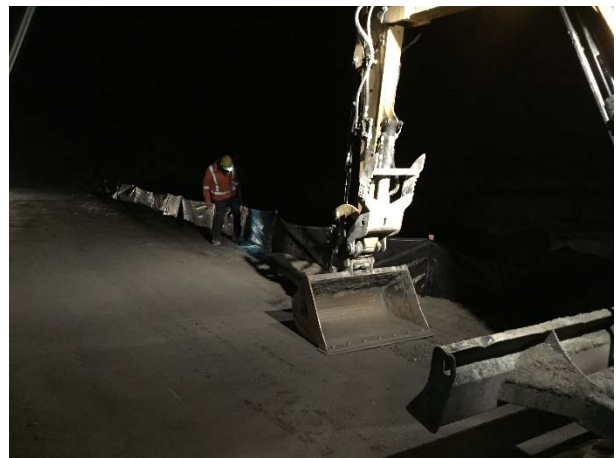
- CE removed the earth berm and replaced it with silt fencing between KM40.9 and KM41.2 of the Lillooet River FSR, during the night shift on March 28, 2016. The IEM was onsite to monitor the works as the activity was occurring within 30m of the Lillooet River (Photo 6).

Photo 6 – Silt fence installation between KM40.9 and KM41.2 of the Lillooet River FSR (March 28, 2016).

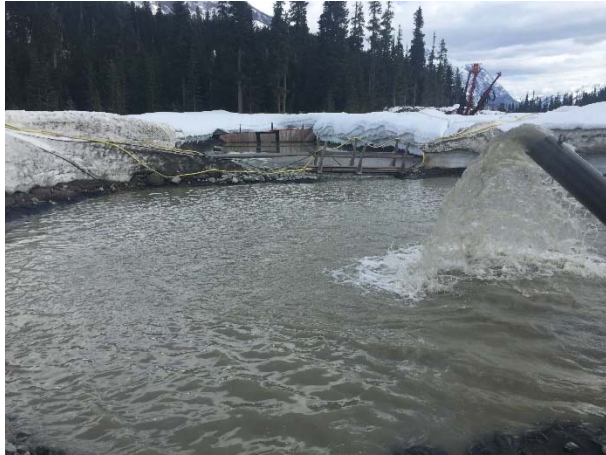
- During canopy tube installation, drilling, grout injection, and excavation all seepage water was directed to the ULRHEF intake sediment basins for treatment (Photo 7 and Photo 8). CE's environmental management team ensured that the active treatment system was functioning as intended and was maintained on a regular basis.

Photo 7 – Dewatering of upper portal water into treatment system (April 2, 2016).

- All water from the ULRHEF upstream tunnel heading should be conveyed to the sediment basins for treatment. CE should perform regular monitoring to ensure that the water treatment system is functioning as intended and that discharge to the Lillooet River continues to meet BCWQGs.

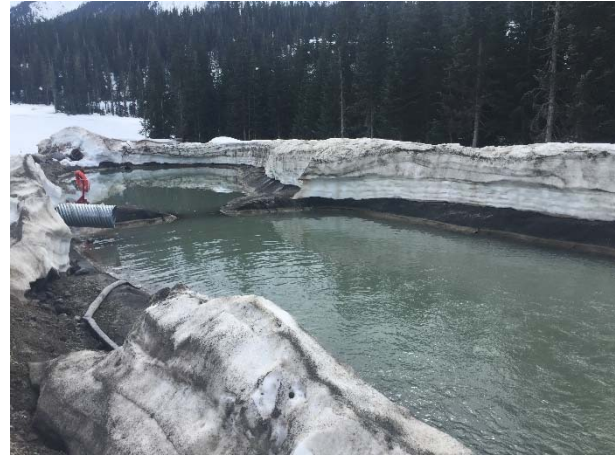
Photo 8 – Pond 6 and 7 of upper tunnel water treatment system (April 2, 2016).

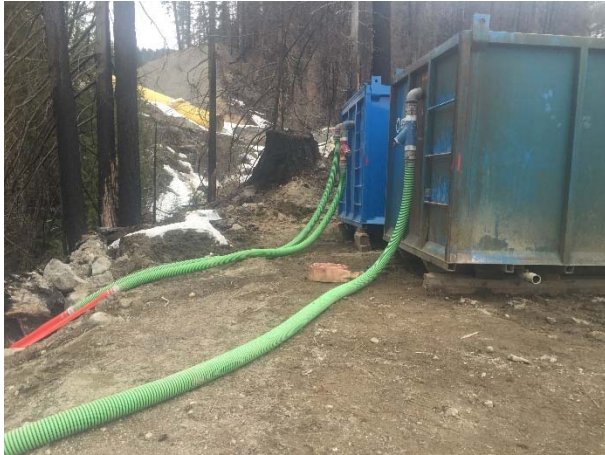
Process water continued to bypass the active water treatment and discharge water offsite above BCWQGs until a new treatment system was installed and operational (April 2, 2016; Photo 9). This issue was first identified and tracked as ITM ULR#46. The IEM acknowledges that CE worked quickly to acquire the services of a water treatment company and install a larger system after all other options had been explored and deemed not feasible. Following the installation of the new treatment on April 2, all water from the downstream tunnel was effectively treated and measured to be within BCWQGs. CE has addressed concerns identified and tracked in the ITM table (ULR#46, FAM#11; ULR#49). Daily water quality sampling results are available upon request.

Photo 9 – ULRHEF downstream tunnel treatment system, installed on April 2, 2016.

- CE should regularly monitor the new water treatment system installed to treat water emanating from the ULRHEF downstream tunnel to ensure the system is functioning as intended and that discharge into ASTR-03 continues to meet BCWQGs. The water treatment system capacity should be regularly assessed to ensure the system can handle the necessary volumes of water and to prevent discharging process water above BCWQGs offsite (ITM ULR#46 & ULR#49 are now considered closed). An assessment of the Lillooet River Trail should be performed to determine the extent of erosion caused by water discharging offsite once the snow melts from the area.

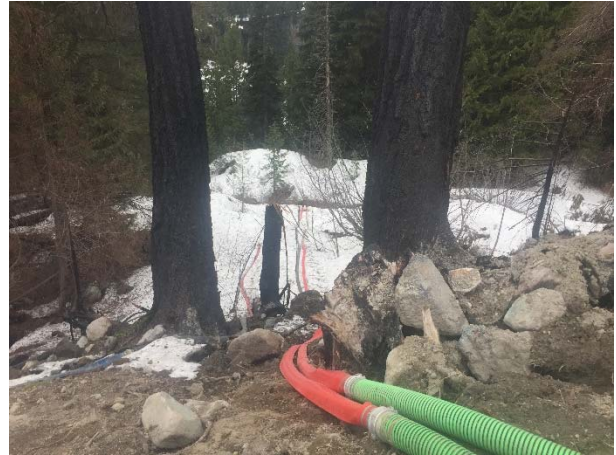
Photo 10 – Outlet hoses from the new water treatment system discharge directly to ASTR-03 (April 2, 2016).

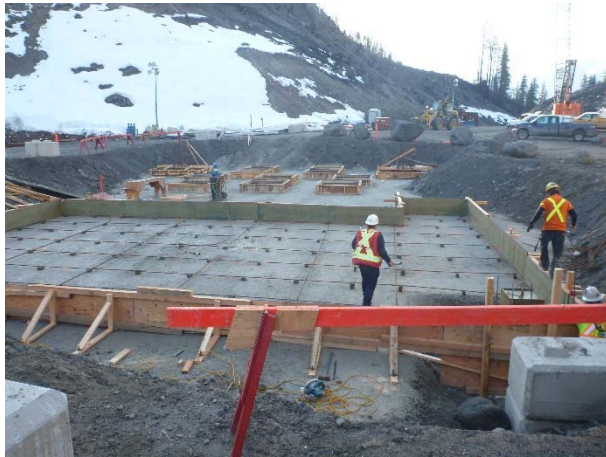
- Construction crews completed the switchyard excavation.
- Formwork, rebar installation, and concrete works for the switchyard structures (Photo 11).
- Excavation of the top of the natural earth berm separating the Lillooet River from the tailrace footprint began above HWM during this reporting period. The excavation was required to permit excavation for the tailrace itself. The excavation began following a pre-work meeting and under IEM supervision on April 8, 2016 (Photo 12).

Photo 11 – Installation of formwork and rebar for the powerhouse switch yard (April 8, 2016).

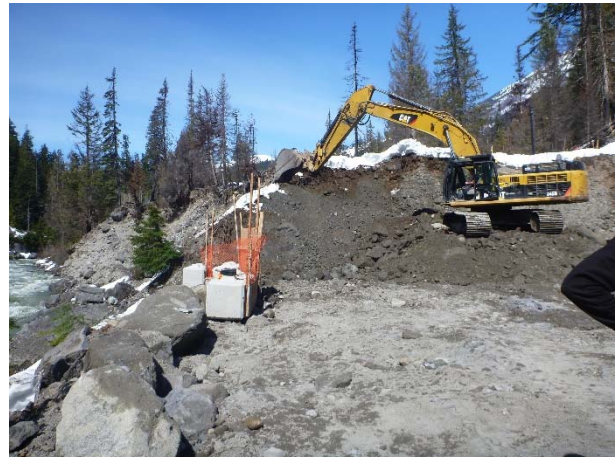
- The IEM monitored the excavation of the ULRHEF tailrace that occurred within 15 m of the Lillooet River (Photo 12). An excavator equipped with biodegradable hydraulic oil performed the excavation. No rocks or excavated material entered the Lillooet River during this construction activity.

Photo 12 – Excavation of the top of the natural earth berm separating the ULRHEF tailrace from the Lillooet River (April 8, 2016).

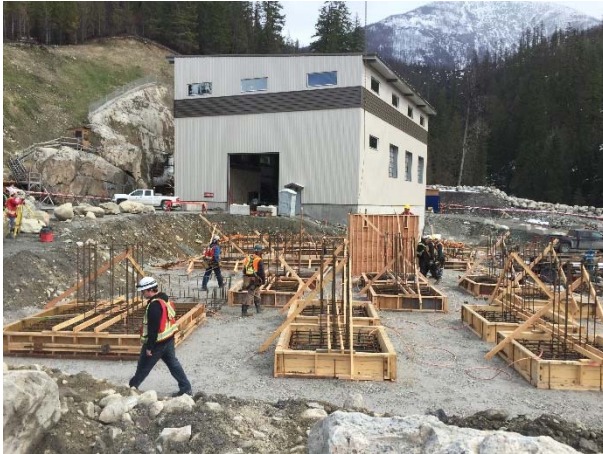
Photo 13 – Current conditions at the BDRHEF tunnel portal, powerhouse, and switch yard (April 04, 2016).

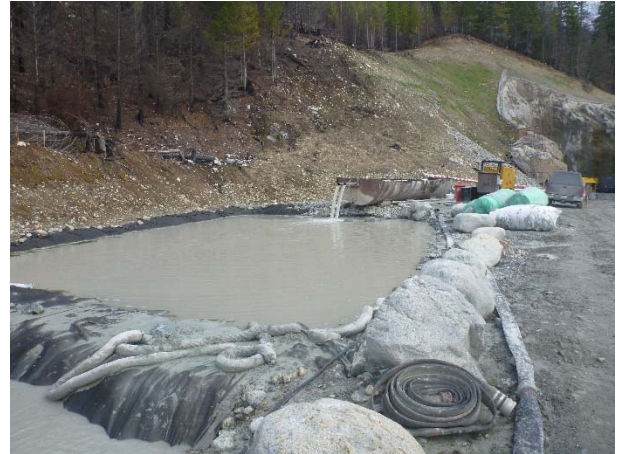
- Drilling, blasting and tunnel stabilization in the downstream tunnel portal.
- BDRHEF powerhouse electrical component installation.
- Rebar and concrete works on the powerhouse switch yard (Photo 13).
- Dewatering of the tunnel and powerhouse to the oil water separator and settling ponds continued (Photo 14).

Photo 14 – BDRHEF downstream portal settling ponds (April 04, 2016).
