Upper Lillooet Hydro Project

Weekly Environmental Monitoring Report #92

Reporting Period: April 10-23, 2016

Upper Lillooet River Hydroelectric Facility (Water File No. 2002561, Water licence No. C130613), Boulder Creek Hydroelectric Facility (Water File No. 2003049, Water licence No. C129969) & Transmission Line (TX Line)

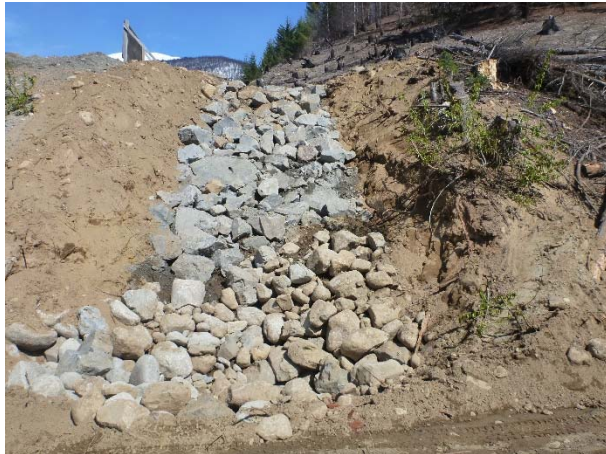
deficiencies, which included oversized riprap used to armor the culvert inlet (Photo 1); the outlet of the culvert was perched approximately 1 meter above the slope (Photo 2), and inadequate armoring of the culvert outlet (Photo 2). SES requested these deficiencies to be rectified. This issue is tracked as ITM ULR#52.

Photo 1 – Over-sized riprap on slope above culvert inlet (April 18, 2016).

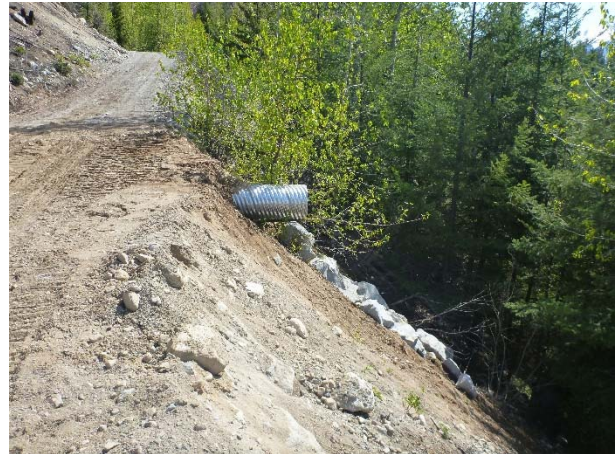
Photo 2 – Perched culvert with inadequate outlet armoring (April 18, 2016).

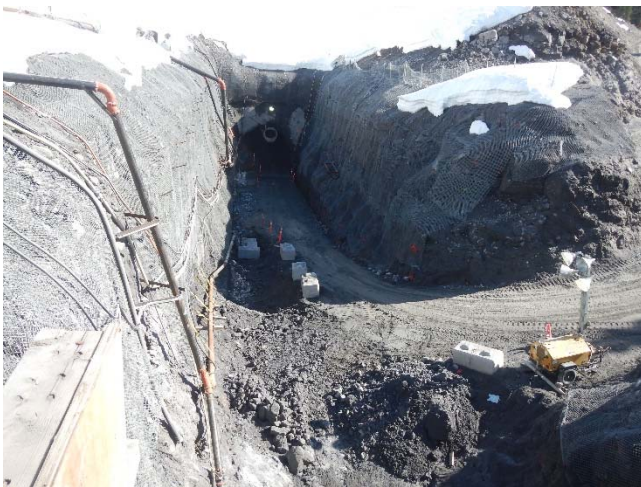
- Grout injection operations and canopy tube instillation at the ULRHEF upstream tunnel portal continued from April 10-23, 2016 (Photo 3).
- Rock hammering and blasting for BEBO (precast arch) wall construction occurred throughout the monitoring period (Photo 3 & Photo 4).
- Rebar, formwork, and concrete works continue on the intake structure throughout the monitoring period (Photo 5).

Photo 3 – ULR Upstream tunnel portal and BEBO wall excavation (April 10, 2016).

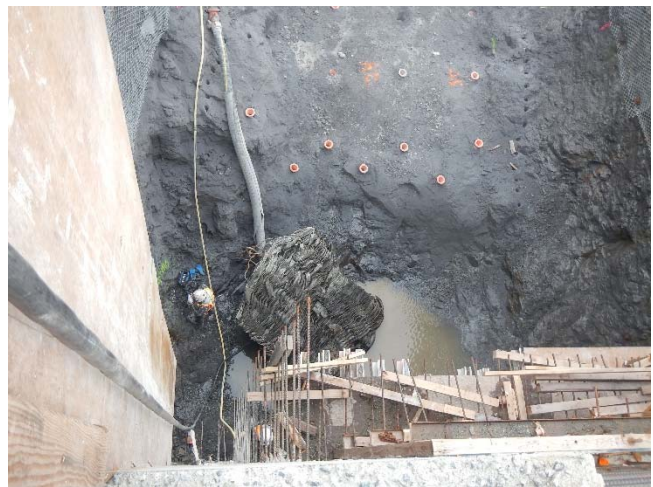
- On April 16, mountain goats on the north slope adjacent to Keyhole falls (UWR UL-11) displayed level 3 disturbance behaviour in response to a blast for the BEBO (precast arch) wall excavation. No evidence of disturbance behaviour has been noted during prior blasts. In communication with the IEM, CE agreed to implement additional blast mitigation measures for all future BEBO (precast arch) wall blasts, including smaller charge weight, fewer holes per blast, longer delays per blast, blast hole stemming, and the use of additional blast mats to muffle the sound. These mitigation measures were implemented and followed subsequent blasts, and no mountain goats disturbance behaviour was observed. .
- The ULRHEF upstream tunnel portal water treatment system was functioning properly during this monitoring period and no environmental issues were identified (Photo 7).

Photo 4 – Blasting at the BEBO wall (April 17, 2016).

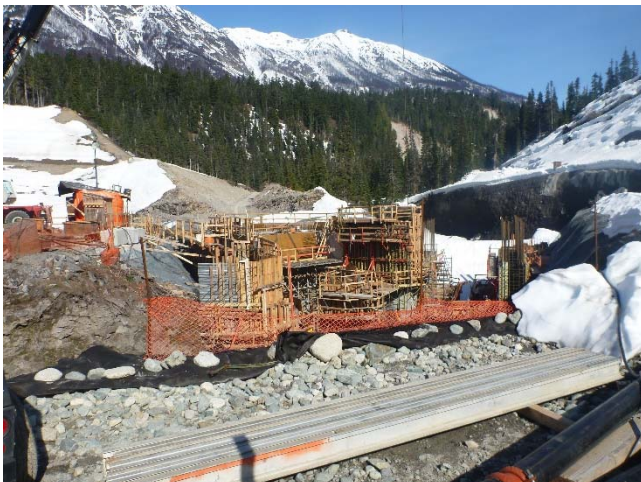
Photo 5 – Rebar, formwork, and concrete works at the ULHEF intake (April 18, 2016).

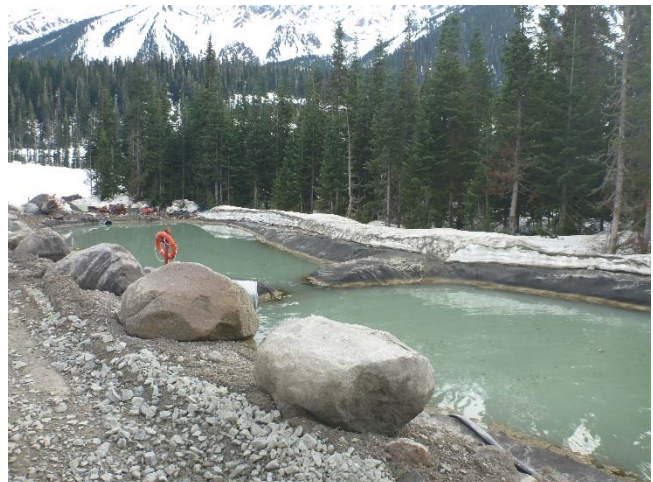
- During grout injection, and tunnel excavation rounds in the upstream tunnel, all seepage water was directed to the ULRHEF intake sediment basins for treatment (Photo 6). CE's environmental management team ensured that the active treatment system was functioning and well maintained.

Photo 6 – Pond 6 and 7 of ULR upstream tunnel portal treatment system (April 17, 2016).

- All water from the ULRHEF upstream tunnel heading should be conveyed to the sediment basins for treatment. CE should perform regular monitoring to ensure that the water treatment system is functioning as intended and that discharge to the Lillooet River continues to meet BCWQGs.

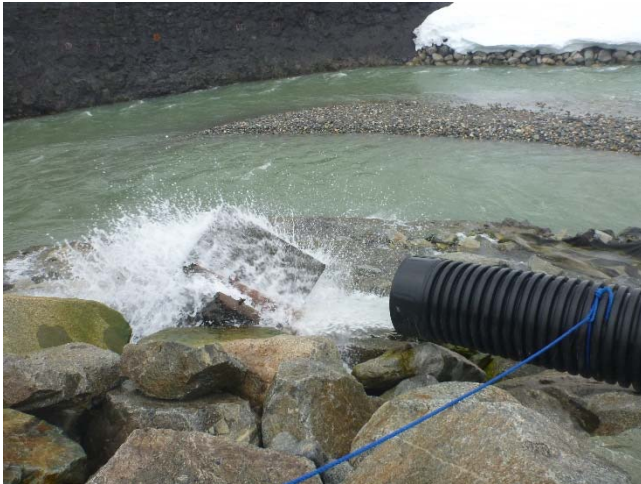
Photo 7 – Discharge of ULRHEF upstream tunnel water treatment system (April 16, 2016).

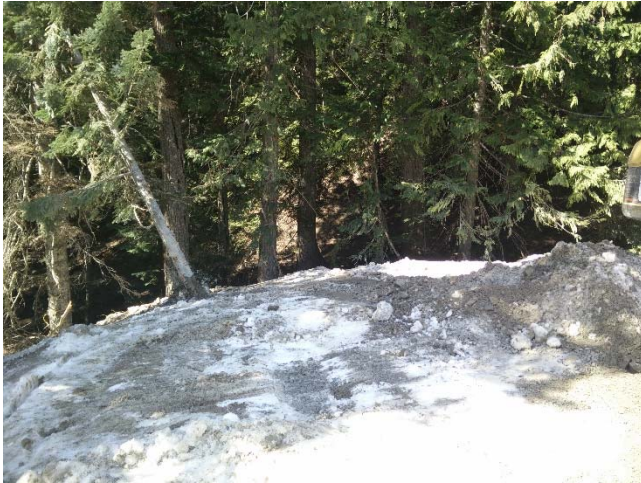
- On April 19, CE began using an excavator to remove snow and sediment that was pushed/plowed into the mountain goat UWR replacement area (Photo 8). Not all material could be removed safely due to the presence of a high voltage powerline. An assessment of impacts to the area will be completed once the snow melts.

Photo 8 – Removal of snow and sediment from Mountain Goat replacement area (April 19, 2016).

- CE should continue to remove deposited material within the mountain goat UWR replacement area, as the snow melts. Once CE has removed as much of the deposited material as possible, and the snow is fully melted, the area should be inspected by a QP to determine what remedial actions are needed (ITM ULR#49; FAM#11).

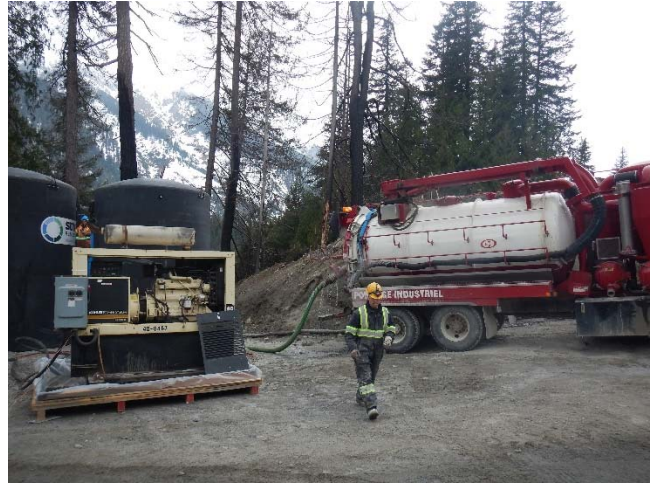
- Drilling, blasting, mucking and stabilization works (shotcrete application) within the tunnel.
- Removal of snow and sediment plowed into mountain goat UWR replacement area at lower portal parking area (Photo 8).
- Maintenance and sediment removal from the active water treatment system at installed at along the penstock access road (Truckwash 2 road; Photo 9).

Photo 9 – Vacuum truck cleaning sediment from the active water treatment system along the penstock access road (April 15, 2016).

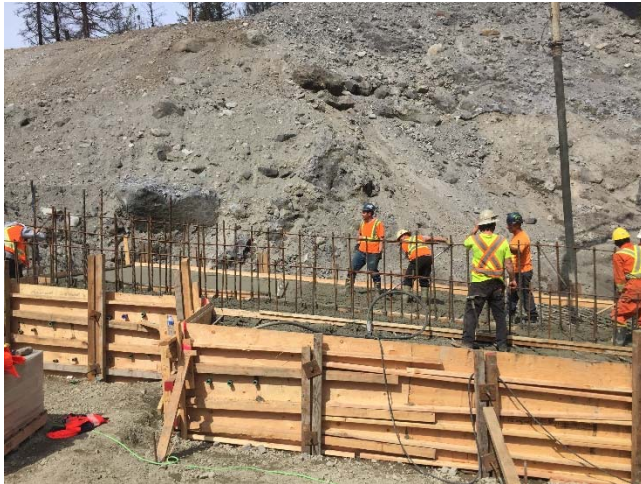
- On April 16 and 17th, the IEM was onsite full time to monitor water quality during excavation of the tailrace behind the earth berm and backfill works (Photo 10). Water quality samples were collected at 15 minutes interval throughout the work to ensure that the excavation did not affect water quality within the clean water sump or cause unmitigated water quality exceedance in the Lillooet River. Water quality in the Lillooet River remained within BCWQGs throughout the work. See Section 4.5 for detailed water quality results.

Photo 10– Concrete pour for the ULRHEF tailrace footing (April 21, 2016).

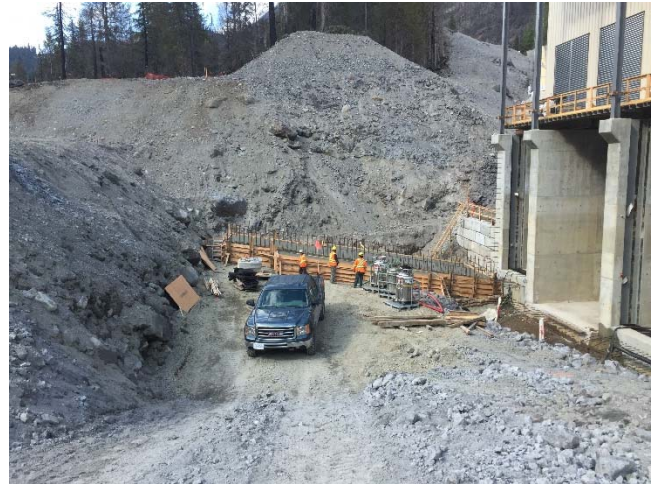
- On April 21, CE poured the northwest tailrace footing. A recirculating CO₂ bubbler was installed within the clean water sump (Photo 11), a sand bag berm placed, and a pre-pour inspection of the formwork was completed as precautionary measures prior to the pour. The IEM was onsite prior to the pour to inspect the sump and observed no gaps in the formwork. Additional bracing was installed to shore the formworks prior to the pour. No concrete or wash water was observed near the clean water sump and water quality in the sump and Lillooet River remained unaffected. Water quality sampling results are available upon request.

Photo 11 – Tailrace footing at ULRHEF powerhouse behind the natural earth berm (April 21, 2014).

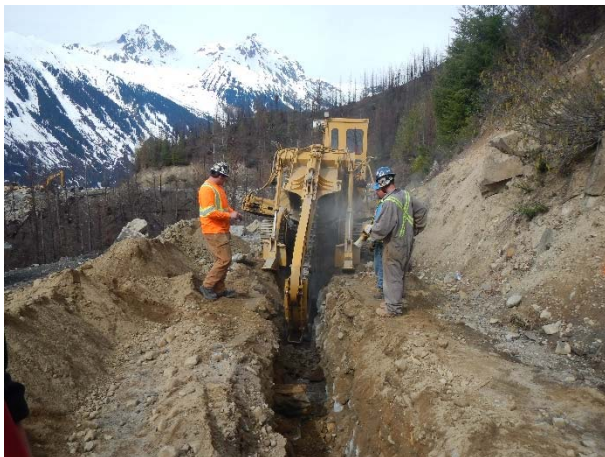
- Trenching and permanent conduit installation in the BDRHEF intake access road outside of the UWR 500 m buffer and below the locked gate (Photo 12 & Photo 13).

- No environmental issues were observed or reported during the trenching and permanent conduit installation on the BDRHEF intake access road during this reporting period.

Photo 12 – Trenching for conduit installation in the BDRHEF intake access road outside of the UWR 500m buffer (April 22, 2016).

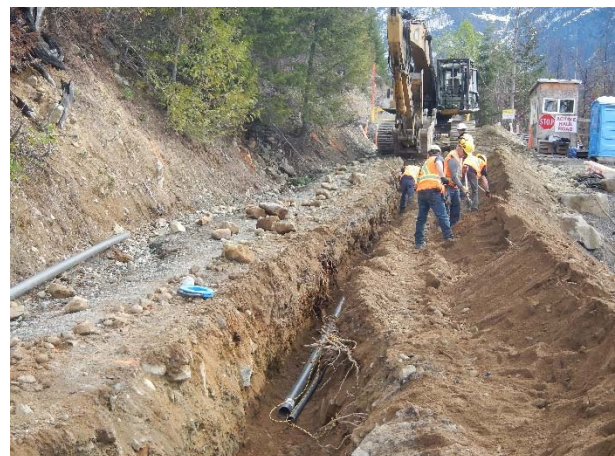
Photo 13 – Conduit installation in the BDRHEF intake access road outside of the UWR 500m buffer (April 22, 2016).

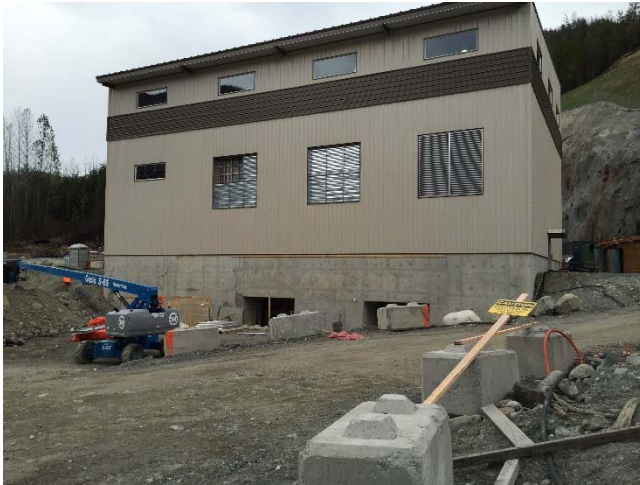
- Drilling, blasting and tunnel stabilization in the downstream tunnel portal.
- Electrical component installation in the BDRHEF powerhouse (Photo 14).

Photo 14 – Current conditions at the BDRHEF powerhouse (April 21, 2016).

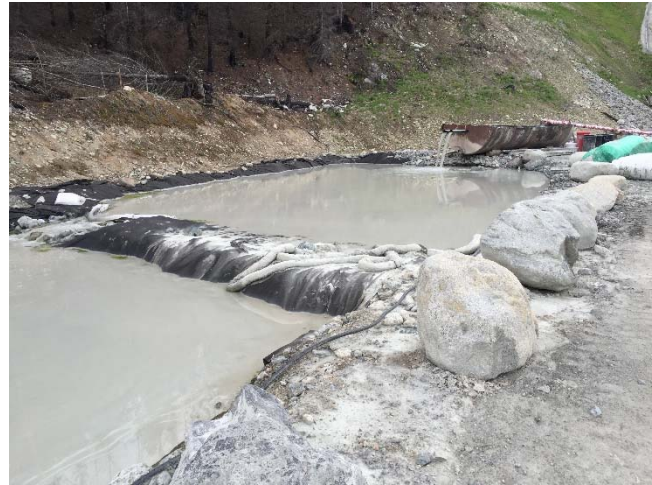
- All wastewater related to the BDRHEF tunnelling works continued to be contained and conveyed to the downstream portal settling ponds for treatment (Photo 15).

Photo 15 – BDRHEF downstream portal settling ponds (April 21, 2016).
