Upper Lillooet Hydro Project

Weekly Environmental Monitoring Report #95

Reporting Period: May 22 – June 04, 2016

Upper Lillooet River Hydroelectric Facility (Water File No. 2002561, Water licence No. C130613), Boulder Creek Hydroelectric Facility (Water File No. 2003049, Water licence No. C129969) & Transmission Line (TX Line)

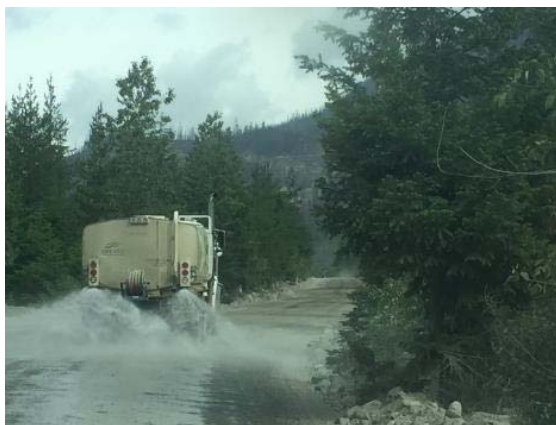
- Routine maintenance of construction equipment within the mechanic shop and fuel management continued at the KM 38 laydown. All hazardous substance materials (waste oil, contaminated soil, used oil/hydraulic fluid containers, etc.) were stored temporarily for off-site disposal in a designated area at the laydown. The materials were all well contained and protected from the weather.
- CE continued to apply water to the Lillooet FSR and construction access roads to minimize fugitive dust production throughout the reporting period (Photo 1).

Photo 1 – CE water truck in use for dust suppression on the Lillooet River FSR (May 26, 2016).

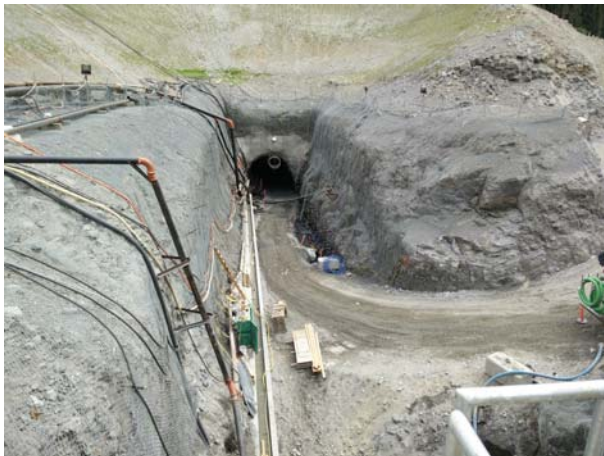
- Grout injection operations and canopy tube installation at the ULRHEF upstream tunnel continued from May 22 – June 4, 2016 (Photo 2).
- Formwork, rebar, and concrete works on the transition between the intake structure and BEBO wall throughout the reporting period (Photo 3).
- Rebar, formwork, and concrete works continue on the intake and sluiceway structures throughout the reporting period (Photo 4).

**Photo 2 – Upstream Tunnel
Portal and BEBO wall (May 23, 2016).**

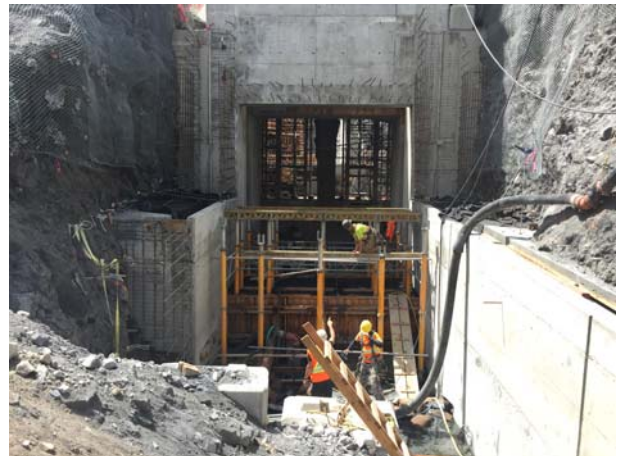
**Photo 3 – Works on the transition between the intake structure
and the BEBO wall (May 29, 2016).**

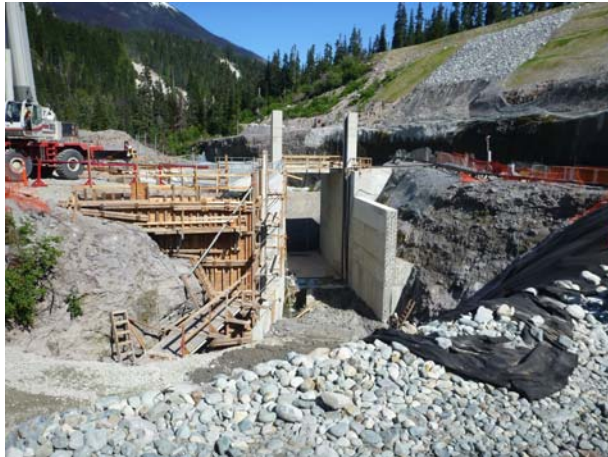
Photo 4 – Rebar, formwork, and concrete works at the ULRHEF sluiceway and intake (June 04, 2016).

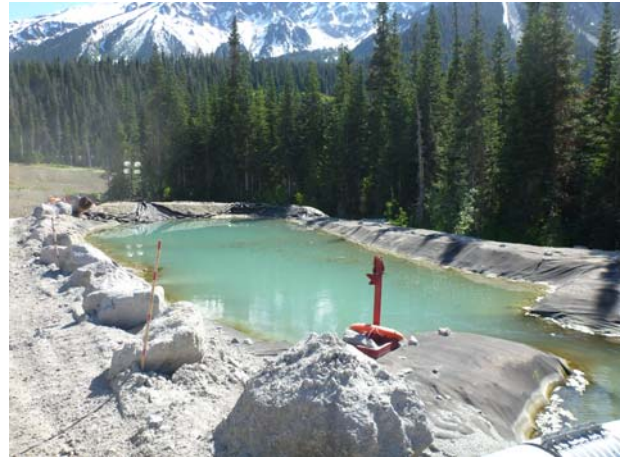
- During grout injection and tunnel excavation rounds in the upstream tunnel, all seepage water was directed to the ULRHEF intake sediment basins for treatment (Photo 5). CE's environmental management team ensured that the active water treatment system was functioning and well maintained. Water quality sampling results are available upon request (Photo 7).
- CE is assembling and installing an additional 12" HDPE hard line from the concrete sump to the settling ponds and water treatment system (Photo 6). This new line will increase pumping capacity and ensure all water from the tunnel and BEBO construction work areas can be directed to the settling ponds for treatment.

Photo 5 – Pond 6 and 7 of ULRHEF intake water treatment system (June 04, 2016).

- All water from the ULRHEF upstream tunnel heading should be conveyed to the sediment basins for treatment. CE should perform regular monitoring to ensure that the water treatment system is functioning as intended and that discharge to the Lillooet River continues to meet BCWQGs.

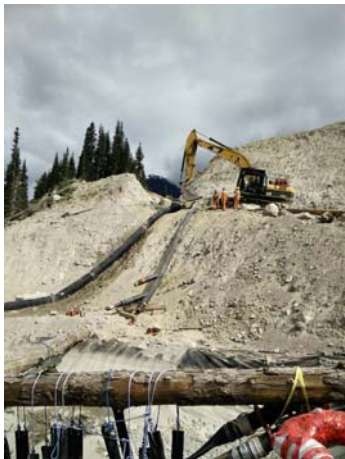
Photo 6 – Assembly and installation of 12” HDPE discharge line (May 23, 2016).

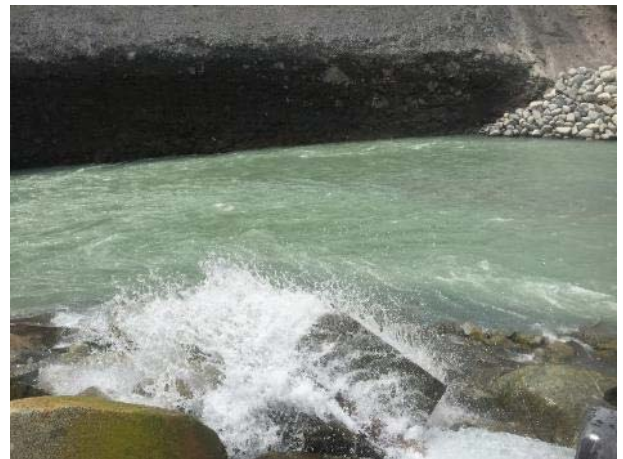
Photo 7 – Discharge of ULRHEF intake water treatment system (June 01, 2016).

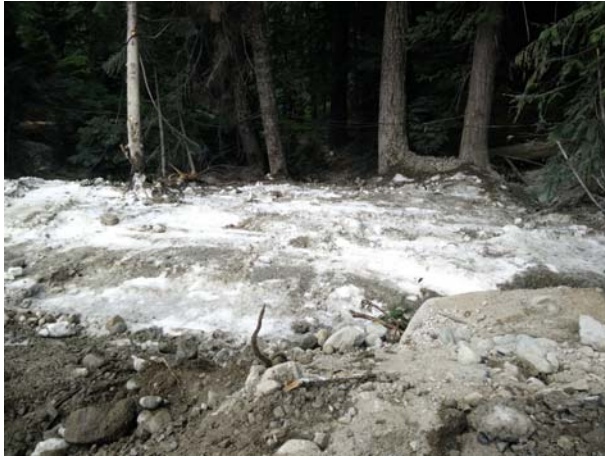
- Drilling, blasting, mucking and stabilization works (shotcrete application) within the tunnel.
- Removal of portions of the sediment deposited within the mountain goat UWR replacement area at lower tunnel portal parking area (Photo 8).
- Maintenance and sediment removal from the active water treatment system installed near ASTR-03.

- CE continued to remove snow and associated material sediment deposited within the mountain goat UWR replacement area at the Downstream Tunnel Portal parking area with an excavator (Photo 8). Not all material was removed. An assessment of impacts to the area will be completed once the snow melts.

Photo 8 – Removal of sediment from Mountain Goat Winter Range (May 24, 2016).

- CE should continue to remove material deposited within the mountain goat UWR replacement area, as the snow melts. Once CE has removed as much of the deposited material as possible, and the snow is fully melted, the area should be inspected by a QP to determine what remedial actions are needed (ITM ULR#49; FAM#11).

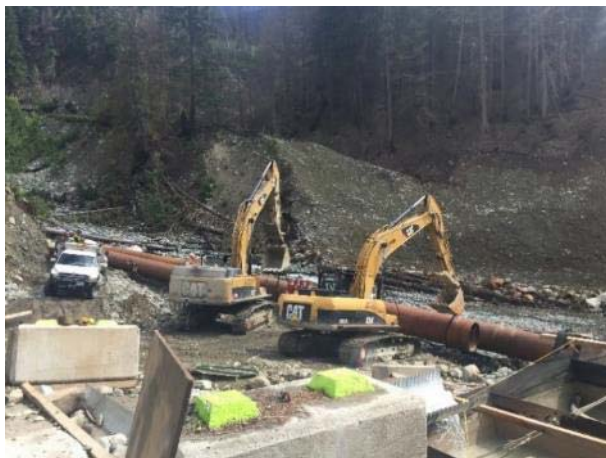
- Installation of steel pipes for Truckwash Creek diversion from June 1-3, 2016 (Photo 9 - Photo 10).
- On June 3, CE diverted Truckwash Creek through steel bypass pipes to permit the start of the penstock crossing works in the dry (Photo 11 - Photo 12).
- Welding, coating, backfill, and compaction of penstock east of Truckwash Creek.

Photo 9 – Installation of steel bypass pipes prior to the Truckwash Creek diversion (June 02, 2016).

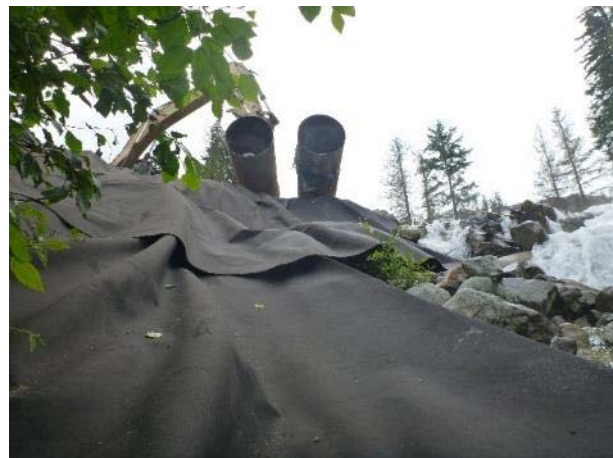
Photo 10 – Armoured outlet of Truckwash Creek bypass pipe outlet (June 02, 2016).

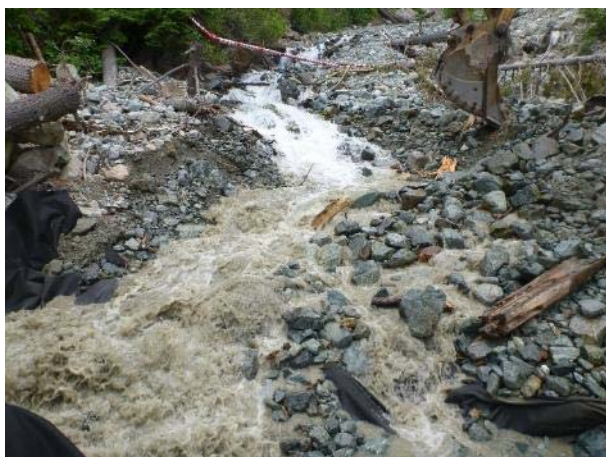
- On June 2, a kick-off meeting was held to discuss safety, environmental and engineering concerns for the diversion of Truckwash Creek.
- On June 3, the IEM monitored the instream works associated with the Truckwash Creek diversion. No salvages were required as Truckwash Creek is non fish-bearing and is non CTF-bearing. Two steel diversion pipes were installed in a dry portion of the channel at the right bank of Truckwash Creek (Photo 9). Instream excavation was performed to direct the creek through the newly installed steel bypass pipes (Photo 11). During the diversion works, temporary pulses of turbid water were observed approximately 300 meters downstream of the construction activities. The first pulse began at 08:35, when the excavator placed puncheon and crossed Truckwash Creek to access the location where instream excavation was required to divert the creek into the newly installed bypass pipes. A second pulse occurred at 09:50, as instream excavation diverted the creek to the steel bypass pipes (Photo 12). Between 8:35 – 11:30 turbidity levels were measured above BCWQGs (Average = 21.6 NTU; max = 1563 AU). The final two

sediment pulses were short lived and associated with armouring the inlet of the diversion pipes and excavation of the isolation berms at 14:40 (30 minute duration; max = 16.7 NTU) and 15:30 (20 minute duration; max = 43.1 NTU), respectively. The IEM conducted water quality sampling throughout the diversion works and detailed results are available upon request. CE successfully employed BMPs throughout the diversion works and minimized the amount of instream works required to complete the diversion to the extent possible. Based on the results of water quality monitoring, the periods of elevated turbidity generated by the diversion works are unlikely to have impacted downstream fish habitat.

Photo 11 – Actively diverting Truckwash Creek (June 03, 2016).

- CE should continue to monitor the clean water sump at the Truckwash Creek diversion to ensure pumps are sufficient to handle seepage water during excavation.

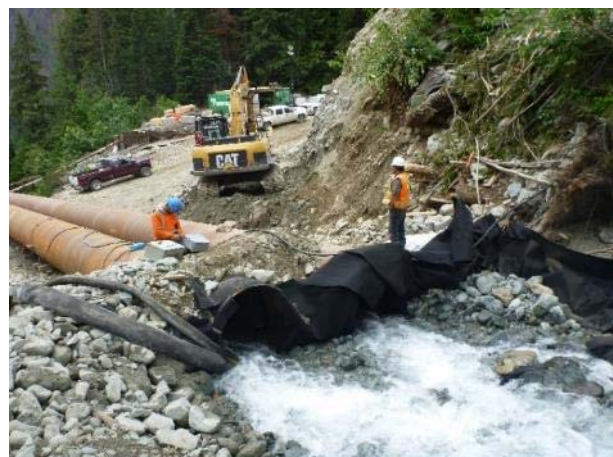
Photo 12 – Inlet of Truckwash Creek temporary bypass pipes following the diversion works (June 03, 2016).

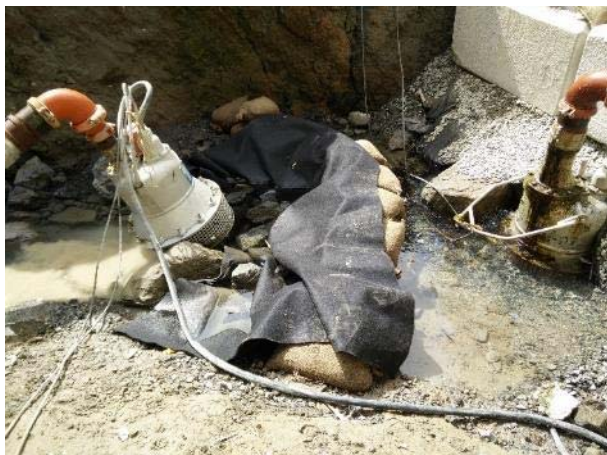
- On May 23, CE installed an impermeable barrier between the two clean water 6" pumps in the ULRHEF tailrace (Photo 13). Dividing these pumps allowed clean seepage water to be pumped directly to the Lillooet River, and sediment laden construction wastewater to be pumped to the ULRHEF powerhouse water treatment system. Discharge from the water treatment system was monitored daily for compliance with BCWQG and no exceedances were documented. Water quality sampling results are available upon request.
- On May 26, CE filled a depression that developed in the ULRHEF tailrace backfill material with 2.5m³ of concrete (Photo 18). All works were conducted in the dry and no environmental issues were observed during the concrete pour.

Photo 13 – Division of clean water sump at ULRHEF tailrace (May 23, 2016).

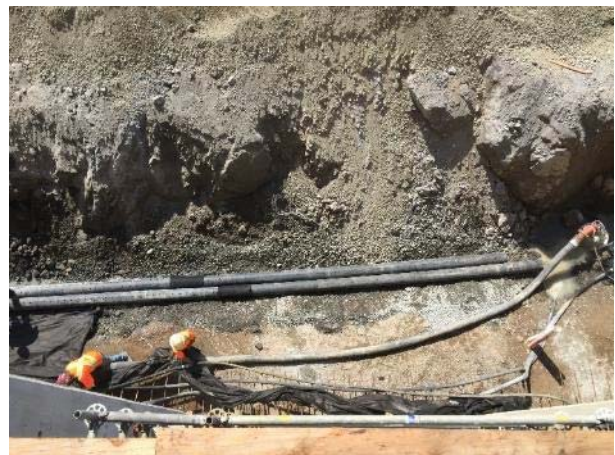
Photo 14 – Installation of perforated pipe at ULRHEF tailrace (May 25, 2016).

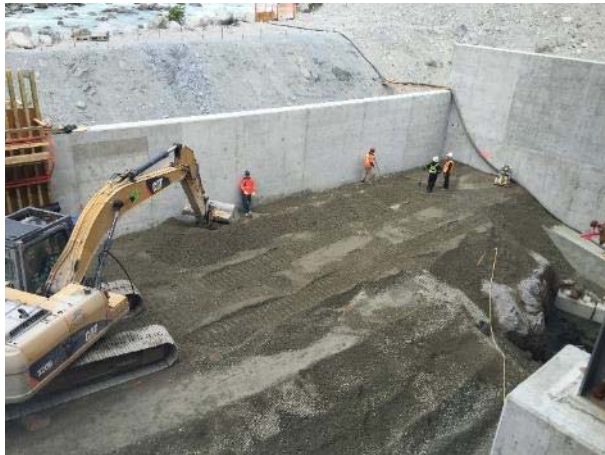
Photo 15 – Backfill and compaction of ULRHEF tailrace (May 27, 2016).

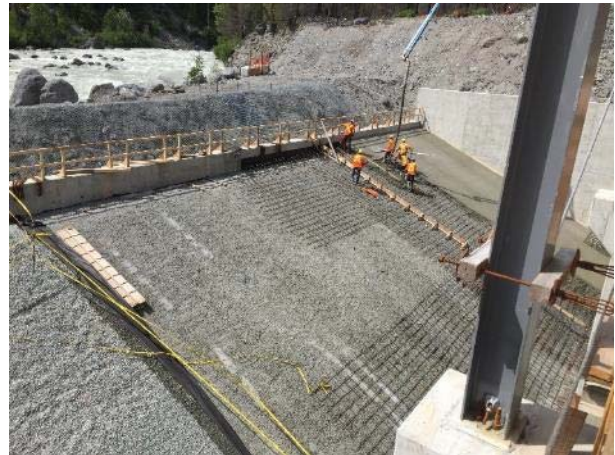
Photo 16 – Rebar, formwork, and concrete at ULRHEF tailrace (June 02, 2016).

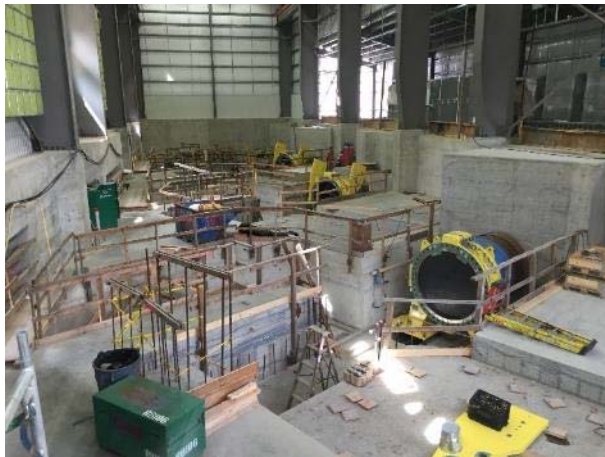
- Excavation of the tailrace (in the dry behind the natural earth berm) at the ULRHEF powerhouse.
- Installation of an impermeable barrier between the two clean water 6" pumps at the ULRHEF tailrace to separate clean water from construction wastewater (Photo 13).
- Installation and backfill of a perforated drain pipe in ULRHEF tailrace (Photo 14).
- Backfill and compaction for tailrace footing (Photo 15).
- Rebar, formwork, and concrete works for the tailrace (Photo 16).
- Installation of the turbine inlet valve (TIV) in the ULRHEF powerhouse (Photo 17).

Photo 17 – Installation of turbine inlet valve at ULRHEF powerhouse (June 02, 2016).

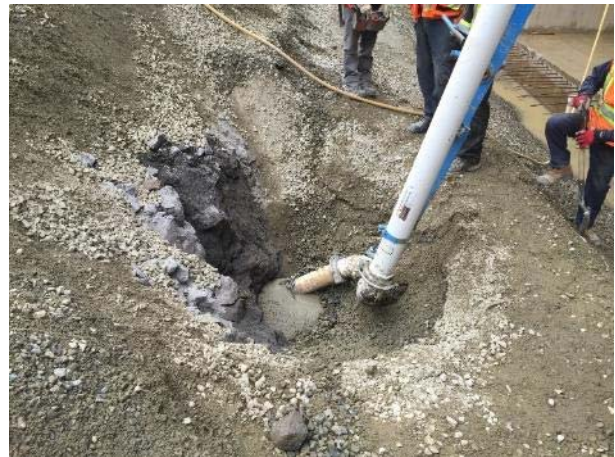
Photo 18 - Filling of ULRHEF tailrace depression (May 26, 2016).

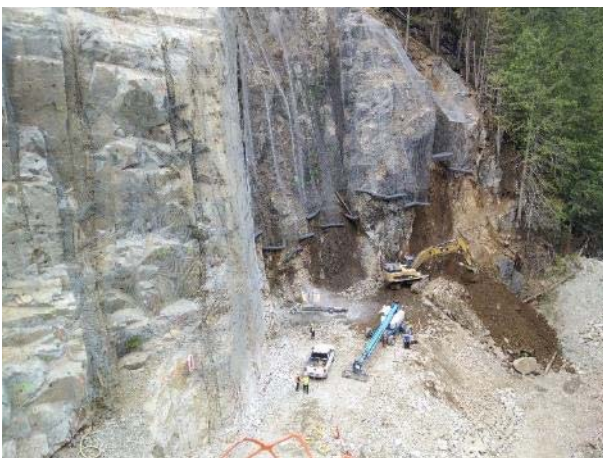
- Rock face consolidation and stabilization (Photo 19).
- Bulk excavation of the intake structure footprint (including blasting) occurred in isolation from Boulder Creek and above the water table throughout the reporting period (Photo 19).
- CE completed the installation of a water treatment system that will be used to treat any seepage water entering the intake excavation (Photo 20).

Photo 19 – Consolidation and stabilization of Boulder Intake rock face, and excavation for concrete works (May 23, 2016).

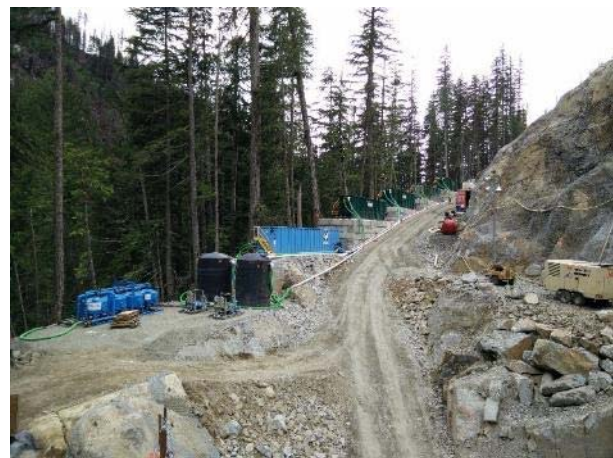
Photo 20 – Installation of water treatment system at Boulder Intake (May 23, 2016).

- All construction related wastewater should continue to be directed to the water treatment systems. CE to continue regular inspections of the water treatment systems to ensure that the systems are in good condition, and all maintenance activities are performed as outlined in the work plan.

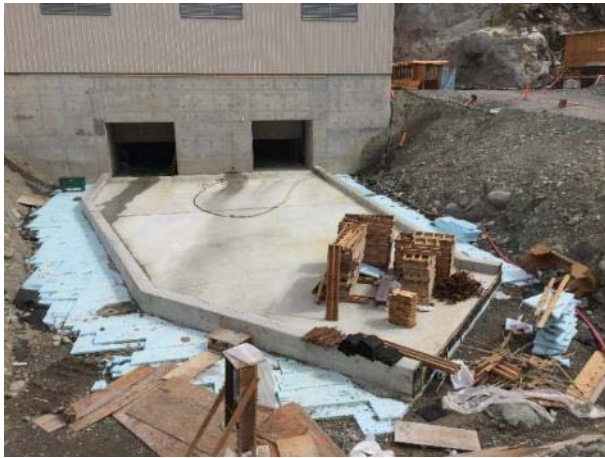
- Drilling, blasting and tunnel stabilization in the downstream tunnel portal.
- Electrical component installation in the BDRHEF powerhouse.
- Tailrace construction including stripping formwork, and concrete curing was completed greater than 15m from Boulder Creek and in the dry during this reporting period (Photo 21).

Photo 21 – Conditions at BDRHEF powerhouse and tailrace (May 29, 2016).

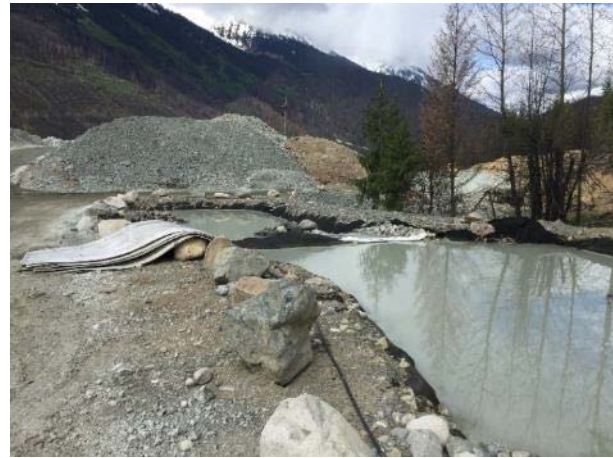
- All wastewater related to the BDRHEF tunnelling works continued to be contained and conveyed to the downstream settling ponds for treatment (Photo 22).

Photo 22 – BDRHEF Downstream Tunnel Portal settling ponds (May 29, 2016).

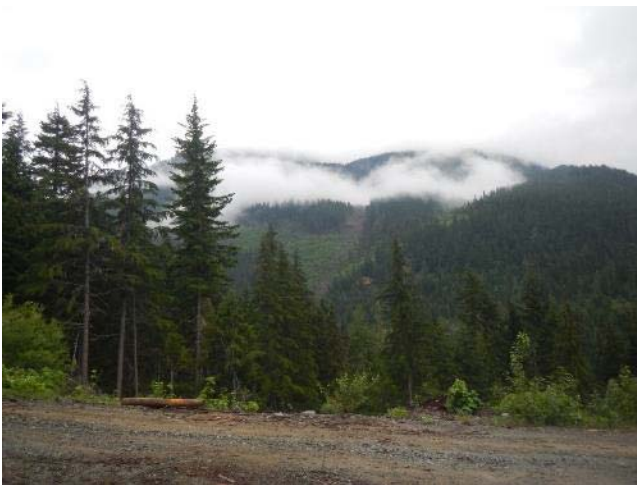
The IEM continued to perform mountain goat monitoring from the station on the Rutherford Creek FSR to monitor the UWRs during active construction and helicopter work in Segment 15 (Photo 23 & Photo 24). The monitoring was performed to ensure that no mountain goats moved into the area. No mountain goats were observed by the IEM on either UWRs during this reporting period.

Photo 23 – View of Segment 15 (May 24, 2016).

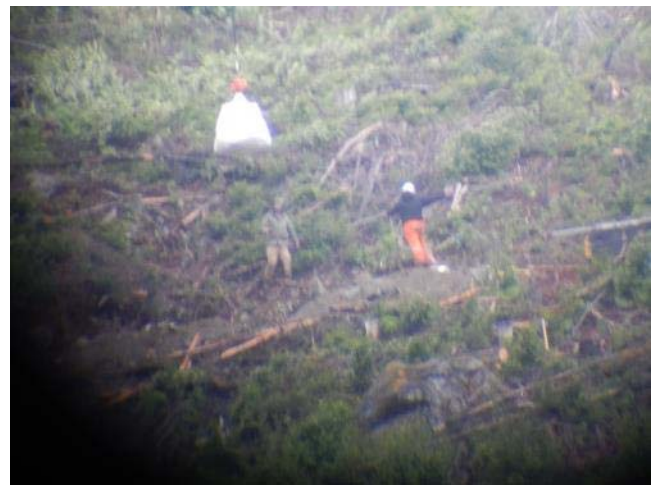
- Slashing felled timber throughout the segment.
- O'Briens – ground preparation (digging, blasting) for towers 372, 374-375, 382 (Photo 24).

Photo 24 – Ground prep in Segment 15 (May 24, 2016).
