# Upper Lillooet Hydro Project

## Weekly Environmental Monitoring Report #99

Reporting Period: July 17-30, 2016

Upper Lillooet River Hydroelectric Facility (Water File No. 2002561, Water licence No. C130613), Boulder Creek Hydroelectric Facility (Water File No. 2003049, Water licence No. C129969) & Transmission Line (TX Line)

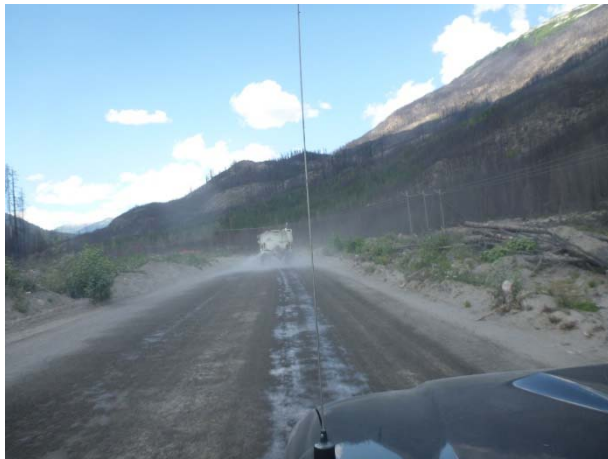
Photo 1 – Dust suppression application on the Lillooet River FSR (July 30, 2016).

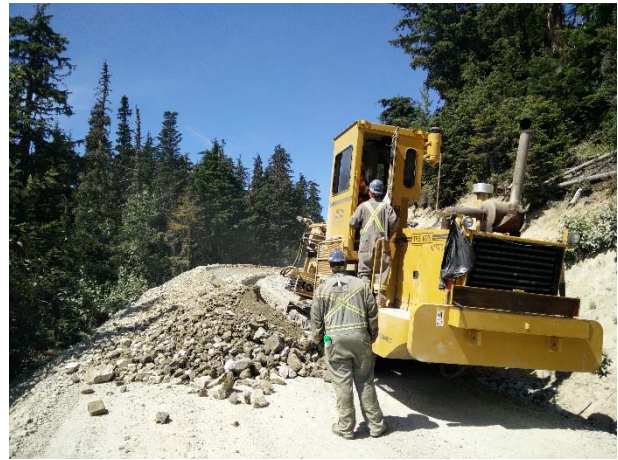
- CE continued routine fuel management and maintenance of construction equipment within the mechanic shop at the KM38 laydown. CE temporarily stored all hazardous substance materials (waste oil, contaminated soil, used oil/hydraulic fluid containers, etc.) in a designated area at the laydown prior to off-site disposal. The materials were all well contained and protected from the weather.
- CE continued to apply water to the Lillooet River FSR and construction access roads to minimize fugitive dust production throughout the reporting period (Photo 1).
- CE trenched and installed electrical conduit along the Lillooet River FSR from the ULRHEF downstream tunnel portal to the ULRHEF intake (Photo 2).

Photo 2 – Conduit trenching and installation on the Lillooet River FSR (July 28, 2016).

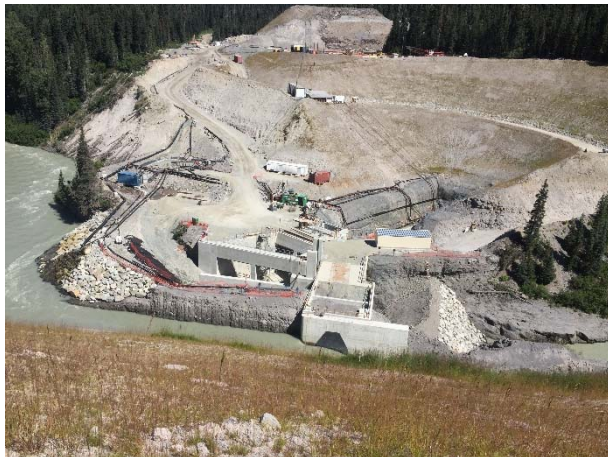
- No activities occurred at the ULRHEF intake (Photo 3) from July 17 - 18, 2016 and July 25-26 & 28-30, 2016 due to elevated landslide risk according to the conditions of the Landslide Risk Management Plan.
- On July 27, CE performed critical stabilization works in the upstream tunnel heading, during a period of “High” landslide risk as defined by the Landslide Management Plan. A

Photo 3 – ULRHEF intake structure (July 27, 2016).

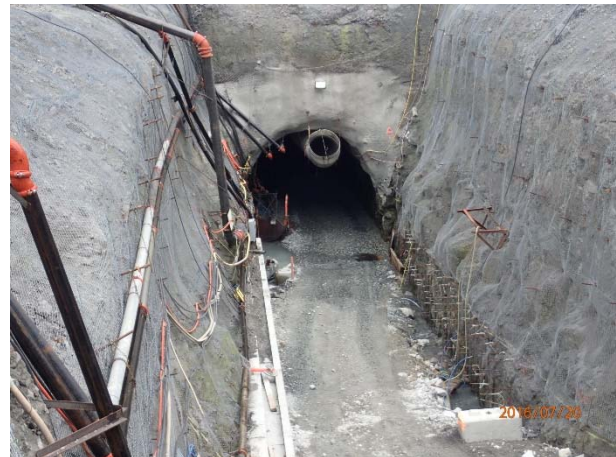
- Grout injection operations and canopy tube installation at the ULRHEF upstream tunnel occurred from July 19 - 27, 2016 (Photo 4).

Photo 4 – ULRHEF upper tunnel portal and BEBO wall (July 20, 2016).

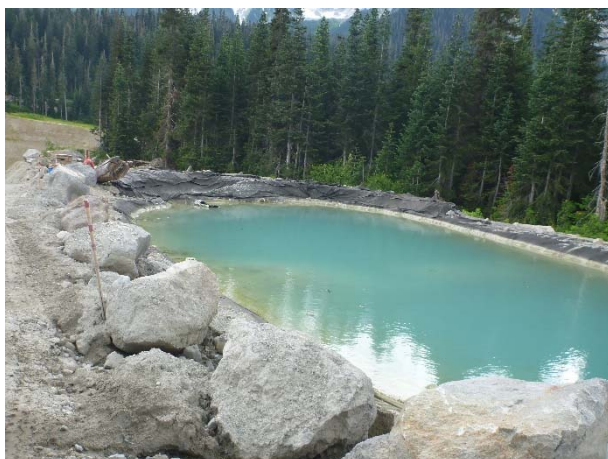
- During grout injection and tunnel excavation rounds in the upstream tunnel, CE directed all seepage water to the ULRHEF intake sediment basins for treatment (Photo 5). CE's environmental management team ensured that the active water treatment system was functioning and well maintained. Additional water quality sampling results are available upon request.

Photo 5 – ULRHEF upper tunnel water treatment system, pond No. 7 (July 17, 2016).

- CE should continue to convey all water from the ULRHEF upstream tunnel heading to the sediment basins for treatment. CE should perform regularly monitoring to ensure that the water treatment system is functioning as intended and that discharge to the Lillooet River continues to meet BCWQGs.
- CE should provide a QP’s assessment of the mountain goat UWR replacement area affected by last winter’s snow clearing operations (ITM ULR #49; FAM#11), and provide recommendations for remediation.

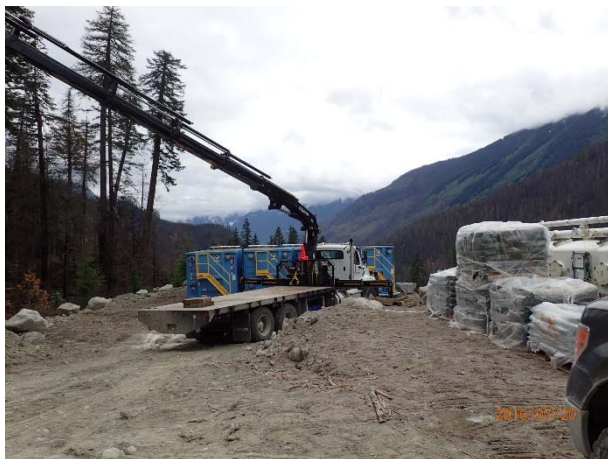
- The IEM monitored the discharge from the active water treatment system for compliance with BCWQG. Water discharged to ASTR-03 did not exceed > 8 NTU above background turbidity during the reporting period. Additional water quality sampling results are available upon request.
- CE is anticipating the completion of the ULRHEF tunnel at the beginning of August, at which time they will convey all wastewater to the lower portal. To ensure sufficient treatment capacity, CE installed a second active water treatment system on July 20, 2016 (Photo 6).
- Maintenance and sediment removal from the active water treatment system installed near ASTR-03 (Photo 7).

Photo 6 – Installation of second active water treatment system at the ULRHEF lower tunnel portal (July 20, 2016).

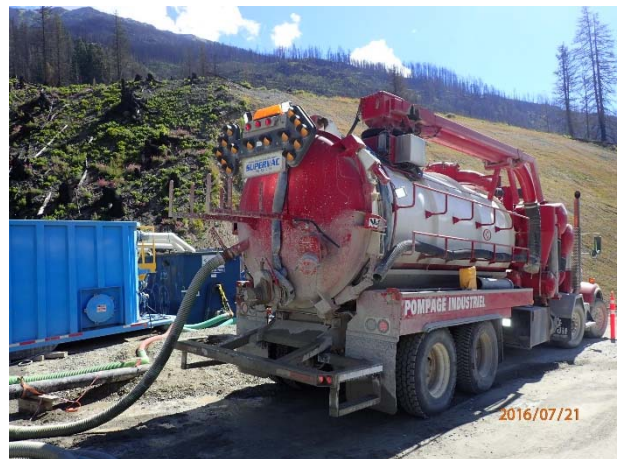
Photo 7 – Regular maintenance (sediment removal) from the primary ULRHEF lower tunnel portal active water treatment system (July 21, 2016).

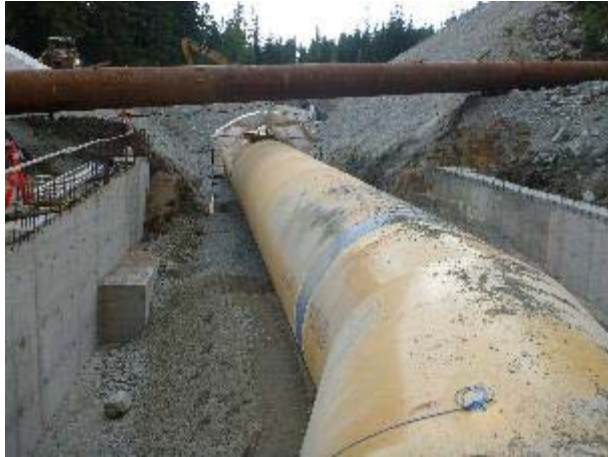
- Welding and coating of penstock through the Truckwash Creek crossing (Photo 8).
- Backfill, compaction, and reclamation of penstock east of Truckwash Creek.
- Formwork, insulation, rebar, and concrete works on the Truckwash Creek protection slab (Photo 9).

Photo 8 – Penstock welding and coating works through the Truckwash Creek crossing (July 17, 2016).

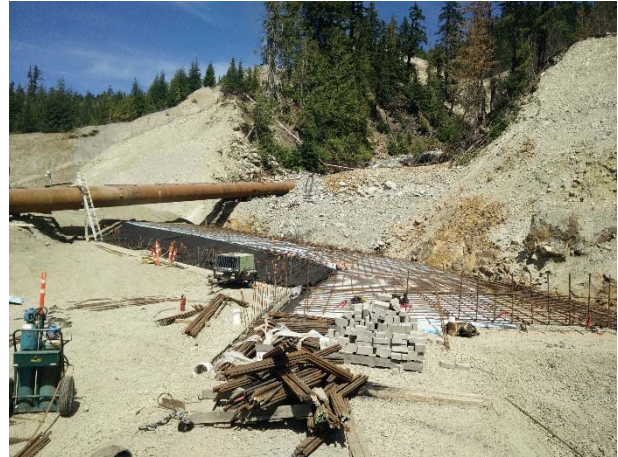
Photo 9 – Formwork and rebar for the Truckwash Creek crossing protection slab (July 28, 2016).

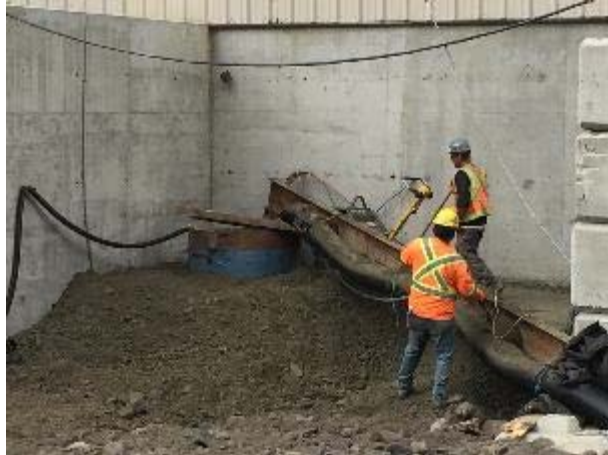
- Installation of the new clean water sump outside of the tailrace structure (Photo 10).
- Excavation of the ULRHEF tailrace up to 2 metres from the Lillooet River (Photo 11).
- Placement of grouted riprap at the ULRHEF tailrace (Photo 12 - Photo 13).
- Andritz mechanical works in the ULRHEF powerhouse.

- CE demobilized the active water treatment system from the ULRHEF powerhouse and relocated it to the lower tunnel portal.
- CE completed the installation of a new clean water sump outside of the tailrace structure. The IEM monitored the installation of the new sump and all associated water quality (Photo 10). The IEM did not observe any environmental issues associated with these works.
- CE continued excavation of the ULRHEF tailrace from July 19 - 27 (Photo 11). Crews conducted all works in the dry, and the IEM was present to monitor excavation activities. The IEM did not observe any environmental issues with these construction activities during the monitoring period.

**Photo 10 – Completion and backfill around the new clean water sump at the ULRHEF powerhouse (July 19, 2016).**

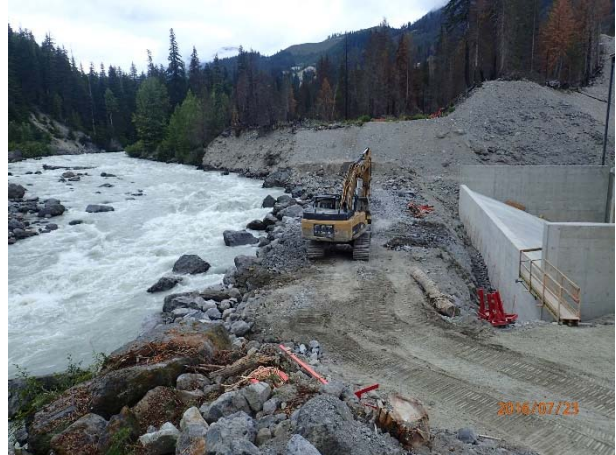
**Photo 11 – Excavation for the ULRHEF tailrace, behind a natural earth berm, isolated from flowing water (July 23, 2016).**

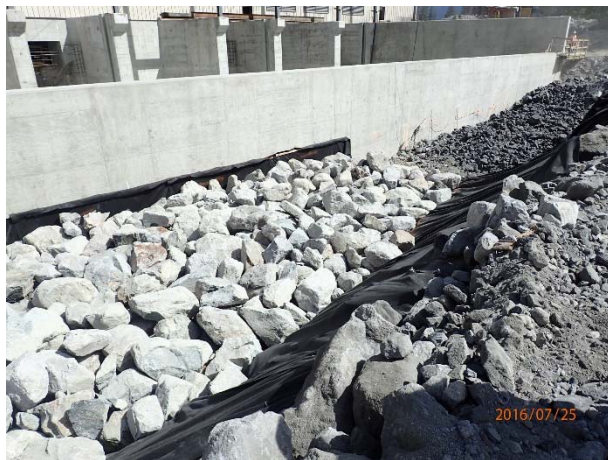
- CE grouted riprap within the ULRHEF tailrace on July 27, 2016 (Photo 12 - Photo 13). CE conducted all concrete works in the dry, behind the tailrace berm. The IEM did not observe any environmental issues with these concrete works during the monitoring period.

**Photo 12 – Placement of riprap at the ULRHEF tailrace (July 25, 2016).**

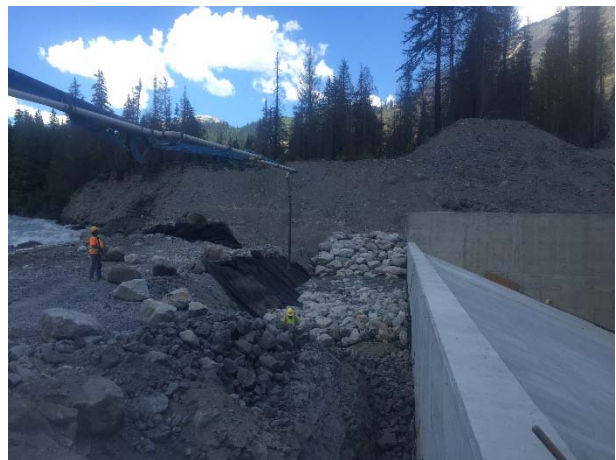
**Photo 13 – Grouting riprap at the ULRHEF tailrace (July 26, 2016).**

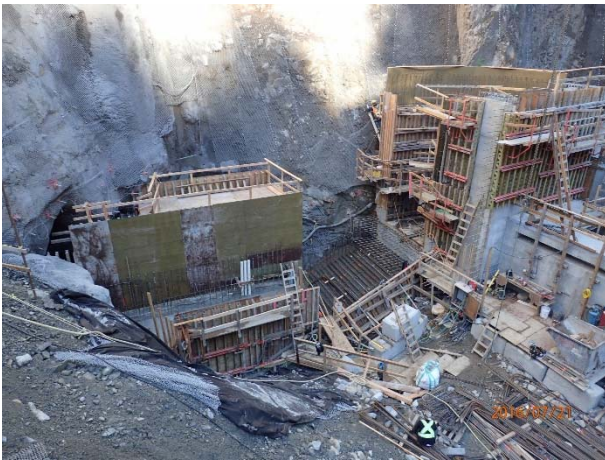
- Formwork, rebar, and concrete works began on the intake structure (Photo 14).

Photo 14 – Formwork and rebar for the tunnel-intake transition (July 21, 2016).

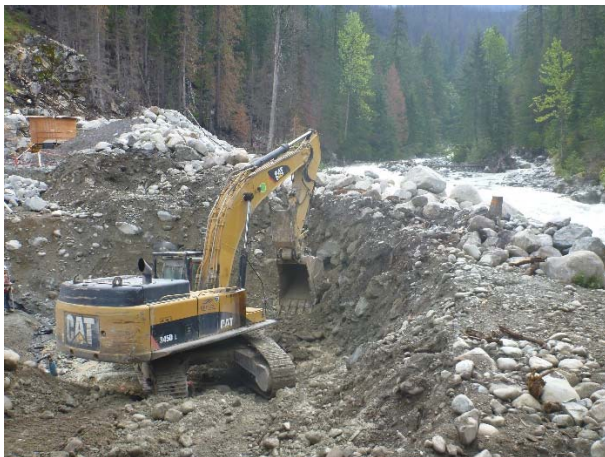
- Drilling, blasting, and tunnel stabilization in the downstream tunnel portal.
- Electrical component installation in the BDRHEF powerhouse.
- Excavation of BDRHEF tailrace (Photo 15).
- Insulation, formwork, rebar, and concrete works in BDRHEF tailrace (Photo 16).
- Excavation of new settling/infiltration pond at the downstream tunnel portal (Photo 17).

Photo 15 – Excavation of BDRHEF tailrace (July 17, 2016).

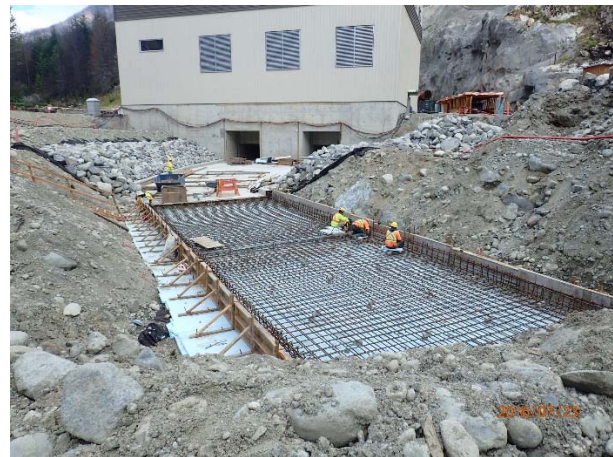
Photo 16 – Formwork and rebar BDRHEF tailrace (July 23, 2016).

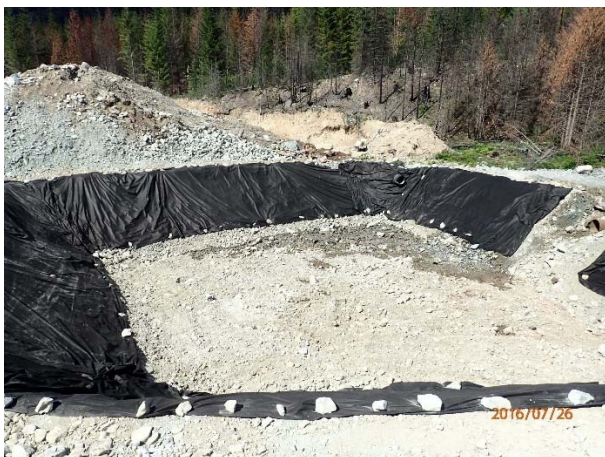
Photo 17 – Excavation of new BDRHEF lower tunnel portal pond (July 26, 2016).

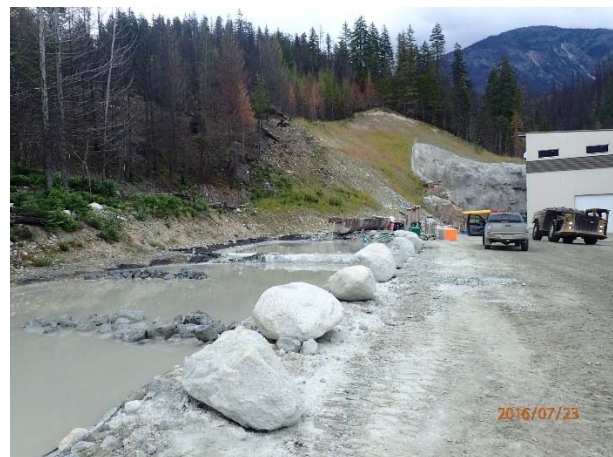
- CE conveyed all wastewater related to the BDRHEF tunnelling works to the downstream settling ponds for treatment (Photo 18).
- On July 18, 2016, the IEM observed the discharge from the BDRHEF lower tunnel portal settling ponds discharging very close to a side channel of Boulder Creek, before infiltrating into the ground. As of July 18th, there is no surface connection between the settling pond discharge and the side channel of Boulder Creek (Photo 19). On July 20, 2016, the IEM requested that CE take steps to ensure all water discharging from the settling ponds meets BCWQG. On July 22, 2016, CE installed a CO<sub>2</sub> injection box in the first of three settling ponds, to treat water with elevated pH (Photo 18). On July 26, 2016, CE excavated a new infiltration pond to decrease the volume of water discharged off site (Photo 17). The newly excavated pond is functioning as intended, and since the commissioning of the pond on July 27<sup>th</sup>, all tunnel wastewater has infiltrated to ground (Photo 20).

Photo 18 – BDRHEF downstream portal settling ponds and CO<sub>2</sub> injection box (July 23, 2016).

- CE should continue to direct all construction related wastewater to the active water treatment systems/settling ponds. CE should continue to monitor the newly constructed settling/infiltration pond to ensure that it remains in good working condition, and perform all maintenance activities as outlined in the work plan. If water begins to discharge from the newly constructed channel, CE should conduct regular inspections to ensure that it meets BCWQG prior to infiltration near or connection to with the Boulder Creek side channel.
- CE should continue to maintain the BDRHEF intake access road, and continue excavation/maintenance of ditch lines as discussed after the BC EAO site tour on June 9, 2016 and subsequent environmental meetings.

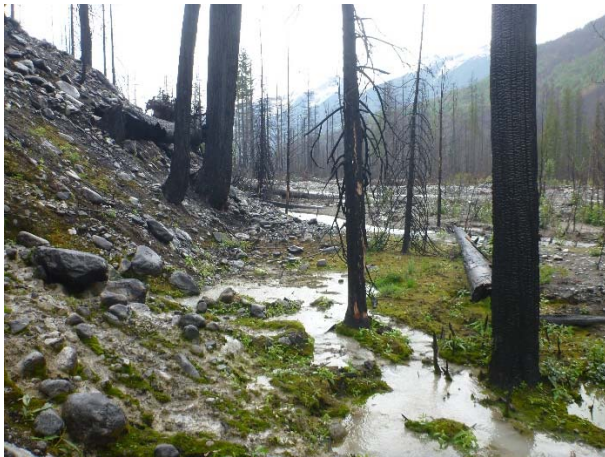
July 20, 22, 23, & 24	<i>Site meeting and email</i>	SES, CE, INX	<p>The IEM observed discharging water from the outlet of the BDRHEF lower-portal infiltration ponds nearing a side channel of Boulder Creek. The IEM requested:</p> <ol style="list-style-type: none"> <li>1. That CE take steps to ensure that water discharging from the ponds met BCWQG.</li> <li>2. That CE inspect the drainage path to determine if additional sediment and erosion mitigation measures were required.</li> </ol> <p>On June 22<sup>nd</sup>, CE installed a CO<sub>2</sub> injection box within the sediment ponds to help mitigate high pH from concrete works in the tunnel. Additionally, CE committed to excavating an additional infiltration pond to increase infiltration capacity and limit the volume of water discharged from the ponds.</p>	-

Photo 19 – Discharge from BDRHEF lower tunnel portal flowing within 5m of a side channel of Boulder Creek (July 17, 2016).

Date	Communication Type	Participants	Issues Discussed	ITM ID No.
			<p>The IEM requested that CE first conduct maintenance on the existing infiltration ponds prior to building a new one. If CE preferred to excavate a new infiltration pond, the IEM requested that the following conditions be met:</p> <ol style="list-style-type: none"> <li>1. The pond location should be completely clear of ANFO rock.</li> <li>2. The pond should be fully excavated in native material as the interface between the spoil blasted with gel dyne and ANFO is not likely to be well defined and would likely become mixed during the excavation process.</li> <li>3. Should water discharge overland from the new pond to surface water, it should be tested for ammonia and nitrate concentration to ensure its compliance with BCWQG.</li> <li>4. Prior to commissioning the new cell, the IEM must verify that the cell had been fully excavated in native material.</li> </ol> <p>CE responded confirming that their preference was to excavate a new infiltration pond, and that they would complete it by July 27<sup>th</sup>. CE also confirmed that they would not use the newly constructed infiltration pond until the IEM had inspected the excavation.</p>

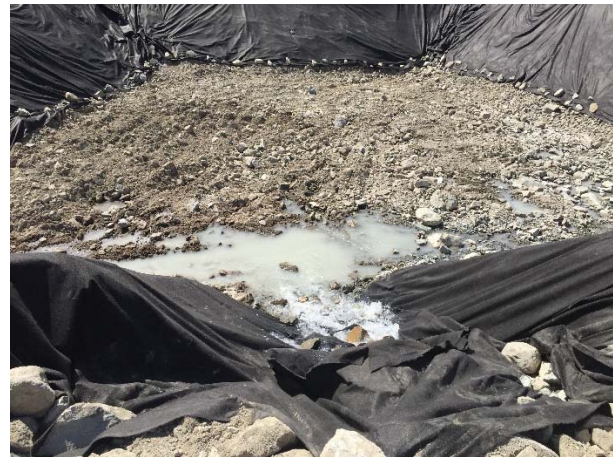
Photo 20 – Water infiltrating into the ground within the newly constructed settling/infiltration pond (July 27, 2016).

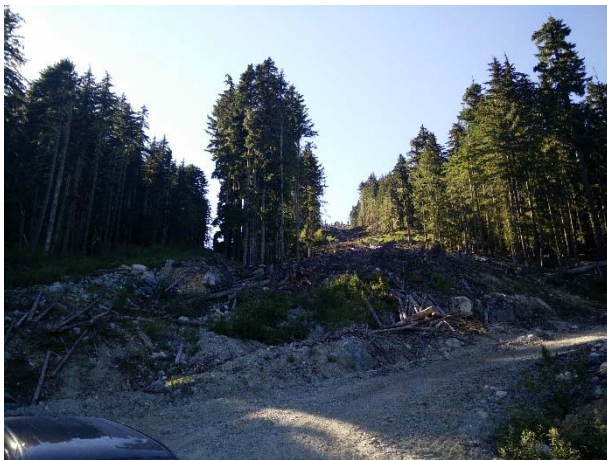
- Installation of pole structure anchors at structure 316, within the RVMA (Photo 21).

- On July 27, 2016, the IEM conducted a site inspection for the manual installation of anchors within the RVMA at structure 316. The IEM did not observe any environmental issues associated with the works.

Photo 21 – Ground preparation and anchor installation for structure 316 (July 29, 2016).
