Upper Lillooet Hydro Project

Weekly Environmental Monitoring Report #103

Reporting Period: September 11 – September 24, 2016

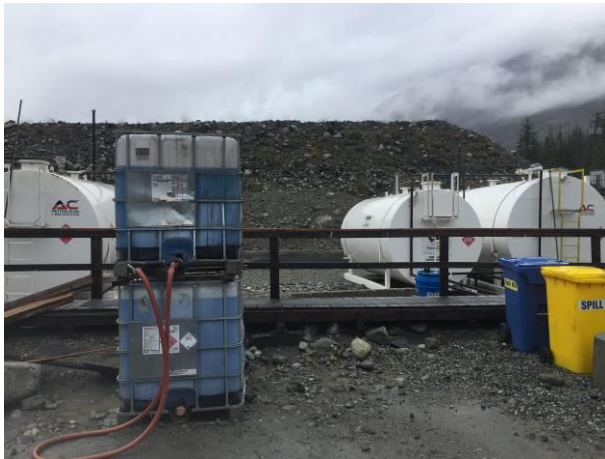
- CE continued routine fuel management and maintenance of construction equipment within the mechanic shop at the KM38 laydown (Photo 1). CE temporarily stored all hazardous substance materials (waste oil, contaminated soil, used oil/hydraulic fluid containers, etc.) in a designated area at the laydown prior to off-site disposal. The materials were all well contained and protected from the weather.

Photo 1 – Fuel storage at the KM38 laydown (September 17, 2016).

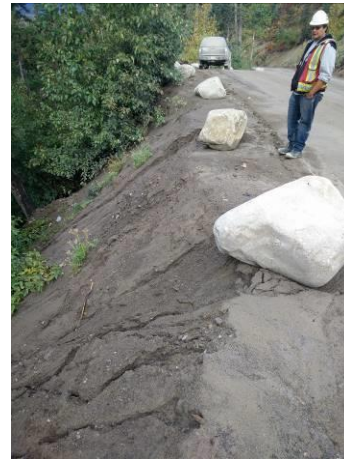
- On September 20, the IEM identified erosion on the downslope of the Lillooet River FSR between KM46.5 and 48 (Photo 2). Runoff from recent rain fall has begun to erode the conduit trenching material that was pushed onto the downslope in August 2016 (ITM #60). The IEM raised the issue with CE and will continue to monitor the slope.

Photo 2 – Erosion on the downslope of the Lillooet River FSR at KM47 (September 20, 2016).

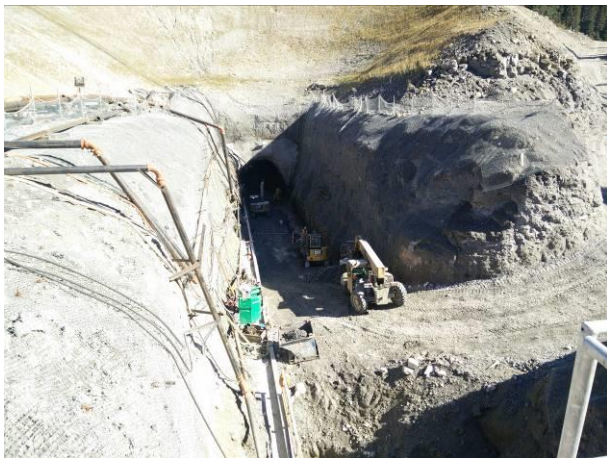
Photo 3 – ULRHEF upper tunnel portal and BEBO tunnel wall (September 14, 2016).

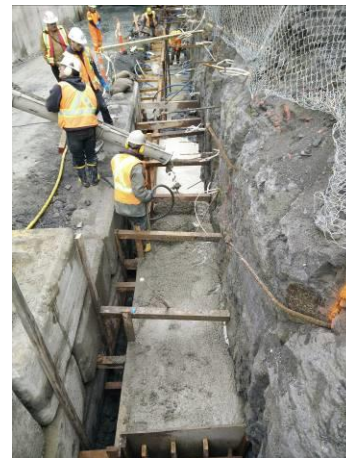
Photo 4 – Concrete works on the east side of the BEBO tunnel wall (September 24, 2016).

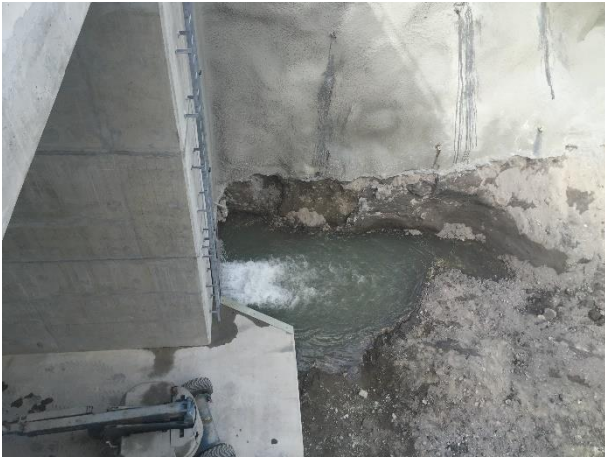
- On September 11, CE began filling the intake/slucice way, with clean ground water pumped from the BEBO tunnel wall excavation, to equalize water levels between the Lillooet River and the intake structure behind the upstream cofferdam. During filling operations crews observed that water was leaking through the IFR gate (Photo 5). CE drained the water within the intake structure to complete the repairs on the IFR gate, water was discharged downstream of the sluice gate to the Lillooet River. The IEM monitored water quality at Keyhole bridge and did not observe any exceedances in BCWQG during the dewatering. Once CE completed repairs on the gate they resumed filling the intake structure. While the intake structure was being filled, CE continued excavation of the upstream cofferdam to an elevation of ~300mm above the water level (Photo 6).

Photo 5 – Water leaking through the IFR gate at the ULRHEF intake structure (September 11, 2016).

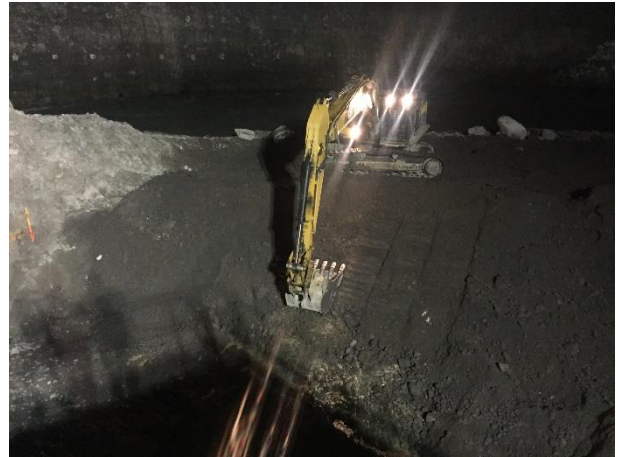
Photo 6 – Excavation of the ULRHEF upstream cofferdam to 300mm above river level on night shift (September 11, 2016).

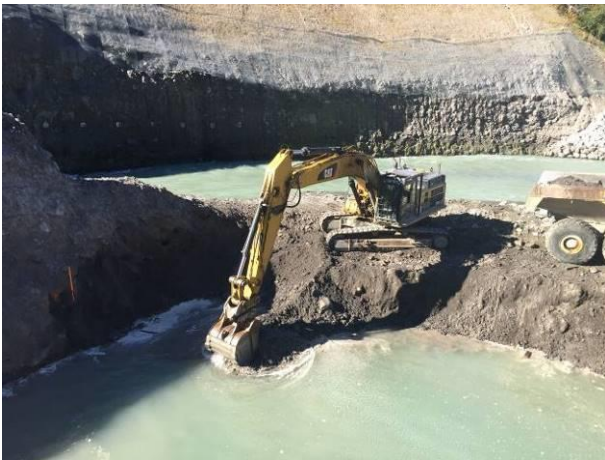
- On September 12, water levels between the intake and the Lillooet River had equalized, allowing CE to begin instream excavation of the ULRHEF upstream cofferdam (Photo 7). At 11:50 a hydraulic hose ruptured on the excavator conducting instream works spilling approximately 2L of biodegradable hydraulic oil to the ground, a portion of which entered a pool of water behind the cofferdam (Spill report #33; EIR #30; Photo 8). CE immediately stopped all construction activities, deployed spill pads, and removed all contaminated material. After the spill was cleaned up and repairs were complete crews resumed instream excavation and connected the intake structure to the Lillooet River at 14:00, instream excavation continued until 22:00. The IEM monitored all construction activities and collected water quality at Keyhole bridge (max turbidity = 58.9 NTU when background condition was 45.8 NTU) and 100 meters downstream of the ULRHEF powerhouse (max turbidity = 43.6 NTU when background condition was 25.4 NTU). The IEM detected slight elevations in turbidity downstream of the cofferdam removal throughout instream excavation, however WQ returned to within BCWQG shortly after instream excavation stopped. Additional WQ results are available upon request.

Photo 7 – Instream excavation once water levels were equal between the Lillooet River and the ULRHEF intake structure (September 12, 2016).

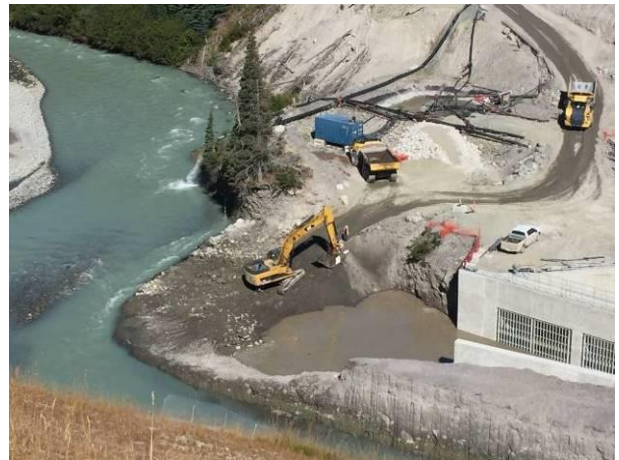
Photo 8 – Crews deploying and cleaning up the hydraulic spill (September 12, 2016).

<input type="checkbox"/> Snow
Specific Location: Upper Lillooet Intake Upstream Cofferdam								
Description and Cause of Incident:								
<u>Description:</u>								
<p>A Caterpillar 345D excavator (unit 50-0524) equipped with biodegradable hydraulic-oil, was working on the Upper Lillooet Intake excavating the upstream cofferdam, when a hose on the excavator's boom failed. Less than 2 liters of hydraulic fluid was lost on the excavator, the ground below as well as a small amount that entered the pool of water behind the cofferdam. Upon noticing the leak the operator placed the excavator bucket on the ground and powered down the machine.</p> <p>Spill pads were placed below the excavator boom used to clean the soil below. A slight sheen was observed on the pool of water behind the cofferdam. The cleanup was overseen by the IEM and completed to their satisfaction.</p> <p>The contaminated pads and soil were placed in a 45 gallon drum and sealed. The drum will be disposed of offsite by third party contractor specializing in hazardous waste.</p>

<u>Cause:</u> Hydraulic hose failure								
Incident Witness: Nicolas Grondin (foreman), Stephane Corivaux (operator) and Tom Hicks (IEM)								
Were there any Potential Environmental impacts as a result of the incident? (e.g., surface contamination, storm sewers, or fish/wildlife mortalities)						Yes <input checked="" type="checkbox"/>	None Observed <input type="checkbox"/>	
If Yes, please describe: See incident description above.								
Has Wildlife Salvage Protocol been followed? i.e. Carrion Removal						Yes <input type="checkbox"/>	No <input type="checkbox"/>	N/A <input checked="" type="checkbox"/>
If No, please explain:								
Water Quality Samples Collected?						Yes <input type="checkbox"/>	No <input checked="" type="checkbox"/>	N/A <input type="checkbox"/>
<p>If yes, attach results of water quality analysis to report in table format. Include Laboratory analysis if completed.</p> <p>If No please explain: The small quantity spilled was cleaned to the satisfaction of the IEM. No confirmatory sampling was required.</p>

Incident Response Measures
See incident description above
Actions to Prevent Incident Recurrence
While the failure of a hydraulic hose is unpredictable, regular maintenance and inspections will continue to reduce the likelihood of a future reoccurrence.

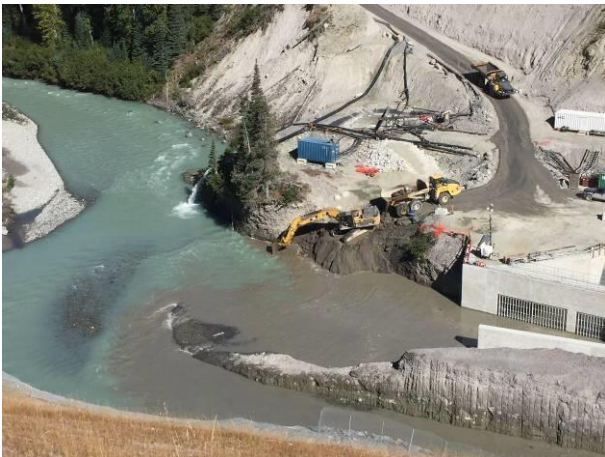
- On September 13, CE completed the removal of the ULRHEF upstream cofferdam at approximately 13:30 (Photo 9_{Photo 7}). CE allowed water to settle in the intake/slucice way over-night prior to opening the sluice gate. The IEM detected slight elevations in turbidity downstream at Keyhole bridge (max turbidity = 54.9 NTU when background condition was 26.9 NTU) and 100 meters downstream of the ULRHEF powerhouse (max turbidity = 39.8 NTU when background condition was 26.1 NTU) throughout instream excavation, however WQ returned to within BCWQG shortly after instream excavation stopped. Additional WQ results are available upon request.

Photo 9 – Crews finishing the ULRHEF upstream cofferdam removal (September 13, 2016).

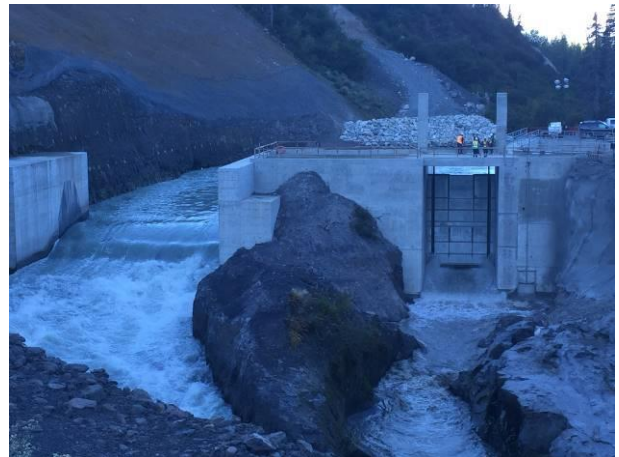
- On September 14, CE opened the sluice gate in stages (Photo 10). At 08:10 crews opened the gate 6-inches, or approximately 5.6 cubic meters per second. The IFR gate was opened for approximately 20 minutes to ensure it was not blocked by sediment and was functioning as intended. At 11:00 CE continued opening the sluice gate 3 inches every 15 – 20 minutes, until fully open. The IEM and Ecofish monitored all construction activities associated with sluicing operations and the IEM collected water quality at Keyhole bridge (max turbidity = 124 NTU when background condition was 107 NTU) and 100 meters downstream of the ULRHEF powerhouse (max turbidity = 85 NTU when background condition was 38.2 NTU). Turbidity was slightly elevated throughout sluicing

operations, however, opening the sluice gate in stages helped to reduce impacts to water quality. Additional water quality results are available upon request.

Photo 10 – Opening of the ULRHEF sluice gate (September 14, 2016).

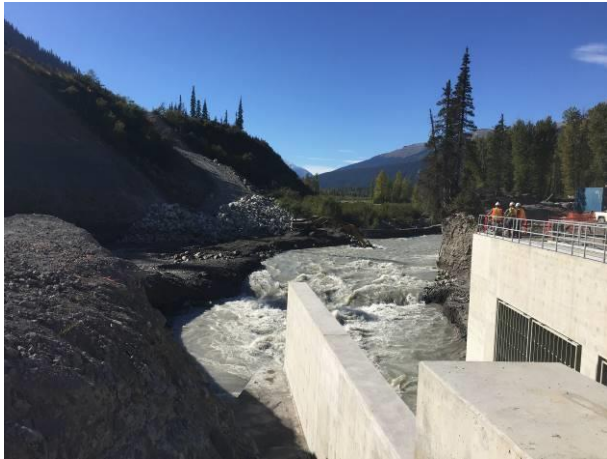
- On September 15, a portion of the Lillooet River was still flowing through the Obermeyer diversion channel. Working from the right bank, CE lowered the elevation of the river channel by excavating instream and constructed a berm along the Obermeyer channel (Photo 11). The IEM monitored all instream activities and collected water quality downstream at Keyhole bridge (max turbidity = 66.9 NTU when background condition was 37.4 NTU) and 100 meters downstream of the ULRHEF powerhouse (max turbidity = 77.1 NTU when background condition was 44.3 NTU) throughout instream excavation. Additional water quality results are available upon request. As per Ecofish's directions the discharge of a 3-inch pump was directed into the Obermeyer diversion channel to provide constant flow and prevent fish stranding, until a salvage could occur on September 16 (Photo 12).

Photo 11 – Instream excavation to lower the elevation of the river channel and to fully divert the Lillooet River through the sluice way (September 15, 2016).

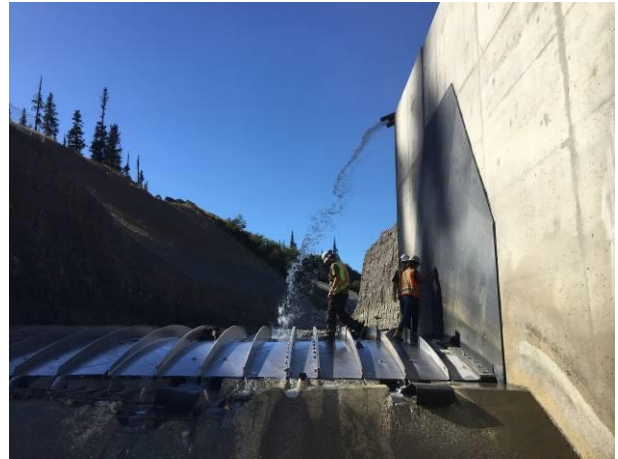
Photo 12 – Discharge of 3-inch pump directed to the Obermeyer diversion channel (September 15, 2016).

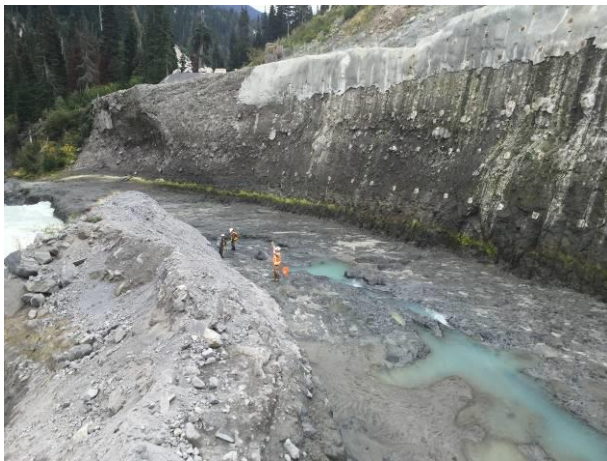
- On September 16, Ecofish conducted a fish salvage (Photo 13) in the Obermeyer diversion channel. Once the fish salvage operation was complete in the diversion channel CE removed the 3-inch pump and isolated the diversion channel to complete repairs on the Obermeyer structure (Photo 14). No fish mortalities were reported to the IEM.

Photo 13 – Ecofish conducting a fish salvage in the ULRHEF Obermeyer diversion channel (September 16, 2016).

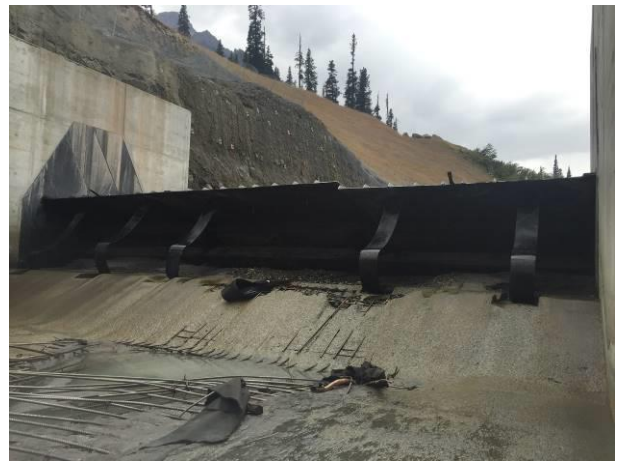
Photo 14 – Damage to the Obermeyer structure (September 16, 2016).

- Andritz electrical work in the ULRHEF powerhouse will continue.
- Repair works on the damaged Obermeyer structure.
- BEBO tunnel construction activities will continue.

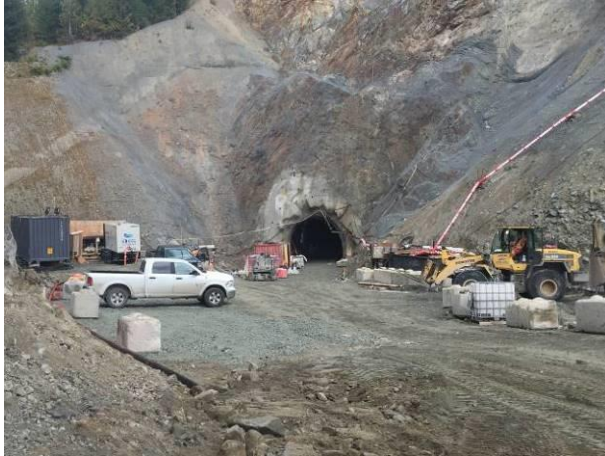
- CE continued to drill, anchor and spray shotcrete as part of rock support activities associated with the rock trap installation (Photo 15).
- CE began tunnel plug and grouting operations on September 16, 2016.

Photo 15 – ULRHEF lower tunnel portal (September 16, 2016).

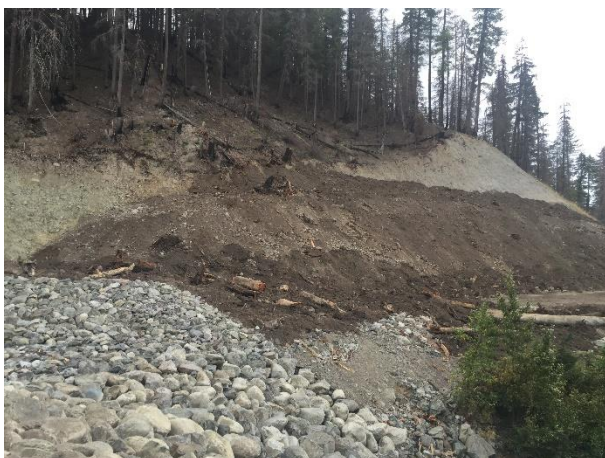
- Reclamation along the ULRHEF penstock alignment and backfill and re-shaping the banks of Truckwash Creek (Photo 16).

Photo 16 – Reconstructed left bank of Truckwash Creek (September 16, 2016).

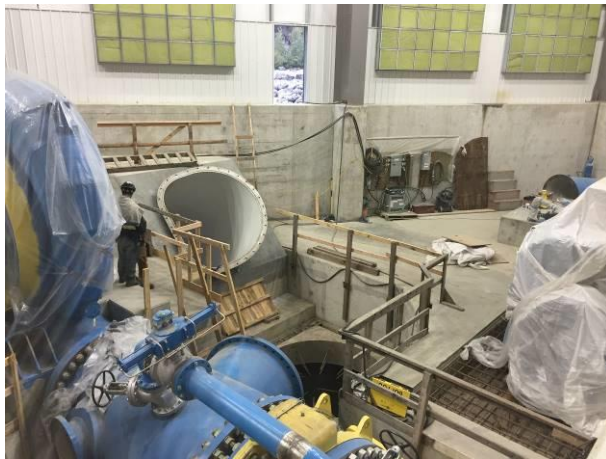
Photo 17 – Andritz electrical works in the ULRHEF powerhouse (September 17, 2016).

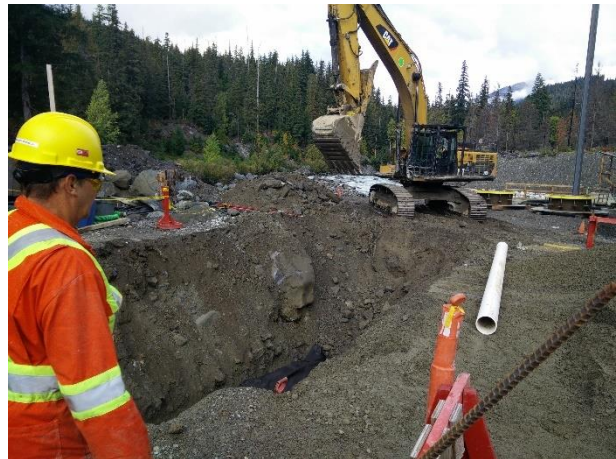
Photo 18 – Backfill of the ULRHEF powerhouse septic field (September 22, 2016).

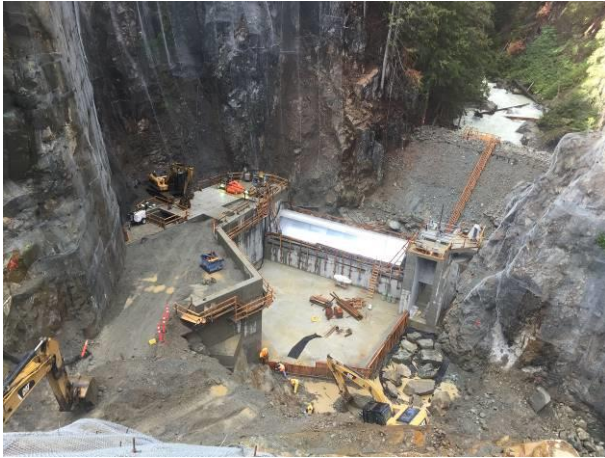
Photo 19 – Excavation of the BDRHEF intake crane pad (September 17, 2016).

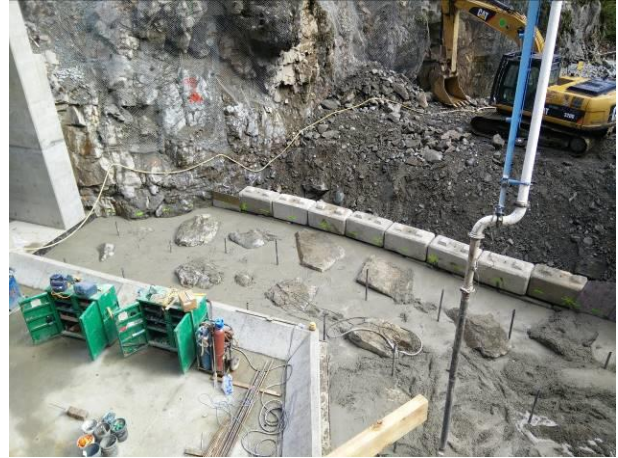
Photo 20 – Concrete pour for the BDRHEF Coanda downstream slab (September 20, 2016).

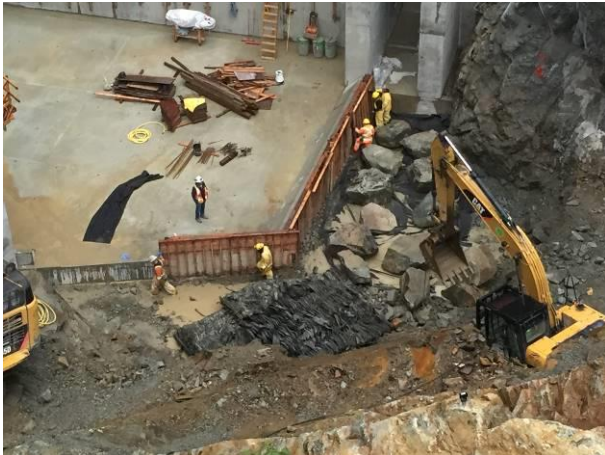
- On September 18, CE excavated a portion of the BDRHEF downstream cofferdam to allow for the installation of downstream scour protection (Photo 21). All construction was completed in the dry and above the high-water mark. The IEM monitored all construction activities and no environmental issues were observed.
- The IEM monitored the discharge from the active water treatment system for compliance with BCWQG. Water discharged to Boulder Creek did not exceed > 8NTU above background turbidity during the reporting period. Additional water quality sampling results are available upon request.

Photo 21 – Excavation of the BDRHEF downstream coffer dam, all works were conducted in the dry and above the high water mark (September 18, 2016).

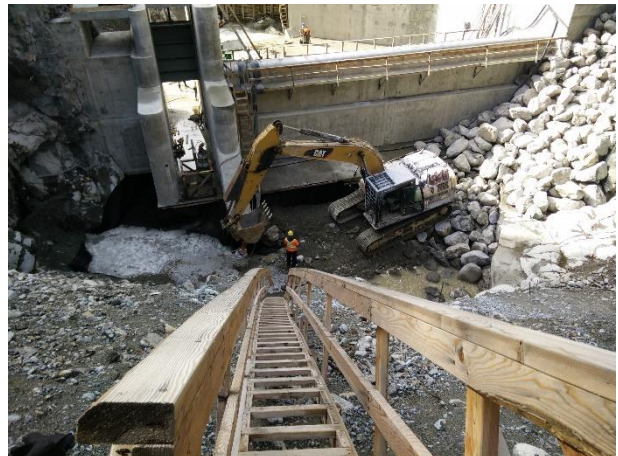
Photo 22 – Installation of scour protection upstream of the BDRHEF intake (September 24, 2016).

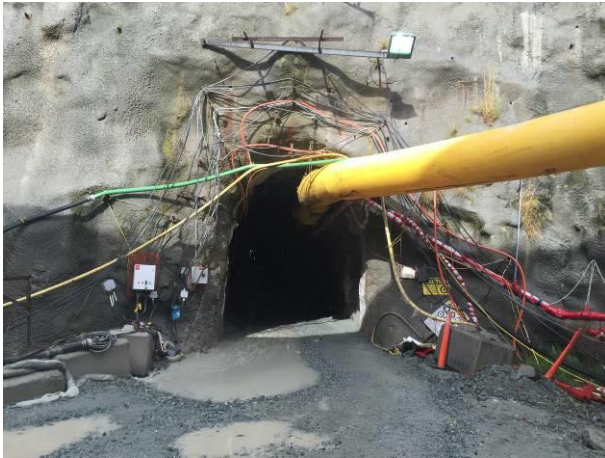
Photo 23 – BDRHEF lower-tunnel portal (September 17, 2016).

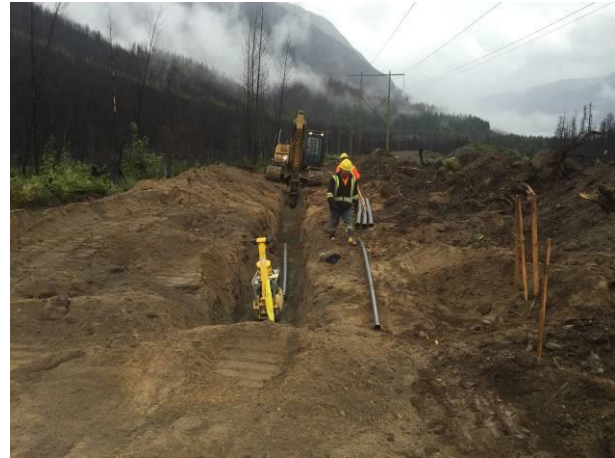
Photo 24 – Conduit installation between BDRHEF powerhouse and intake access road (September 17, 2016).

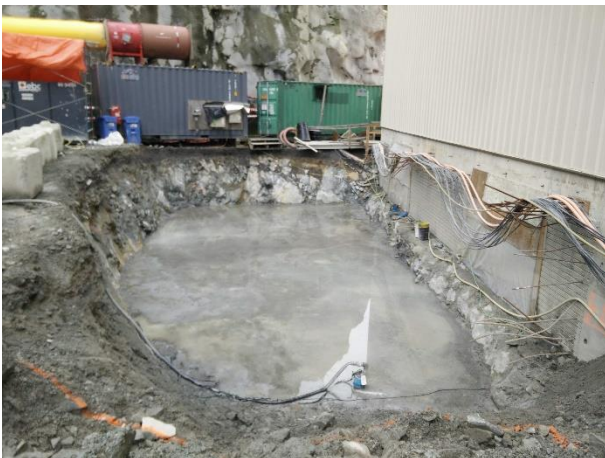
Photo 25 – BDRHEF bifurcation excavation and mud slab cure (September 24, 2016).
