Upper Lillooet Hydro Project

Weekly Environmental Monitoring Report #113

Reporting Period: April 1 – 30, 2017

Upper Lillooet River Hydroelectric Facility (Water File No. 2002561, Water licence No. C130613), Boulder Creek Hydroelectric Facility (Water File No. 2003049, Water licence No. C129969) & Transmission Line (TX Line)

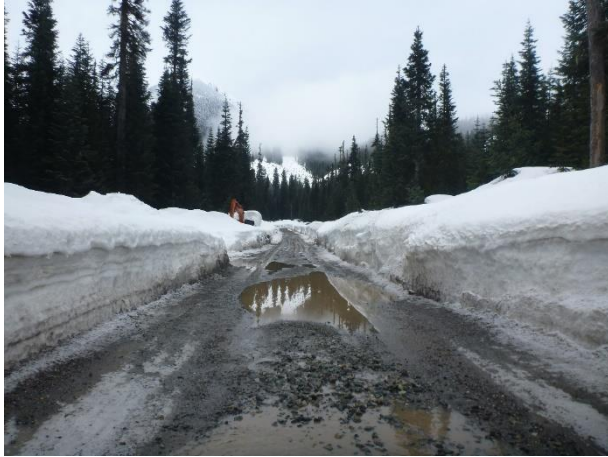
Photo 1 – Maintenance of the Lillooet River FSR at KM48 (April 6, 2017)

- CE continued routine fuel management and maintenance of construction equipment within the mechanic shop at the KM38 laydown. CE temporarily stored all hazardous substance materials (waste oil, contaminated soil, used oil/hydraulic fluid containers, etc.) in a designated area at the laydown prior to off-site disposal. The materials were all well contained and protected from the weather. CE continued to demobilize equipment from various locations around site in preparation for project completion.
- Maintenance of the Lillooet River FSR continued throughout this period (Photo 1).

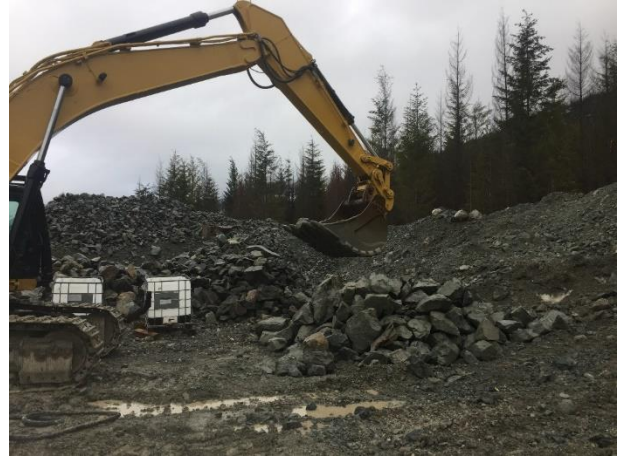
Photo 2 – CE washing BDRHEF tunnel rock at KM38 (April 18, 2017)

- CE washed stockpiles of BDRHEF blast rock at KM38 (Photo 2). Water samples were collected and tested for residual ANFO. All samples testing had concentration below the BC Water Quality Guidelines for the Protection of Aquatic Life allowable limits. Based on the results the IEM agreed that the blast rock could be used to amour ditches across the construction site, as long as it came from the washed and sampled stock pile.

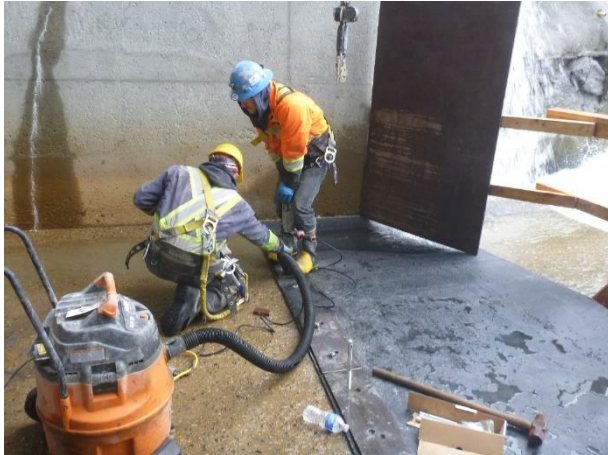
Photo 3 – Crews vacuum concrete dust while installing protective rubber matting on the downstream portion of the ULRHEF sluice way. (April 8, 2017)

- CE repaired the concrete and placed protective rubber matting on the downstream side of the ULRHEF sluiceway, all repairs were conducted in isolation from flowing water (Photo 3).
- Commercial divers examined, cleaned, and installed protective rubber matting on the upstream portion of the ULRHEF sluiceway (Photo 4).
- Repairs the trash rack cleaner were completed.

- During the November 2016 flood event, high water levels and heavy sediment loads eroded portions of the concrete in the ULRHEF sluiceway. Due to the severity of the damage, repairs to sections of concrete and the installation of protective rubber matting were required to prevent future erosion. On April 7, CE grouted a 2-meter section of the slab immediately downstream of the sluiceway gate (Photo 5). On April 8, crews began installing protective rubber matting downstream of the sluiceway gate. The matting was secured in with ¾” anchors drilled into the sluiceway concrete. Crews used a shop vacuum to clean up all drilling residue (Photo 3), and disposed of any concrete slurry into the designated concrete wash pit located more than 30 meters from the intake structure. All construction activities were conducted in isolation of flowing water. The IEM monitored all activities associated with these works and did not observe any environmental issues.

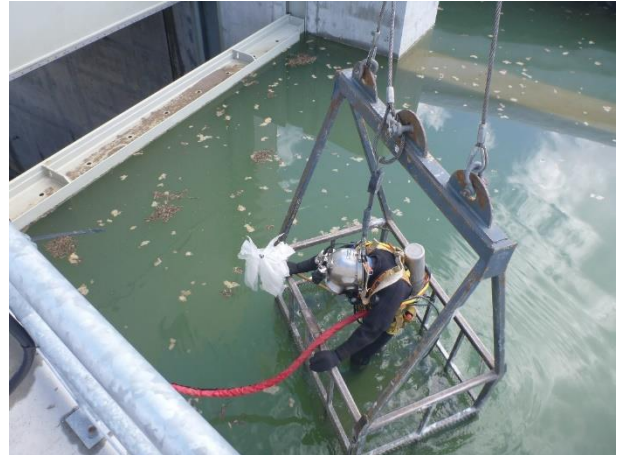
- On April 11, commercial divers inspected the upstream portion of the ULRHEF sluiceway for damage (Photo 4). Divers had to clear the sluiceway of approximately 6 inches of sediment before the inspection could be completed. The IEM installed a multi-sensor

Photo 4 – Commercial divers inspecting the upstream portion of the ULRHEF sluice way slab (April 11, 2017)

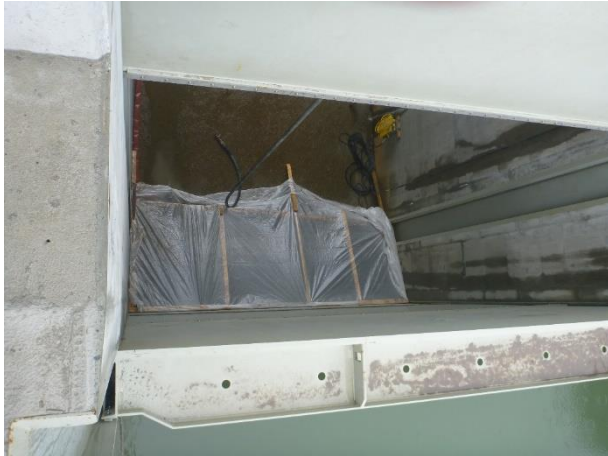
Photo 5 – Concrete works to repair a 2-meter section of the concrete on the downstream side of the ULRHEF sluice way (April 07, 2017)

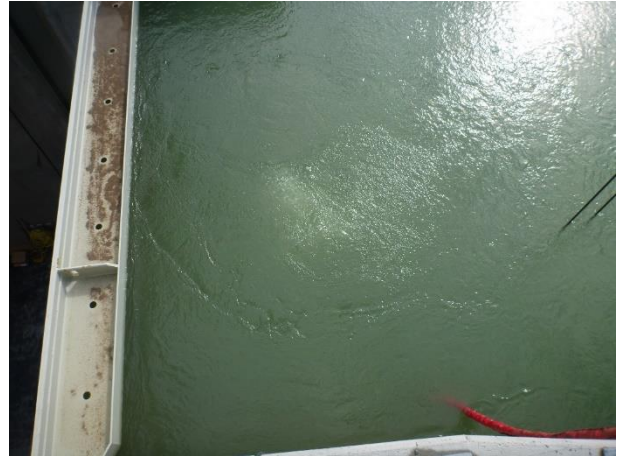
Photo 6 – No change in visual water quality while divers clear sediment from the upstream portion of the ULRHEF sluice way (April 11, 2017)

probe above the divers to monitor turbidity and pH. During the sediment removal turbidity levels fluctuated resulting in minor (12 – 51 NTU) exceedances of BCWQG. All exceedances were short lived (usually <1 minute each). Additionally, the works posed minimal risk to downstream WQ because there was no flowing water near the sluice way (Photo 6). Additional water quality results are available upon request. The divers inspected the damage to the concrete and found that the upstream edge of the sluice way concrete slab was significantly eroded and would require concrete works to repair the damage. A new work plan to repair the upstream edge of the slab, and to mitigate the effects of underwater concrete works was developed and submitted to MFLNRO for approval. While waiting for approval, the divers installed protective rubber matting on the undamaged portion of the slab (Photo 7). A CO₂ diffuser was installed to mitigate elevated pH that could be associated with drilling into concrete. The IEM monitored all underwater works and did not observe an increase in sediment or pH associated with the installation of the protective rubber matting.

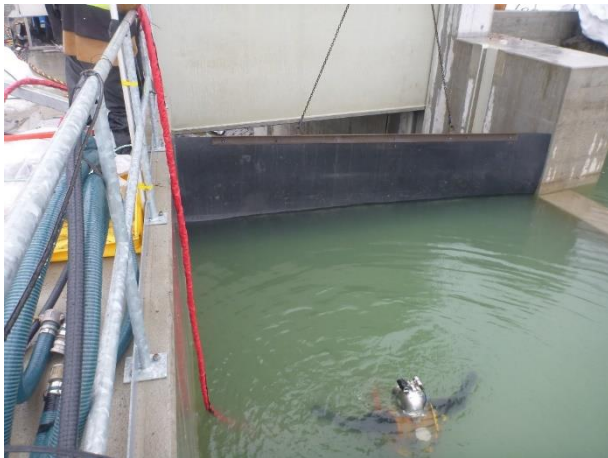
Photo 7 – Divers installing protective rubber matting on the upstream portion of the ULRHEF sluice way (April 13, 2017)

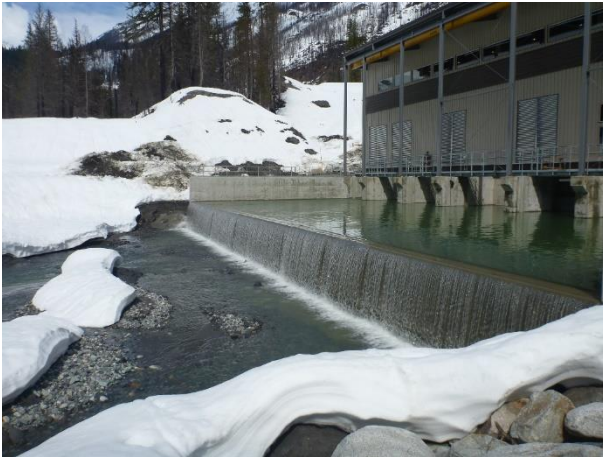
Photo 8 – Current conditions at the ULRHEF powerhouse (April 14, 2017)

- The IEM monitored construction activities throughout the monitoring period and observed no environmental issues (Photo 8).

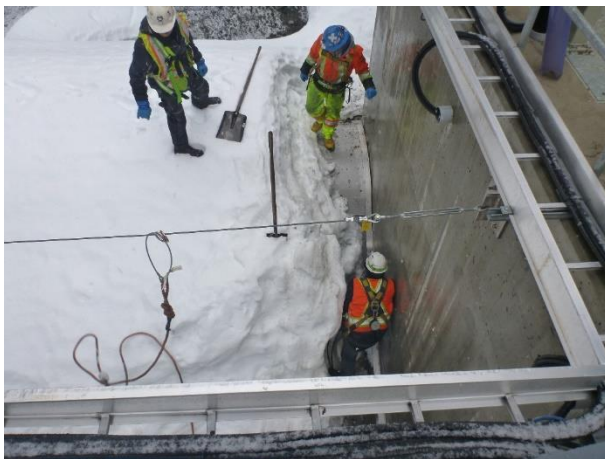
- On April 14, CE addressed deficiencies at the BDRHEF intake structure, including concrete patching and caulking joints in the Coanda screen (Photo 9).

Photo 9 – CE patching concrete and caulking joints in the Coanda screen at the BDRHEF intake (April 14, 2017)

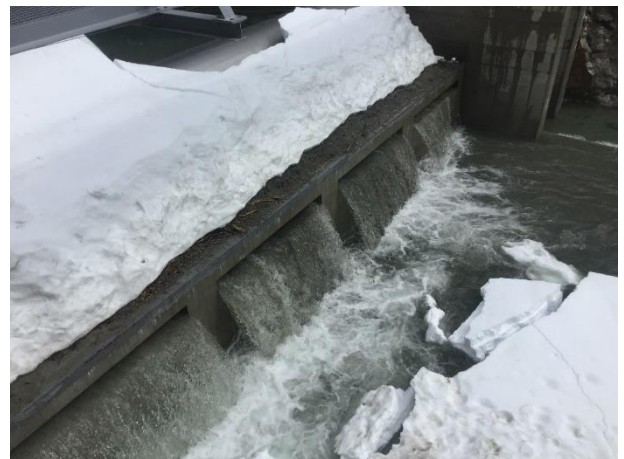
Photo 10 – Water and sand spilling out of the BDRHEF regulation channel (April 18, 2017)

- On April 18, CE began filling the BDRHEF headpond. Crews slowly closed the sluice gate allowing the head pond to fill while maintaining IFR (Photo 12). Sand deposited in the regulation chamber during the November 2016 floods, had to be removed prior to filling the tunnel, to prevent damage to the turbines. The sand was removed by allowing water into the regulation chamber through the coanda. Crews then quickly opened and closed the bypass gate to flush out the sand (Photo 11). The IEM monitored these works to ensure that the sand was released downstream slowly. The bypass gate was opened and closed 19 times over the course of the day to completely clear the sand from the regulation

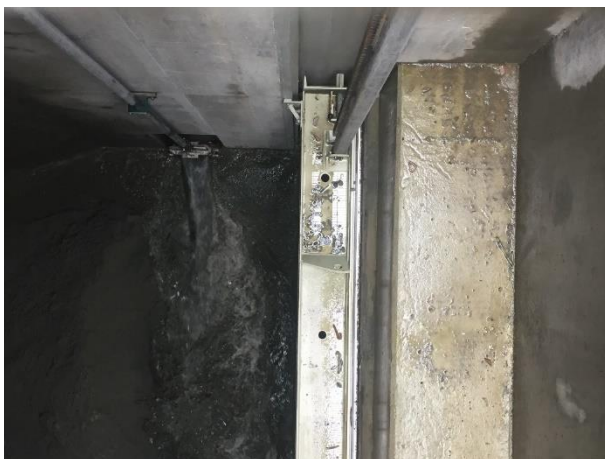
Photo 11 – Flushing sand out of the BDRHEF regulation chamber via the bypass gate (April 18, 2017)

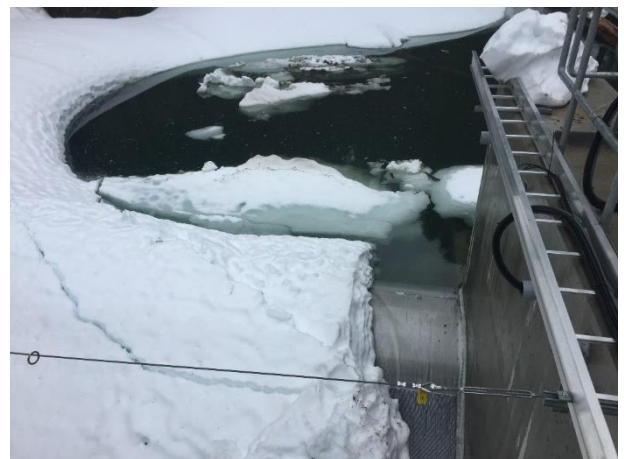
Photo 12 – Filling the BDRHEF head pond (April 18, 2017)

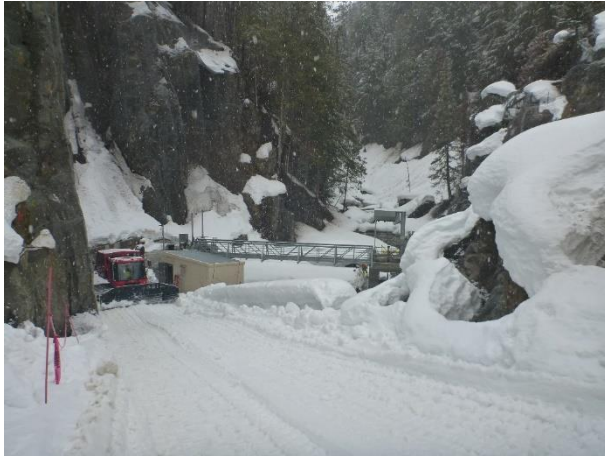
Photo 13 – Snowcat transporting crews to the BDRHEF intake (April 14, 2017)

- A small team of Andritz electricians continue to complete commissioning activities. As these works are being completed inside UWR u-2-002 UL12 during the sensitive winter period (November 15 – April 30), the IEM has been conducting regular audits to ensure that no works are occurring that would result in adverse effects to mountain goats. No plowing has occurred in UWR u-2-002 UL12 during this monitoring period and all personnel accessed the BDRHEF Intake by snowcat (Photo 13).

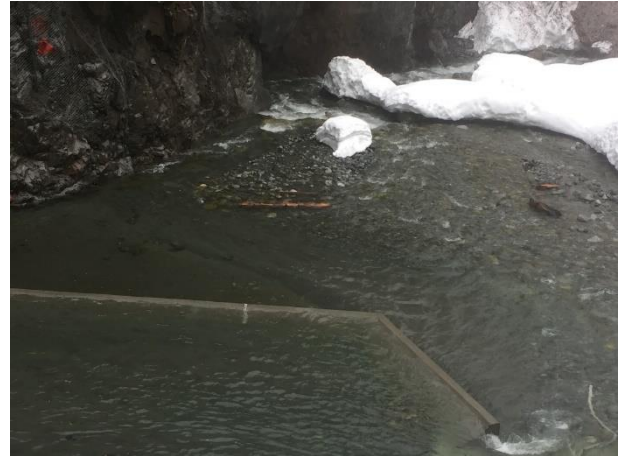
Photo 14 – Sand from the regulation chamber deposited directly downstream of the BDRHEF intake (April 18, 2017)

chamber. Because the sand was very coarse most of it dropped out of suspension directly downstream of the intake structure (Photo 14). Water quality was not taken directly downstream of the intake structure due to safety concerns. However, Ecofish monitored turbidity levels 300 meters upstream of the BDRHEF powerhouse on behalf on the IEM and did not observe any increase in turbidity associated with these works. Water quality results are available upon request. Once the sand was removed from the regulation chamber, CE slowly opened the head gate to allow water to begin filling the tunnel on April 19. The tunnel was filled by the evening of April 21. Crews were careful to maintain minimum instream flows during tunnel filling operations. The IEM and Ecofish monitored tunnel filling operations and did not observe any environmental issues.

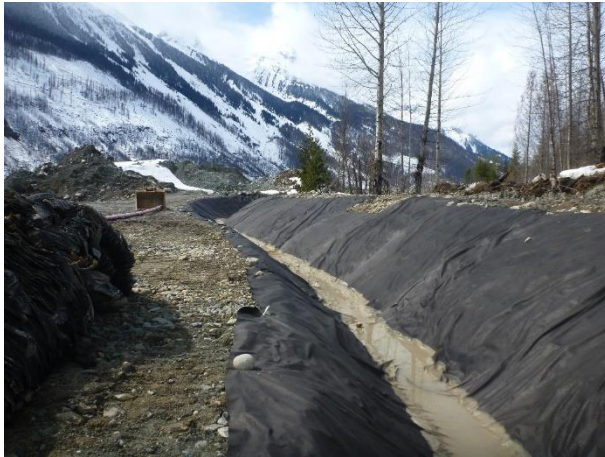
Photo 15 – Drainage and final grading around the BDRHEF powerhouse (April 14, 2017)

- CE completed final grading and drainage around the BDRHEF powerhouse (Photo 15 - Photo 16).
- First release of water to Boulder Creek through the water conveyance and generating equipment in the BDRHEF powerhouse (Photo 17 - Photo 18).

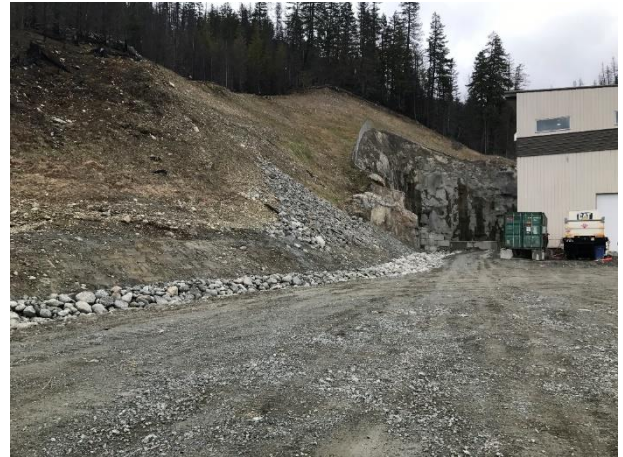
Photo 16 – Completed drainage at the BDRHEF powerhouse (April 26, 2017)

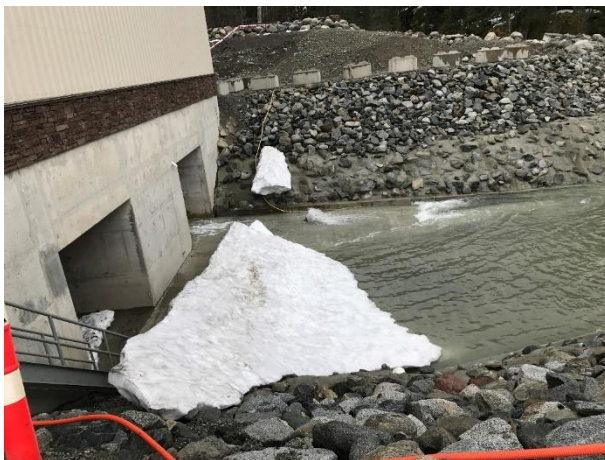
Photo 17 – First flush of water through the BDRHEF generating equipment (April 26, 2017)

- On April 26, a small amount of water from the BDRHEF tunnel was conveyed through the generating equipment and released into the tailrace and Boulder Creek. The IEM collected water samples from the tailrace during the initial flush to confirm that water quality met BCWQGs for the protection of aquatic life. The IEM did not observe any environmental issues associated with the release of water.

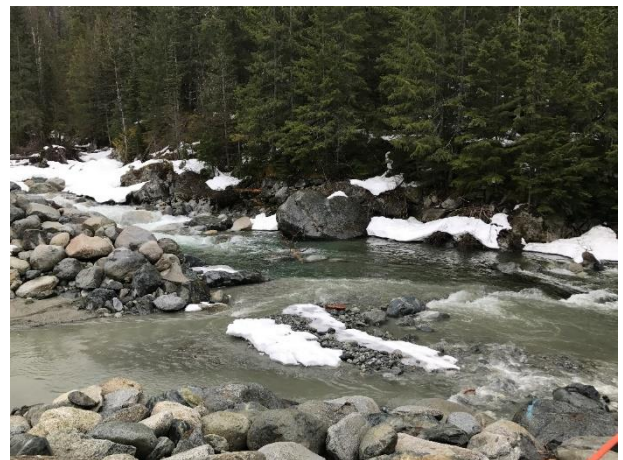
Photo 18 – First flush of water entering Boulder Creek from the BDRHEF tailrace (April 26, 2017)
