Upper Lillooet Hydro Project

Weekly Environmental Monitoring Report #114

Reporting Period: May 1 – 31, 2017

Upper Lillooet River Hydroelectric Facility (Water File No. 2002561, Water Licence No. C130613), Boulder Creek Hydroelectric Facility (Water File No. 2003049, Water Licence No. C129969) & Transmission Line (TX Line)

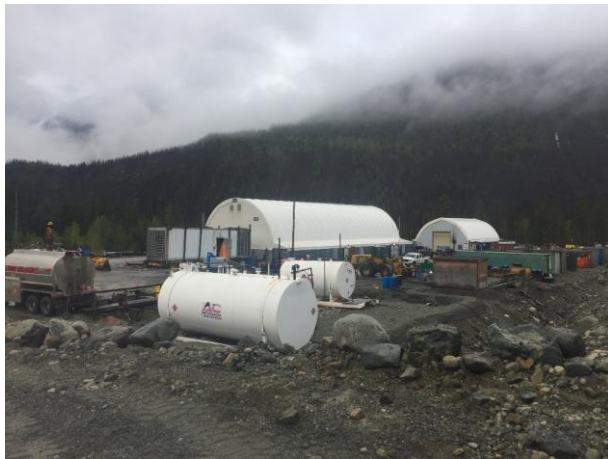
Photo 1 – Mechanics shop and KM38 laydown (May 8, 2017).

- CE continued routine fuel management at the KM38 laydown (Photo 1 - Photo 2). CE temporarily stored all hazardous substance materials (waste oil, contaminated soil, used oil/hydraulic fluid containers, etc.) in a designated area at the laydown prior to off-site disposal. The materials were all well contained and protected from the weather. CE also continued to demobilize equipment from various locations around site in preparation for project completion.
- CE began raising the elevation of the Lillooet River FSR and armoring the ditch line from KM41.5 – 42.75 (Photo 3 - Photo 6).
- After the end of the mountain goat operational shutdown, CE continued with restoration works and deactivation of the Truckwash 2 and KM44.7 access roads (Photo 7).

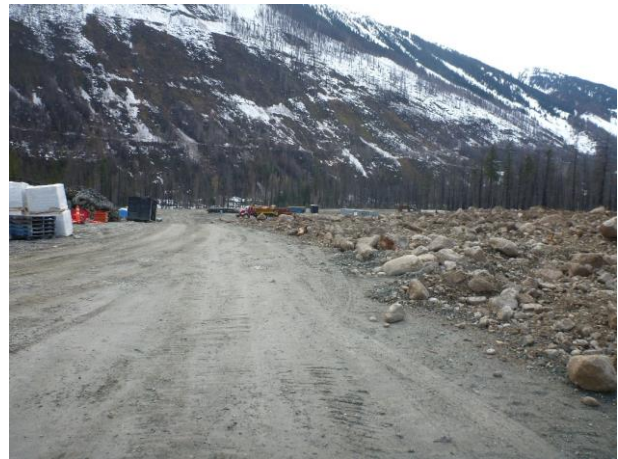
Photo 2 – Decompaction of the concrete batch plant site at the KM38 laydown (May 5, 2017).

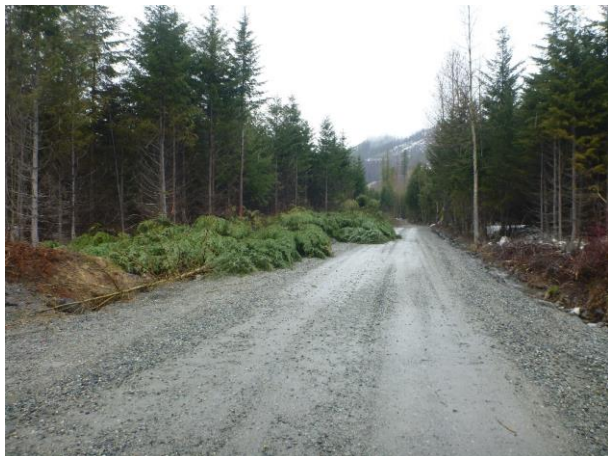
Photo 3 – Tree clearing at KM42 for road widening and raising (May 1, 2017).

- On the morning of May 1, CE fallers cleared 3 meters of forest on the south side of the Lillooet River FSR from KM42 – 42.5 to widen and raise the elevation of the FSR (Photo 3). All necessary song bird and raptor surveys were completed by Ecofish prior to the commencement of clearing activities. Lil'wat Nation archeologists were on site during all clearing and grubbing operations to monitor a known archeological area and to monitor for potential cultural artifacts that could have been encountered during the grubbing process, no artifacts were found. After clearing and grubbing operations were completed CE began raising the elevation of the FSR 1.5 meters from KM41.5 – 42.75 (Photo 4). The IEM monitored all construction activities and did not observe any environmental issues associated with these works.

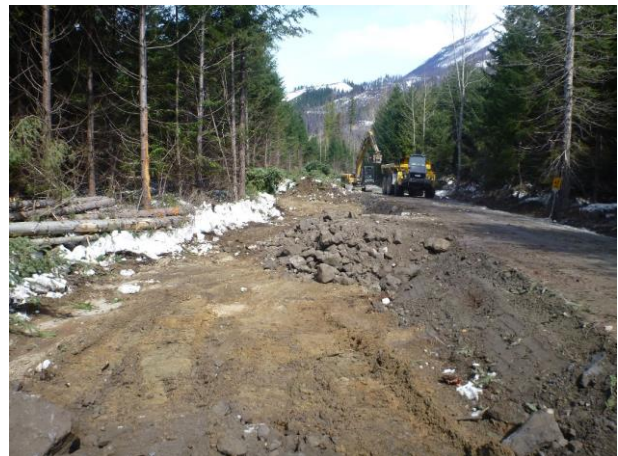
Photo 4 – Grubbing for road widening at KM42 (May 3, 2017).

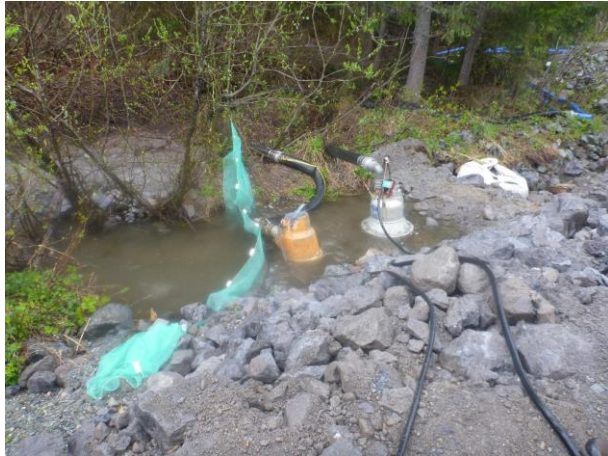
Photo 5 – Ditch isolation and pump around at KM42 (May 12, 2017).

- On May 12, CE began armoring the ditch line between KM41.5 – 42.75. Armouring was completed by isolating 100 foot sections of the ditch with large sandbags and earthen berms. A 6-inch pump was installed to pump water around the work area (Photo 5). Ecofish completed a CTF salvage in each section of the ditch prior to the placement of rip rap (Photo 6). In total, 100 CTF were captured within the ditch line and relocated upstream

of the work area. The IEM monitored water quality during all isolation/re-watering and pump movement activities and did not observe any increases in downstream turbidity at KM41.2.

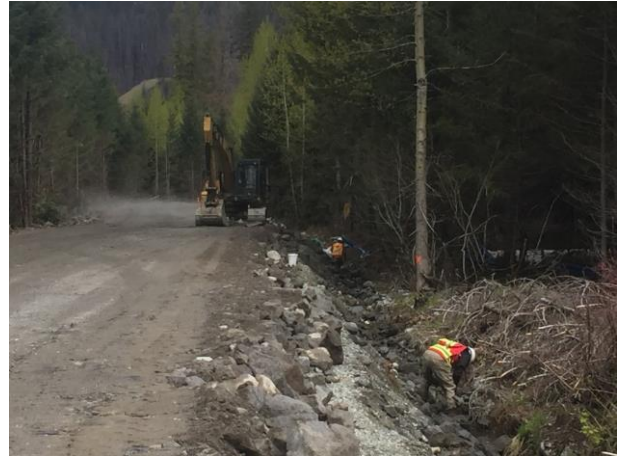
Photo 6 – Ecofish staff conducting a CTF salvage in the ditch line at KM42 (May 12, 2017).

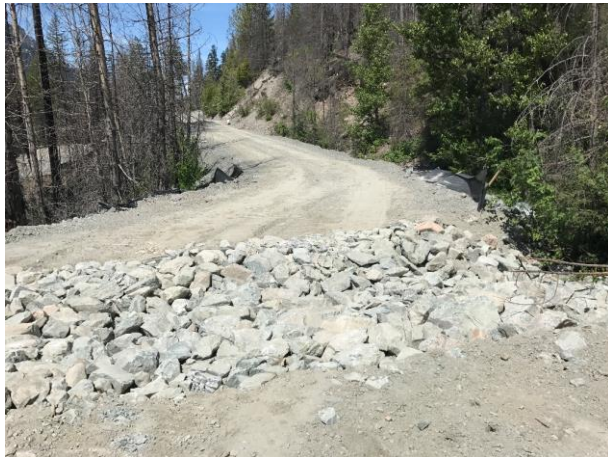
Photo 7 – Deactivated Truckwash 2 access road (May 29, 2017).

- From May 19 – 22, CE placed top soil and decommissioned the Truckwash 2 and KM44.7 access roads (Photo 7).
- On May 5, snow depths dropped below threshold levels triggering the two-week spring mountain goat migration corridor shutdown of “All drilling and construction associated activities ... at the Upper Lillooet River HEF downstream portal near Truckwash Creek and at the Intake”. All loud construction activities at the ULRHEF intake are complete and therefore the shutdown no longer applies to this area.

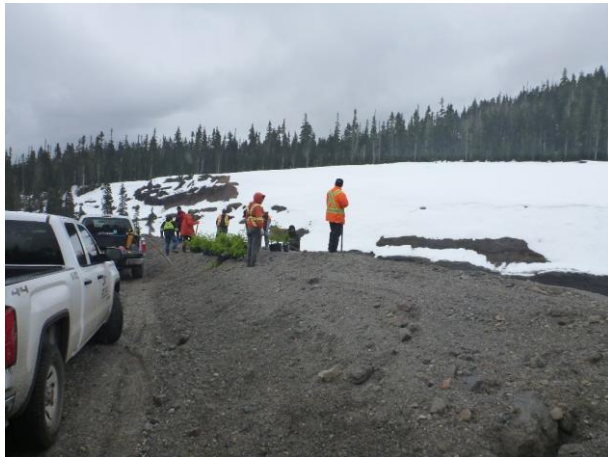
Photo 8 – Crews planting trees at KM48.5 of the Lillooet River FSR (May 15, 2017).

- Restoration planting at KM48.5 of the Lillooet River FSR (Photo 8).
- Commercial divers examined, cleaned, and installed protective rubber matting on the upstream portion of the ULRHEF sluiceway (Photo 9 - **Error! Reference source not found.**).
- Obermeyer repairs.

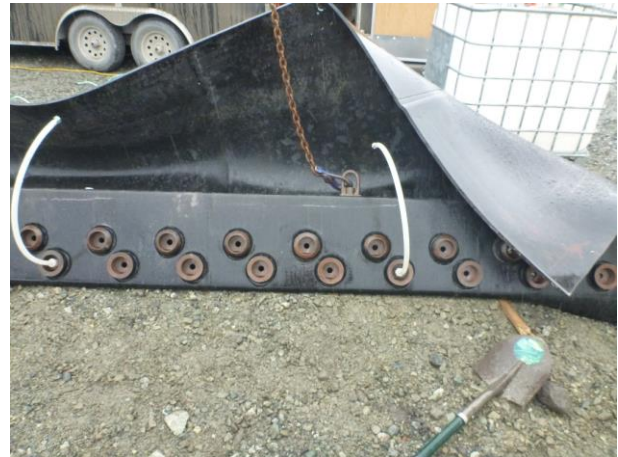
- On May 3, commercial divers began installing the final piece of rubber protective matting over the damaged section of the ULRHEF sluiceway foundations (Photo 9). Once the matting was anchored in place divers began grouting the 2.8 x 0.4 x 0.3-meter void in the sluiceway slab. Crews used a pressurized hose to inject grout into ports welded to the

angle piece of the protective matting (Photo 9). Each port had a corresponding relief valve, which allowed water out from under the matting. Each relief valve was covered by a bucket and a 2" pump. The bucket and pump created a negative pressure differential between the interior and exterior of the bucket, forcing displaced water to the 2" pump which discharged into 1,000-liter totes and was neutralized with CO₂ near the intake structure (**Error! Reference source not found.**). To deter fish from entering the work area, CE installed a bubble curtain 5 meters away from the work area. Crews also installed a CO₂ diffuser to mitigate elevated pH water if the negative pressure gradient failed to remove contaminated water. On May 6, the IEM observed pH readings exceeding BCWQG (pH = 9.04 – 9.16, for four minutes) associated with the underwater grouting activities. The IEM immediately turned on the CO₂ diffuser and pH values returned to allowable levels quickly. The cause of the elevated pH is unknown, but underwater visibility was very poor and the divers were likely unaware that grout was temporally seeping out of a void between the protective matting and concrete slab.

Photo 9 – Rubber Protective matting with angle iron and grouting ports to be installed on the ULRHEF sluiceway slab (May 5, 2017).

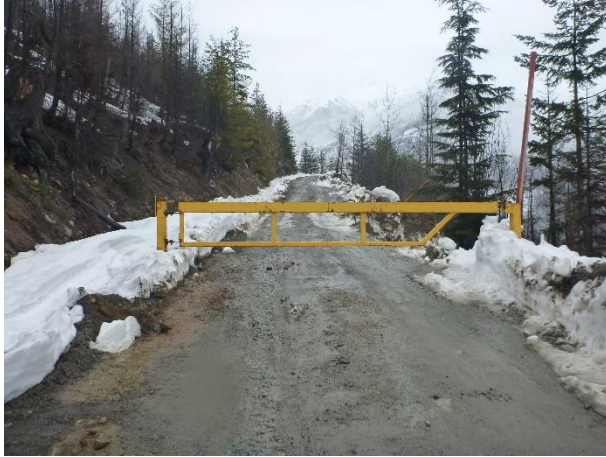
Photo 10 – BDRHEF road ploughing and closed mountain goat gate (May 2, 2017)

- On May 1, CE plowed the BDRHEF intake access road (**Error! Reference source not found.**). The IEM inspected these works and did not observe any environment issues. The IEM also reminded all construction staff that the mountain goat gate at KM3 must remain closed until June 15 to prevent public access within the UWR.

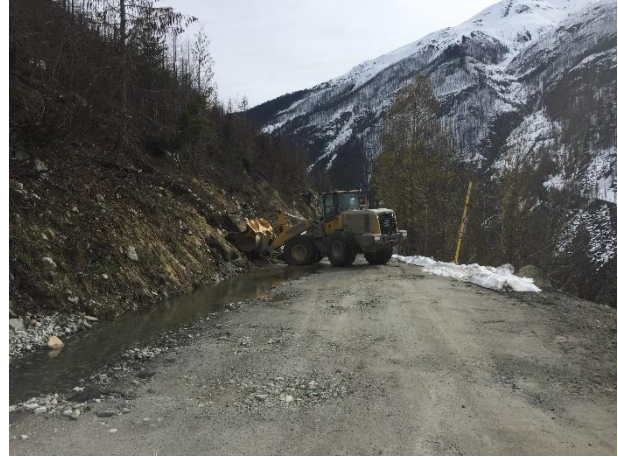
Photo 11 – Ditch maintenance on the BDRHEF intake access road (May 9, 2017)

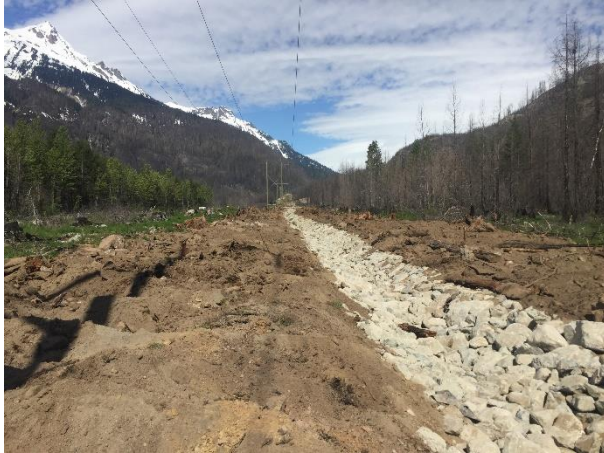
- CE completed drainage works and restoration under the powerlines from the BDRHEF powerhouse to the intake access road (Photo 12). CE provided an update to the design of the drainage ditch that was installed that bisects six identified ephemeral drainage paths along the conduit alignment between the BRDHEF intake access road and the BDRHEF powerhouse. CE completed all repairs to the drainage system including: armoring the ditch and the 6 ephemeral channels the empty to the newly constructed ditch, and installed an upgraded culvert on the Lillooet River FSR. These works were completed on May 18 and ITM ULR#63 is therefore considered closed.

Photo 12 – Completed drainage and restoration under the transmission lines from BDRHEF powerhouse to the intake access road (May 22, 2017)
