Upper Lillooet Hydro Project

Final Environmental Monitoring Report #115

Reporting Period: June 1 – November 30, 2017

Upper Lillooet River Hydroelectric Facility (Water File No. 2002561, Water Licence No. C130613), Boulder Creek Hydroelectric Facility (Water File No. 2003049, Water Licence No. C129969) & Transmission Line (TX Line)

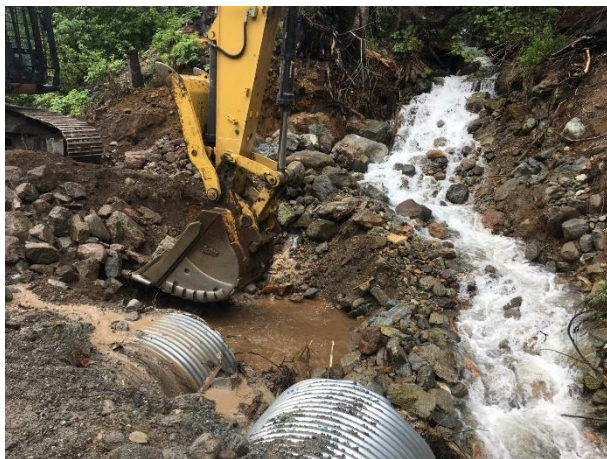
Photo 1 – Excavation and armouring of the KM41.2 culvert inlets with the majority of flow diverted (June 2, 2017).

- On June 2, CE completed maintenance of the KM41.2 culvert under the supervision of Ecofish. Ecofish conducted a CTF salvage of the works area, prior to the start of works. No CTF were observed or captured during the salvage operation. To repair the culvert inlets, water was diverted to river left culvert first, which allow excavation and rock armouring of the river right and center culverts to proceed in isolation of the majority of the flow (Photo 1). Once this work was completed, CE diverted flow to these newly repaired culverts which allow the remaining rock armouring and culvert repair on river left to be completed in the absence of the majority of the flow. Ecofish monitored water quality throughout the works. Temporary pulses of turbid water were generated during the flow diversions, resulting in temporary exceedance of BCWQGs for a period of less than two hours (maximum turbidity = 804AU), and works were complete in under three hours (Photo 2). Detailed water quality results are available upon request.

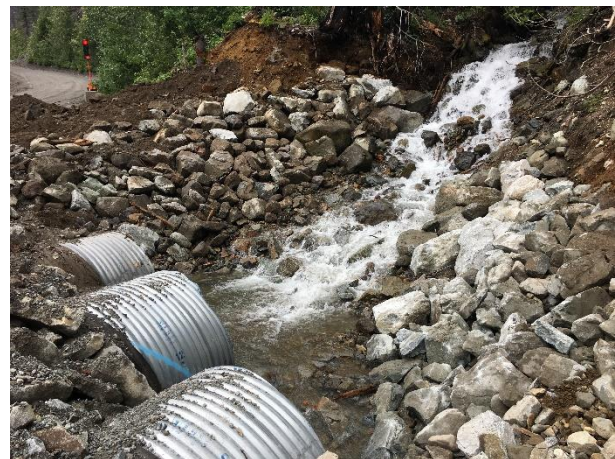
Photo 2 – Completed excavation and rock armouring of the KM41.2 culvert inlets (June 2, 2017).

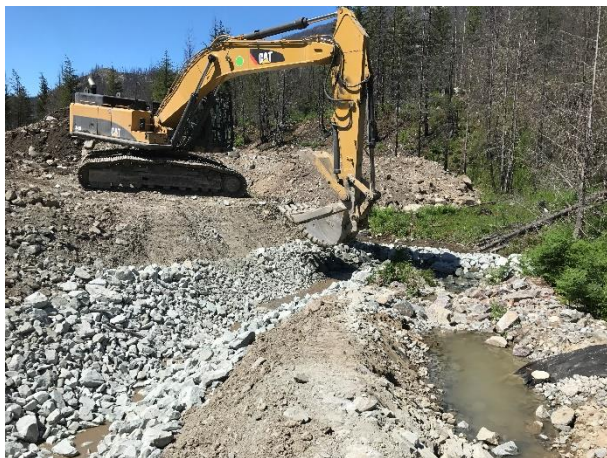
Photo 3 – Drainage tie-in at the completed BDRHEF powerhouse drainage ditch. All water infiltrated to ground and no surface water discharged offsite (June 22, 2017).

- On June 22, CE completed construction of the BDRHEF powerhouse access road drainage and performed a wet connection to the BDRHEF tunnel seepage ditch under IEM supervision (Photo 3). All water continues to infiltrate to ground within the rock armoured drainage ditch and to water quality concerns were noted.

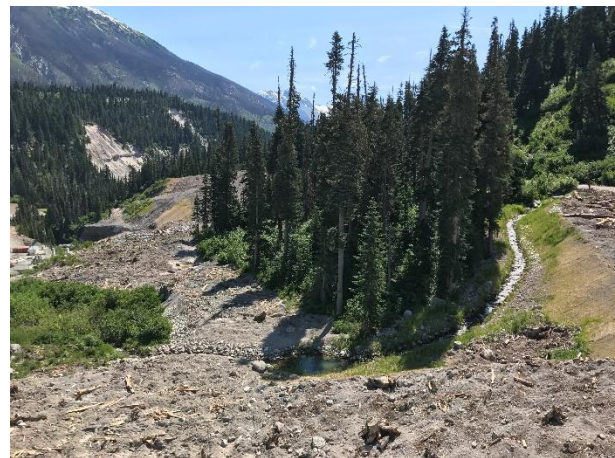
Photo 4 – Overview of the final condition of the ULRHEF intake river right area (July 14, 2017).

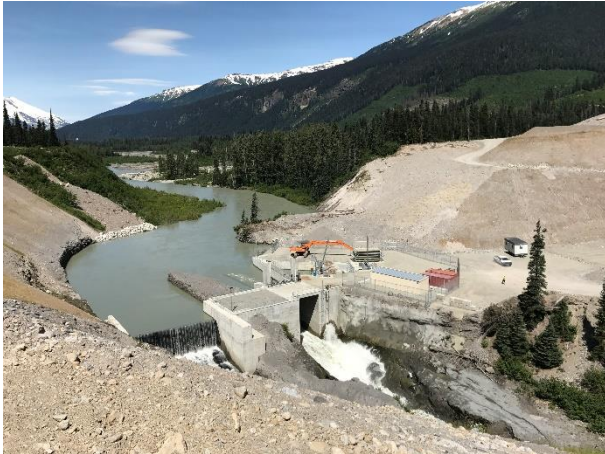
Photo 5 – Overview of the final condition of the ULRHEF intake river left area, slopes have been planted (July 14, 2017).

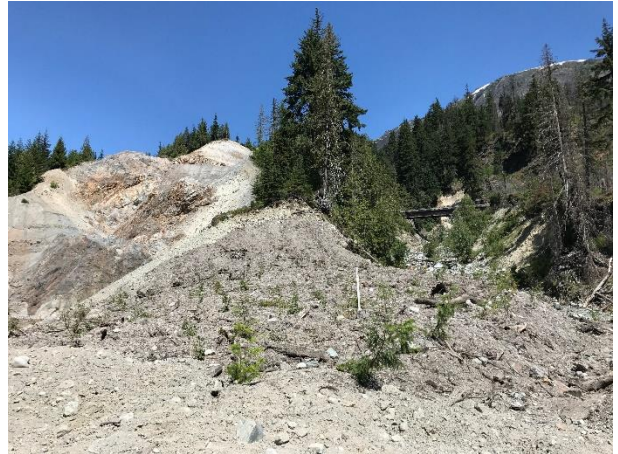
Photo 6 – Final condition of the ULRHEF downstream tunnel portal and Truckwash Creek Mountain goat migration corridor and riparian area (July 14, 2017).

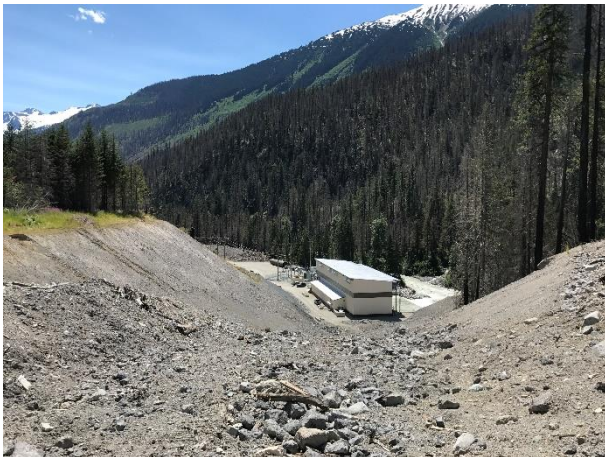
Photo 7 – Final condition of penstock leading to ULRHEF powerhouse. Alder seed has been spread (July 14, 2017).

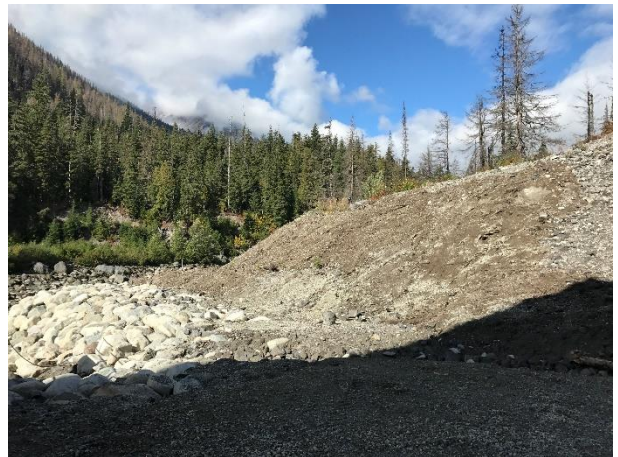
Photo 8 – Final condition of the ULRHEF powerhouse riparian area. The area has been planted (September 22, 2017).

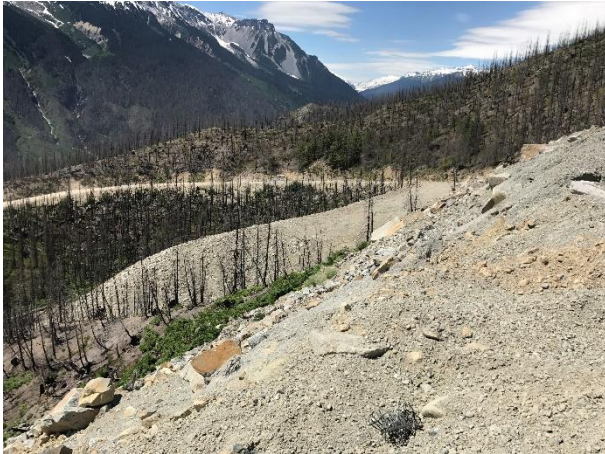
Photo 9 – Final condition of the two main BDRHEF intake spoil areas. Alder seed has been spread (July 14, 2017).

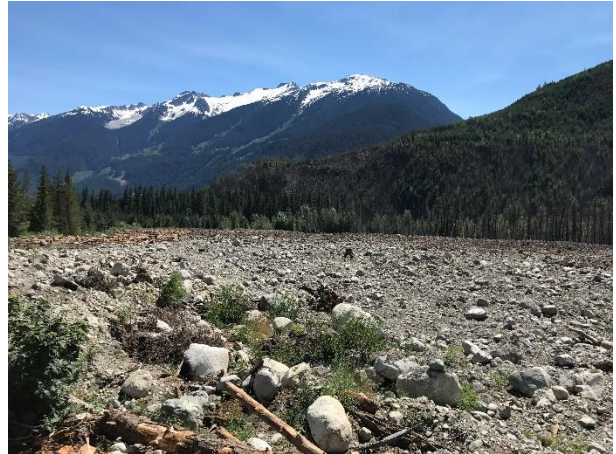
Photo 10 – Final condition of the KM38 laydown area (July 14, 2017)

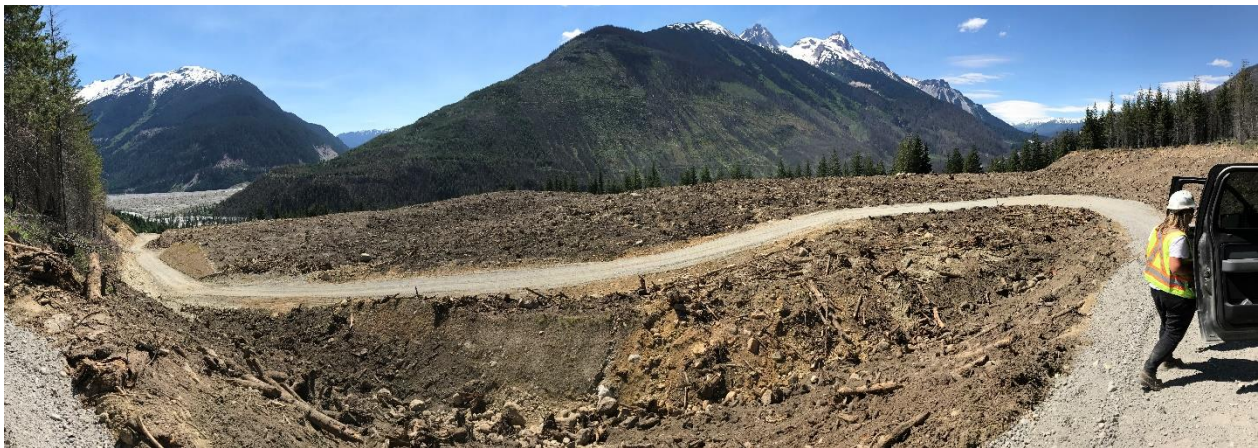
Photo 11 – Final condition of the ULHP construction camp area following reclamation (July 14, 2017).

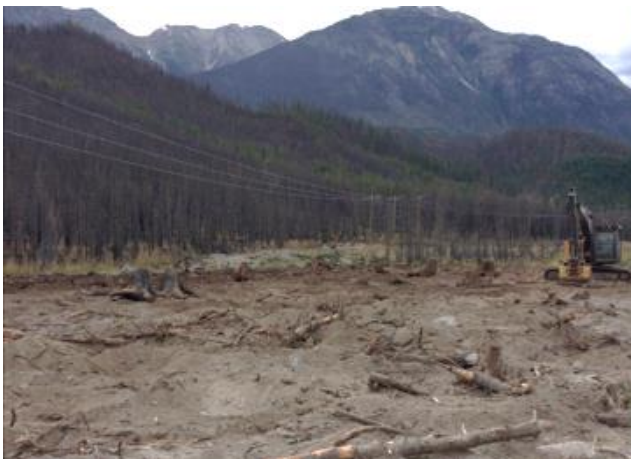
Photo 12 – Final reclamation of the KM39.5 laydown (September 2, 2017)

River FSR). It was determined that WEL would be completing reclamation of this area at a later date. Following the inspection the IEM requested supporting documentation to confirm that all reclamation activities had been completed according to the ULHP Master Reclamation Plan – Revision 4. The IEM received supporting documentation confirming that reclamation of the BDRHEF and ULRHEF was completed on July 28. Confirmation of the completion of final reclamation of the KM39.5 laydown was provided to the IEM on September 2 (Photo 12– Final reclamation of the KM39.5 laydown (September 2, 2017)).

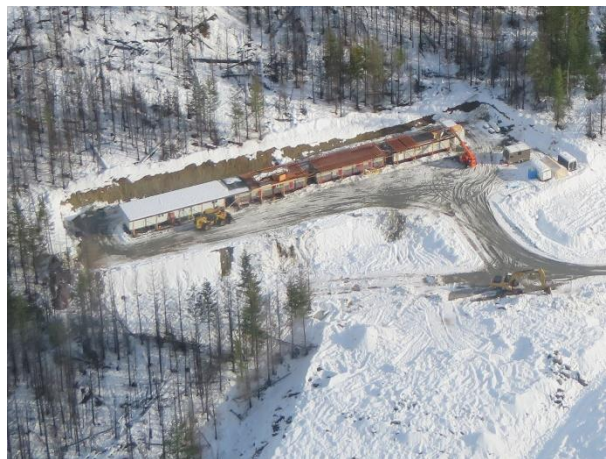
Photo 13 – Completed residence (November 16, 2017).

- Construction of the Operators residence began following issuance of the OLTC (L49818 amendment 5) obtained to allow clearing of the site footprint. Following a pre-work meeting and based on a review of the site conditions and lack of environmental sensitivities, the IEM determined that full time monitoring of construction of the Operators residence would not be required as works presented low environmental risk. Opportunistic monitoring of the area occurred and no environmental concerns were noted (Photo 13).

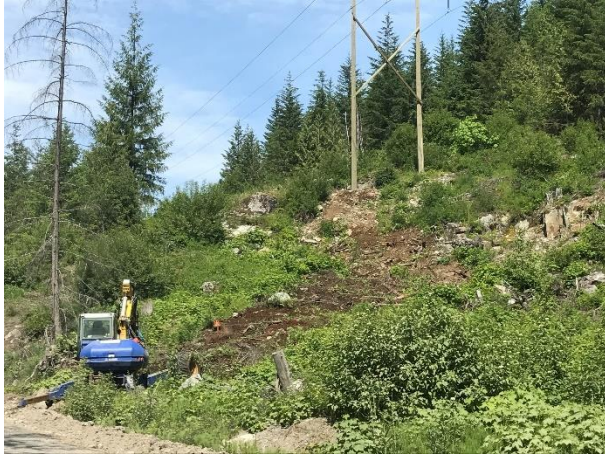
Photo 14 – Typical access road reclamation works in the North Zone (KM23 of the Lillooet River FSR; June 7, 2017).

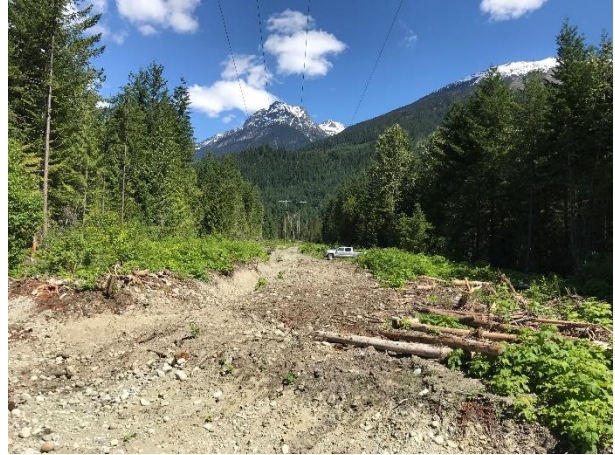
Photo 15 – Access road seasonal deactivation and reclamation (Segment 5 near the Lillooet River crossing; June 22, 2017).

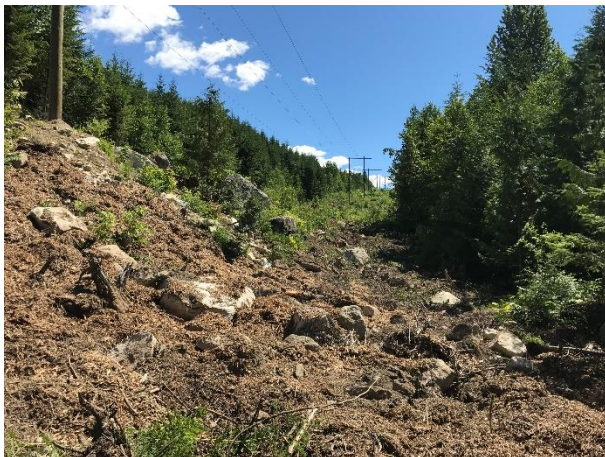
Photo 16 – Access road reclamation (spur at KM29 of the Lillooet River FSR; June 22, 2017).

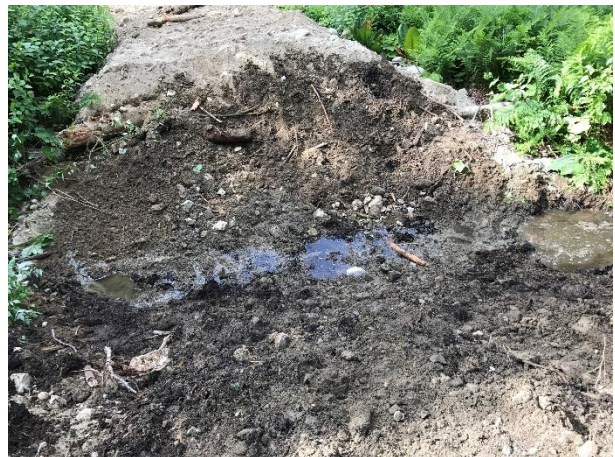
Photo 17 – Reclamation of the 185.1 access road in Segment 8 following culvert removal. Minimal flow infiltrated to ground following culvert removal (July 7, 2017).

- On July 7, the IEM monitored the removal of three temporary culverts (non-fish bearing & non-CTF bearing streams) and the permanent deactivation of two spur roads (184.1 and 185.1). Water quality monitoring was performed throughout the works, which were performed according to best management practices. Minimal flow was present during the removal of the culvert on access road 185.1 and the second culvert on access road 184.1, and works were completed without affecting downstream water quality, as water infiltrated into ground following removal of the culverts (Photo 17 & 18). The removal of the 600mm CSP on access road 184.1 required pumps to divert flow around the work area during the

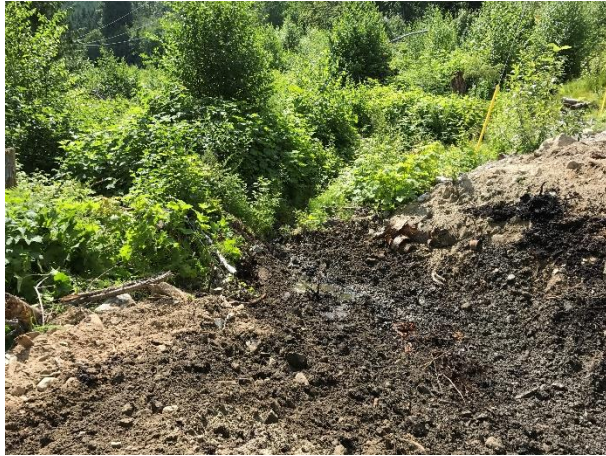
Photo 18 – Reclamation of the 184.1 access road in Segment 8 following removal of the smaller of the two culverts. Minimal flow infiltrated to ground following culvert removal (July 7, 2017).

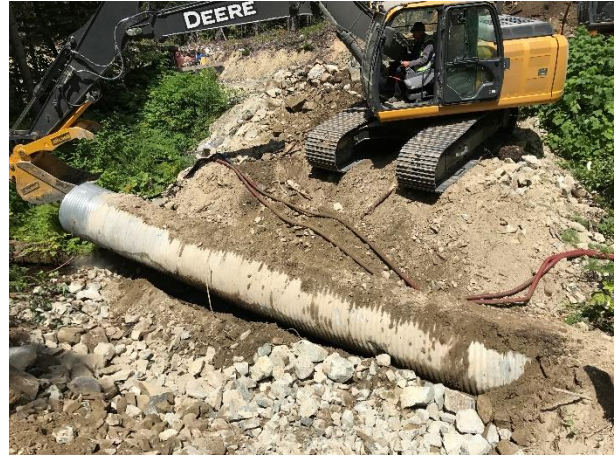
Photo 19 – Removal of the 600mm CSP culvert on the 184.1 access road in Segment 8 with bypass pumps in place (July 7, 2017).

culvert removal (Photo 19 & 20). A temporary pulse of turbid water was generated during removal of the culvert and rock armouring of the channel. The temporary pulse occurred as some water bypassed the pumps and flowed through the work area once the culvert was removed. The temporary pulse of turbid water resulted a temporary exceedance of BCWQGs (duration = <25 minutes; max turbidity = 1076 AU). No lasting environmental impacts are expected to have resulted as a result of the temporary increase in turbidity.

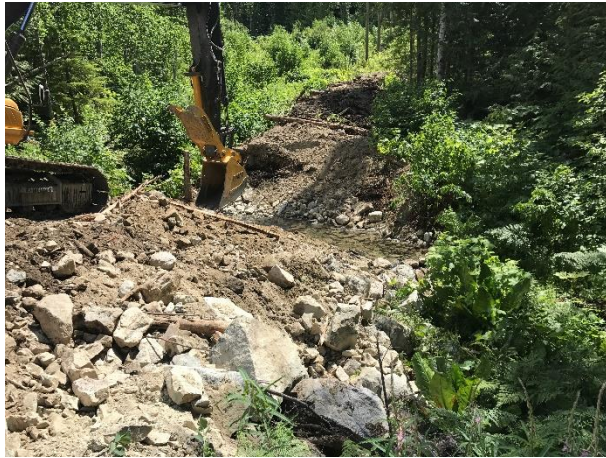
Photo 20 – Conditions ~30 minutes following the removal of the second culvert on the 184.1 access road in Segment 8 with bypass pumps removed and water flowing clear (July 7, 2017).

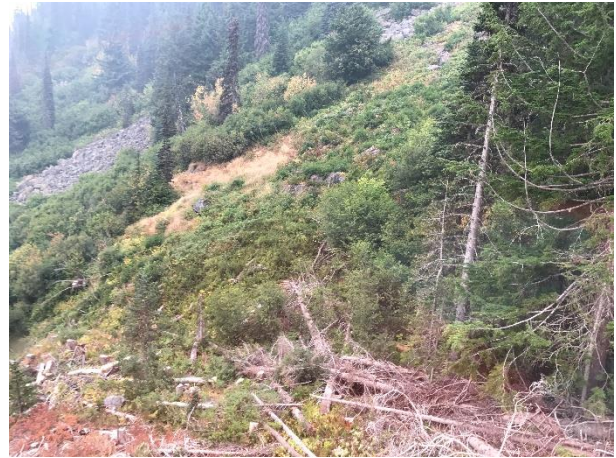
Photo 21 – Conditions within GB59 as seen from the helipad location during the overflight assessment. Note: Fall conditions have not yet arrived (September 6, 2017)

- On September 6, the IEM participated in a helicopter overflight assessment to inspect conditions at 7 permanent helicopter landing pad locations. The helipad location closest to structure 376 in Segment 15 was assessed to determine whether an adaptive management approach could be developed to permit the construction of the helicopter pad, while minimizing the potential to displace grizzly bears from utilizing the GB59 fall forage habitat. As the helipad was not located within the GB59 polygon, no clearing was required, and conditions typical of fall were not yet apparent (Photo 21), the IEM determined works could proceed provided helicopter flights to and from the area were minimized to the extent possible, and that all flights followed a pre-determined flight path agreed upon during the overflight assessment. No grizzly bears were observed within GB59 or in the surrounding area during the overflight assessment. As outlined in the work plan, all grizzly bear sightings were to be reported to the IEM immediately and work was to cease in the area until further direction was provided by the IEM. Based on the proposed mitigation measures and the works required to install the helipads the IEM determined that monitoring would not be required. Installation of the helipad near structure 376 was completed by September 15, and no grizzly bear sightings were reported during the works.

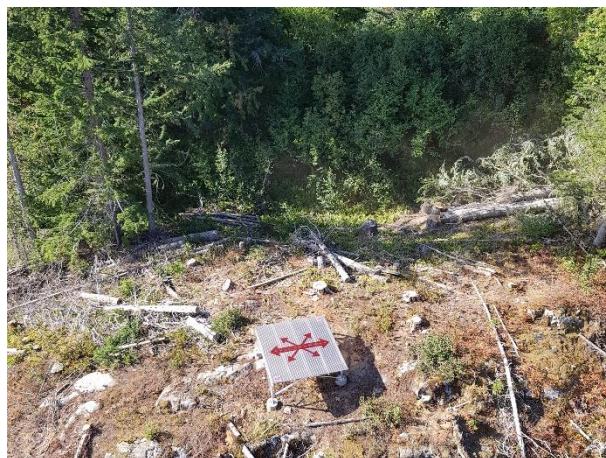
Photo 22 – Helipad H376 final condition (September 15, 2017).

- The installation of 7 helicopter landing pads were completed by the end of November 2017. These activities posed low environmental risk and were completed according to the IEM and IE approved work plan and within project approved timing windows (Photo 22).
