Alena Creek Fish Habitat Enhancement Project

Year 1 Monitoring Report

Upper Lillooet River Power Limited Partnership
200 – 666 Burrard Street
Vancouver, BC, V6C 2X8

Ecofish Research Ltd.

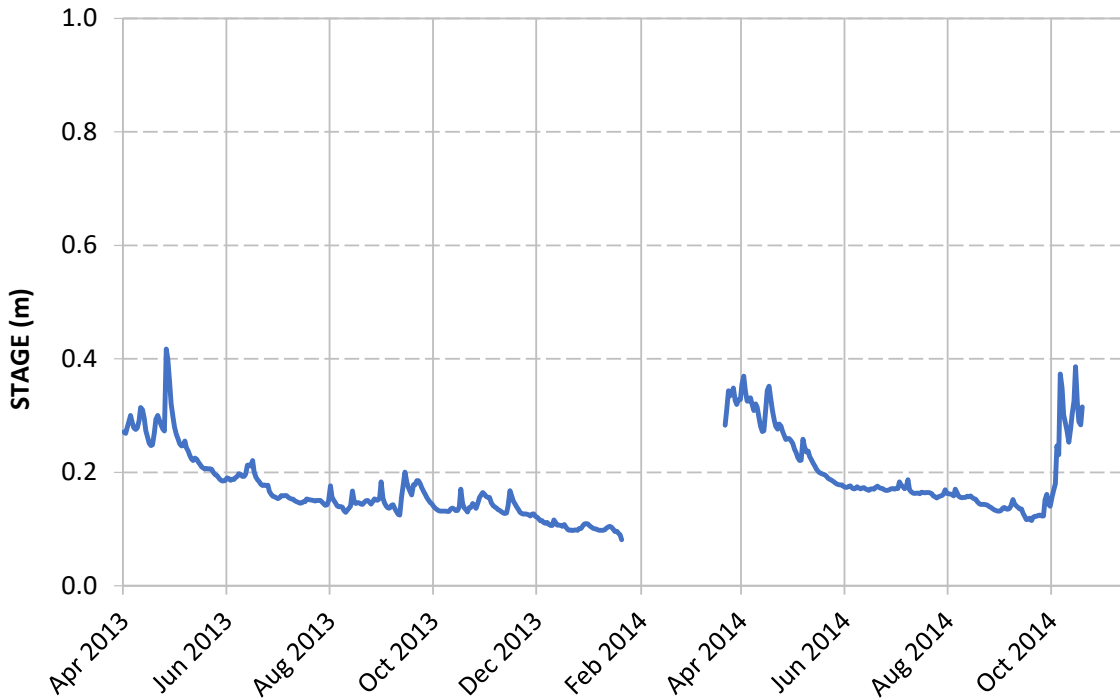
Figure 1. Stage in Alena Creek at the Lillooet River FSR bridge during a) baseline (Apr 2013 to Nov 2014) and b) year 1 monitoring (Nov 2016 to Oct 2017).

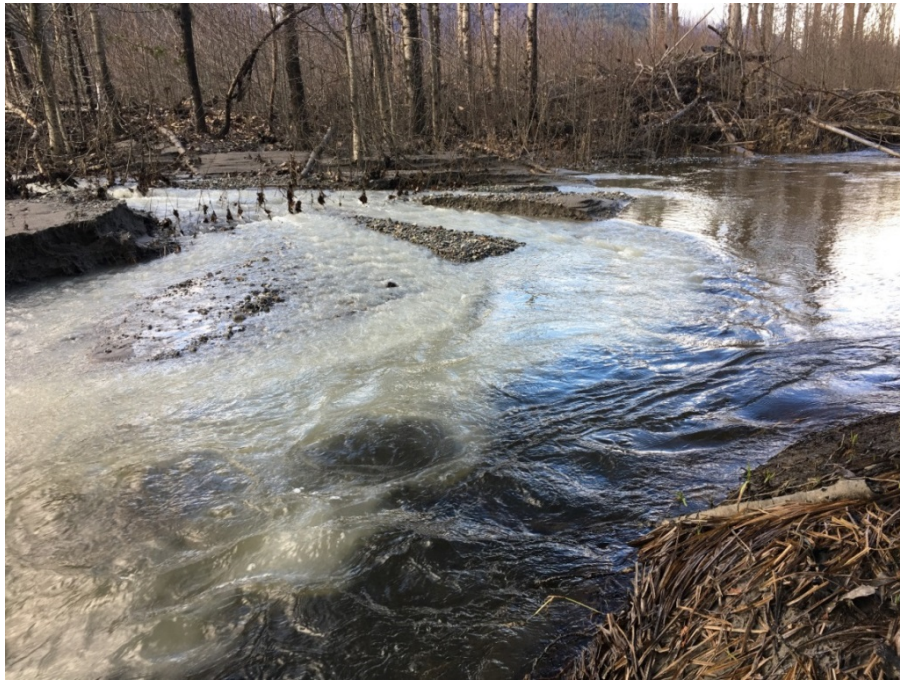
Figure 2. Looking upstream at a newly formed side channel of the Upper Lillooet River entering Alena Creek approximately 25 m downstream of the Lillooet FSR Bridge on November 14, 2016.

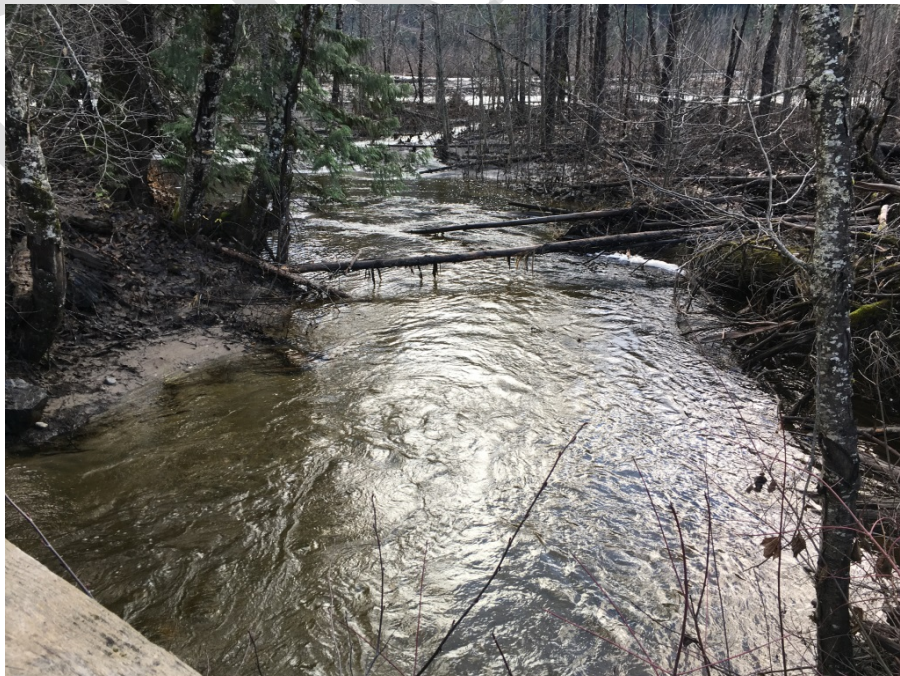
Figure 3. Looking downstream at Alena Creek from the Lillooet River FSR bridge in November 2016. The new Upper Lillooet River side channel is visible on river right.

To account for the backwatering of the gauge at the FSR bridge over Alena Creek when flows in the Upper Lillooet River are high, and to ensure the stage data collected are representative of Alena Creek water levels, we recommend moving the gauge upstream.

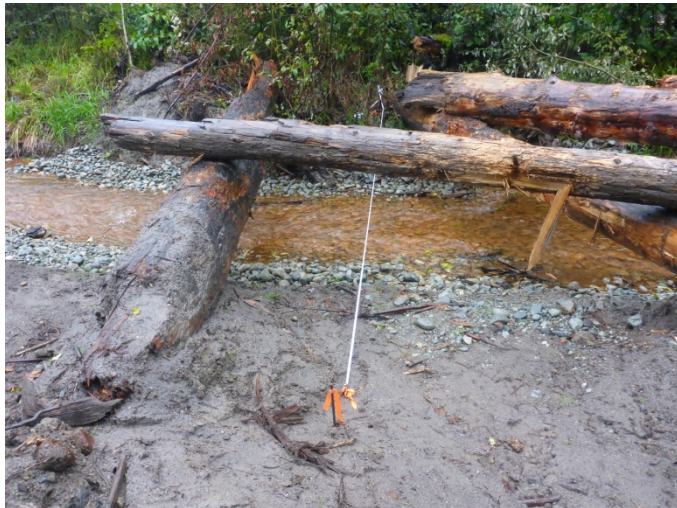
Figure 8. Looking RR-RL at ALE-XS1 on Sep 19, 2016.

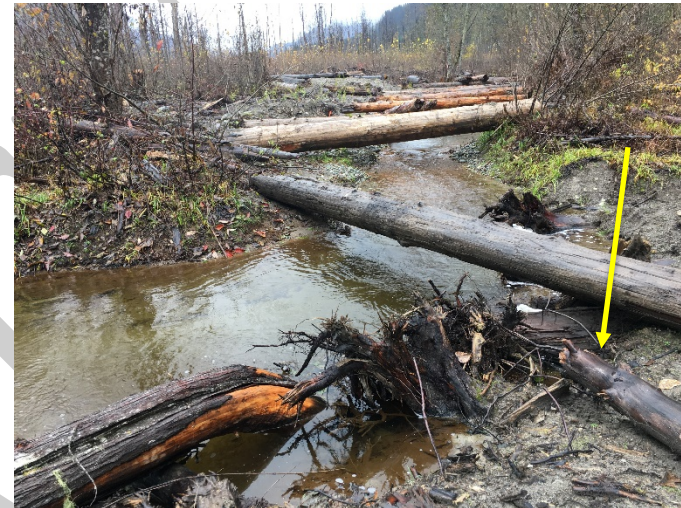
Figure 10. Looking upstream at bend at installed rootwads on Oct 26, 2016.

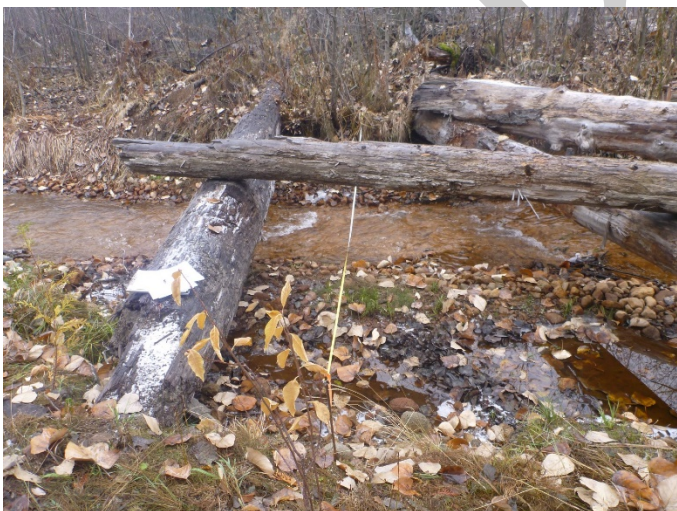
Figure 9. Looking RL-RR at ALE-XS1 on Nov 10, 2017.

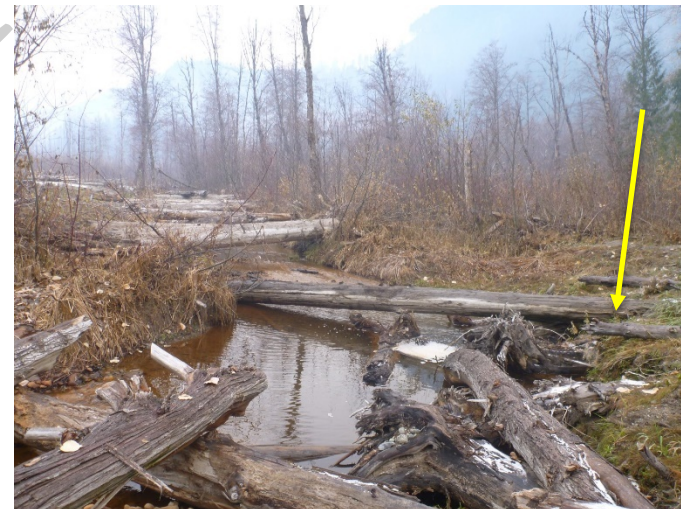
Figure 11. Looking upstream at bend at installed rootwads where bank has eroded on Nov 10, 2017.

A total of 668 m² of new instream habitat and 1,139 m² of floodplain was created in the upstream enhanced reach, Reach 3. Twelve cobble riffles were installed with over 100 pieces of large woody debris. The high-water flood event in 2016 had a greater impact to the habitat features in Reach 3 than Reach 1; however, as in Reach 1, it has not diminished the overall function or usability of the constructed habitat. Three of the four surveyed cross-sections show evidence of erosion and deposition which has caused widening and some bank instability. We recommend undertaking repairs during the least risk timing window in August 2018. All repairs can be completed by a hand. All areas experiencing bank erosion should be stabilized using materials like cobble and small boulders; willow and red-osier stakes should also be planted at select bank sites to aid in short-term stability.

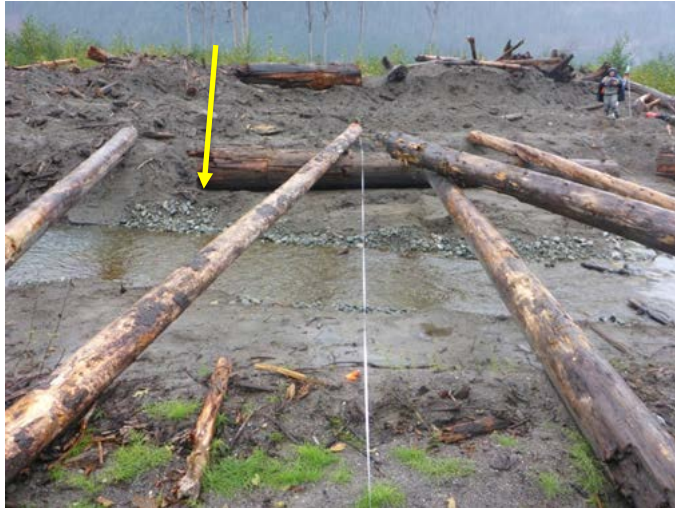
Figure 13. Looking RL-RR at ALE-XS5 on Sep 19, 2016.
Note wetted width at yellow arrow.

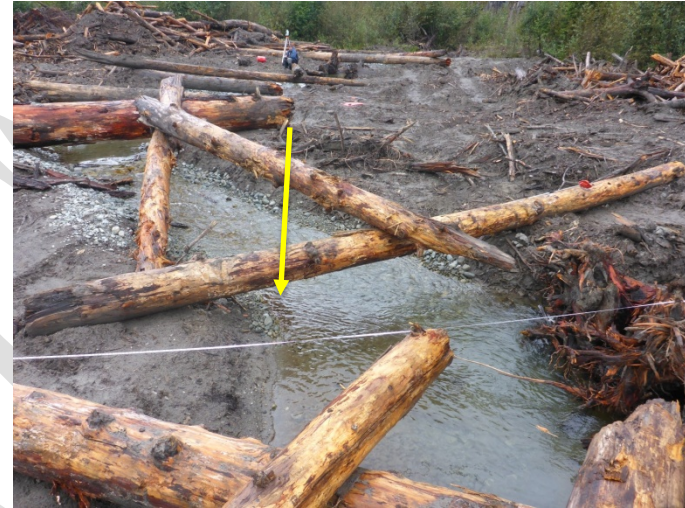
Figure 15. Looking upstream at riffle crest (0+185, Reach 3) on Sep 16, 2016.

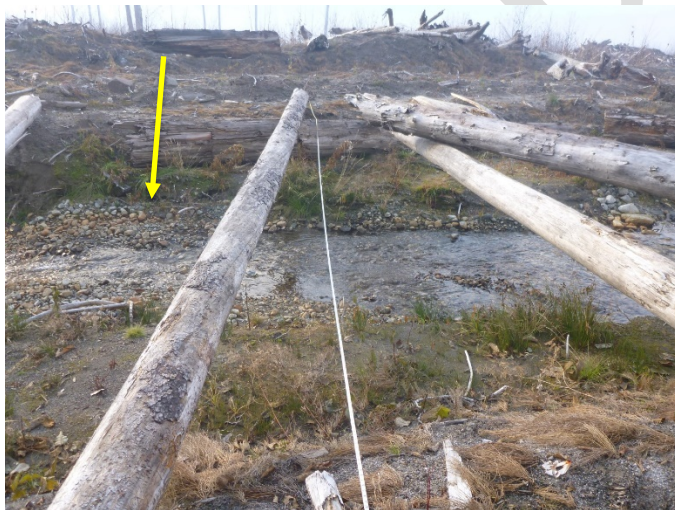
Figure 14. Looking RL-RR at ALE-XS5 on Nov 10, 2017.
Note wetted width at yellow arrow.

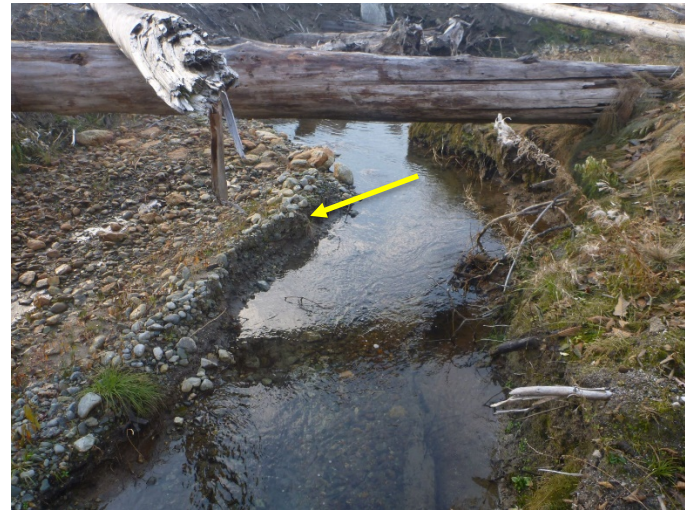
Figure 16. Looking upstream at riffle crest (0+185, Reach 3) at right bank erosion on Nov 10, 2017.

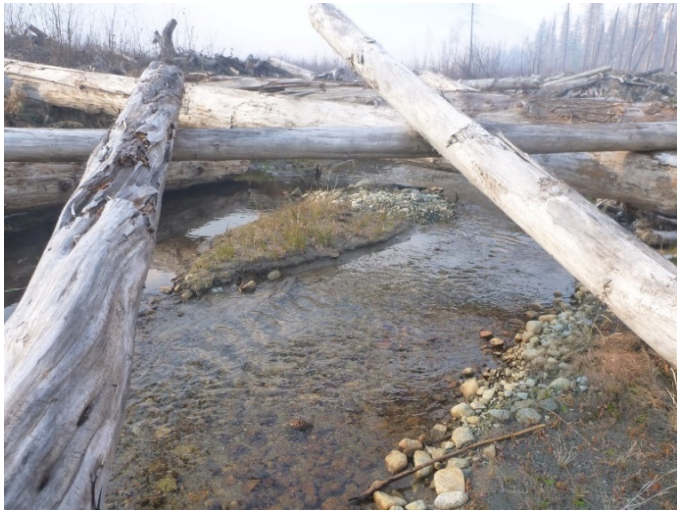
Figure 17. Looking upstream of ALE-XS6 at the formation of a mid-channel bar on Nov 10, 2017.

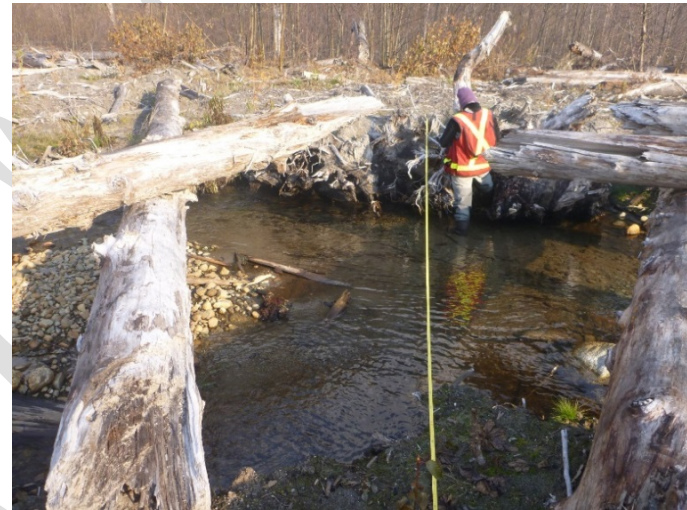
Figure 19. Looking RR-RL at ALE-XS7 on Nov 10, 2017. Note upstream mid-channel bar formation.

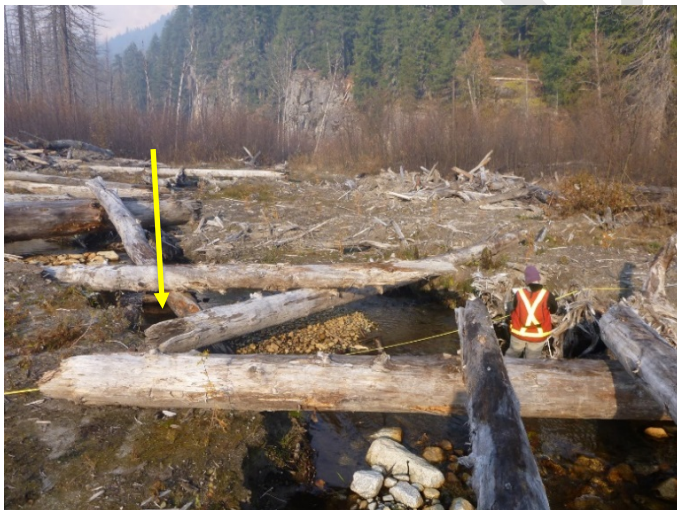
Figure 18. Looking upstream of ALE-XS6 at the formation of a mid-channel bar on Nov 10, 2017.

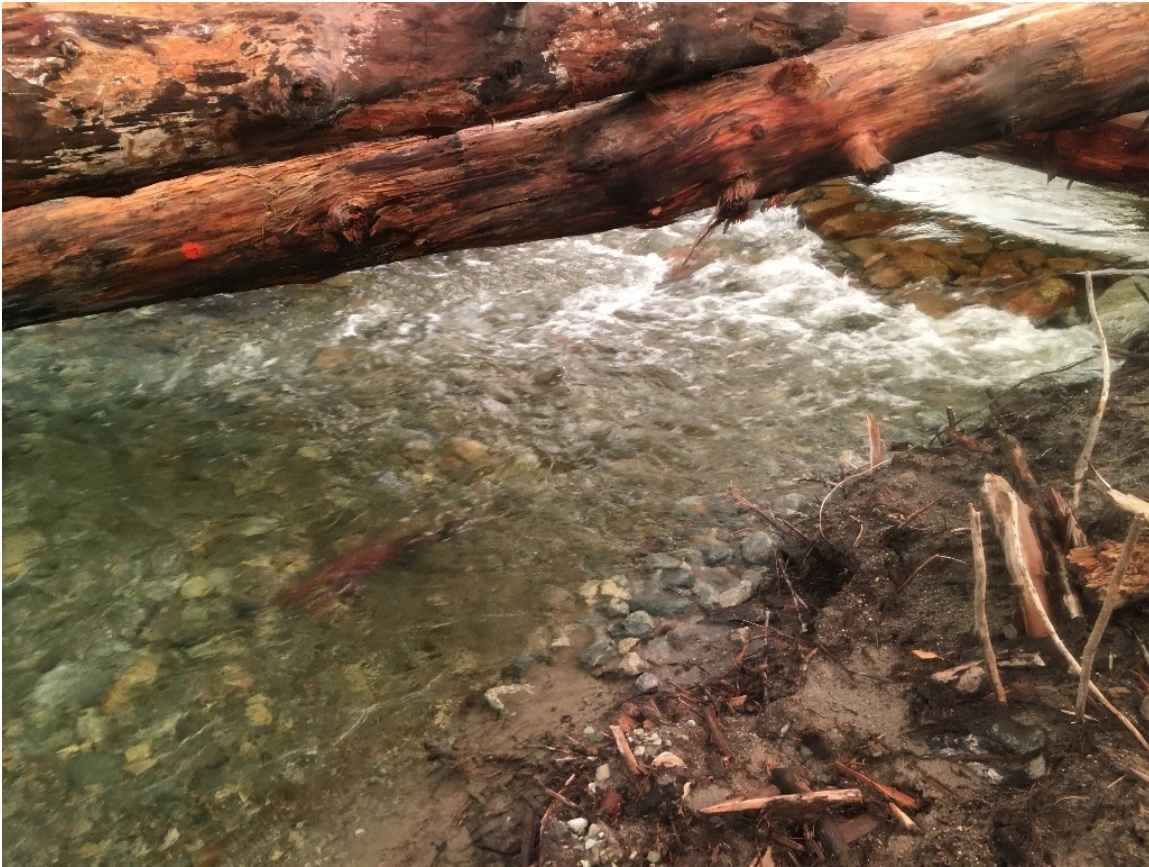
Figure 21. Spawning Coho Salmon observed spawning in enhanced habitat on November 14, 2016.

Observations of Coho Salmon during fall spawner surveys were made in 2016 (Table 26) and 2017 (Table 27). In both years, the peak counts of adult spawning Coho Salmon (Figure 21) were greater than 100 individuals, with the peak count in 2017 being the same as that observed in 2011 during the baseline period (Table 27). In contrast, the peak count in 2016 was 174, which represents a notable increase in the number of spawners compared to the two baseline years and 2017. A comparison of the 2016 and 2017 results also highlights the variability in run timing between years, with the peak count recorded on November 14, 2016 and similarly high numbers two weeks later (November 27), whereas the peak count in 2017 was observed on November 26. Although surveys are not conducted at a frequency to allow total spawner abundance to be compared among years, and peak counts may be influenced by survey timing and spawner residence time and predation, the counts nevertheless provide an indication of use and demonstrate that Alena Creek supports equivalent or greater use by Coho spawners relative to pre-enhancement.

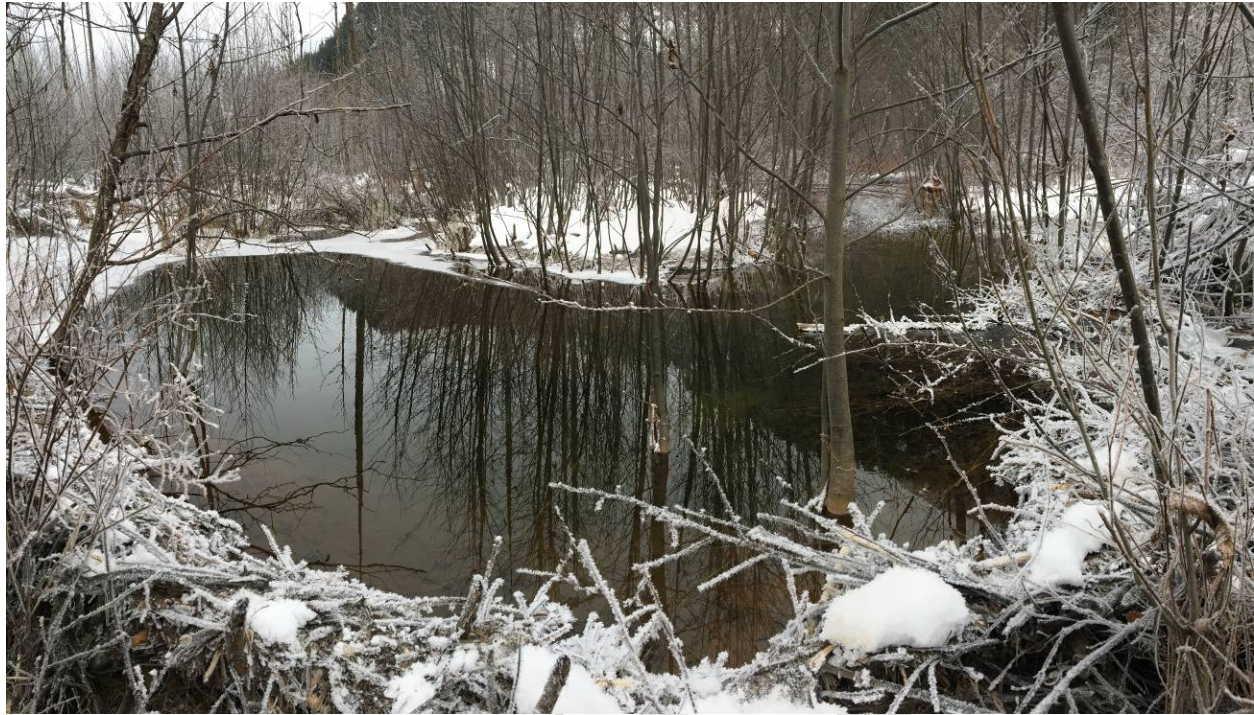
Beaver activity has created significant damming upstream of both Reach 1 and Reach 3. This activity has not affected either of the constructed reaches to date; however, the backwatered areas and new channel formation has the potential to affect both constructed reaches in the future. For example, immediately upstream of ALE-XS8, a new side channel has formed that has the potential to create erosion at this site if it becomes more established.

Figure 32. Panoramic view looking upstream at the primary dam 100 m upstream of Reach 1 on December 9, 2016.

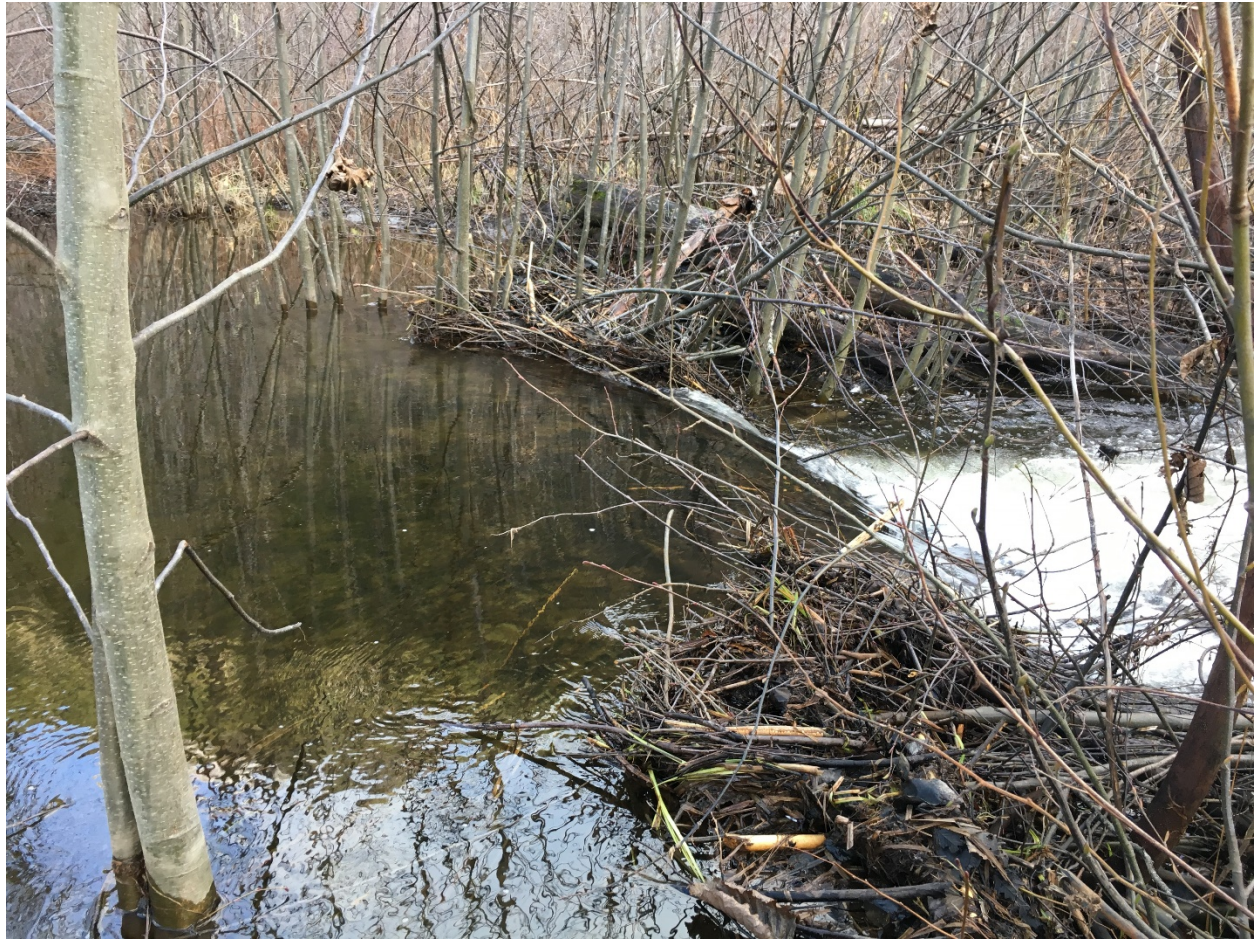
Figure 33. Looking river right to left at the dam 100 m upstream of Reach 1 showing sufficient overflow to allow Coho Salmon migration on November 10, 2016.

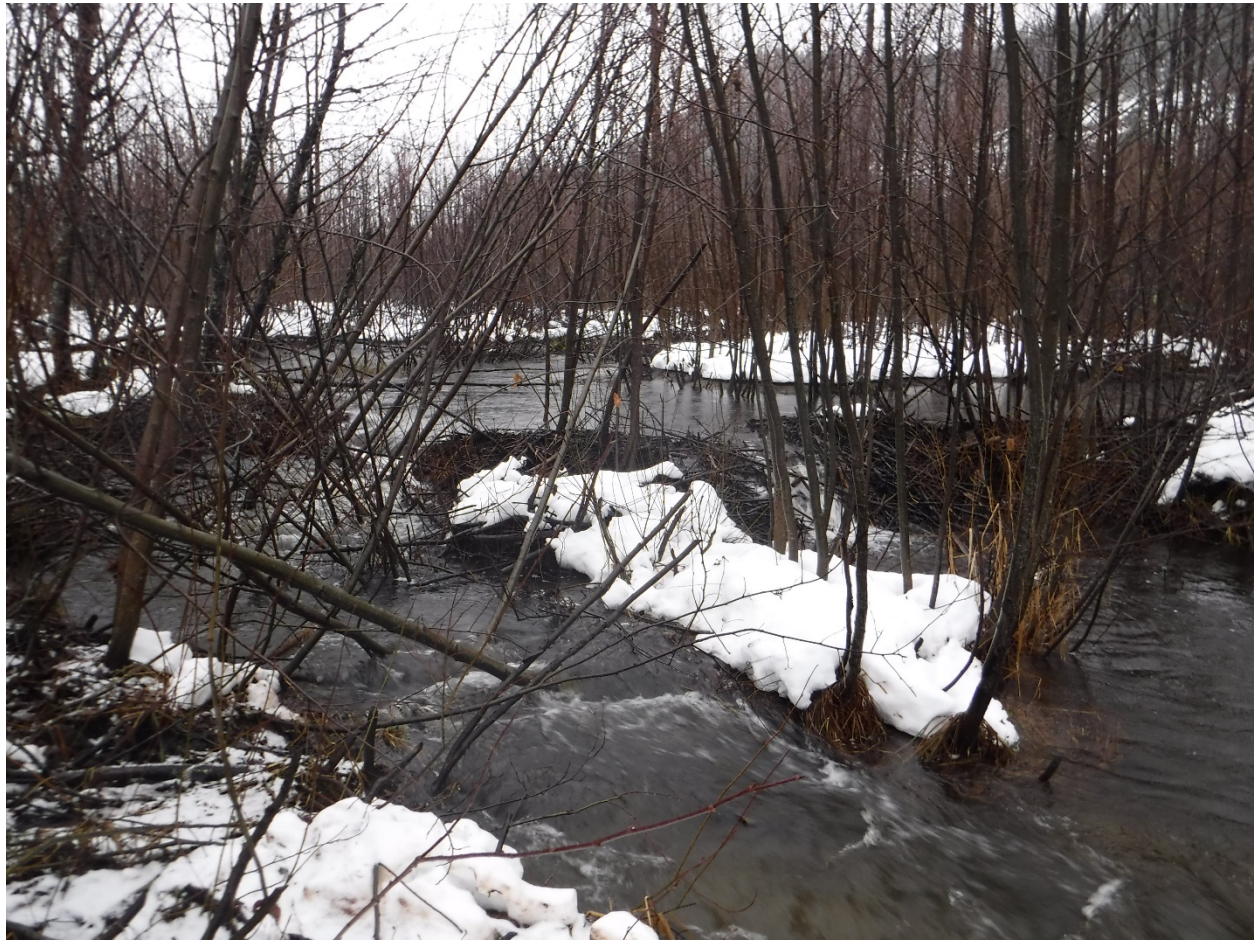
Figure 34. Looking upstream at the primary dam 100 m upstream of Reach 1 showing the formation of a new channel on river right (photo left) on November 26, 2017.

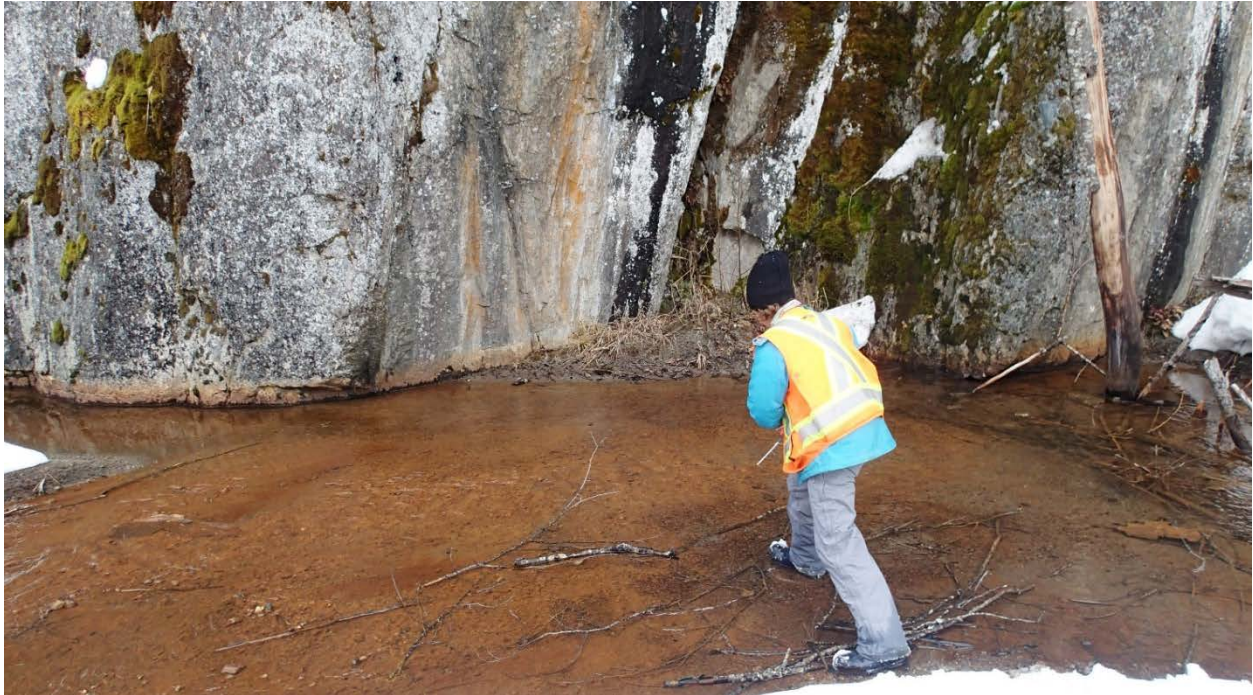
The beaver dam activity affected habitat availability and/or accessibility to all of the six minnow trap sites. The backwatering resulted in a significant increase in the amount of rearing habitat available, but also restricted movement under the flow conditions observed at the time of minnow trapping. The restriction of downstream movement may have contributed to the reduced number of Coho captured in the enhanced Reach 1 compared to baseline sampling. Cutthroat would have been equally affected by the large dams which would have restricted movement by spawning adults and

Figure 35. Comparison of water levels at ALE-MT05 site on a) February 27, 2014 and b) November 10, 2017.

Based on these habitat changes, we recommend adjusting and increasing the sites minnow trapped in September 2018 (Section 5.4).

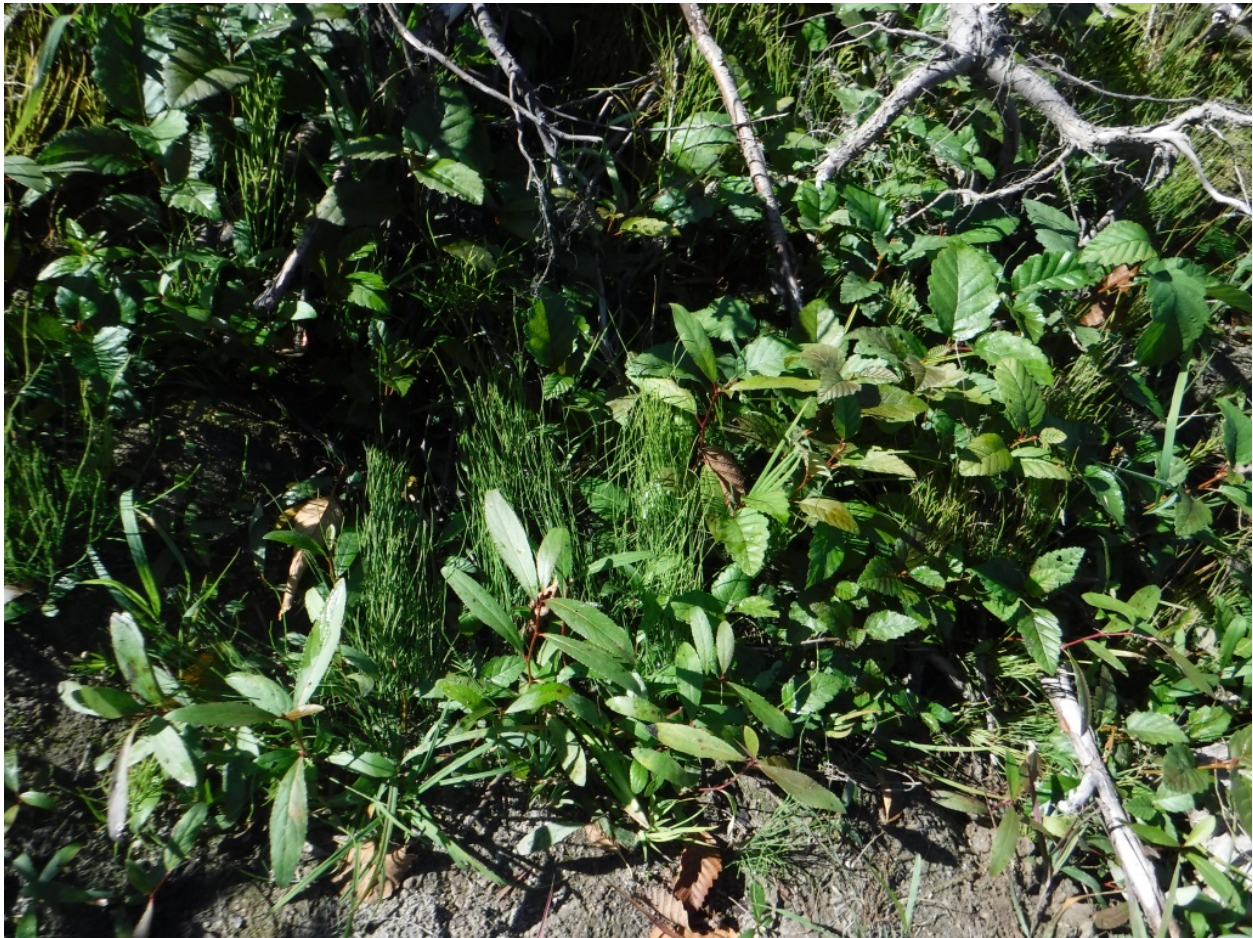
Figure 36. Natural regeneration observed at ALE-PRM07. Photo is representative of vigorous re-establishment of red alder and black cottonwood, within the Alena Creek FHEP, on October 5, 2017.

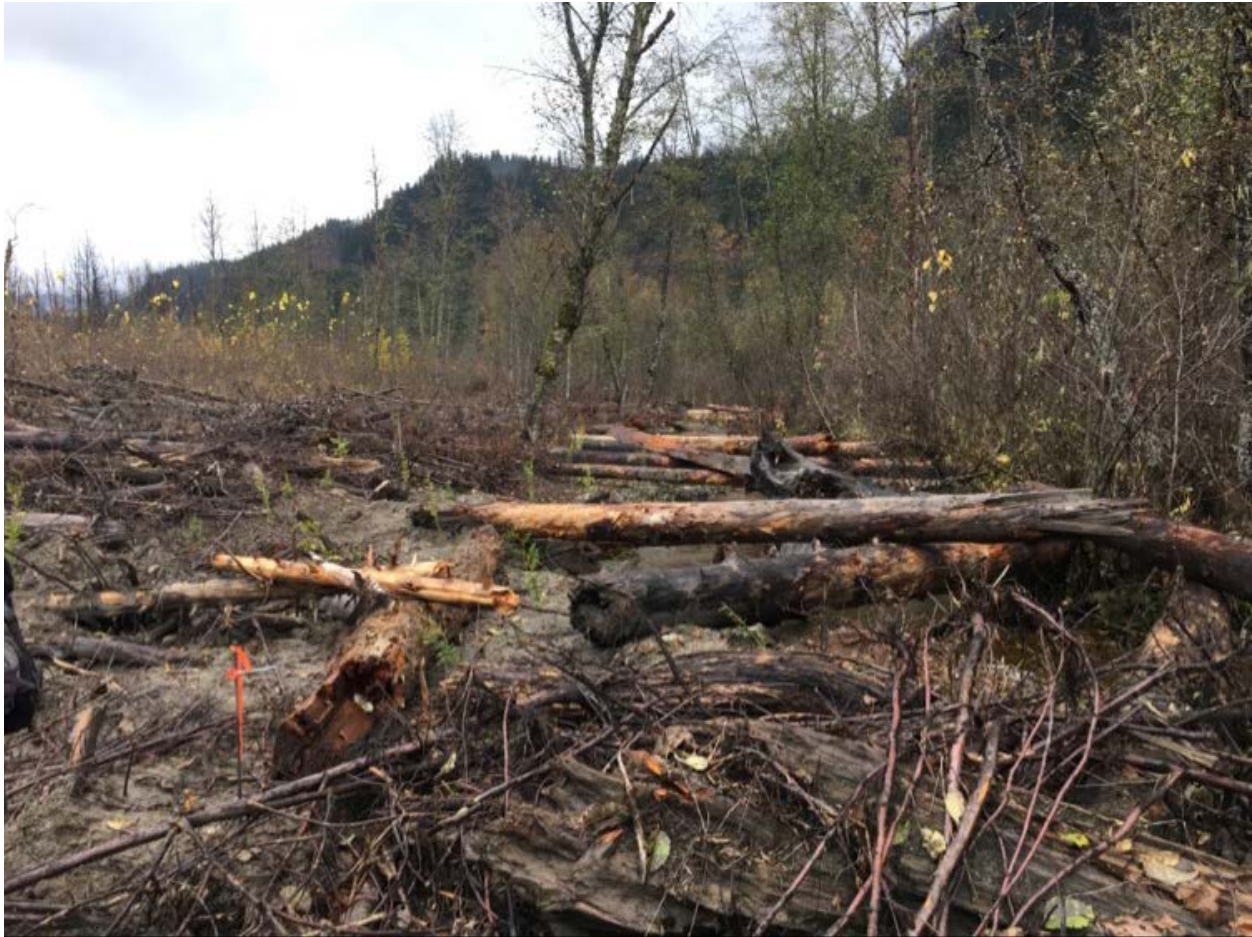
Figure 37. Photo of ALE-PRM07 after the implementation of riparian restoration works, on October 25, 2016.

Between 2016 and 2017, vigorous regeneration of black cottonwood and red alder was observed (Figure 36). These floodplain pioneer species, with high initial growth rates, rapidly recolonized and infilling the compensation area (Figure 36, Figure 37, Appendix J). The estimated density for the four monitoring plots increased to $43,200 \pm 36,210$ stems/ha, with 90% certainty that the density of trees and shrubs ranges from 6,900 to 79,410 stems/ha (Table 36, Table 38). The DFO and MELP (1998) guided revegetation effectiveness target of 2,309 stems/ha was exceeded within all four permanent vegetation monitoring plots in 2016 and 2017 (Table 36).

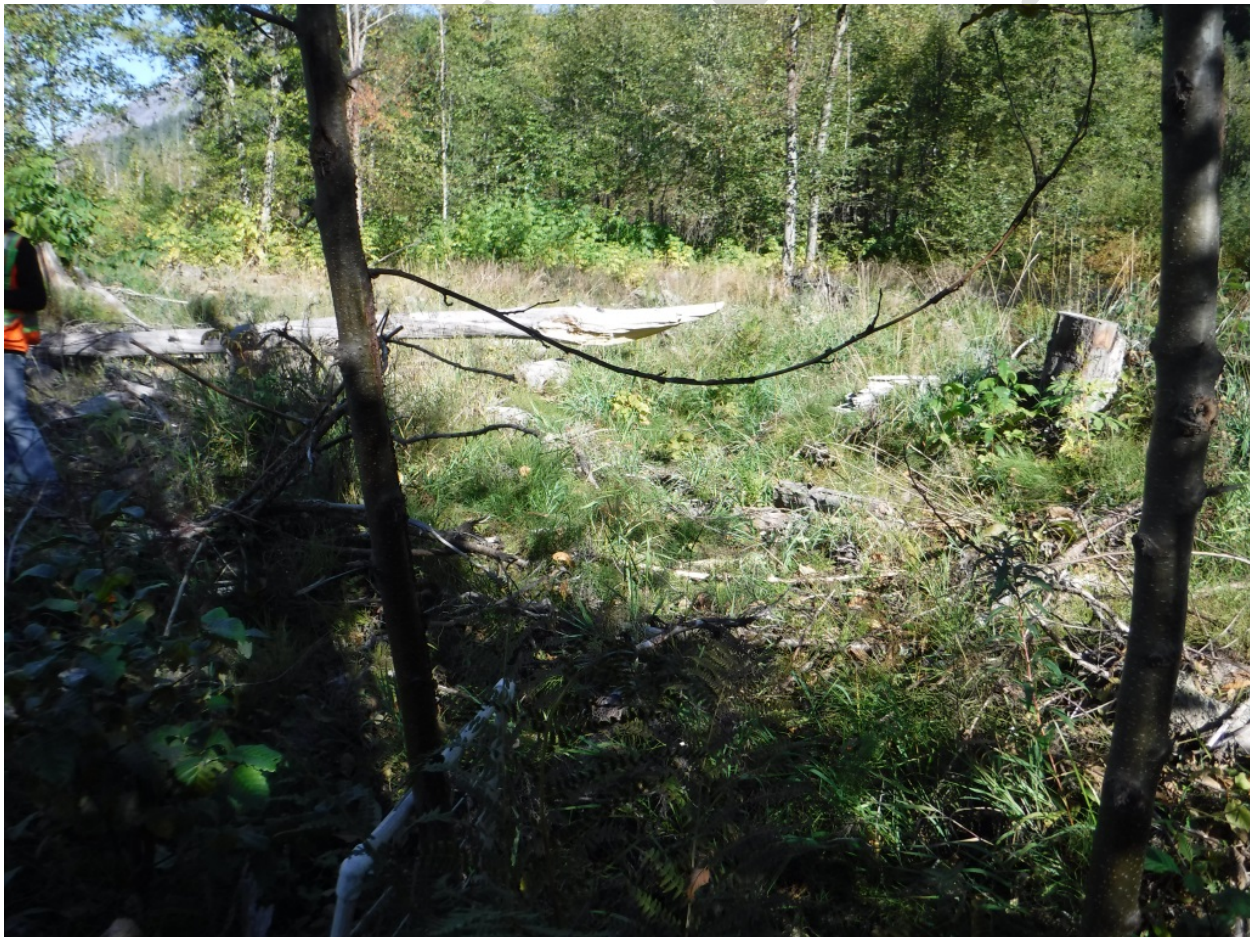
Figure 38. Higher percent vegetation cover (80%), primarily horsetail, grass and ferns, at ALE-PRM03, October 5, 2017.

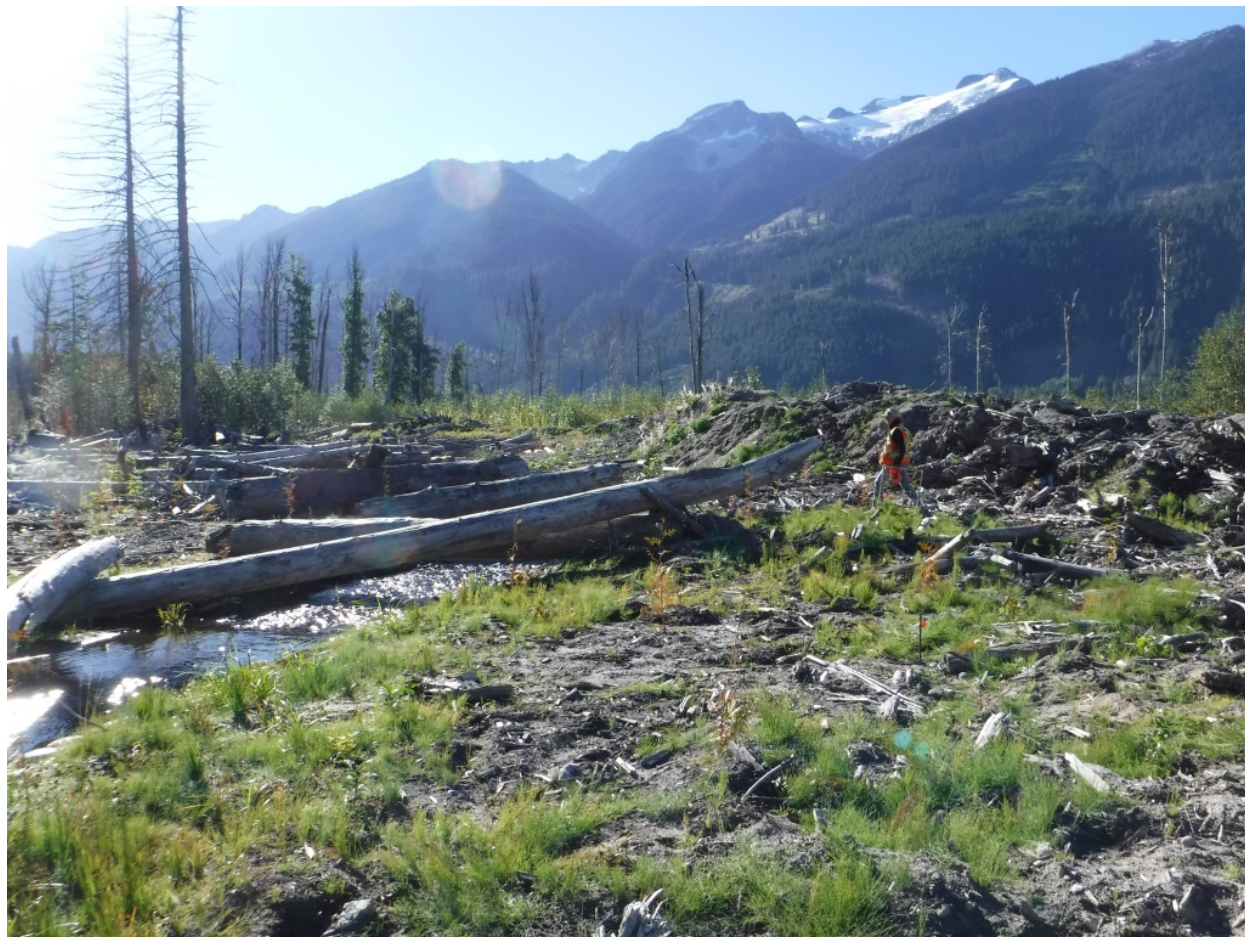
Figure 39. Lower percent vegetation cover (37%), primarily horsetail, at ALE-PRM05 located within the Meager Creek slide path, October 5, 2017.

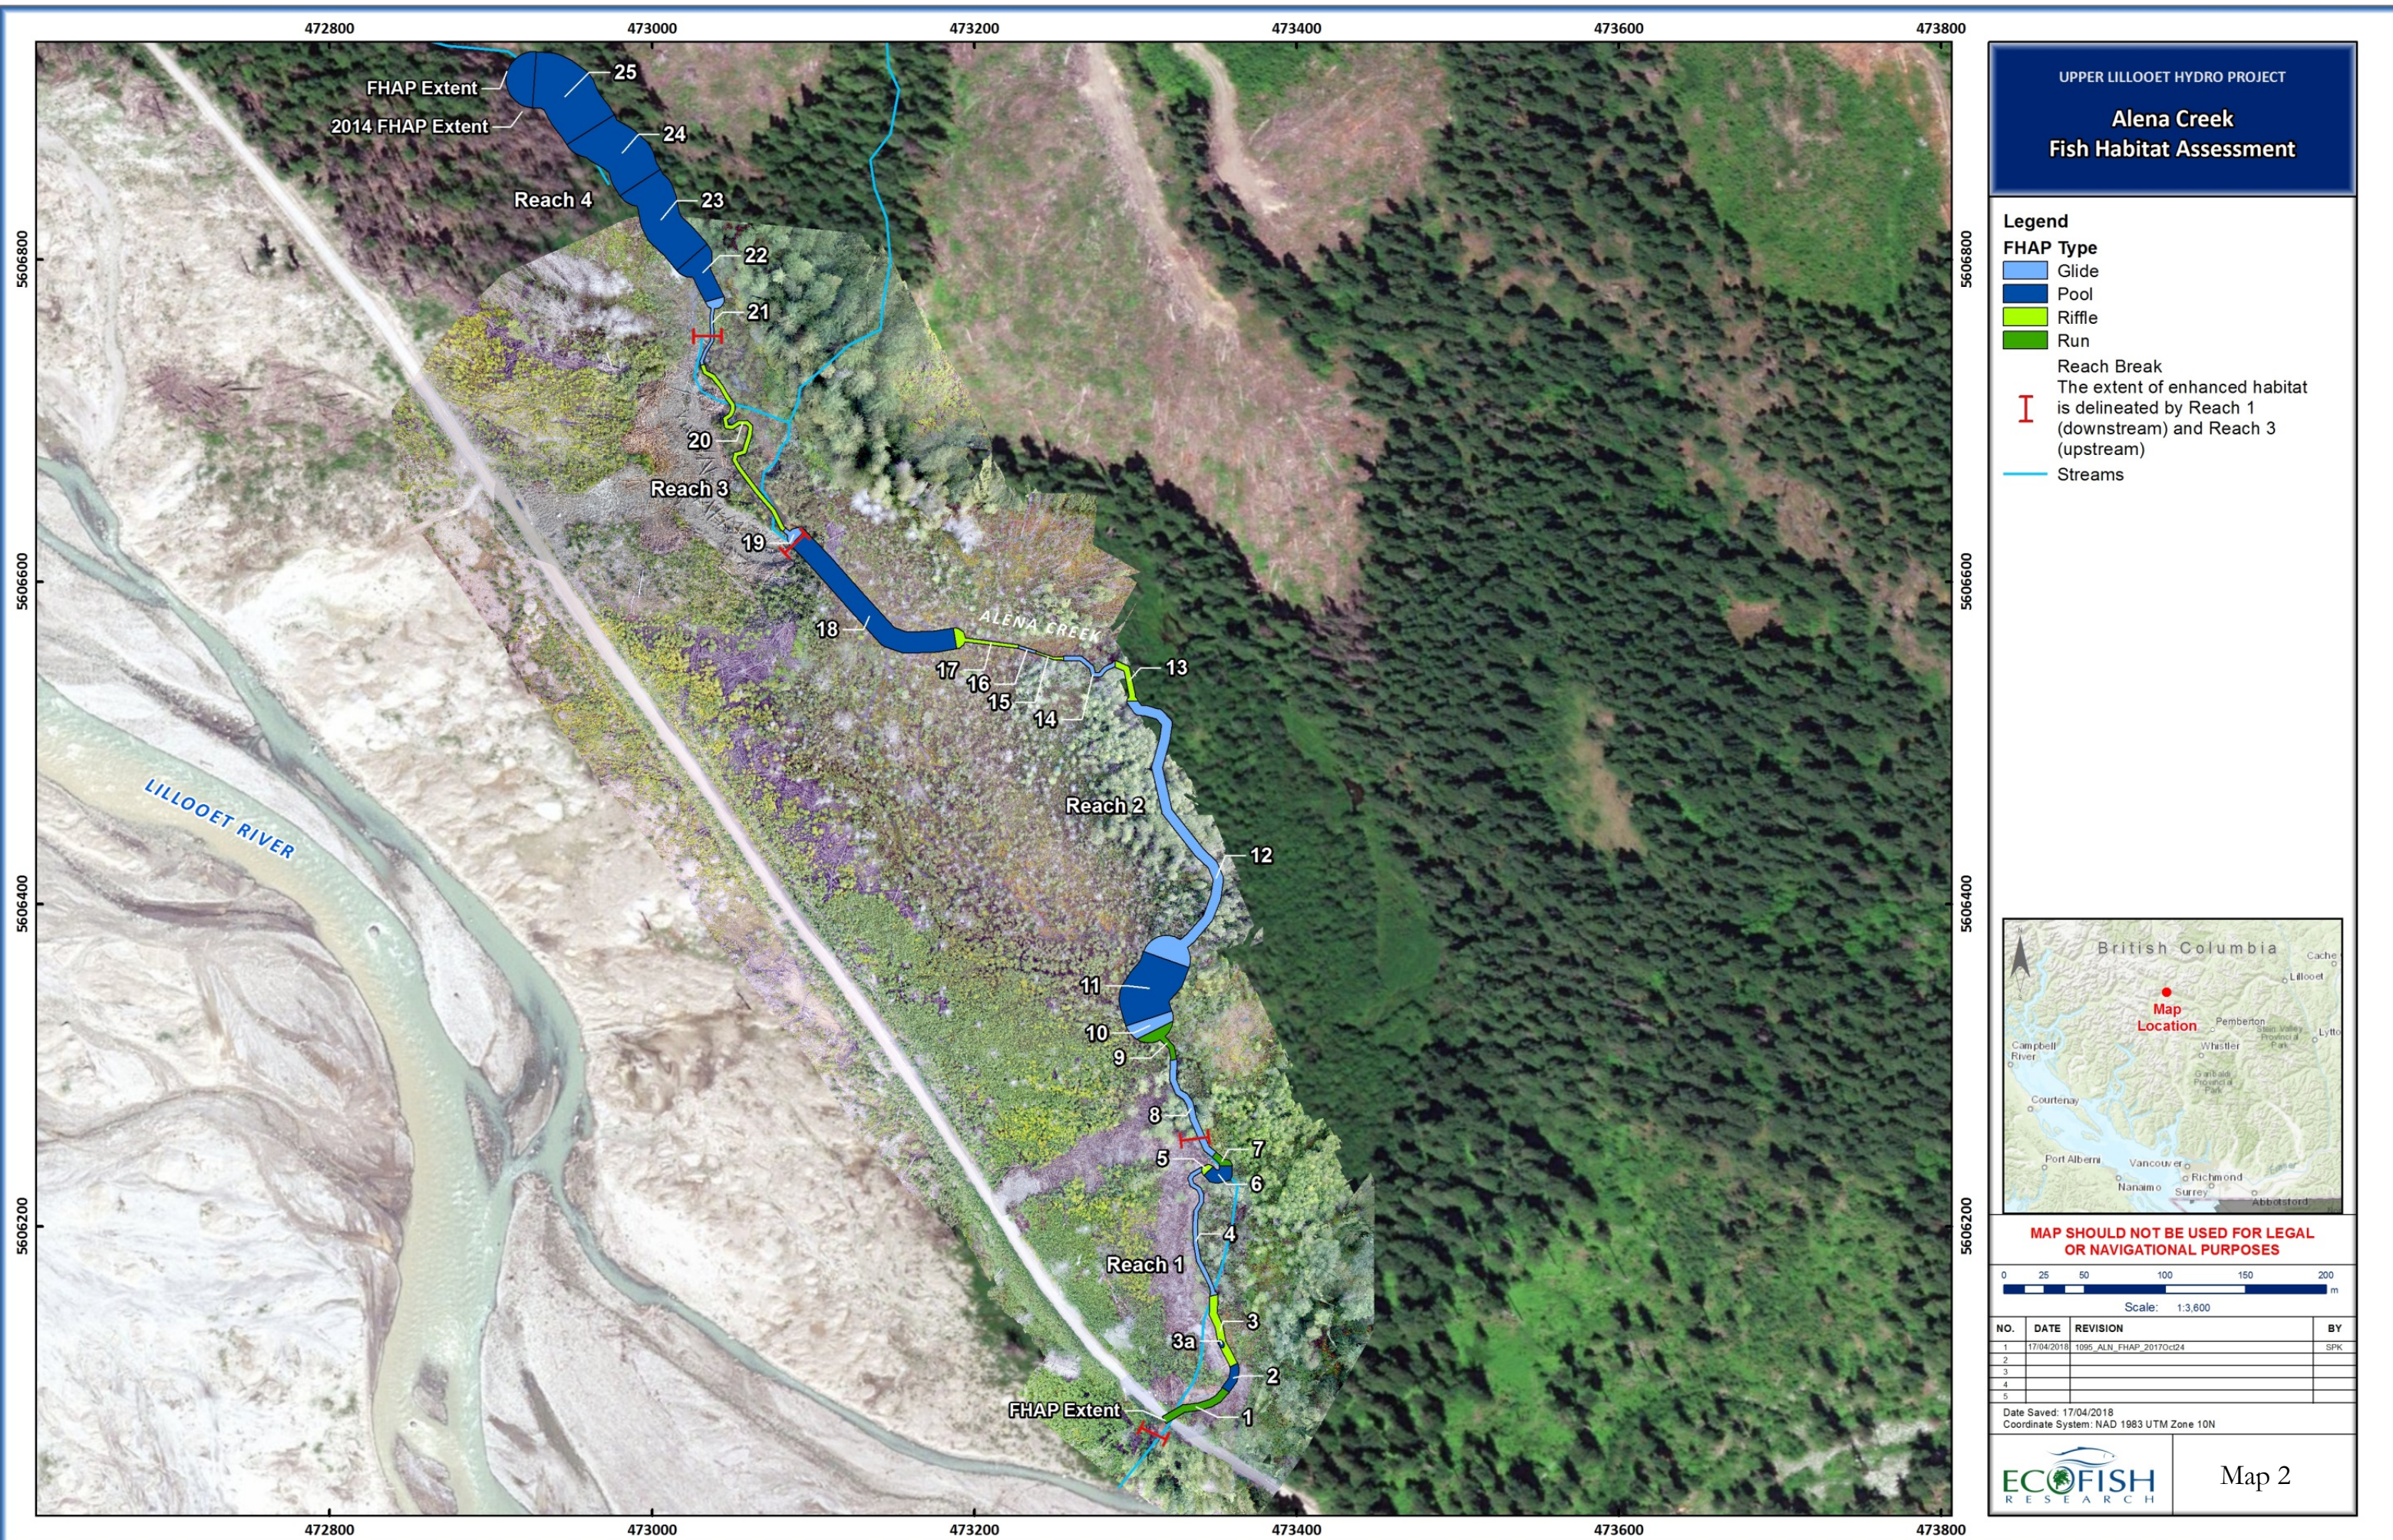
UPPER LILLOOET HYDRO PROJECT
Alena Creek
Fish Habitat Assessment
