Alena Creek Fish Habitat Enhancement Project

Year 3 Monitoring Report

April 28, 2020

Ecofish Research Ltd.

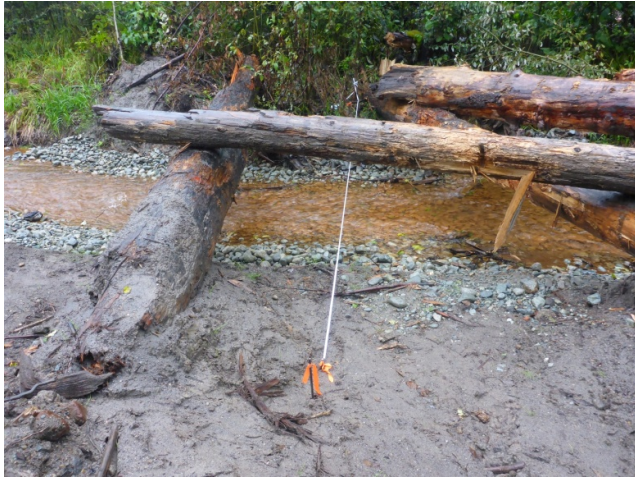
Figure 1. Looking from river left to river right at ALE-XS1 on September 19, 2016.

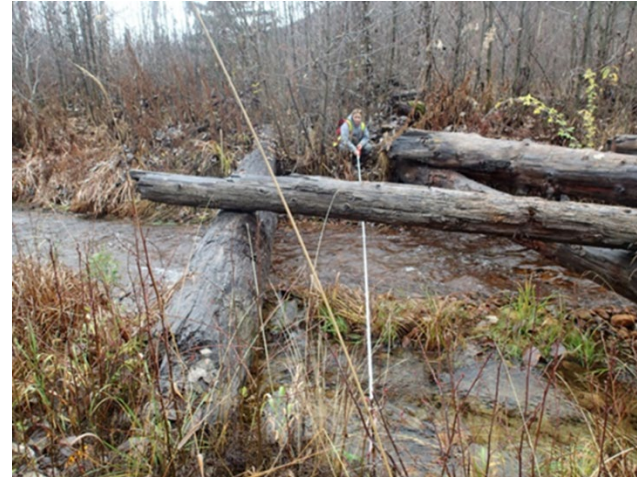
Figure 3. Looking from river left to river right at ALE-XS1 on November 5, 2018.

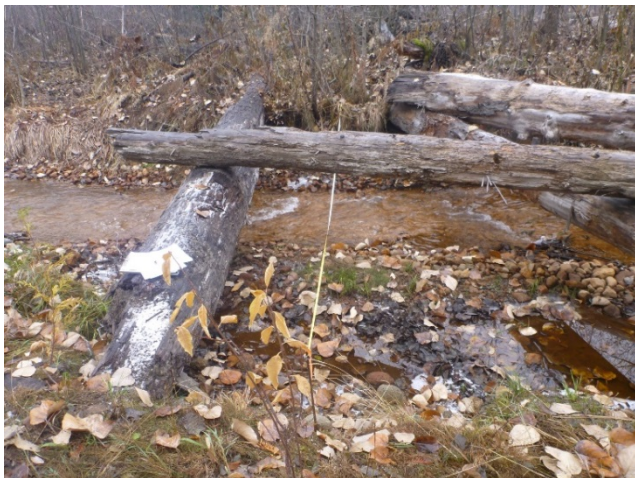
Figure 2. Looking from river left to river right at ALE-XS1 on November 10, 2017.

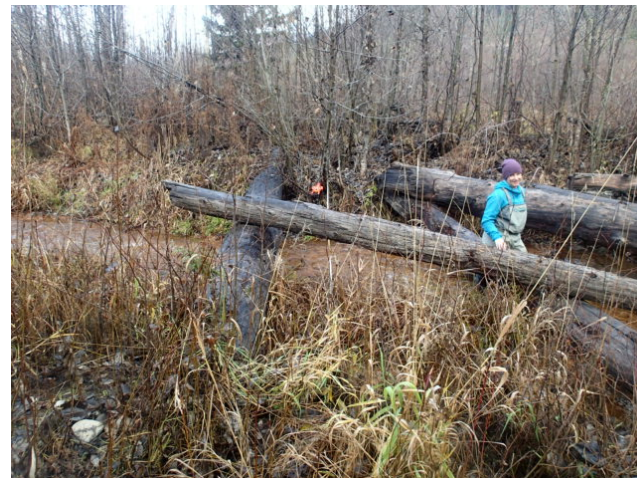
Figure 4. Looking from river left to river right at ALE-XS1 on November 13, 2019.

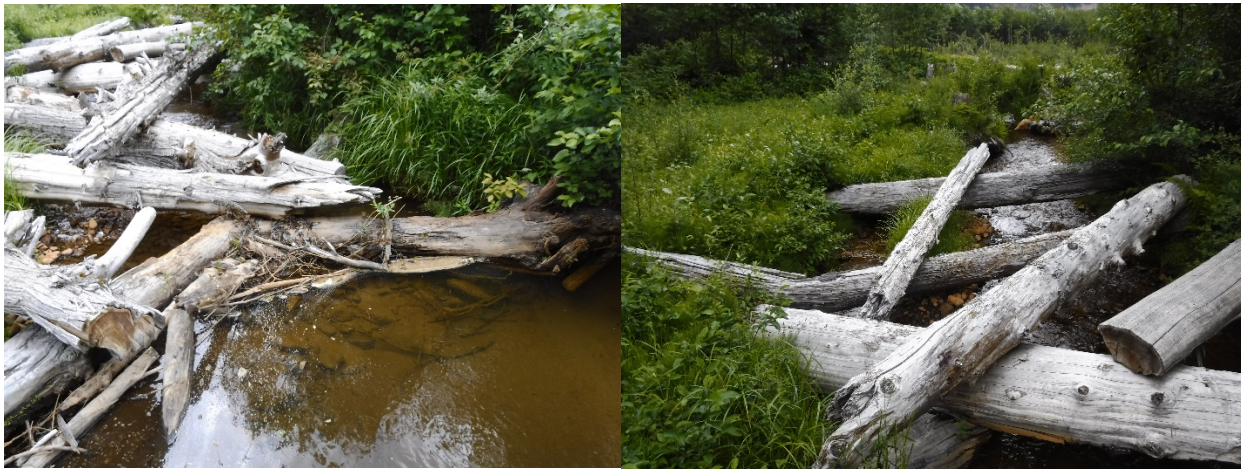
Figure 5. Log that has collapsed between ALE-XS1 and ALE-XS2 (left) causing moderate side-channel formation (right and shown in Figure 1 to Figure 4) and partial backwatering of a riffle. Photos taken on June 20, 2019.

Excessive erosion that reduces the quality of the constructed habitat has not occurred to date. The channel adjustments that occurred after the November 2016 peak flow event were modest and have largely stabilized since then due to vegetation establishment and natural sorting of sediment. However, three locations were identified where remediation is required to limit potential loss of habitat quality. First and foremost is the beaver dam complex located immediately upstream of Reach 3. This beaver dam has begun to cause flows to partially bypass Reach 3 and deliver fine sediment that is eroded from newly cut channels. Maintaining a lower beaver dam height at the dam that is blocking flow to the mainstem is recommended to keep flows in the channel and limit fine sediment loading. At the downstream extent of Reach 3, the last riffle has incised, which could cause progressive head-cutting and associated incision upstream. Rebuilding this riffle is recommended, which can likely be done without the need for excavators. Lastly, a log jam just upstream of ALE-XS1 has formed in Reach 1 where a channel-spanning log collapsed. This jam should be monitored to ensure it does not grow. If the jam grows and begins to cause backwatering of upstream riffles and associated fine sediment

deposition, then it should be removed. Continued monitoring and the repairs to Reach 3 are recommended to occur during summer 2020.

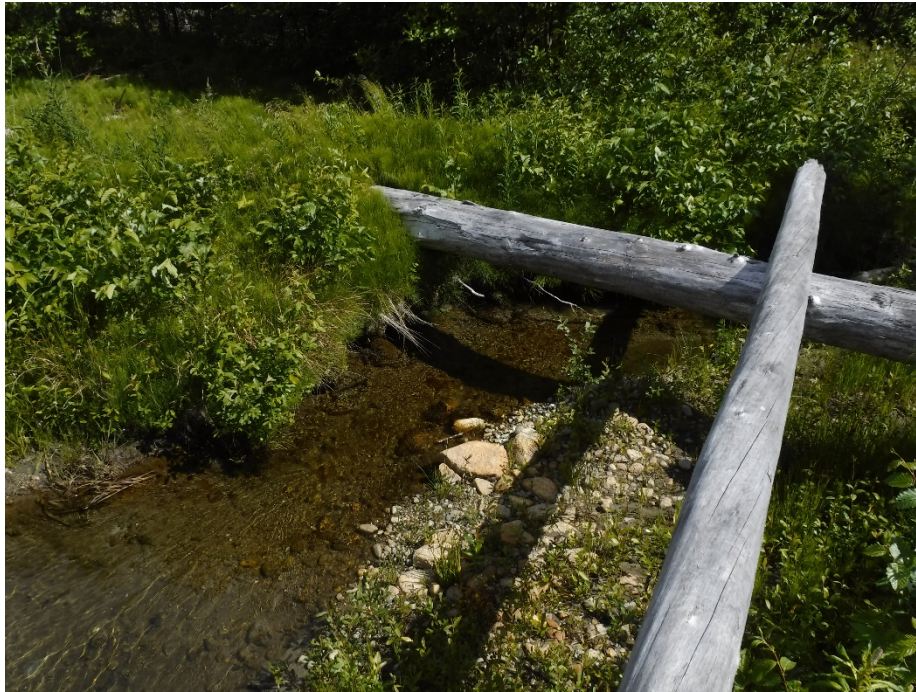
- **ALE-XS5** - Channel hydraulic diversity remains as designed, and the riffle has low fines content despite moderate bank erosion upstream. One channel-spanning log has collapsed but is only subtly affecting hydraulics. Root wads upstream of the riffle continue to provide good cover conditions; there are no concerns for long term stability.

Figure 7. Bank erosion and channel down-cutting at ALE-XS5 requiring repair. Photo taken on June 20, 2019.

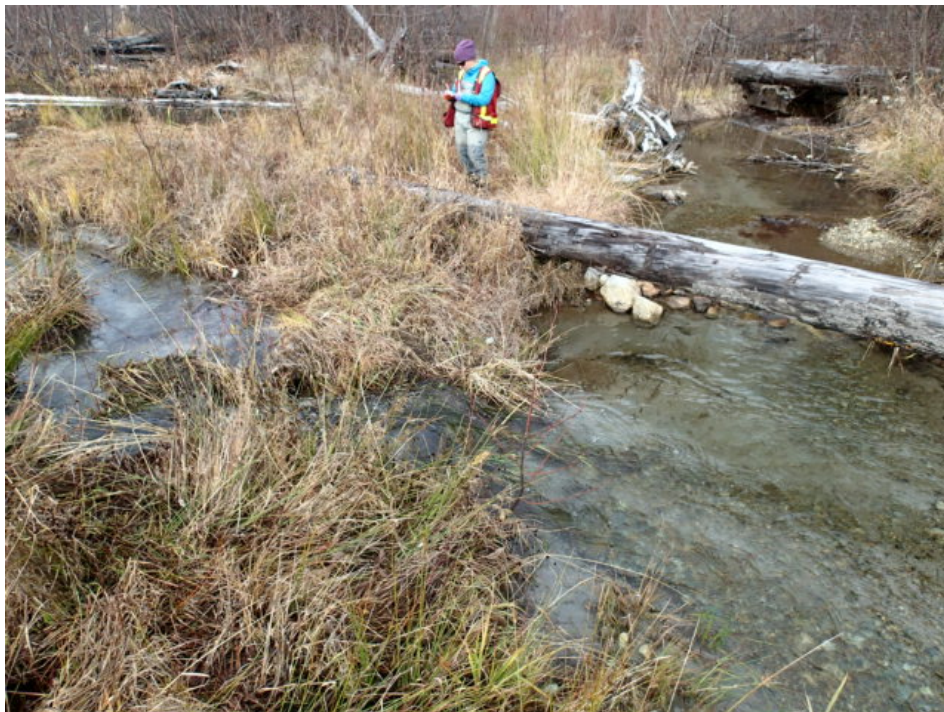
Beaver damming activity has been increasing upstream of Reach 3. The dams may restrict fish migration to the upstream spawning reach, impede gravel supply to Reach 3, and cause diversion of flow around the Reach 3 constructed channel. Furthermore, a sudden dam breach could cause a pulse of fine sediment to be delivered to, and deposited in, Reach 3. Two new channels have already formed on the west side of Reach 3 due to a large beaver pond approximately 30–50 m upstream of Reach 3. These channels are cutting into fine sediment and delivering it to Reach 3. One channel enters Reach 3 approximately 40 m downstream from the head of Reach 3 (Figure 8) and the other enters where the construction access road came in midway through the reach (Figure 9).

Figure 8. Entry point of upper new channel formed near upstream extent of Reach 3. Photo taken on November 13, 2019.

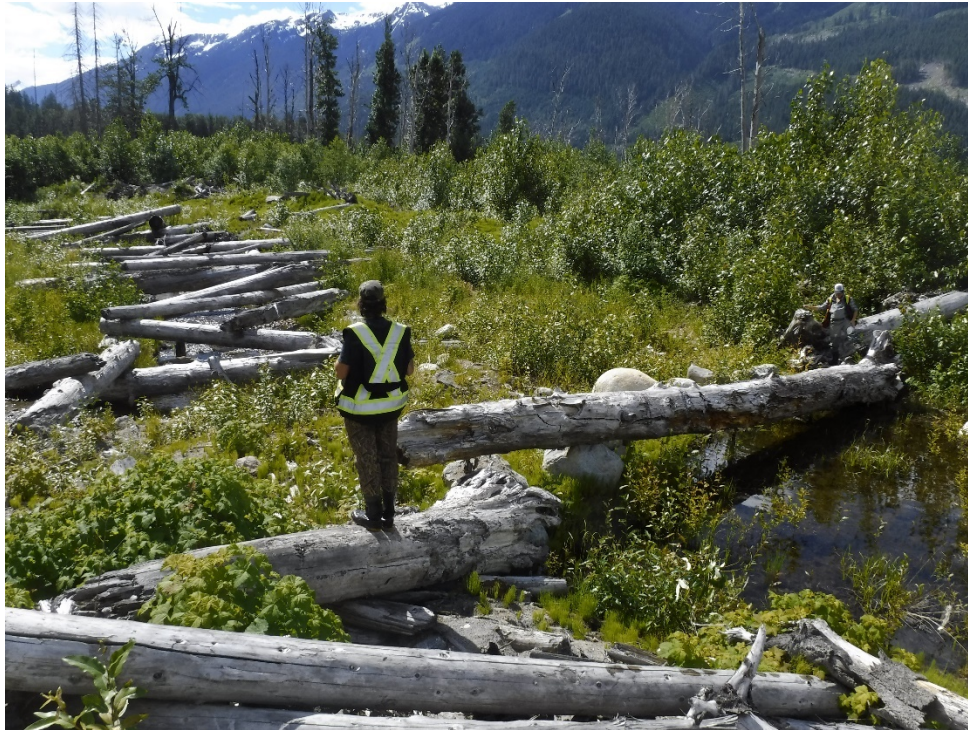
Figure 9. Entry point of lower new channel formed near upstream extent of Reach 3. Photo taken on June 20, 2019.

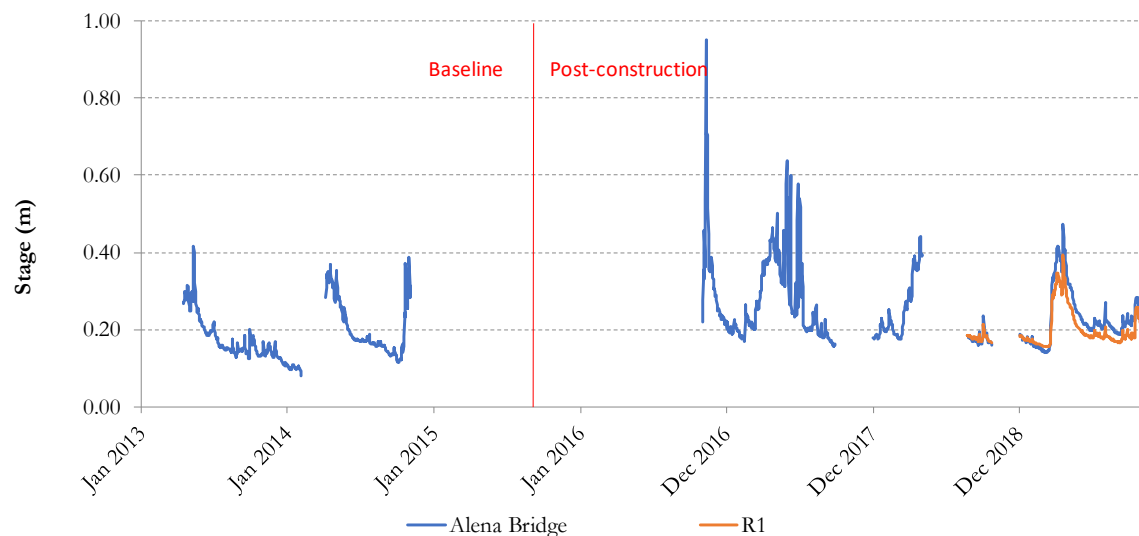
Seasonal trends in the Alena Creek hydrograph in 2019 were consistent with a coastal, snow-dominated watershed. Seasonal hydrograph patterns remained broadly consistent with observations from baseline and Year 1 and 2 post-construction monitoring. Stage readings in 2019 remained relatively low throughout the winter (January to mid-March) when precipitation was snow dominated, then increased during snow melt in spring (March and April). Stage remained low during monitoring in late-summer and early fall (August 23 to October) when precipitation was minimal (Figure 19).

During 2017, high stage readings were recorded at the FSR bridge that were suspected to be a result of backwatering from Upper Lillooet River (Harwood *et al.* 2018). A second gauge (R1) was installed on August 23, 2018 approximately 125 m upstream of the Alena Bridge gauge for comparison to assess backwater effects. During 2019, the stage trends at the FSR bridge and R1 gauge closely aligned (Figure 19), indicating that backwatering from Upper Lillooet River to the FSR bridge was no longer occurring.

Figure 19. Stage in Alena Creek at the Lillooet River FSR bridge during baseline (April 2013 to November 2014), and Year 1 to Year 3 of post-construction monitoring (November 2016 to November 2019).

During 2019, the stage trends at the FSR bridge and R1 gauge closely aligned, indicating that backwatering from Upper Lillooet River to the FSR bridge did not occur. We recommend continued stage monitoring at both the FSR bridge and the upstream R1 gauge.

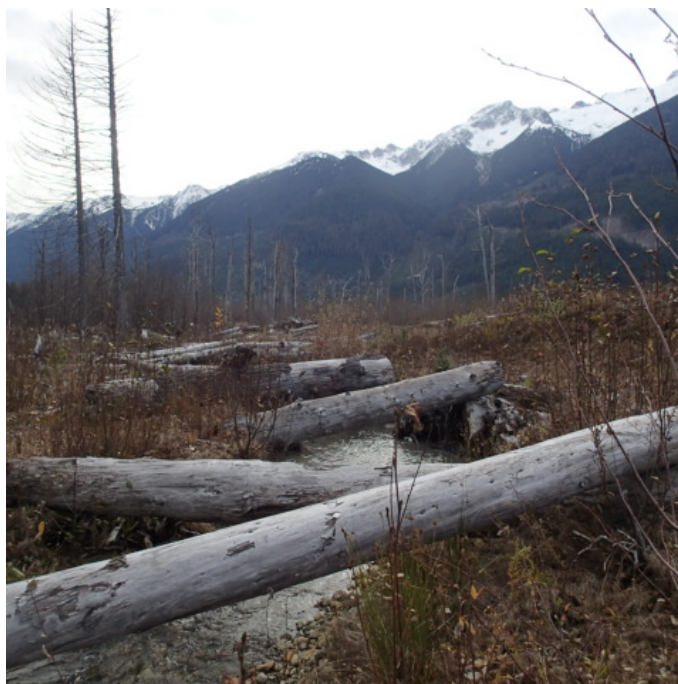
Figure 23. Overview of FHEP channel taken from ALE-PRM05, demonstrating revegetation success of trees and shrubs, on October 29, 2019.

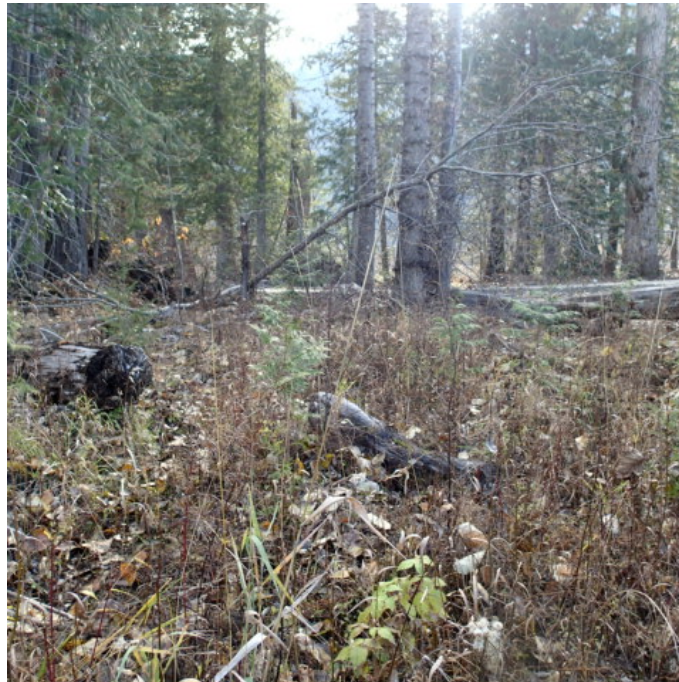
Figure 24. Revegetation success observed at ALE-PRM07. Photo is representative of western redcedar growth and the regeneration of other shrub and herb species, as well as the potential future condition in the background, on October 29, 2019.

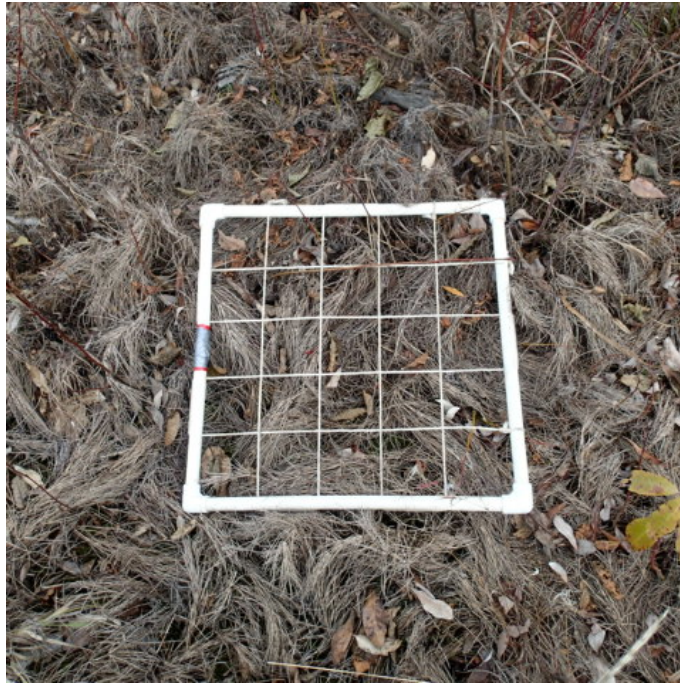
In 2019, the mean percent cover of vegetation among all four plots was 86%, surpassing the target of 80% survival (assuming the natural regeneration potential cover of 100%), and an increase from 61% in 2017 and 23% post-treatment in 2016 (Table 24). This is similar to the pre-treatment mean percent cover of 82% estimated in 2014. In 2019, the percent cover of individual plots ranged from 64% cover at ALE-PRM06, to 100% cover at ALE-PRM03. ALE-PRM03 also had the highest percent cover in 2017, possibly due to the dominance of undisturbed soil. In 2017, ALE-PRM05 had the lowest percent cover (37%) of all sites, which was attributed to its location within the Meager Creek slide path, resulting in substrate with low organic content. However, in the 2019 survey, percent cover at ALE-PRM05 had increased to 97%, due to increases in cover of horsetail (*Equisetum* spp.) (Figure 25). Horsetail is an indicator of disturbed sites and is associated with sandy or silty soils and streambanks, as it can fix its own nitrogen (Klinka *et al.* 1989). The plot with the lowest percent cover in 2019 was ALE-PRM06, at 64%. Leaf litter was abundant in quadrats within ALE-PRM06, and it is possible that the relatively low percent cover observed in this plot was an artefact of sampling late in the season when many leaves had already senesced, and that the high amounts of leaf litter will contribute to future soil enhancements and growth (Figure 26).

Figure 25. High percent vegetation cover of primarily horsetail in a sampling quadrat at ALE-PRM05, located within the Meager Creek slide path, October 29, 2019.

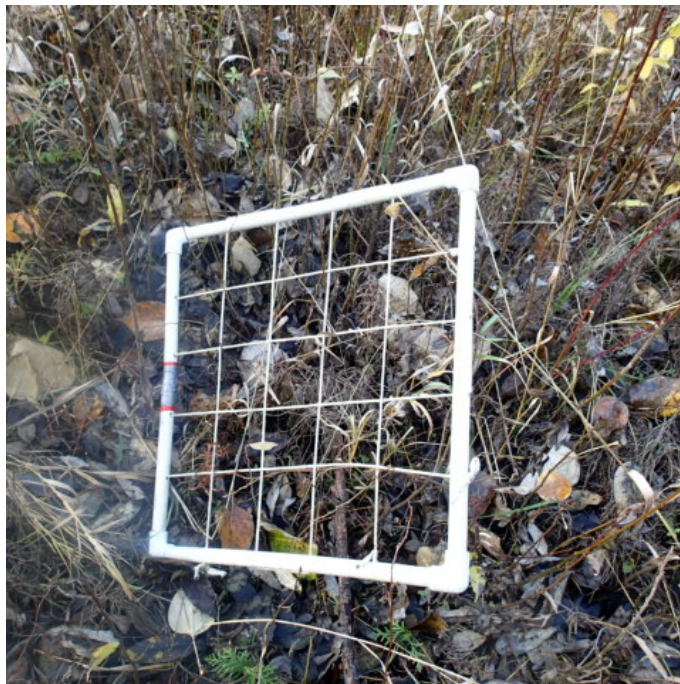
Figure 26. Relatively low percent vegetation cover in sampling quadrat at ALE-PRM06 October 29, 2019 due to abundance of leaf litter.

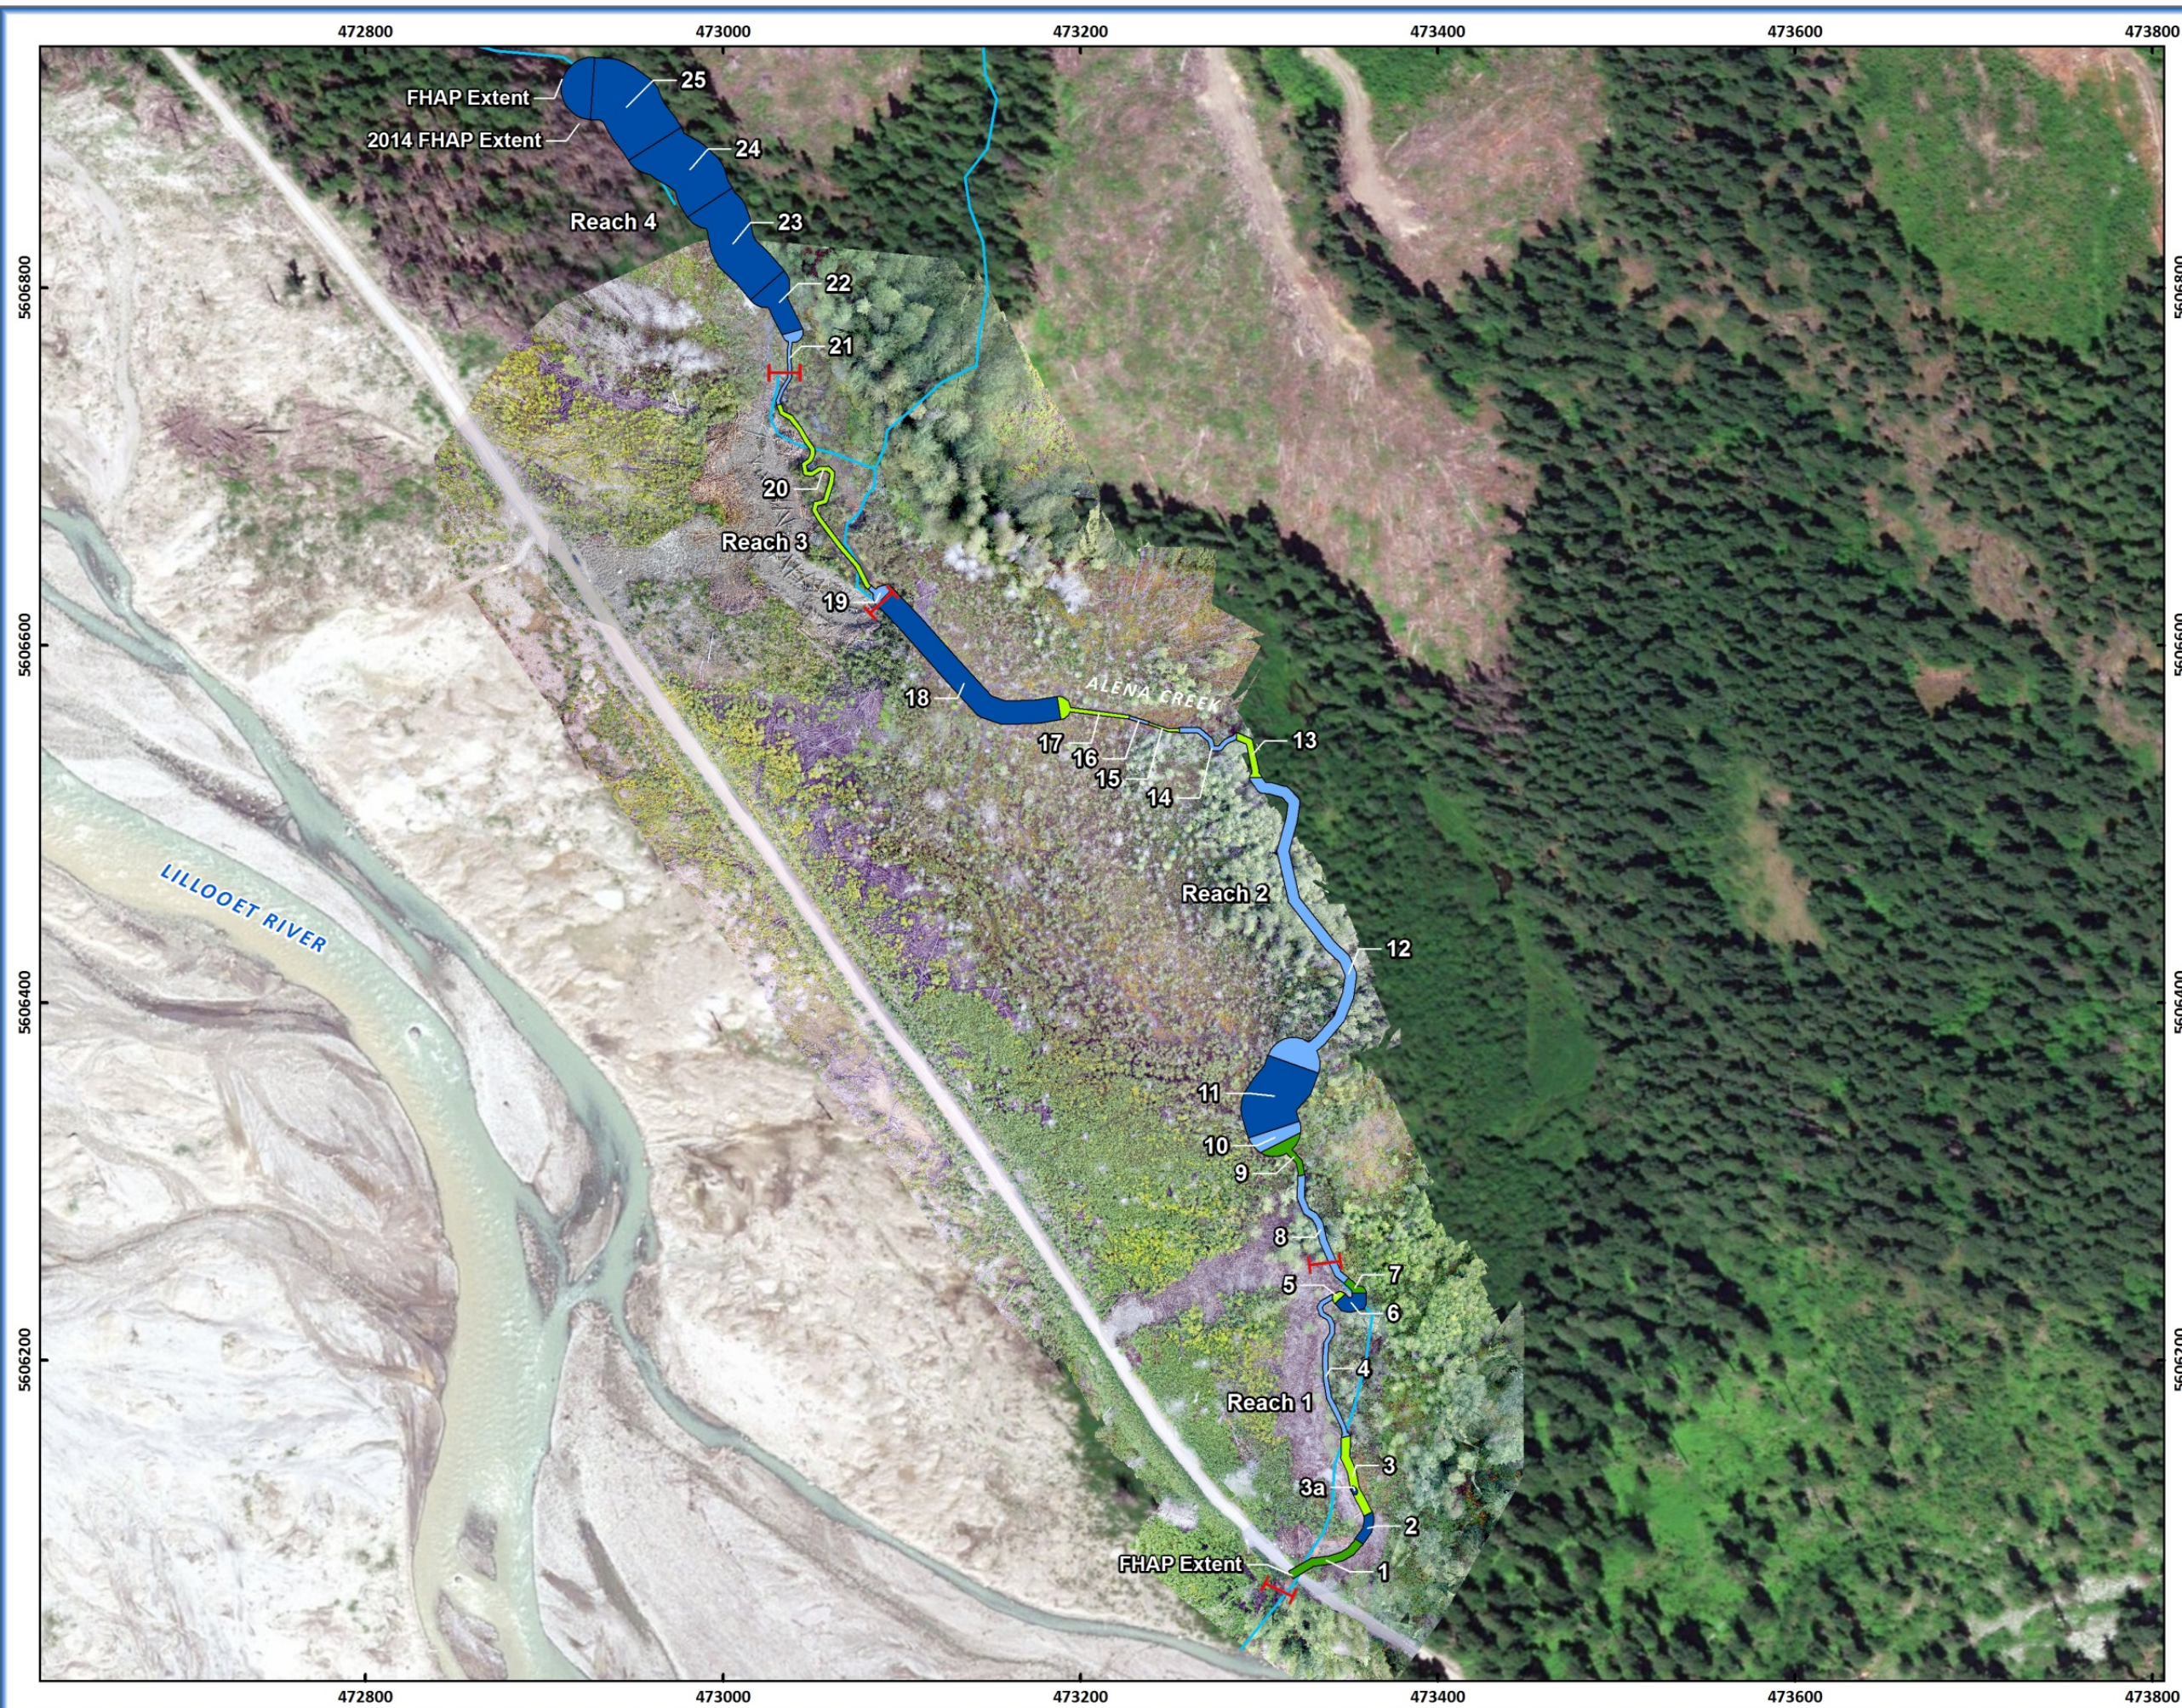
UPPER LILLOOET HYDRO PROJECT

Alena Creek Fish Habitat Assessment

- Legend**
- FHAP Type**
- Glide
 - Pool
 - Riffle
 - Run
- Reach Break**
- I The extent of enhanced habitat is delineated by Reach 1 (downstream) and Reach 3 (upstream)
- Streams

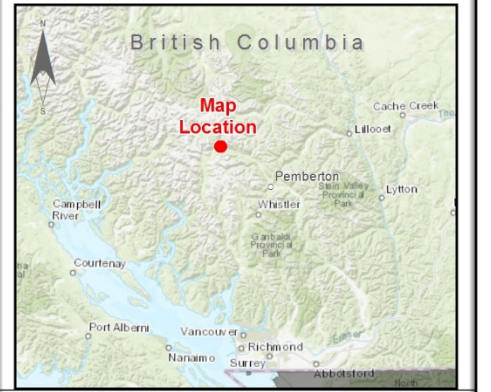
UPPER LILLOOET HYDRO PROJECT
Alena Creek
Water Temperature
Monitoring Sites

- Legend**
- Water Temperature Monitoring Site
 - I Reach Break
 - I The extent of enhanced habitat is delineated by Reach 1 (downstream) and Reach 3 (upstream)
 - Meager Creek Slide Extent
 - Enhanced Reaches
 - Streams (Hedberg)

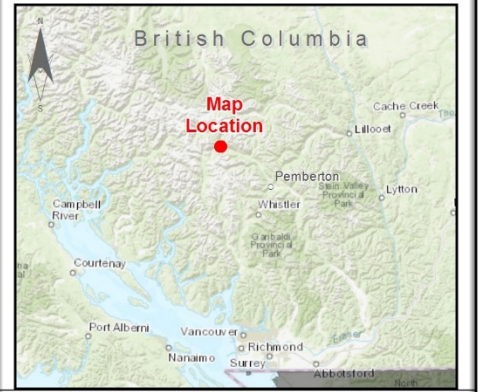
UPPER LILLOOET HYDRO PROJECT
Alena Creek
Fish Abundance Sampling and
Riparian Monitoring Sites

- Legend**
- Minnow Traps
 - Permanent Vegetation Monitoring Plots
 - Reach Break
The extent of enhanced habitat is delineated by Reach 1 (downstream) and Reach 3 (upstream)
 - Transect Sites
 - Meager Creek Slide Extent
 - Enhanced Reaches
 - Streams (Hedberg)
