Alena Creek Fish Habitat Enhancement Project

Year 5 Monitoring Report

April 29, 2022

Ecofish Research Ltd.

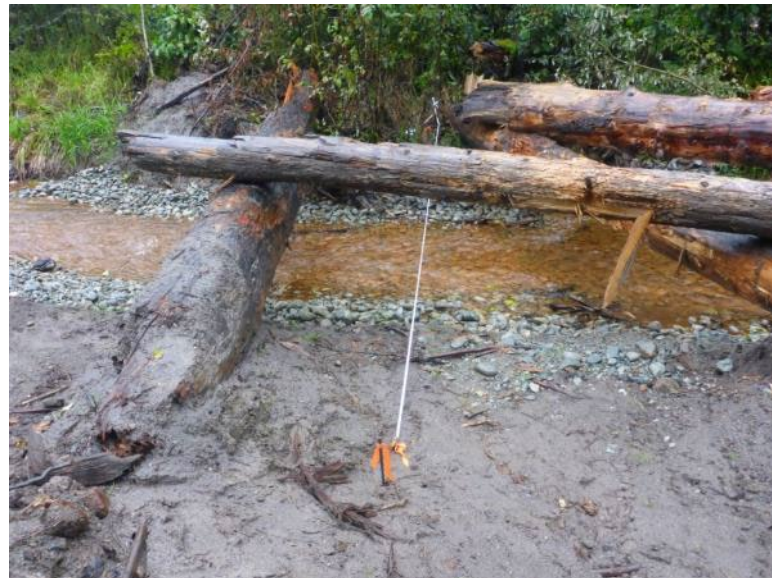
Figure 2. Looking from river left to river right at ALE-XS1 on November 10, 2017, showing the beginnings of a secondary channel forming on the river left floodplain.

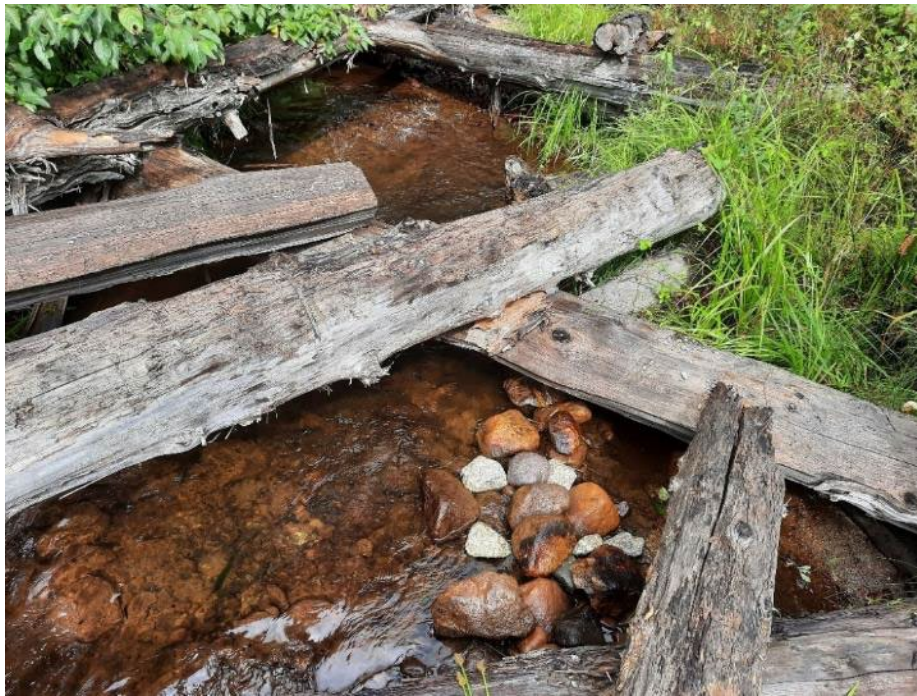
Figure 7. Cobble placement at the head of the side channel upstream of ALE-XS1 on August 06, 2020.

In Reach 1, a log jam just upstream of ALE-XS1 has formed. However, no backwatering was observed during the stability assessment on October 27, 2021. Associated bank erosion issues from this log jam were partially addressed in 2020 by placing cobble along the head of a cut-off channel that has formed and largely stabilized. During the stability assessment on October 27, 2021, the cobble placement appeared to be stable and functioning as intended.

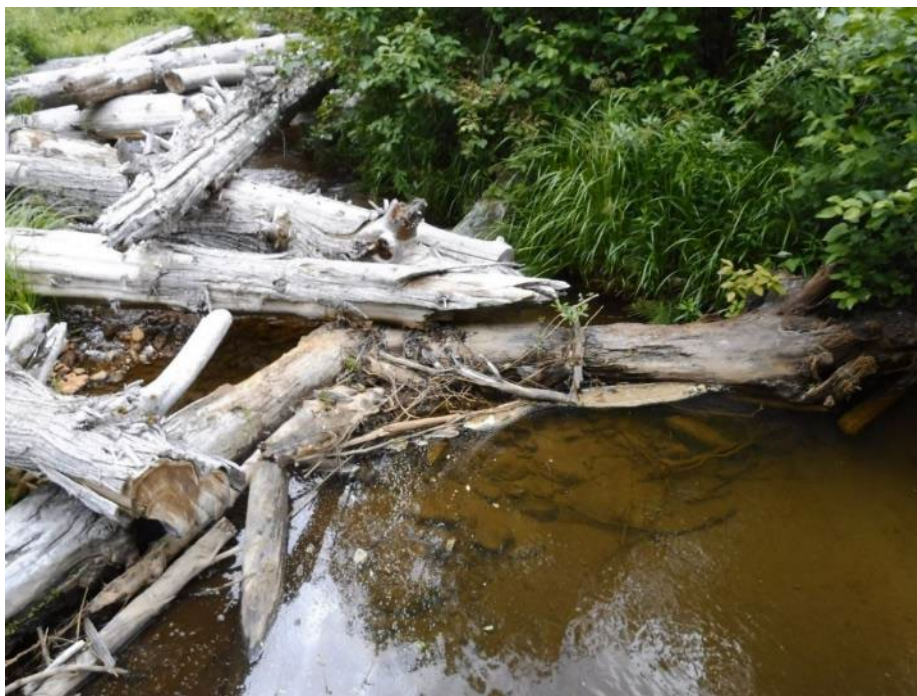
Figure 8. Log jam that has formed at a collapsed channel spanning log approximately 10 m upstream of at ALE-XS2. Photo taken on June 20, 2019.

Reach 1 was generally found to be stable after the high flow event except for one location where a channel spanning log had collapsed, creating a wood jam and minor avulsion of the channel around the jam. The channel at this location had largely stabilized and was not expected to continue eroding at an unnatural rate. Some repairs were made in 2020 at this location, but they were restricted to

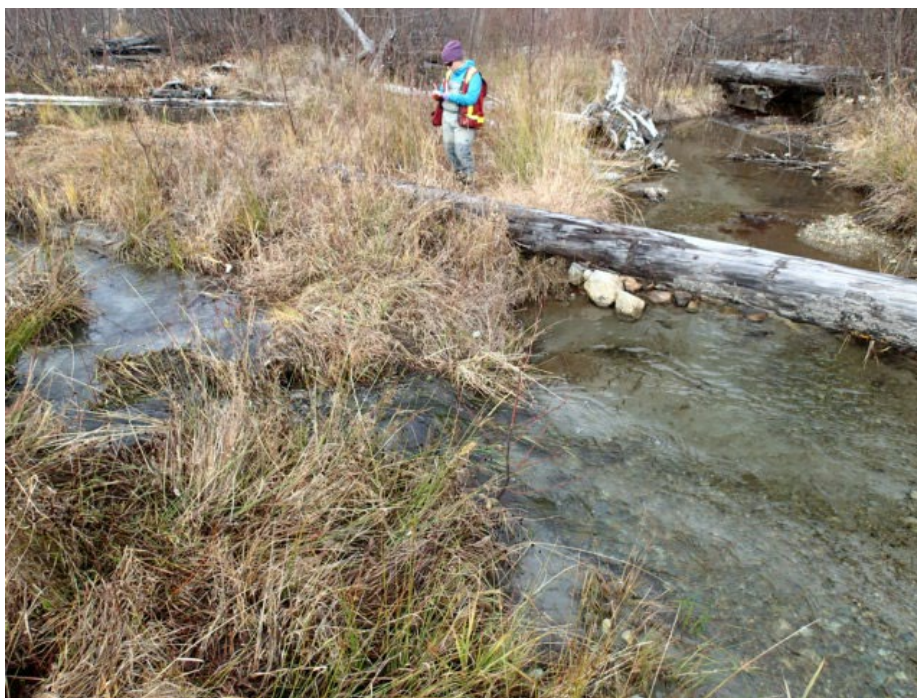
Figure 9. Confluence of overflow channel that formed during 2019 as a result of beaver activity upstream of Reach 3. Photo shows uppermost 20 m of Reach 3 (right) and overflow channel (left). Photo taken on November 13, 2019.

A beaver dam complex located immediately upstream of Reach 3 was causing partial flow bypass and formation of newly cut channels that increased fine sediment deposition within the reach; therefore, the dam height was lowered to prevent further channel erosion. No new beaver activity was observed above Reach 3 in 2021, and the dam was considered inactive in 2021. A newly constructed beaver dam in the lower end of Reach 3, which was previously removed in 2020, had been reconstructed and continued to create moderate backwatering in ALE-XS5, ALE-X06, and ALE-XS7. Beavers were removed from the Alena Creek enhancement area in the fall of 2021 by a licensed trapper from EBB Environmental Consulting Inc. with the objective of ensuring salmon spawner access and spawning riffle functionality.

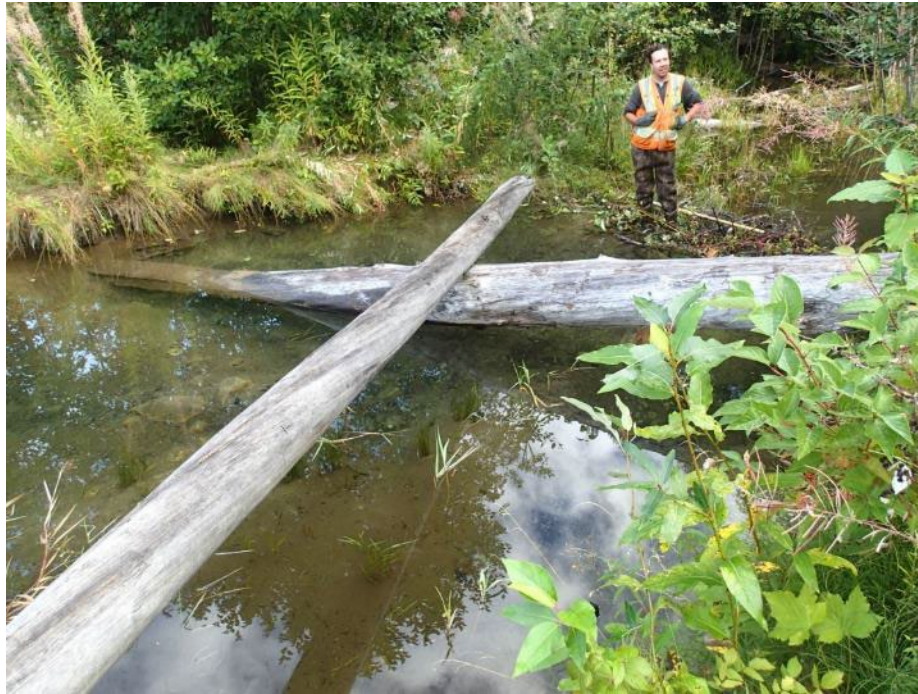
New beaver activity was observed in the lower end of Reach 3: two reconstructed beaver dams created moderate backwatering at ALE-XS5, ALE-XS6 and ALE-XS7 (Figure 10). Beavers were trapped within the Alena Creek enhancement area and dams were removed in the fall of 2021 by a licensed trapper from EBB Environmental Consulting Inc.

Figure 10. New reconstructed Beaver dam at the lower end of Reach 3 that was identified during fall 2021 and subsequently removed.

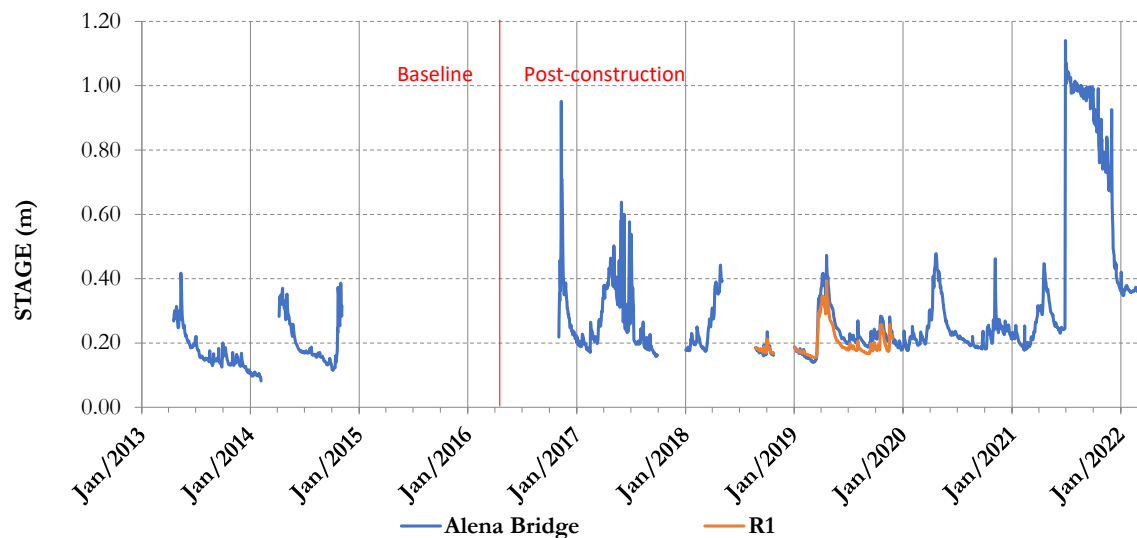
A precipitation event shifted hydrological controls again on December 1, 2021, decreasing base stage level from 0.66 m prior to the event to 0.36 m post event. This event likely disconnected Alena Creek from backwatering by the Lillooet, as indicated by a return to smaller daily oscillations, but low flow stage levels remain higher than in previous years, indicating a shift in creek morphology and making the comparison with previous levels difficult without redefining the stage offset from a local benchmark.

Figure 24. Stage in Alena Creek at the Lillooet River FSR bridge during baseline (April 2013 to November 2014), and post-construction monitoring (November 2016 to March 2022).

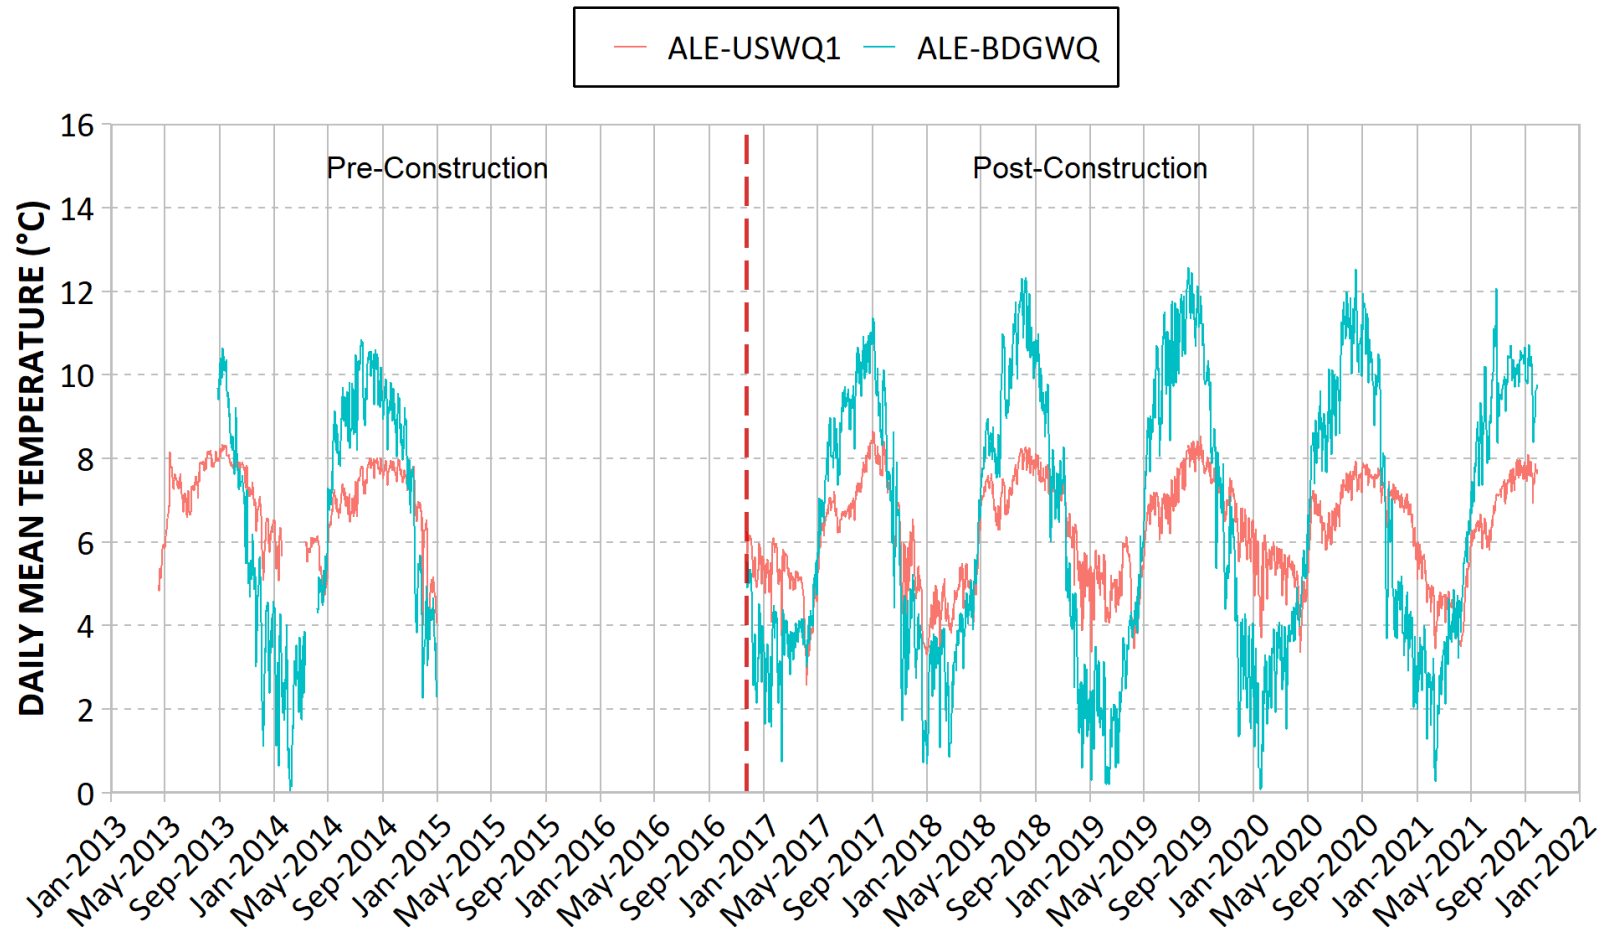
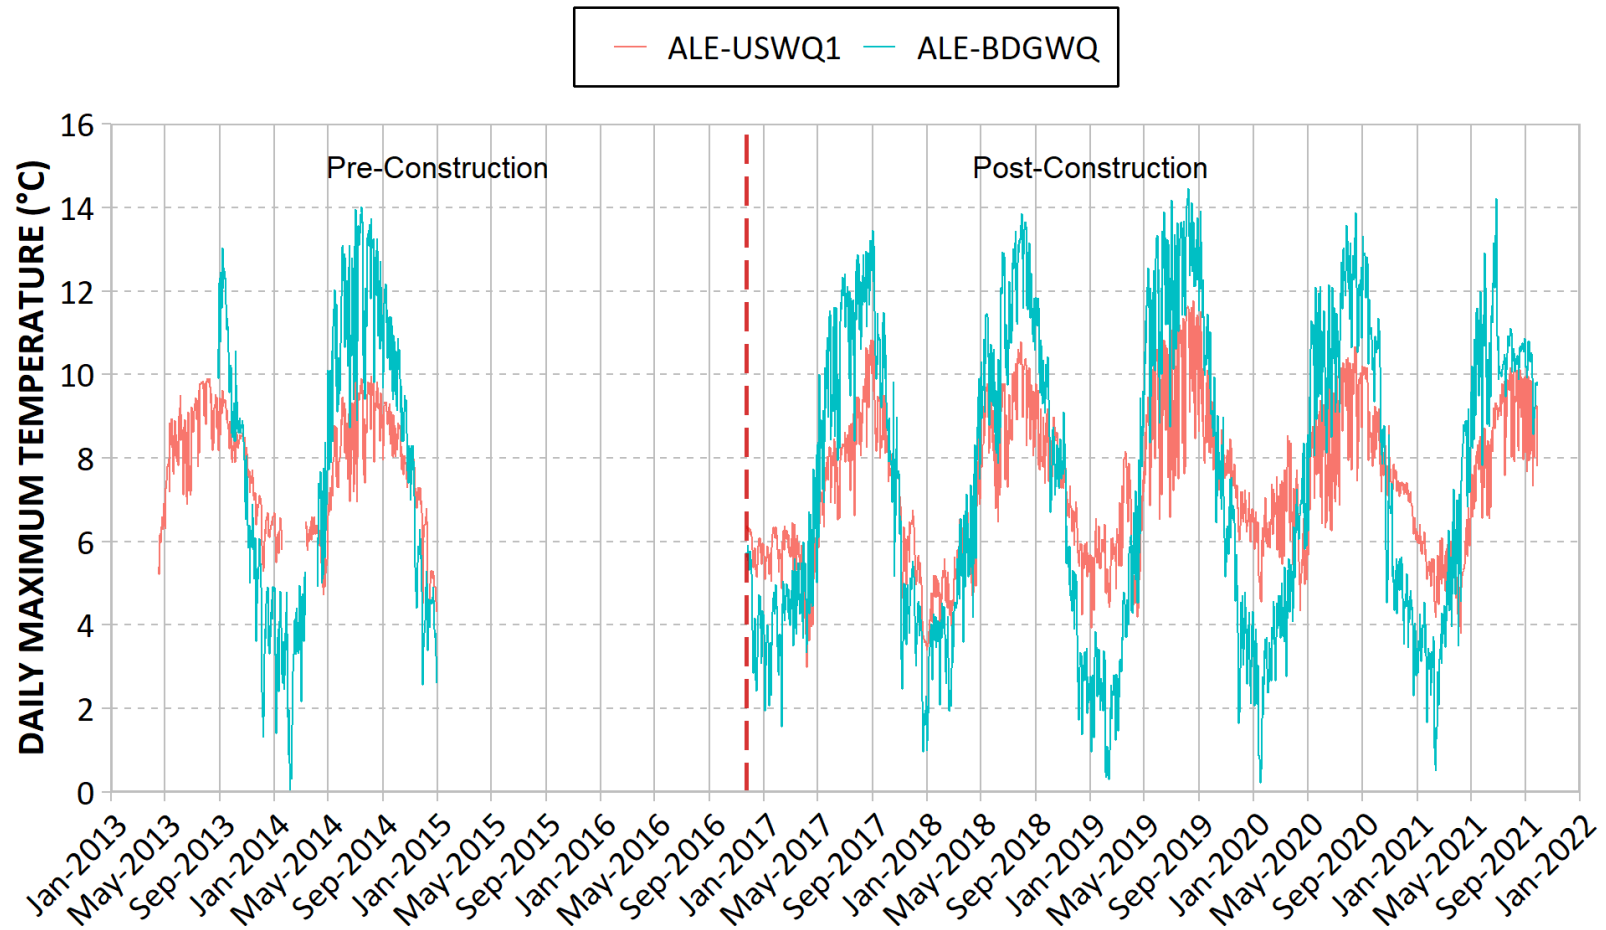
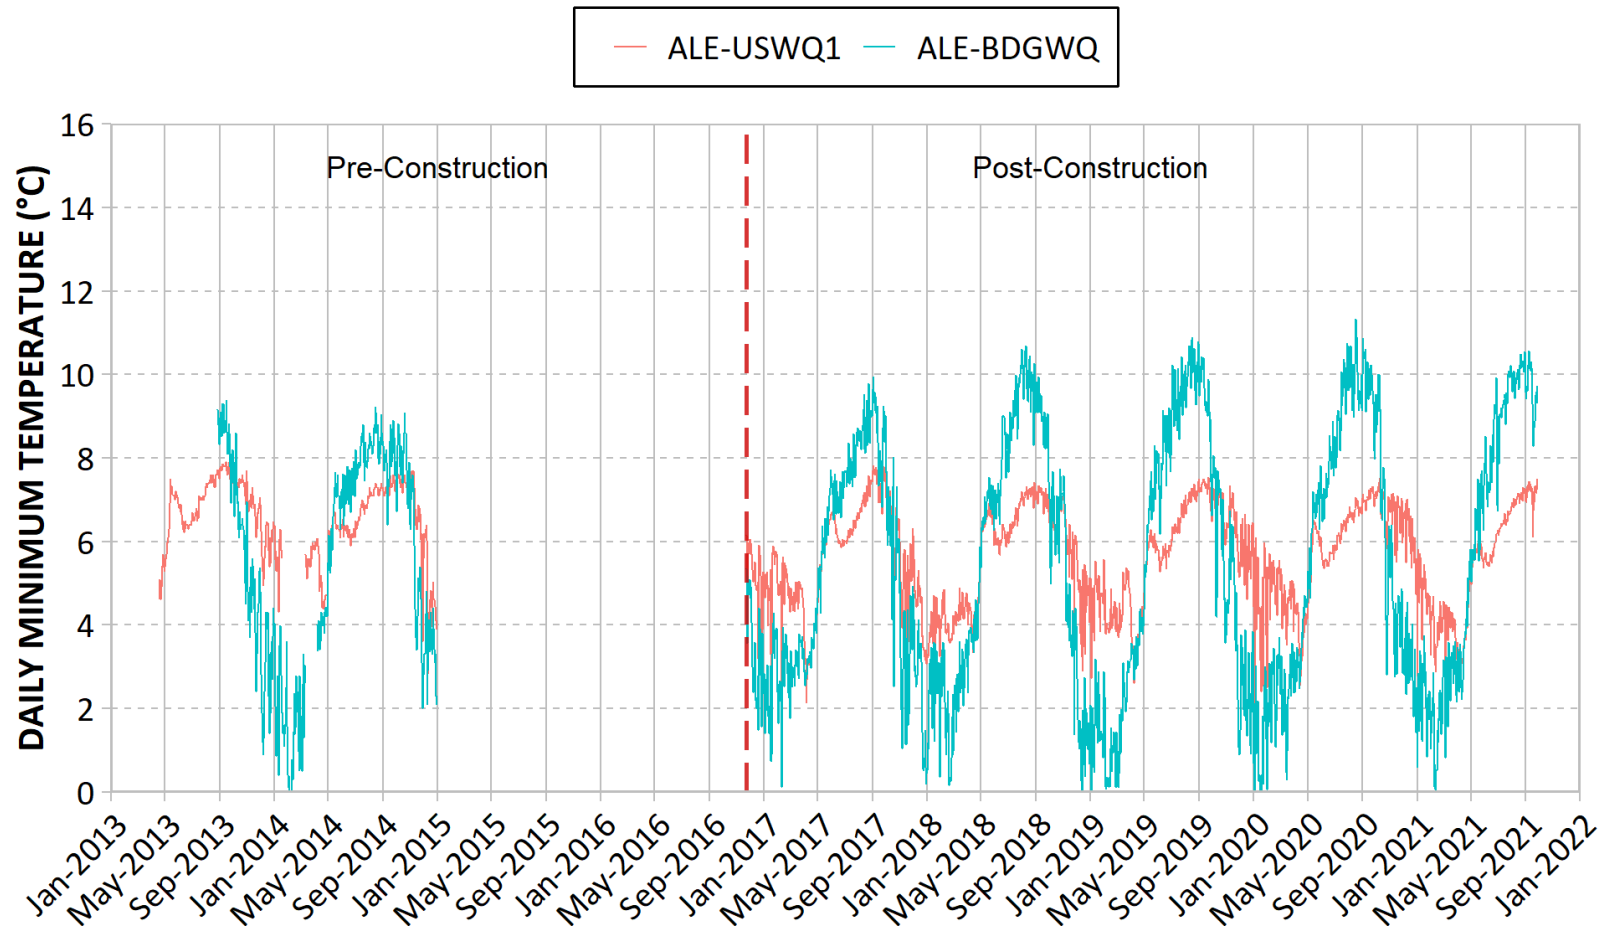
Figure 25. Daily average (a), maximum (b), and minimum (c) temperature in Alena Creek pre-construction (April 17, 2013 to December 30, 2014) and post-construction (November 23, 2016 to September 27, 2021) recorded at the upstream control (ALE-USWQ1) and downstream impact (ALE-BDGWQ) sites.

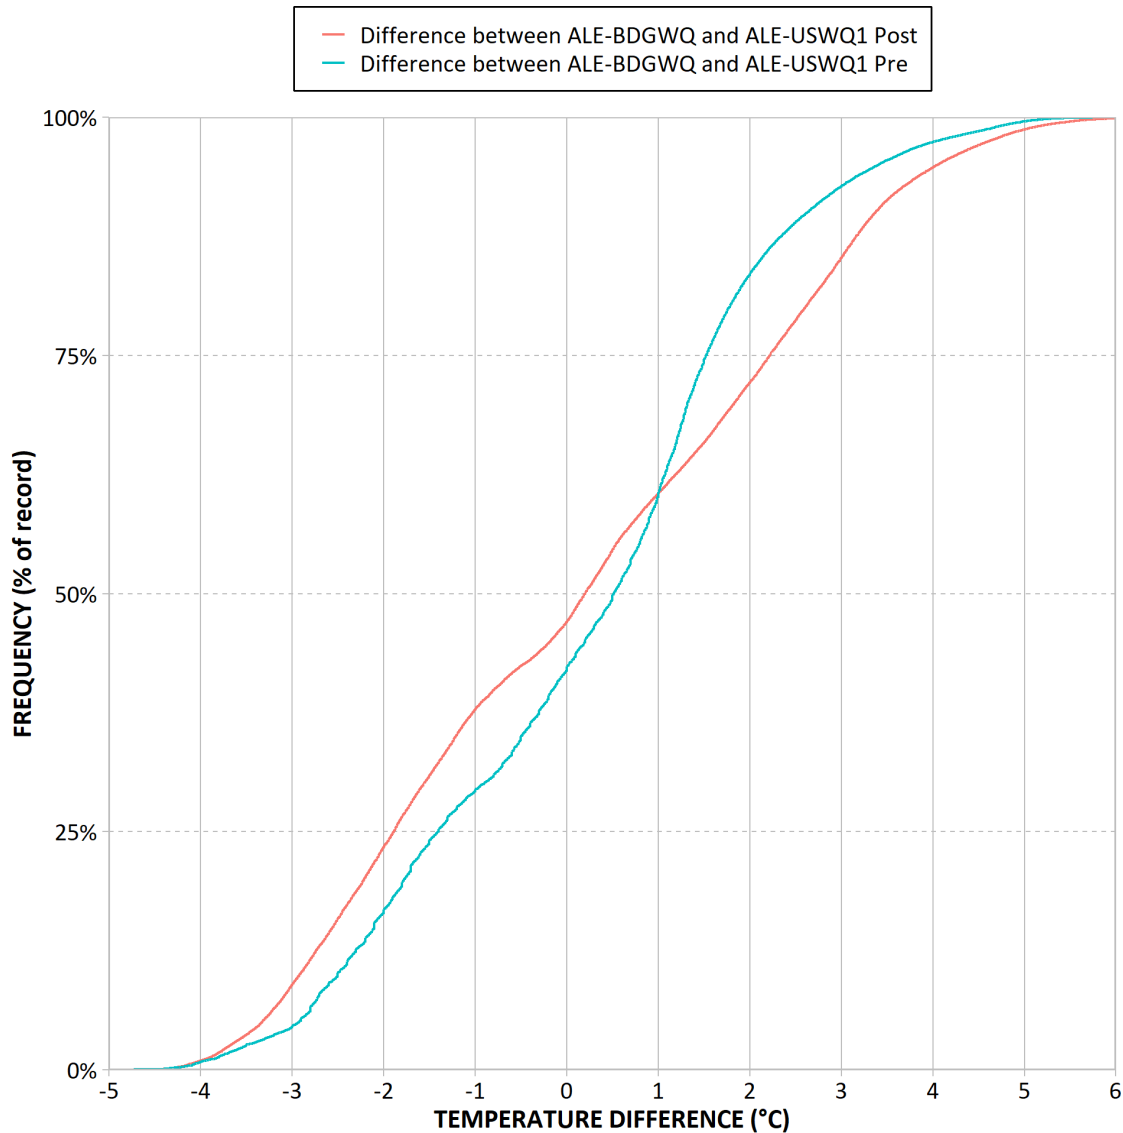
Figure 26. Cumulative frequency distribution of differences in pre-construction (April 2013 to December 2014) and post-construction (November 2016 to September 2021) instantaneous water temperature between the downstream site (ALE-BDGWQ) and the upstream site (ALE USWQ1) (positive values indicate warmer temperatures at ALE-BDGWQ).

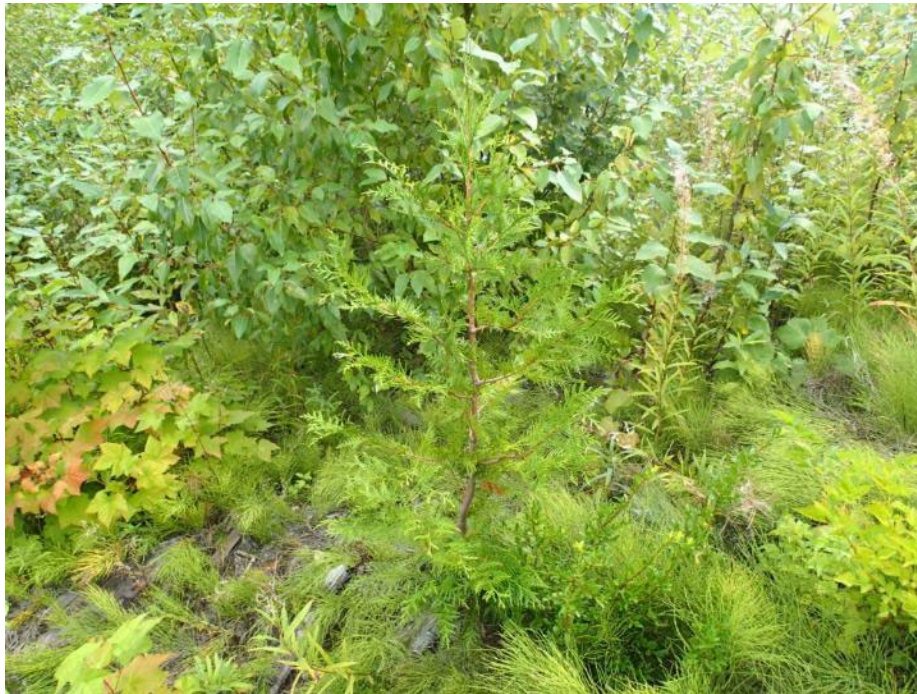
Figure 27. Western redcedar approximately 1 m in height at ALE-PRM05, on September 01, 2021.

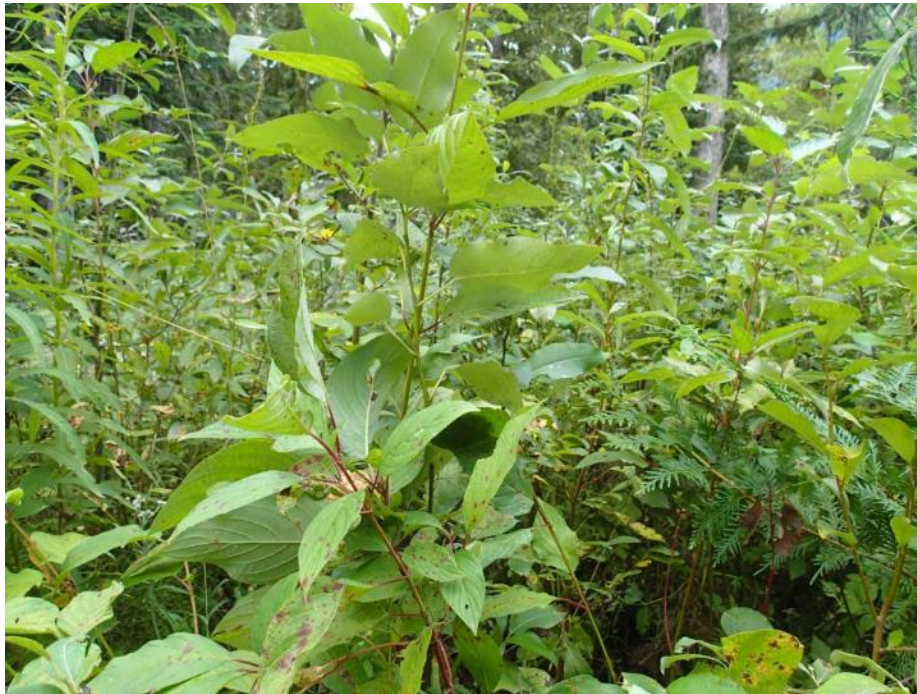
Figure 28. Diversity of woody species observed at ALE-PRM06, with red-osier dogwood in foreground. Western redcedar visible in right of photograph. Photograph taken on September 01, 2021.

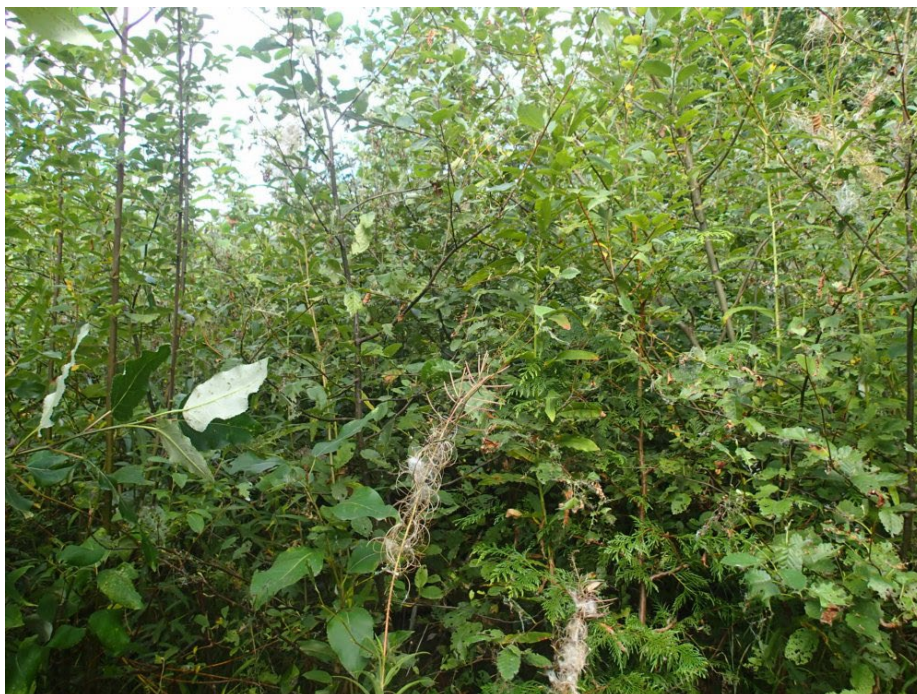
Figure 29. Abundant black cottonwood and red alder at ALE-PRM07 on September 01, 2021.

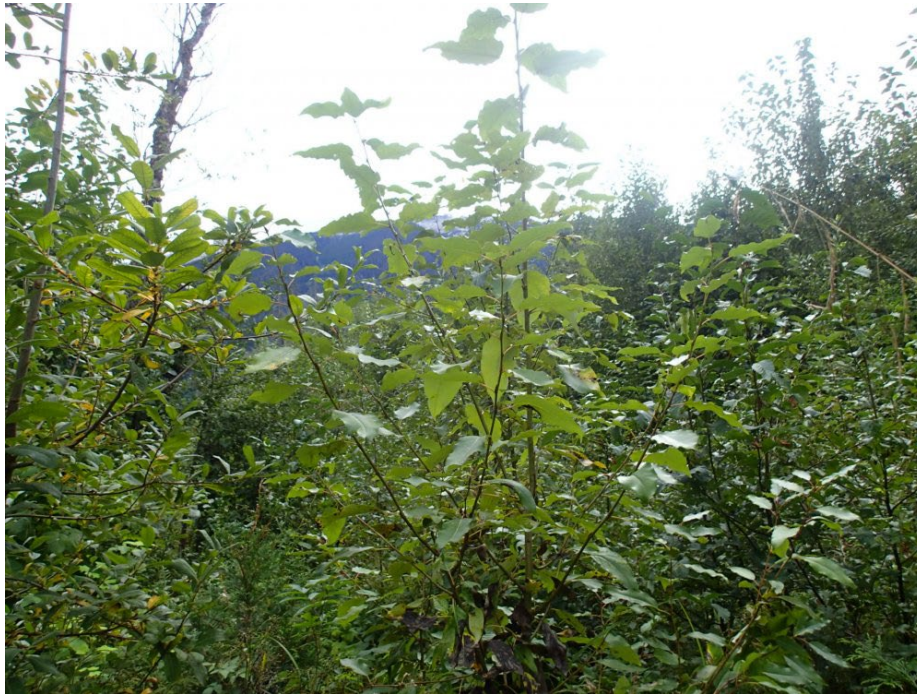
Figure 30. Tall vegetation at ALE-PRM03 on September 01, 2021.

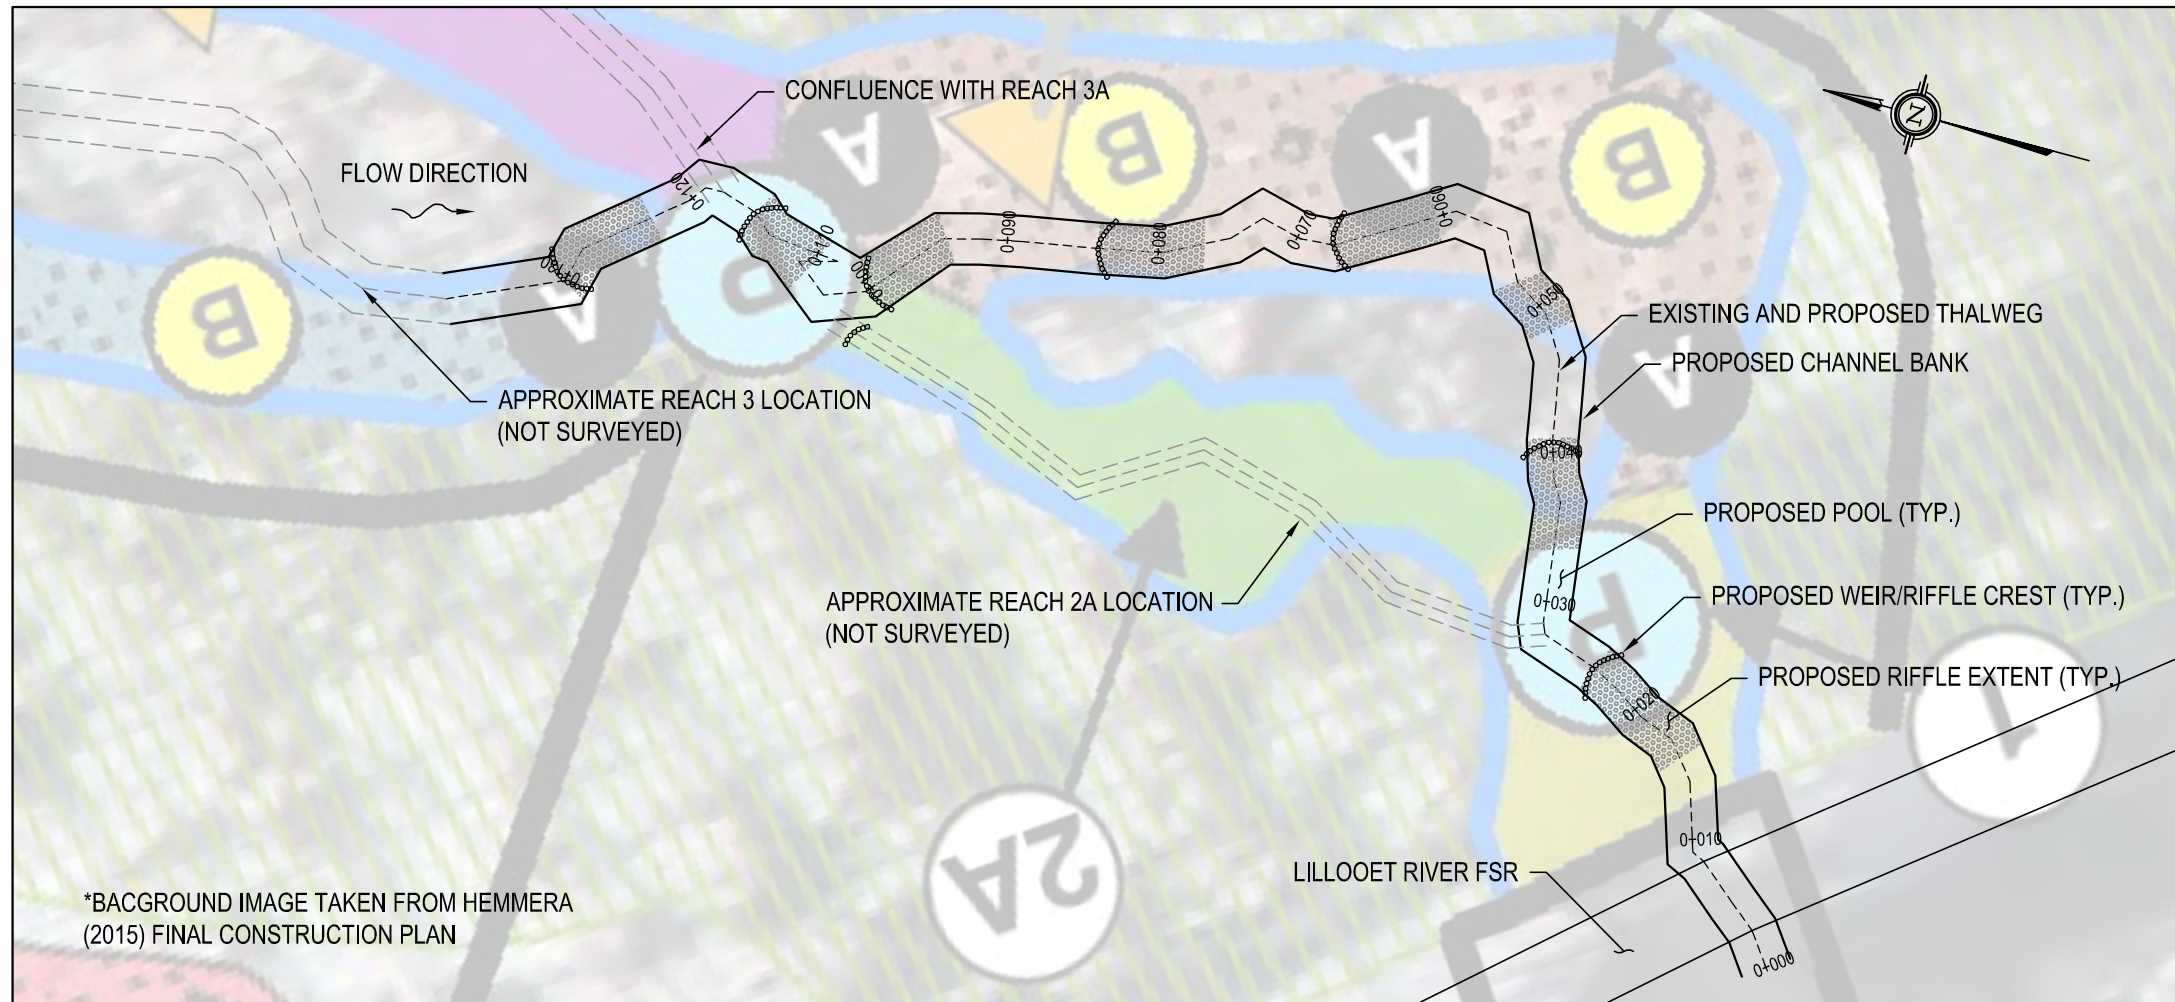
REACH 1, 2, & 2A PLANVIEW

*BACKGROUND IMAGE TAKEN FROM HEMMERA (2015) FINAL CONSTRUCTION PLAN
