Upper Lillooet Hydro Project

Operational Environmental Monitoring: Year 1

April 25, 2019

Ecofish Research Ltd.

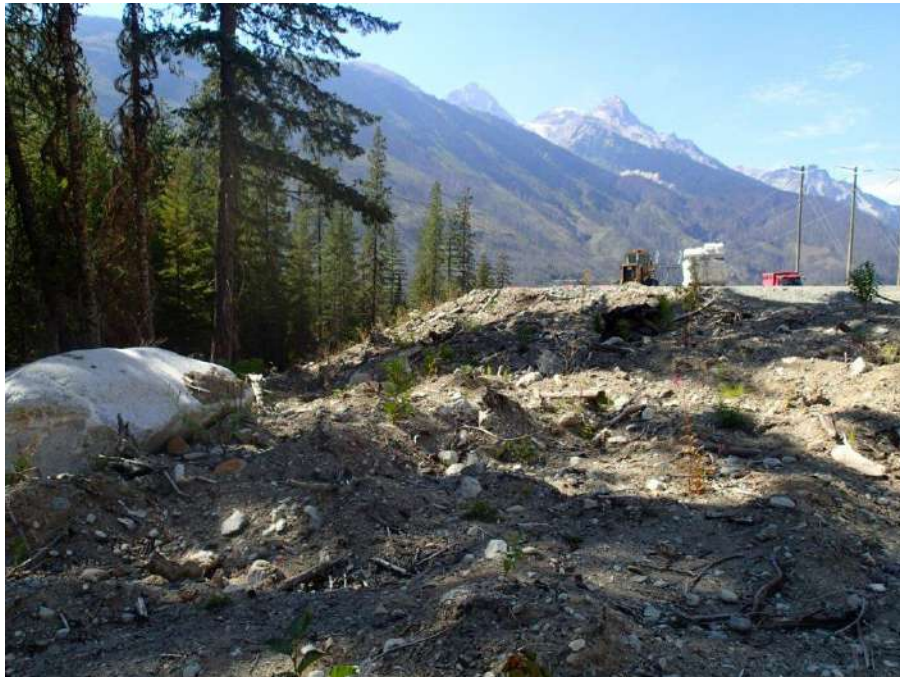
Figure 2. Abundant grasses and fireweed present at ULL-PRM01 on September 7, 2018.

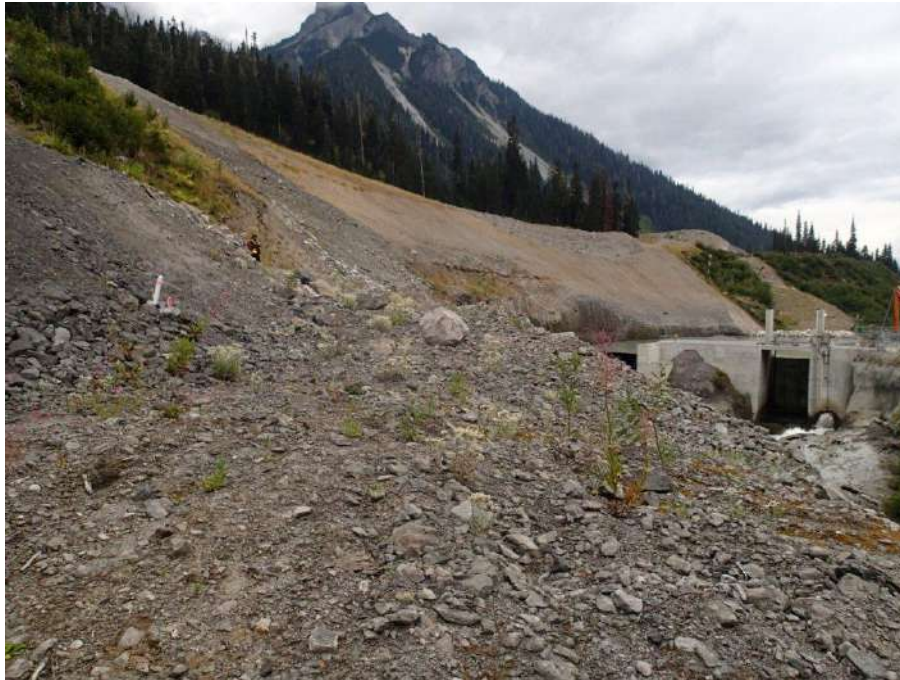
Figure 3. Rough and loose substrate with limited woody stem regeneration at ULL-PRM02 on September 7, 2018.

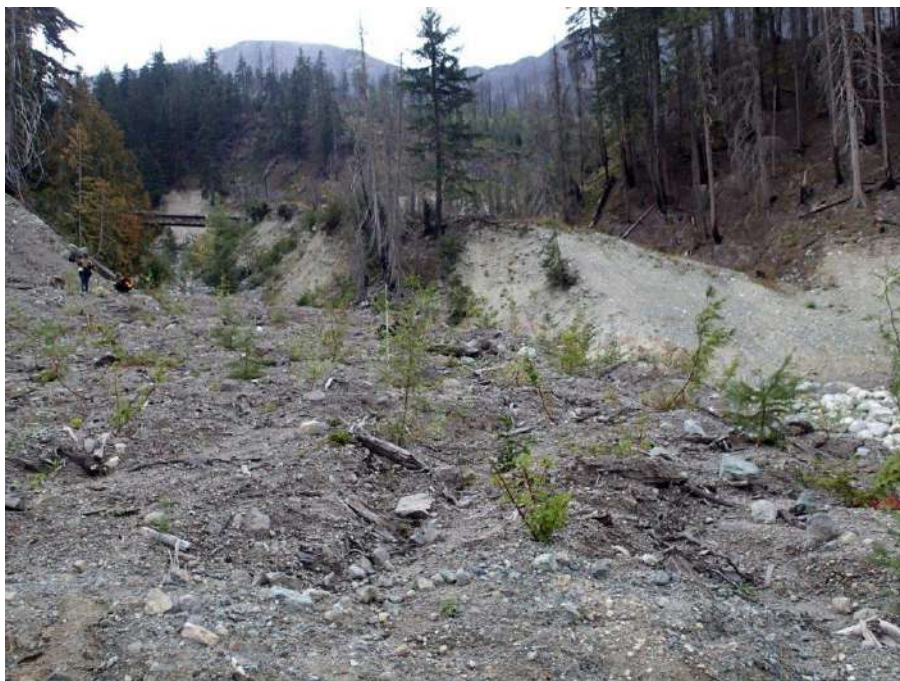
Figure 5. Naturally regenerating black cottonwood at ULL-PRM05 on September 7, 2018.

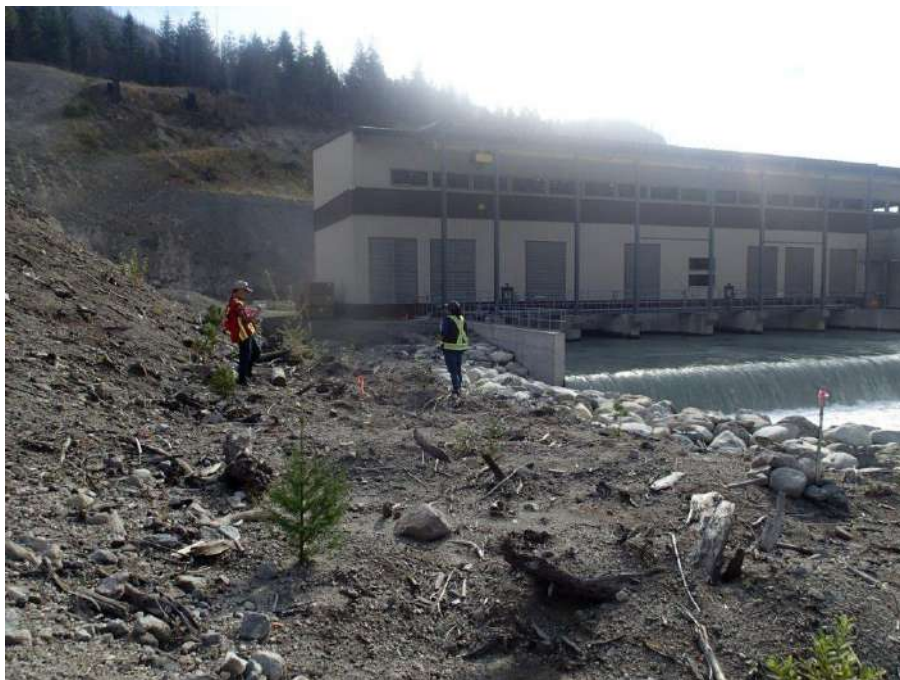
Figure 8. Sparse but healthy planted stock at ULL-PRM11 on September 6, 2018.

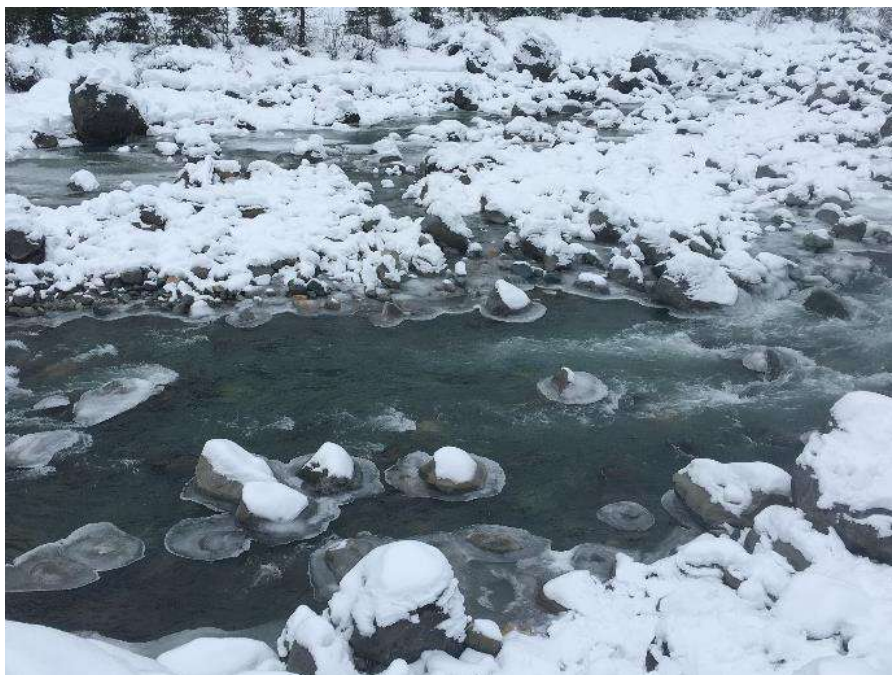
Figure 9. Looking river left to river right at ULL-DVIC01 on December 24, 2017 showing the lack of frazil or anchor ice and limited shelf ice.

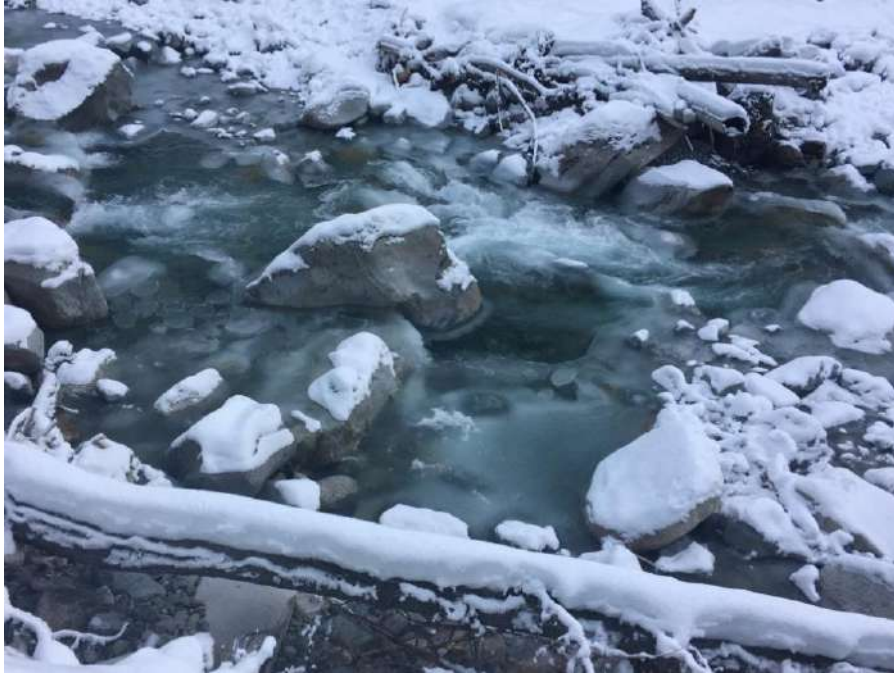
Figure 10. The river right side channel at BDR-DVIC03 on December 23, 2017 showing one of the deepest sections of frazil ice.

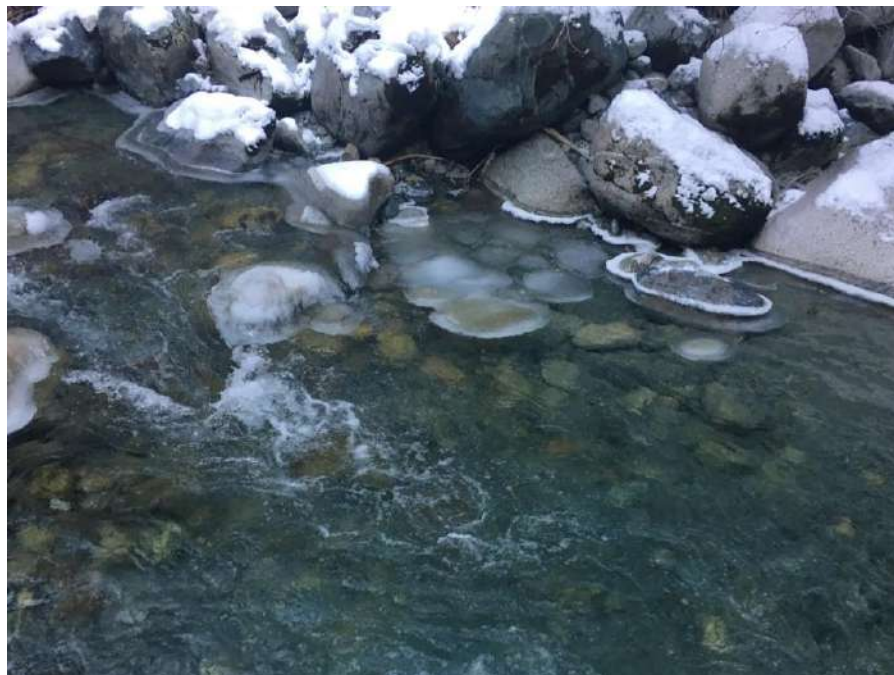
Figure 11. Ice conditions at BDR-DVIC05 on December 23, 2017 showing ice coverage at typical overwintering habitat (BDR-DVSN04).

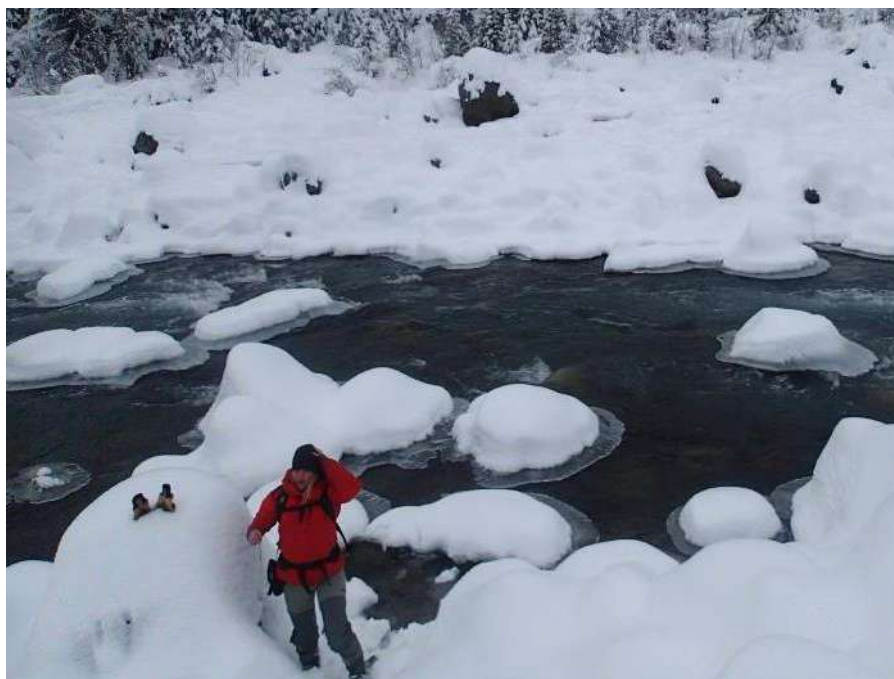
Figure 12. Looking from river left to river right at ULL-DVIC01 on January 2, 2018 showing the minimal margin ice and lack of frazil or anchor ice.

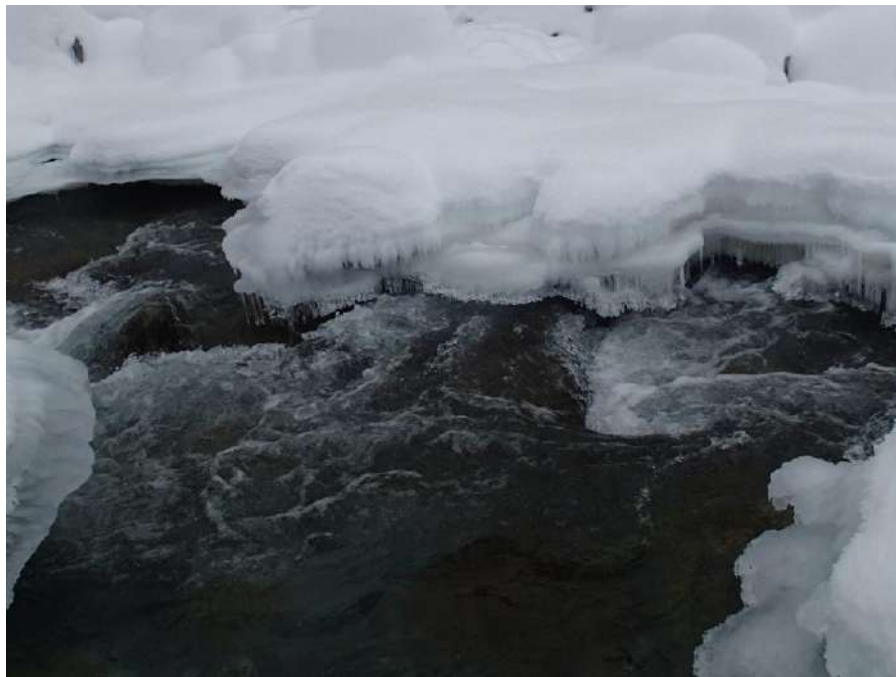
Figure 13. Looking from river right to river left at BDR-DVIC01 on January 2, 2018 showing the margin ice above the water level and the lack of frazil and anchor ice.

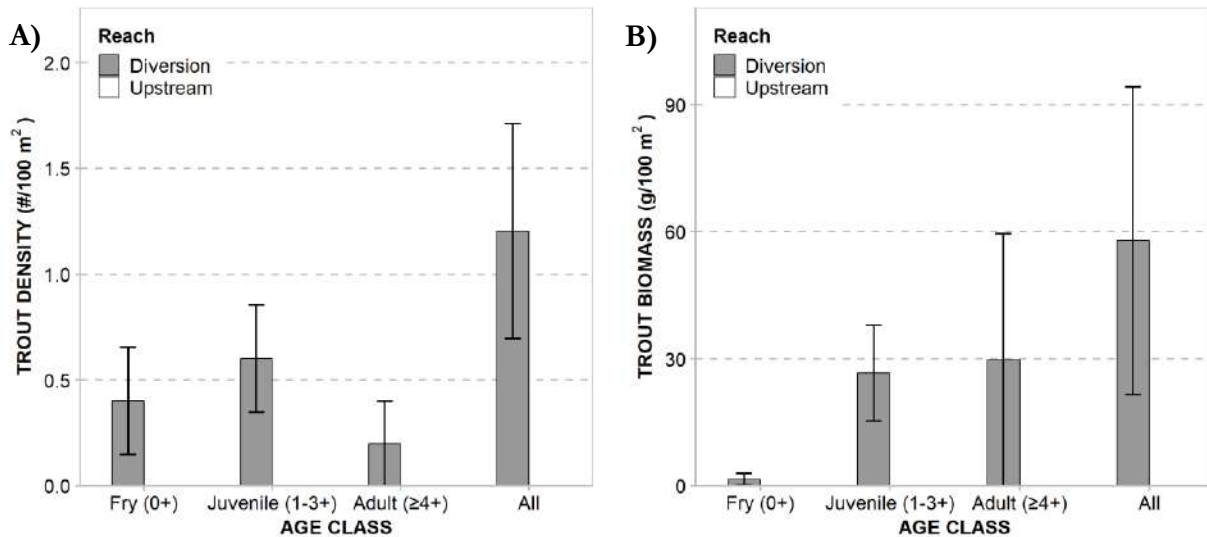
Figure 14. Average observed densities (± standard error) by age class of Bull Trout determined from closed-site electrofishing in the Upper Lillooet River in 2018 presented as: A) fish density per 100 m² (FPUobs), and B) fish biomass per 100 m² (BPUobs).

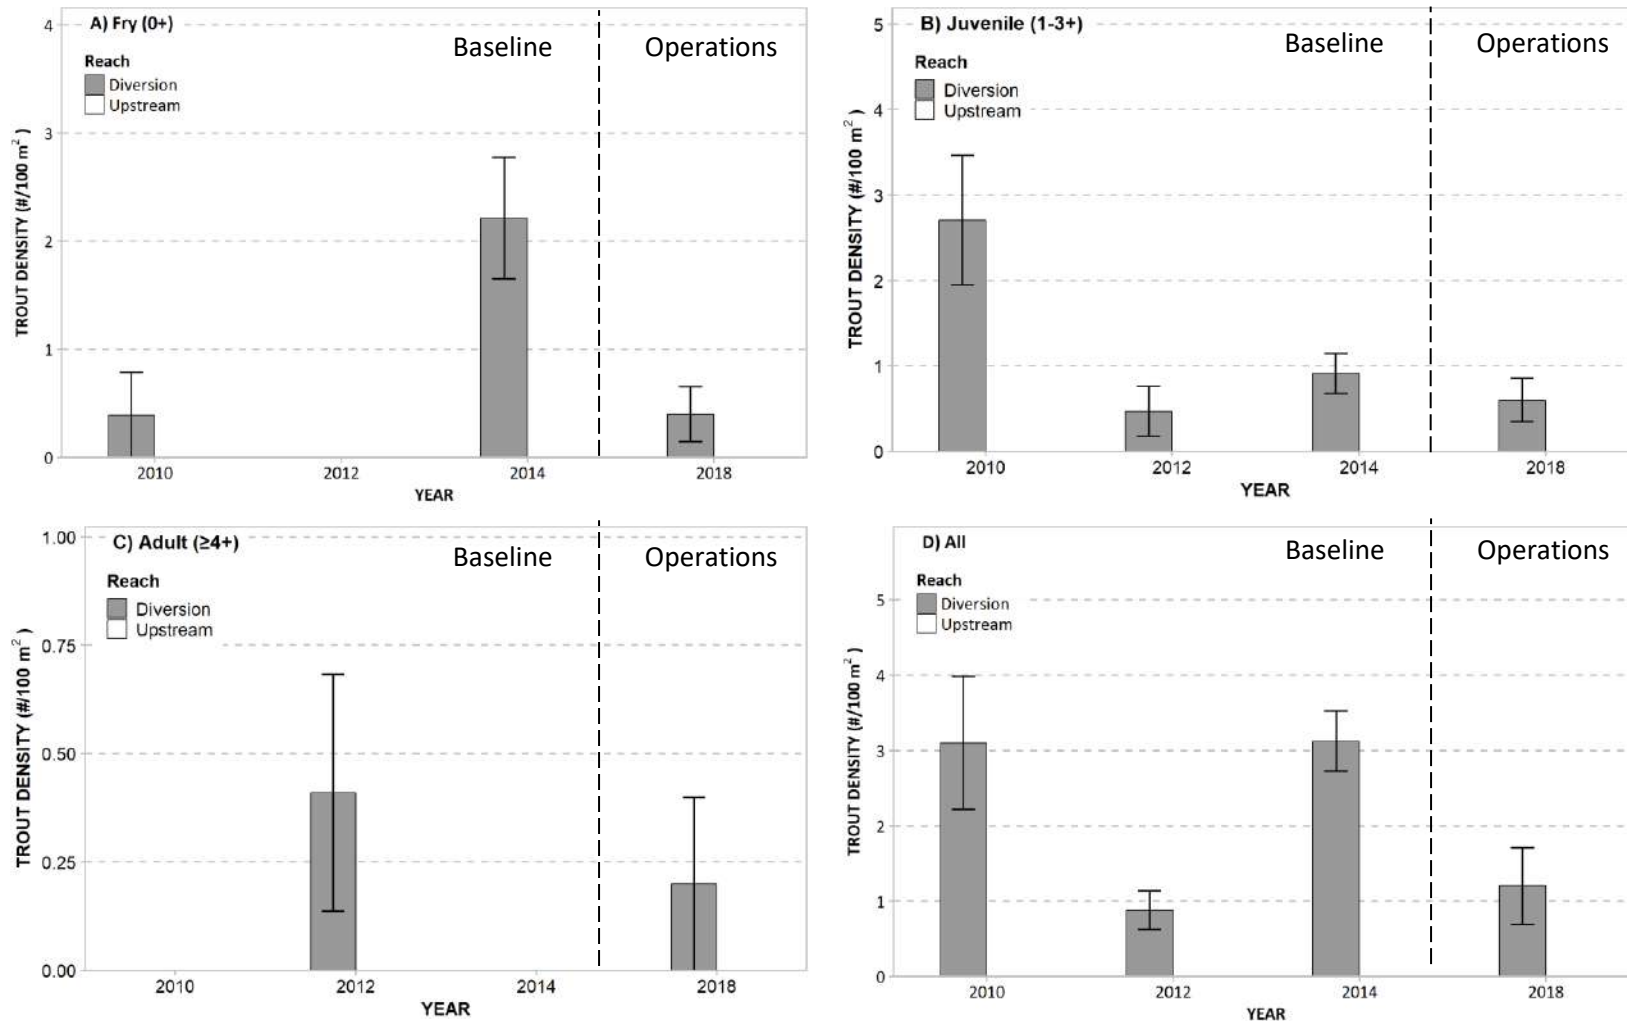
Figure 16. Average observed Bull Trout densities (FPUobs; \pm standard error) determined from closed-site electrofishing in the Upper Lillooet River in 2010, 2012, 2014, and 2018 presented by age class: A) fry (0+); B) juveniles (1-3+); C) adult ($\geq 4+$); and D) all age classes combined.

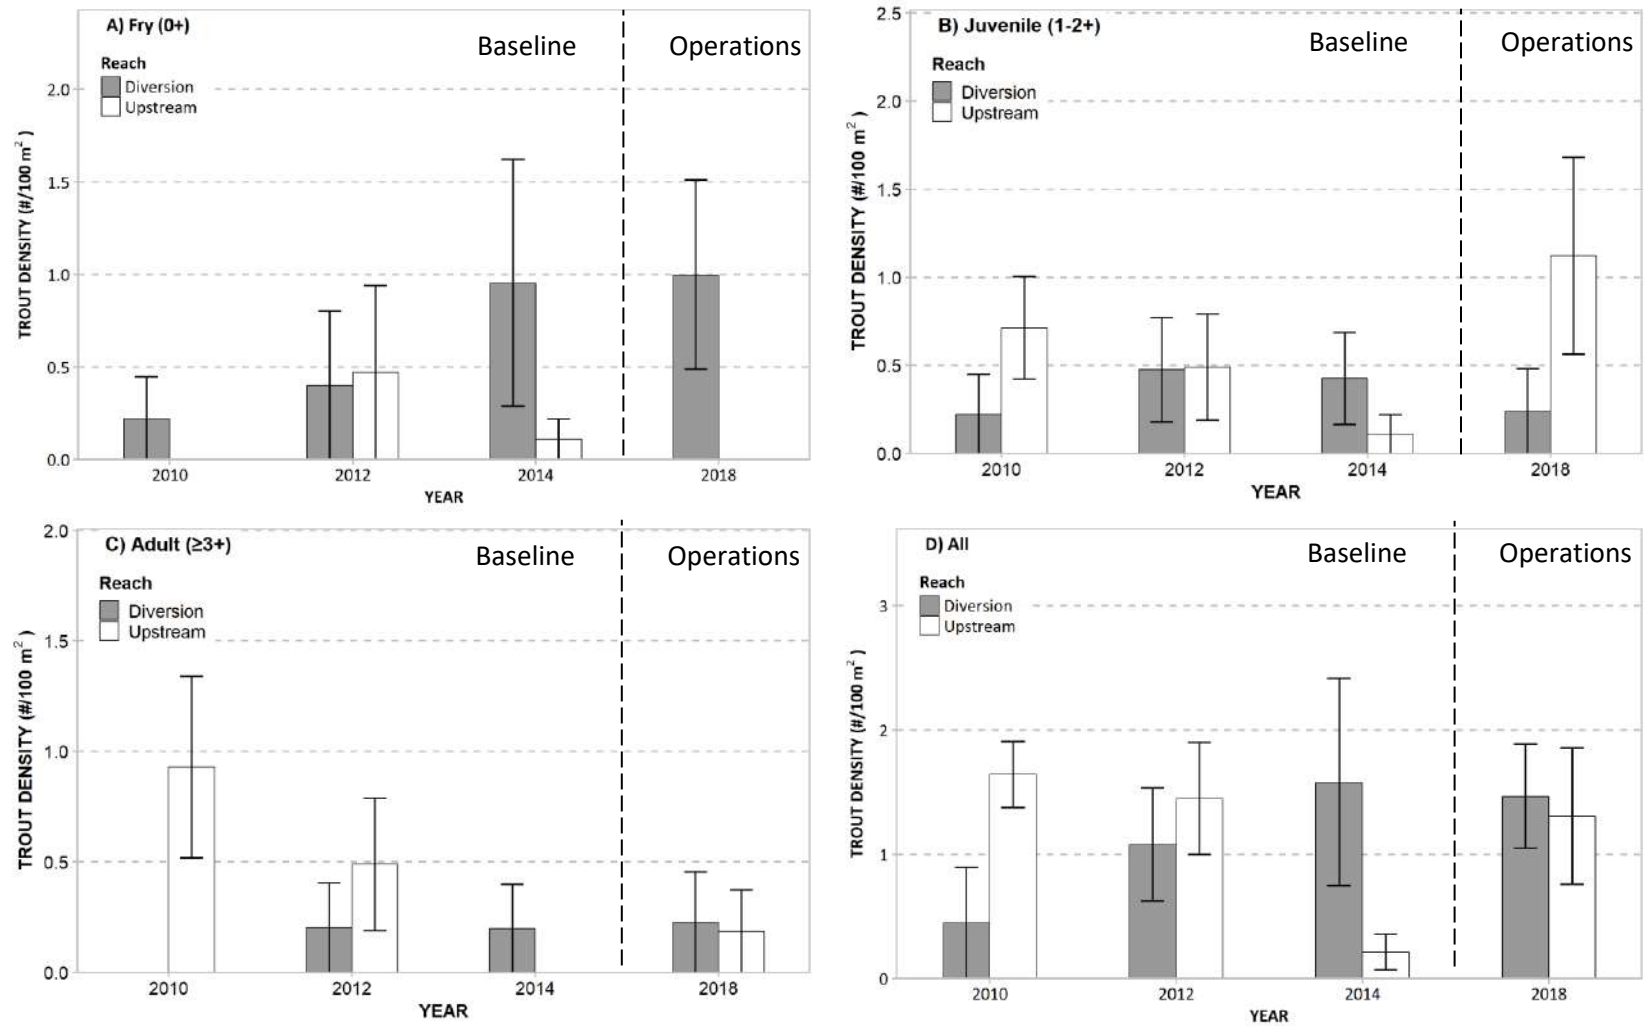
Figure 18. Average observed Cutthroat Trout density (FPUobs; \pm standard error) determined from closed-site electrofishing in the Upper Lillooet River in 2010, 2012, 2014, and 2018 presented by age class: A) fry (0+); B) juveniles (1-2+); C) adult ($\geq 3+$); and D) all age classes combined.

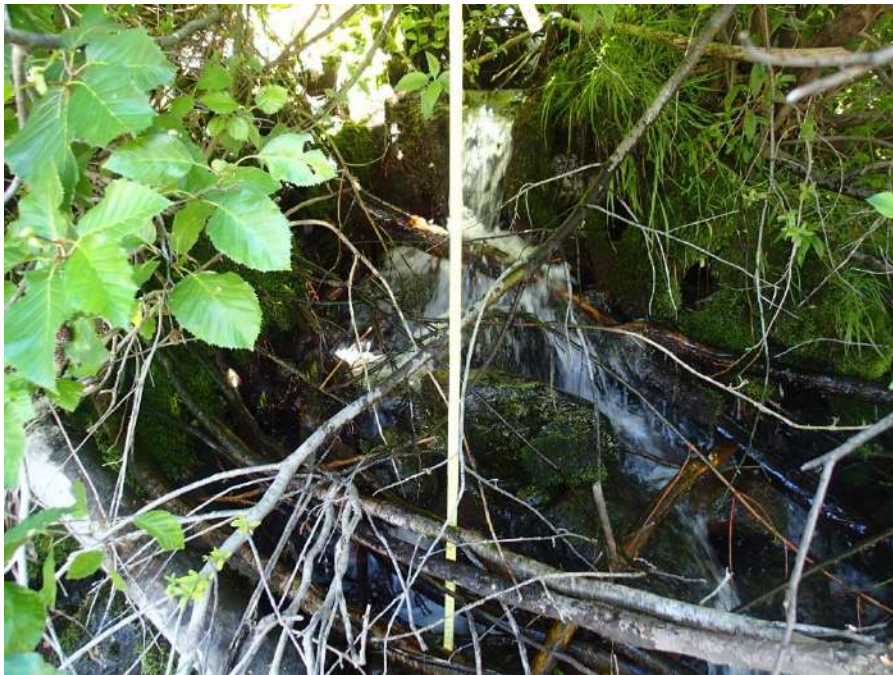
Figure 21. Obstacle to fish passage in the tributary at km 83.6 at daily average Upper Lillooet River flows of $41.5 \text{ m}^3/\text{s}$ on June 18, 2018.

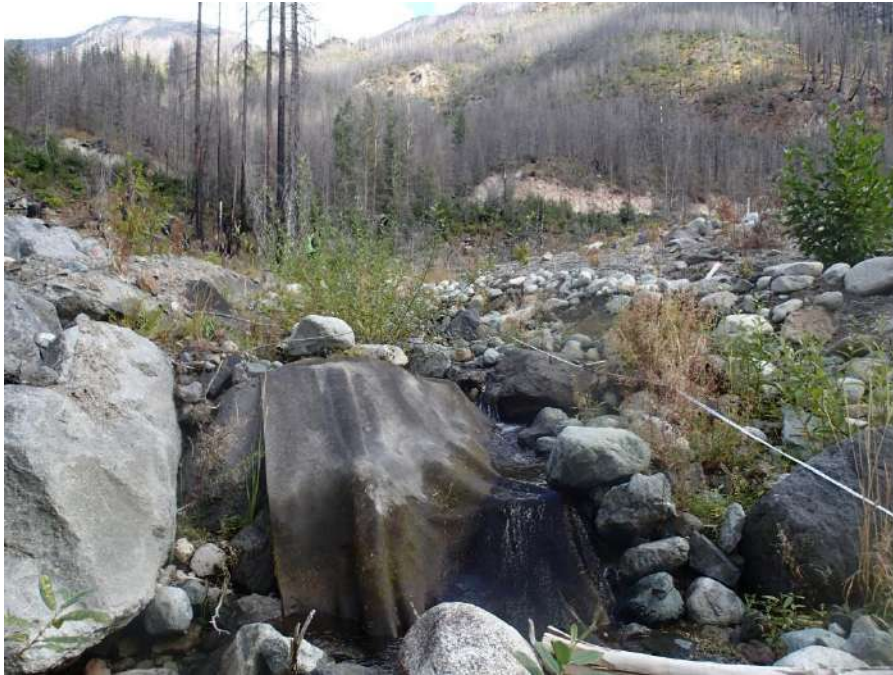
Figure 33. Exposed geotextile within the stream channel at ULL-ASTR04IM on August 31, 2019.

- Add rocky material to cover areas of exposed geotextile at ULL-PRM09, by the Coastal Tailed Frog stream (ULL-ASTR04) crossed by the penstock (this recommendation also applies to amphibian habitat restoration monitoring). The area of exposed geotextile is small enough that this work can be accomplished by hand, using local materials already on site.

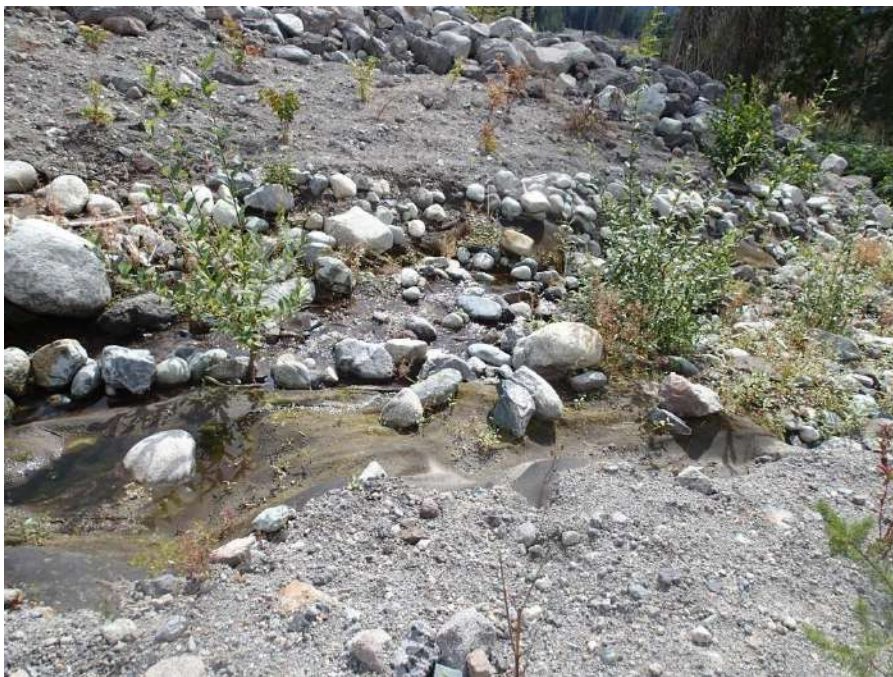
Figure 34. Exposed geotextile along ULL-ASTR04 on August 31, 2018.

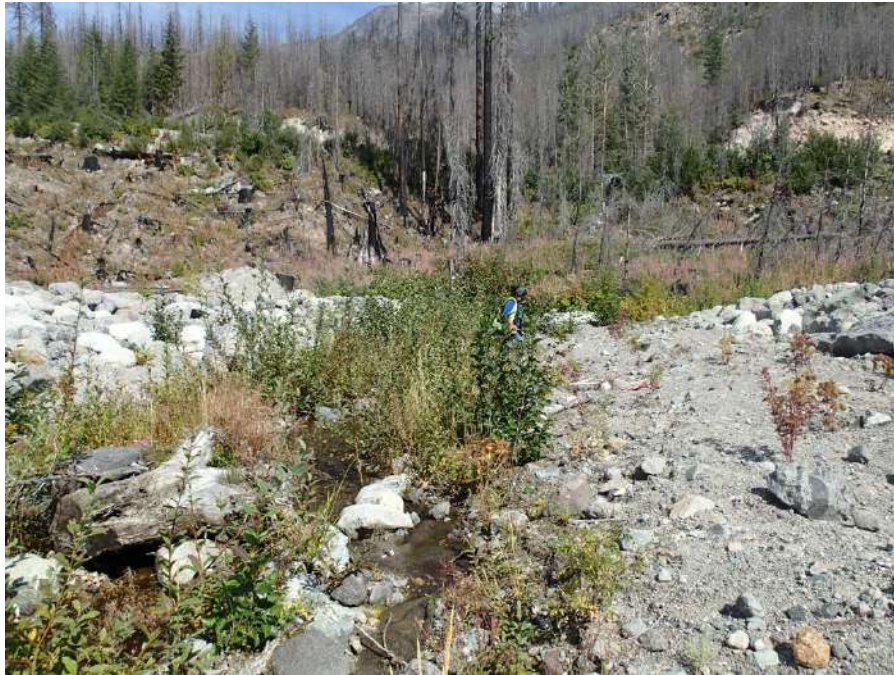
Figure 35. Looking upstream along the impact reach of ULL-ASTR04 on September 6, 2018.

- Covering the areas of exposed geotextile within the riparian areas with additional rocky substrate (this recommendation also applies to riparian revegetation effectiveness monitoring); and
- Covering the area of exposed geotextile within the stream channel impact reach (ULL-ASTR04IM) with additional rocky substrate.

The area of exposed geotextile is small enough that this work can be accomplished by hand, using local materials already on site. Given exposed geotextile within the stream channel the following monitoring action is also recommended:

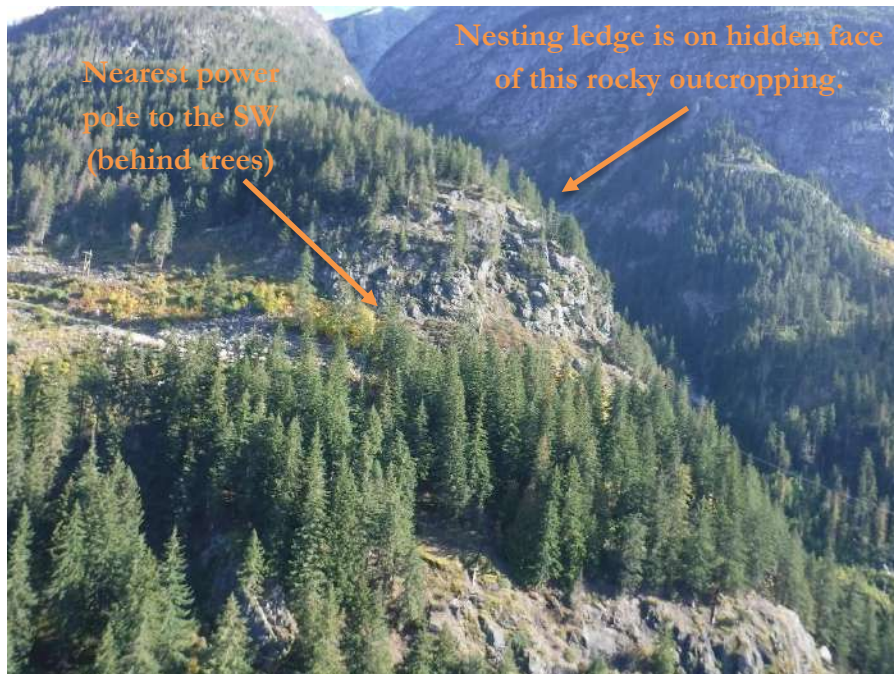
The vertical and horizontal distances between Peregrine Falcon nesting ledges and the nearest power pole of the transmission line are presented in Table 65 for the three nesting ledges identified. The smallest horizontal (150 m) and vertical distance (0 m) were both recorded for site ULH-PEFACM01 (habitat polygon ULH-PEFA01) (Figure 36). However, these minimum measurements did not consider orientation of the nesting ledge. When the nearest power pole facing the nesting ledge orientation (SE) was considered, horizontal and vertical distances increased to 287 m and ~75 m, respectively (see comments in Table 65). Vertical and horizontal distances measured for site ULH-PEFACM03 (habitat polygon ULH-PEF16) (Figure 37, Figure 38) are conservative, since nesting ledges are oriented to the east and the transmission line is north of the nesting ledges. Distances between nesting ledges and the nearest power pole for site ULH-PEFACM02 (habitat polygon ULH-PEF04) are intermediate, and as is apparent from Figure 39, the transmission line is well separated from the nesting ledges, both horizontally and vertically. Thus, in all cases, when vertical and horizontal distances are considered together, along with orientation of the nesting ledges relative to the power pole locations, the locations of the nearest poles are far enough away to not compromise the suitability of the nesting ledges for Peregrine Falcons. This evaluation is based on professional judgement and the classification of Peregrine Falcons as a species “moderately” tolerant of human activities near the nest site (MOE 2013).

Figure 36. Transmission line in the vicinity of Peregrine Falcon nesting ledges at ULH-PEFACM01, on September 24, 2018.

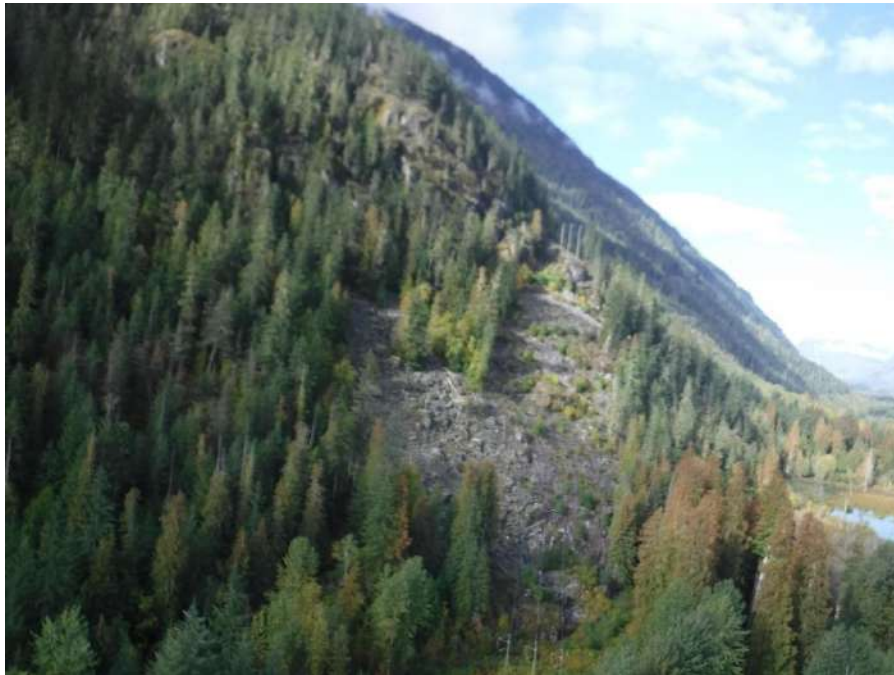
Figure 37. Transmission line below Peregrine Falcon nesting ledges at ULH-PEFACM03, on September 24, 2018. The nearest nesting ledges are approximately 300 m above the transmission line, not visible in this photo.

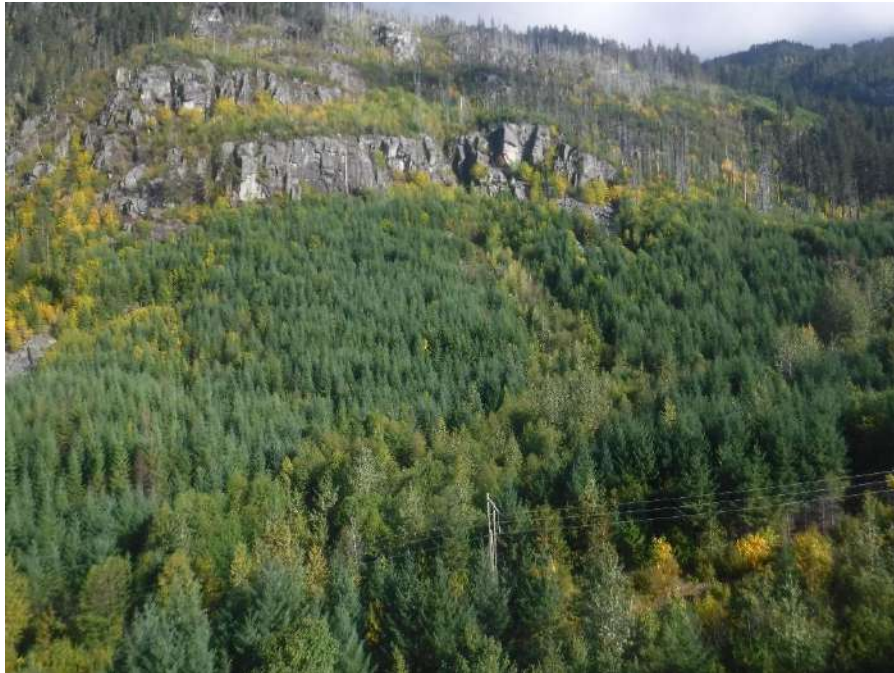
Figure 39. Transmission line below Peregrine Falcon nesting ledges at ULH-PEFACM02, on September 24, 2018.

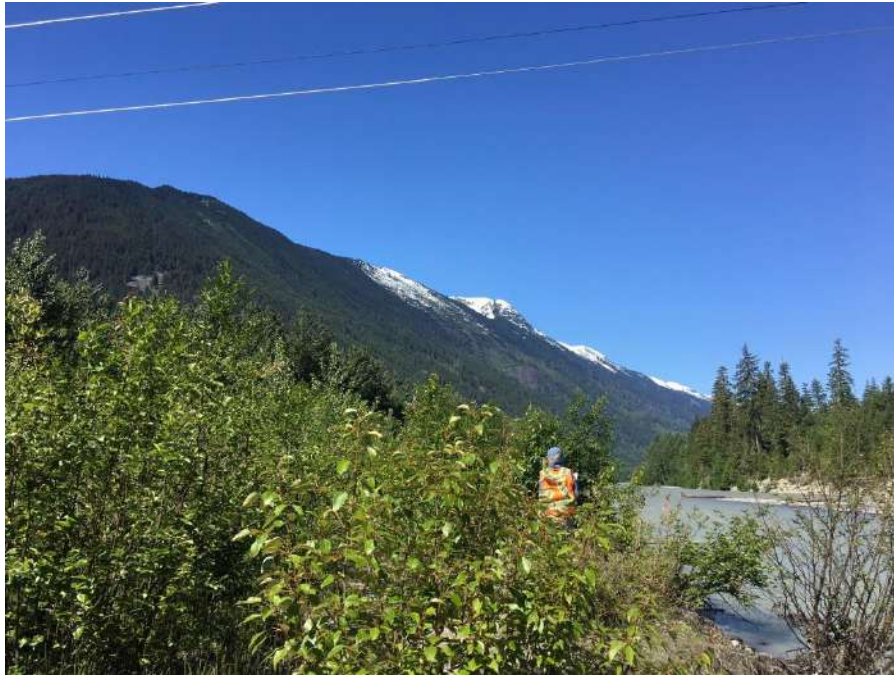
Figure 40. Avian collision transect along the Lillooet River transmission line crossing (south side), showing thick vegetation under the power line, on May 23, 2018.

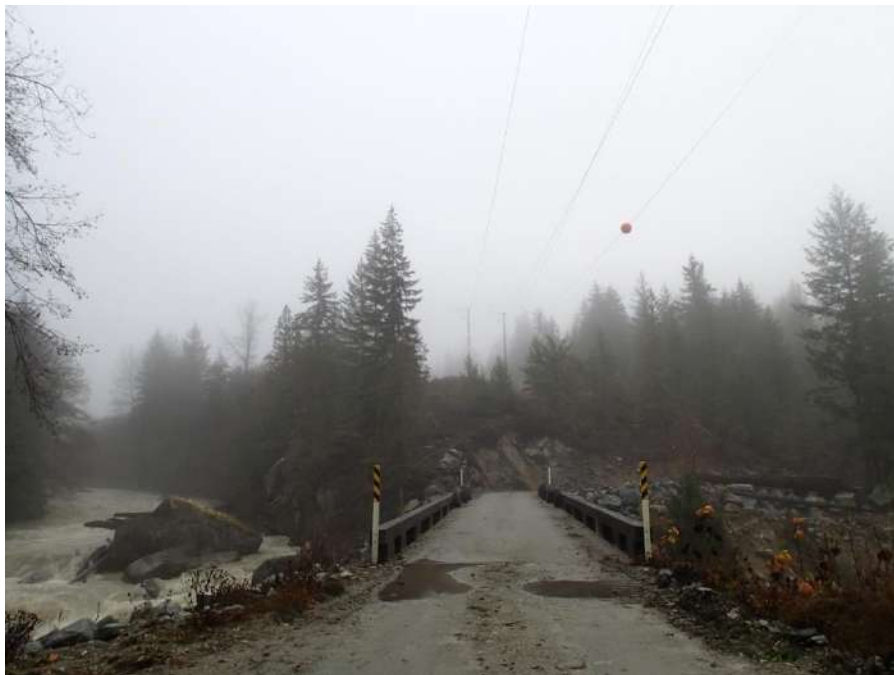
Figure 41. Avian collision transect along the Ryan River transmission line crossing, showing high flows in the Ryan River, on November 2, 2018.

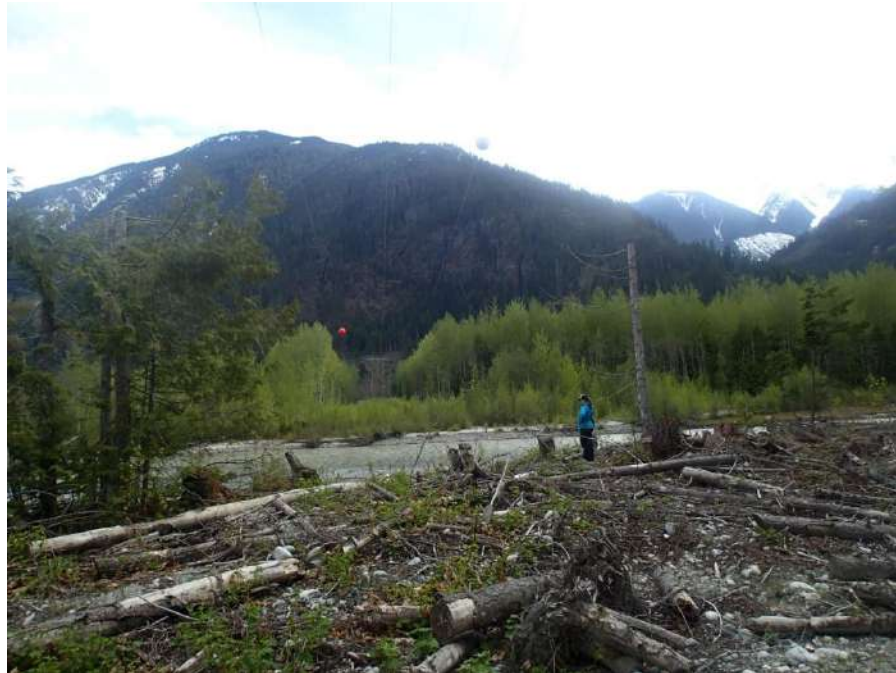
spring survey at the north side of the Lillooet River transmission line crossing; Figure 42). In all cases, surveys for carcasses provide only an indicator of potential avian losses, because any birds that collide with the power lines and fall to the ground are likely to be scavenged rapidly.

Figure 42. Avian collision transect along the Lillooet River transmission line crossing (north side), showing good ground visibility, on April 30, 2018.

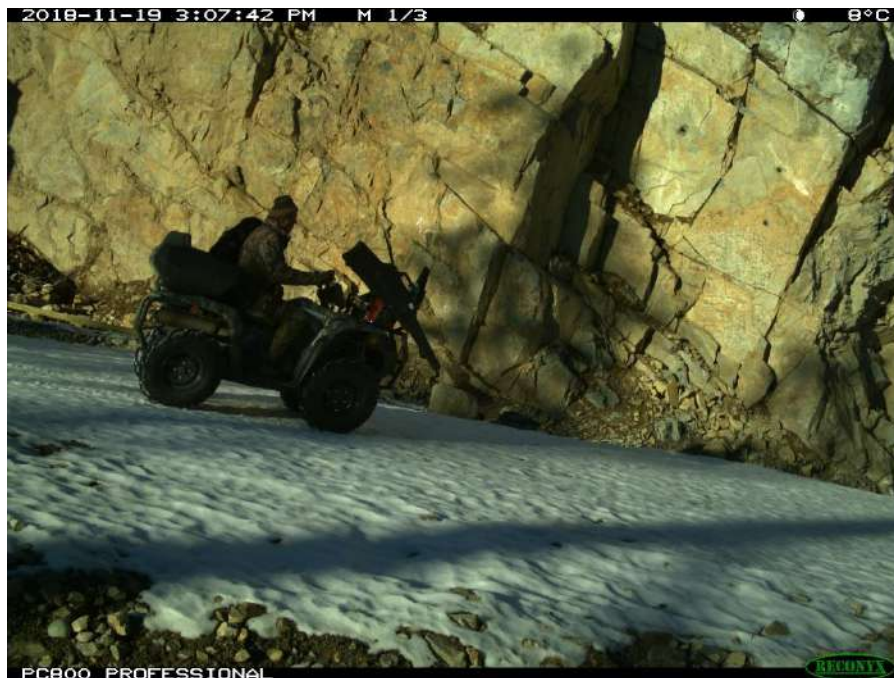
Photographs taken by the three remote infrared cameras installed along the Boulder Creek HEF intake access road indicated that one member of the public was able to travel past the gate on an ATV during the Year 1 monitoring period. A hunter on an ATV was photographed by BDR-CAM01 and BDR-CAM02 along the intake access road on November 19, 2018 (Figure 44). BDR-CAM03 was not functional on this date (Table 20); thus, the means by which the hunter travelled past the gate is not known (i.e., whether the gate was open or closed and if the ATV passed through it or around it). Later in the winter, the gate became non-functional due to snow height. During the camera maintenance trip on January 17, 2019, both the gate and the camera (BDR-CAM03) were completely buried in snow (Figure 45).

Figure 44. Hunter on ATV travelling along the Boulder Creek HEF intake access road northeast of the gate photographed by BDR-CAM02 on November 19, 2018.

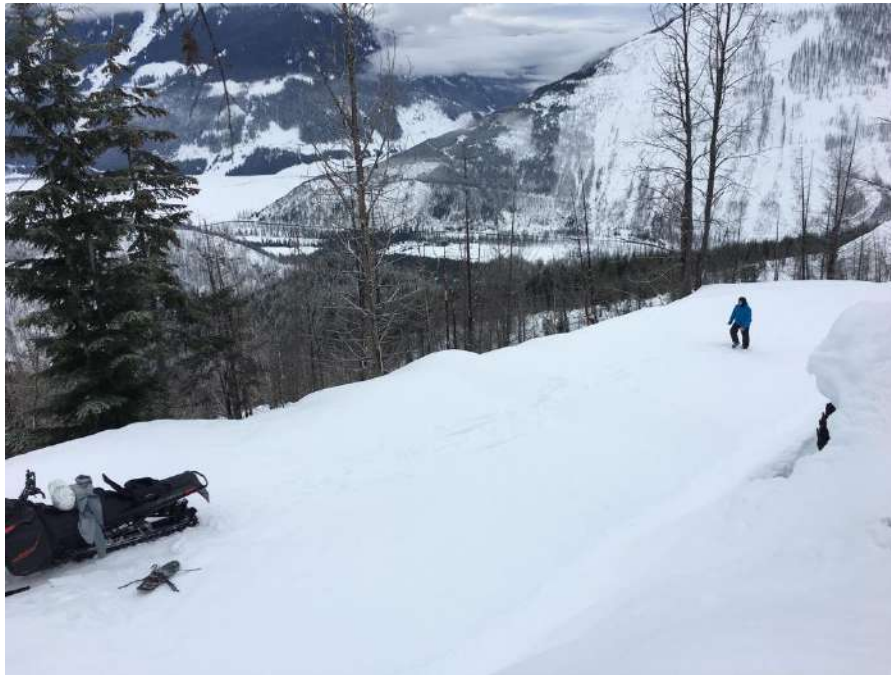
Figure 45. Gate across the Boulder Creek HEF intake access road buried in snow and non-functional on January 17, 2019. Snowmobile in photo belongs to crew accessing the area for camera maintenance.

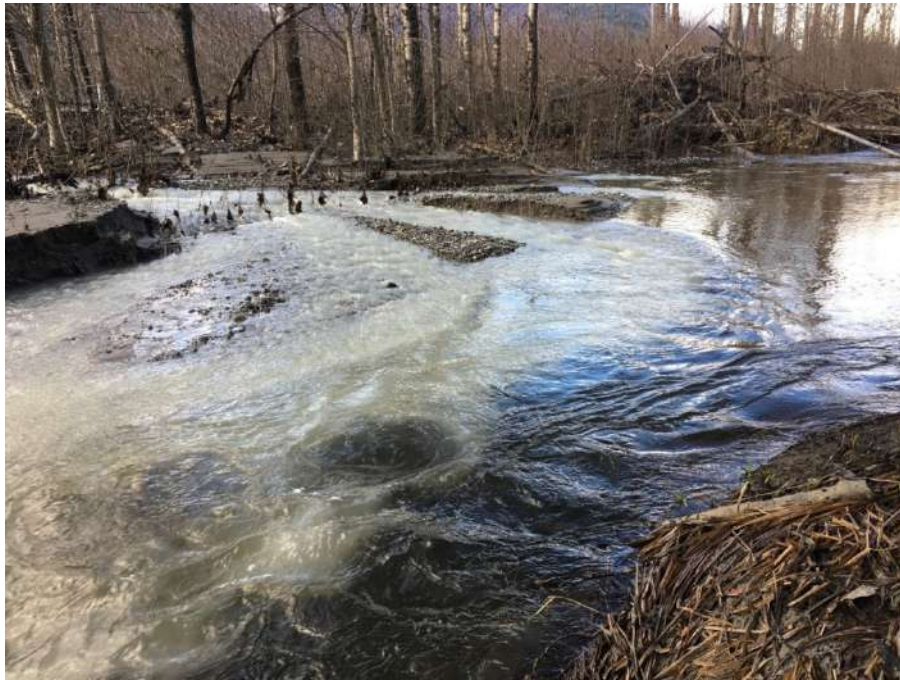
Figure 2. Looking upstream at a newly formed side channel of the Upper Lillooet River entering Alena Creek approximately 25 m downstream of the Lillooet FSR Bridge on November 14, 2016.

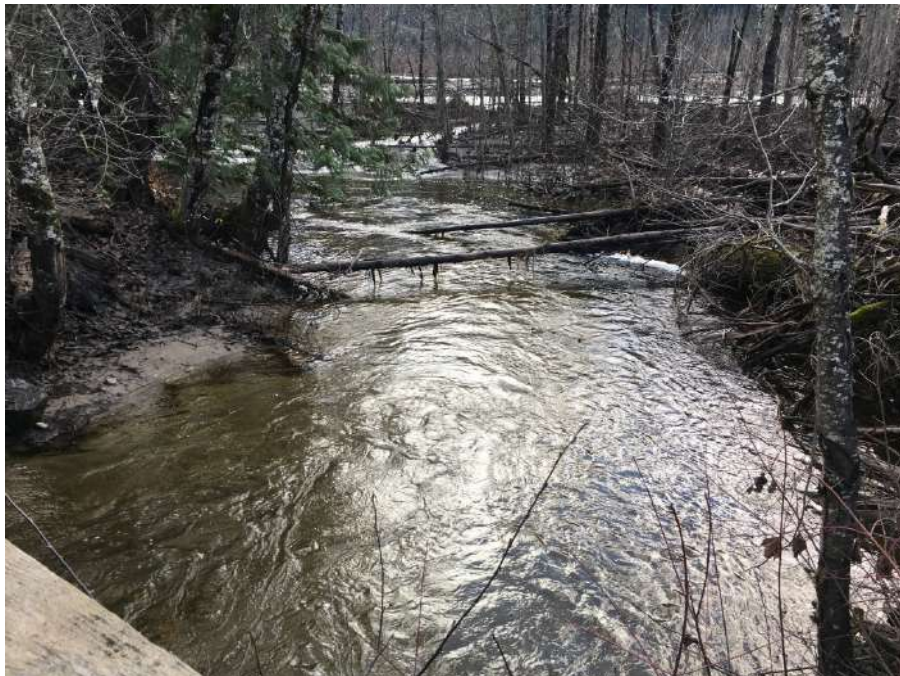
Figure 3. Looking downstream at Alena Creek from the Lillooet River FSR bridge in November 2016. The new Upper Lillooet River side channel is visible on river right.

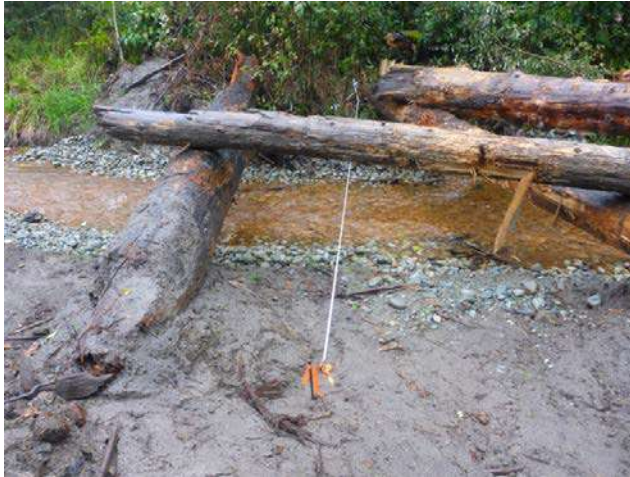
Figure 7. Looking RR-RL at ALE-XS1 on Sep 19, 2016.

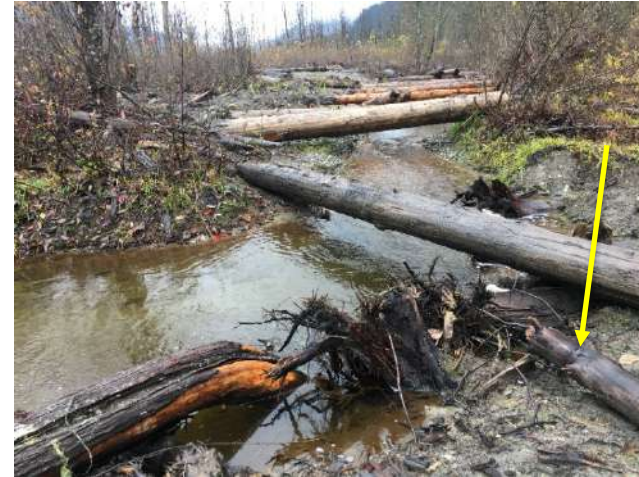
Figure 9. Looking upstream at bend at installed rootwads on Oct 26, 2016.

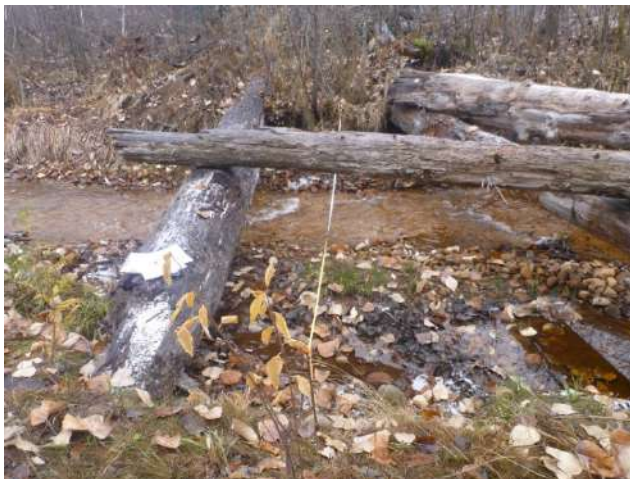
Figure 8. Looking RL-RR at ALE-XS1 on Nov 10, 2017.

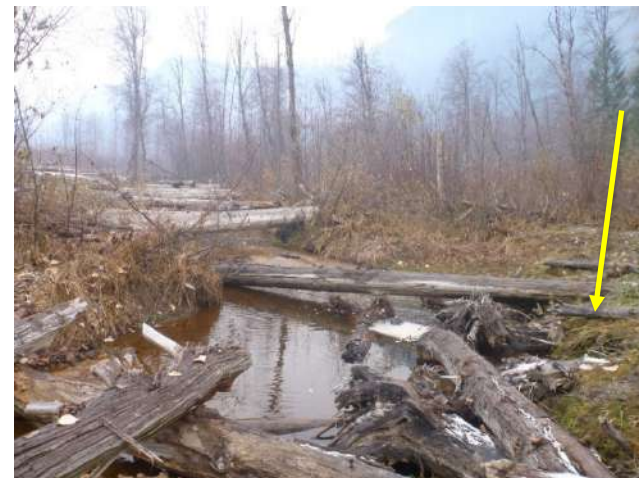
Figure 10. Looking upstream at bend at installed rootwads where bank has eroded on Nov 10, 2017.

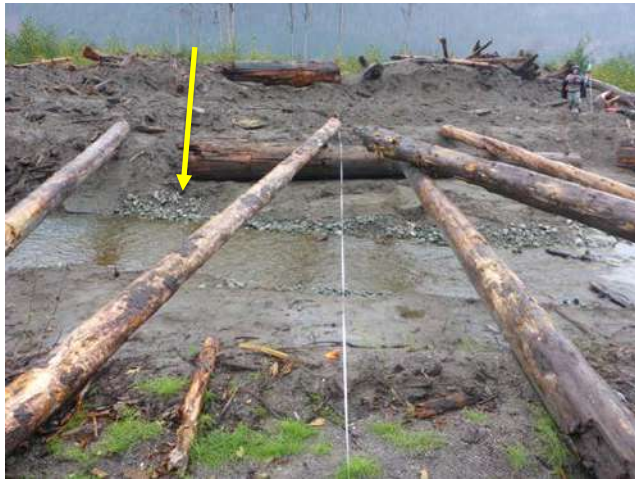
Figure 12. Looking RL-RR at ALE-XS5 on Sep 19, 2016.
Note wetted width at yellow arrow.

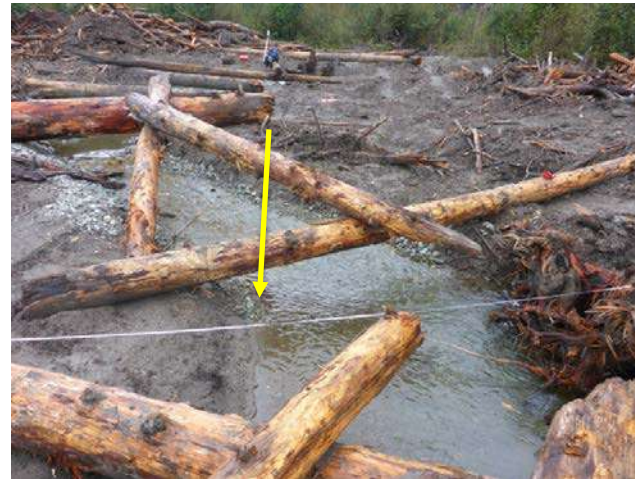
Figure 14. Looking upstream at riffle crest (0+185, Reach 3) on Sep 16, 2016.

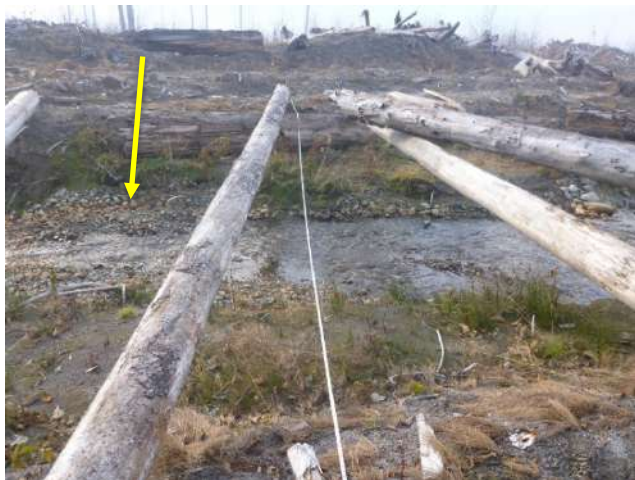
Figure 13. Looking RL-RR at ALE-XS5 on Nov 10, 2017.
Note wetted width at yellow arrow.

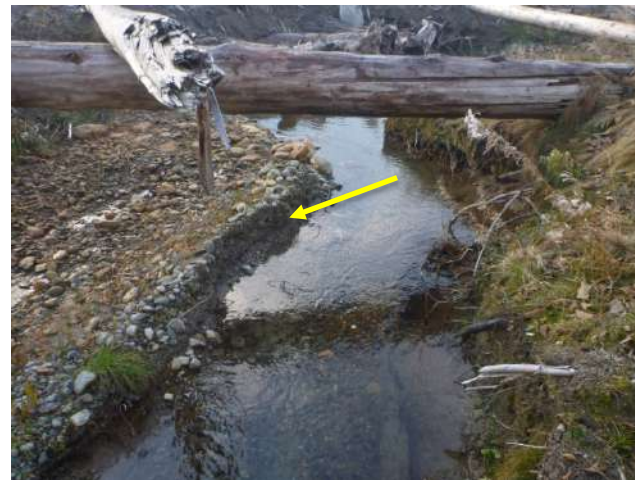
Figure 15. Looking upstream at riffle crest (0+185, Reach 3) at right bank erosion on Nov 10, 2017.

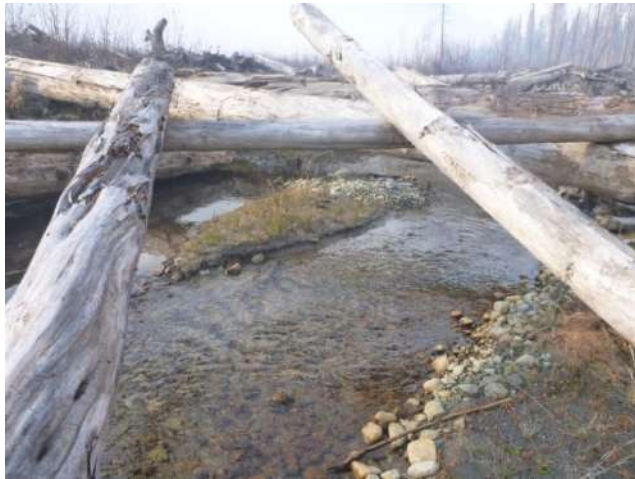
Figure 16. Looking upstream of ALE-XS6 at the formation of a mid-channel bar on Nov 10, 2017.
