Upper Lillooet Hydro Project

Operational Environmental Monitoring: Year 1

April 25, 2019

Ecofish Research Ltd.

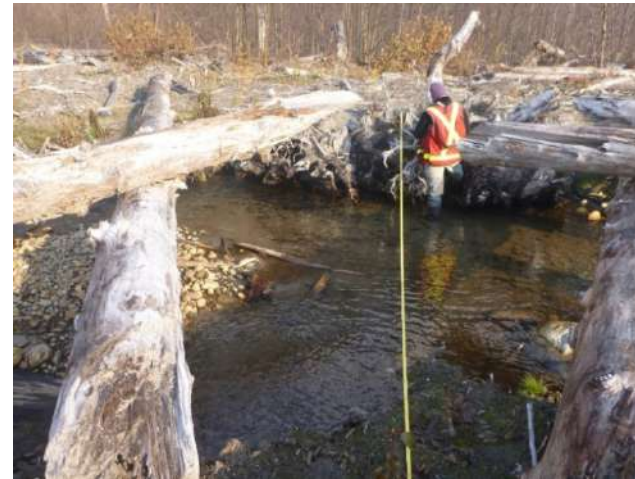
Figure 18. Looking RR-RL at ALE-XS7 on Nov 10, 2017. Note upstream mid-channel bar formation.

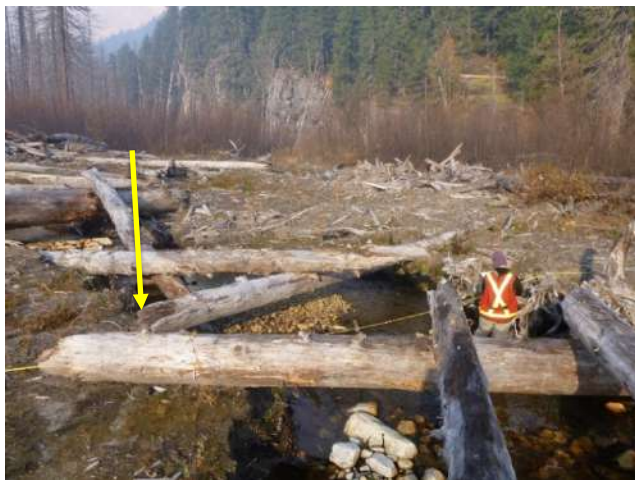
Figure 17. Looking upstream at ALE-XS7 on Nov 10, 2017.

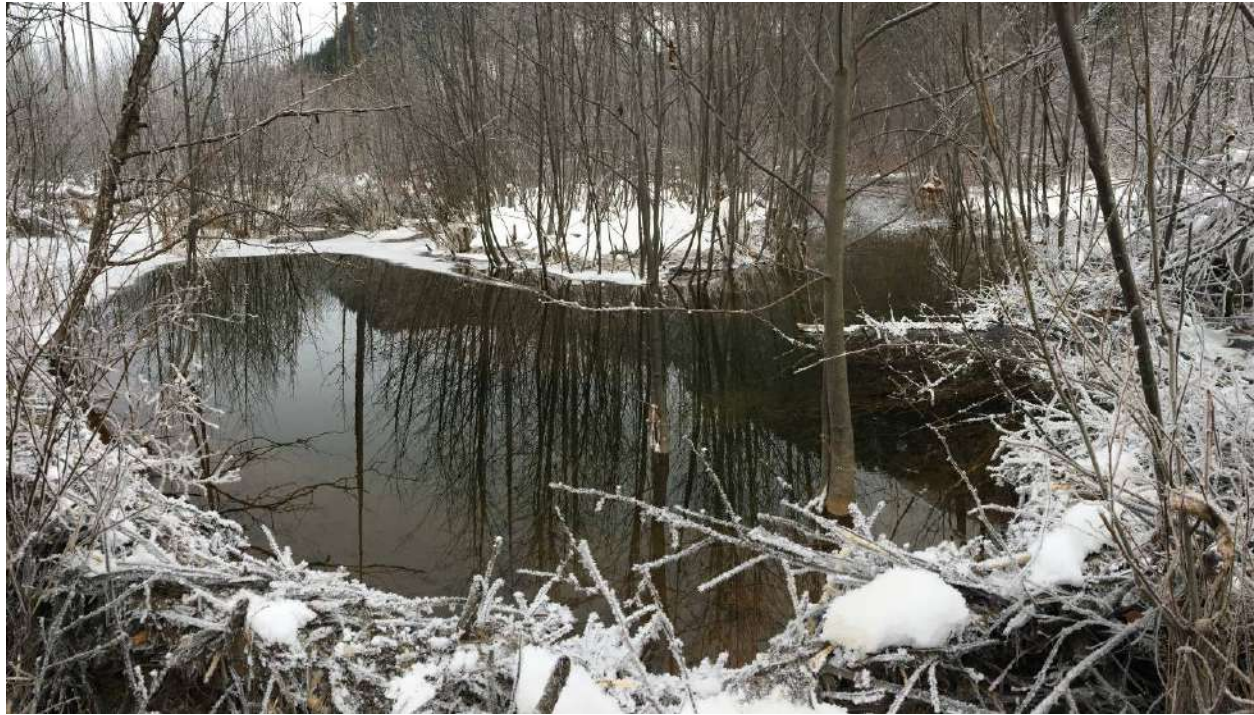
In 2016, Alena Creek saw a notable increase in beaver activity in Reach 2, in which ALE-MT03, 04 and 06 are located (Map 4). The largest dam was located approximately 100 m upstream of the upper extent of the enhancement work conducted in Reach 1. This dam was approximately 50 m in length and up to 1.8 m high (Figure 31). This was the key dam responsible for the backwatering seen throughout Reach 2, though there were other large dams constructed, including ones that diverted water away from the primary channel surveyed during baseline studies. The beavers were trapped and removed from the area in late 2016, though the dams remained intact. The 1-in-20 year flow on November 9, 2016 allowed enough water over the key dam to allow Coho Salmon access to upstream spawning areas, though the dam was undamaged (Figure 32). The dam(s) resulted in a significant increase in the amount of rearing habitat available at ALE-MT03, but also restricted movement downstream to Reach 1 under the flow conditions observed at the time of sampling in September 2017. This likely contributed to the higher catch of Coho Salmon observed at ALE-MT03 in 2017 compared to 2013; the higher catch observed in 2014 is biased high by the short daytime sets and the likelihood that catchability is not constant throughout the trap's soak time, with a high initial catch rate that diminishes over time (Figure 29, Harwood *et al.* 2016). The restriction of downstream movement may also have contributed to the reduced number of Coho captured in the enhanced Reach 1 compared to baseline sampling. The key dam in Reach 2 was breached during a rain event on November 26, 2017, and a new channel was carved around the dam (Figure 33). This rain event allowed spawning Coho access through Reach 2 into the upstream reaches, including the enhancement work in Reach 3. This breach ultimately resulted in a dewatering of the channels throughout Reach 2 and a change of channel configuration compared to baseline years.

Figure 31. Panoramic view looking upstream at the primary dam 100 m upstream of Reach 1 on December 9, 2016.

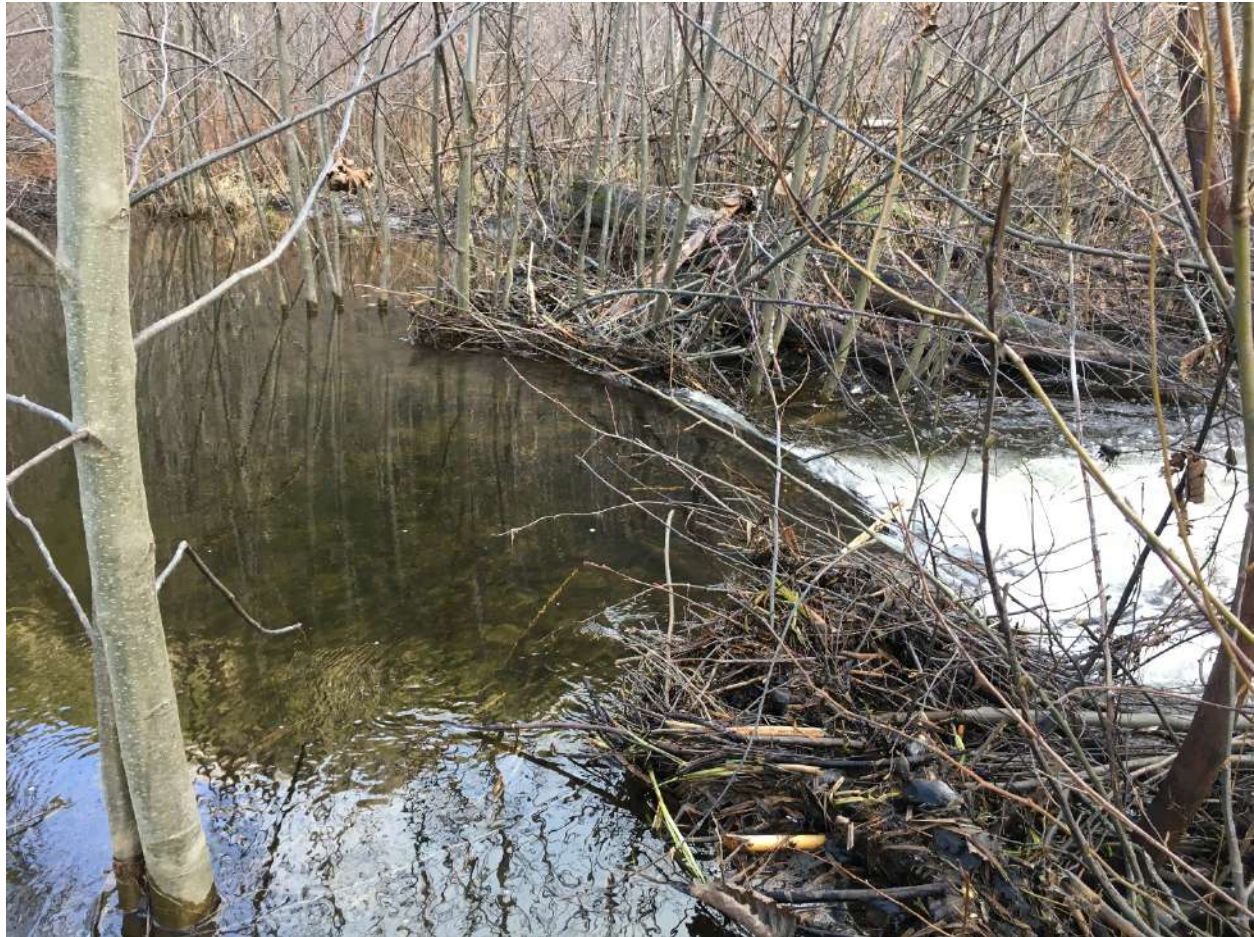
Figure 32. Looking river right to left at the dam 100 m upstream of Reach 1 showing sufficient overflow to allow Coho Salmon migration on November 10, 2016.

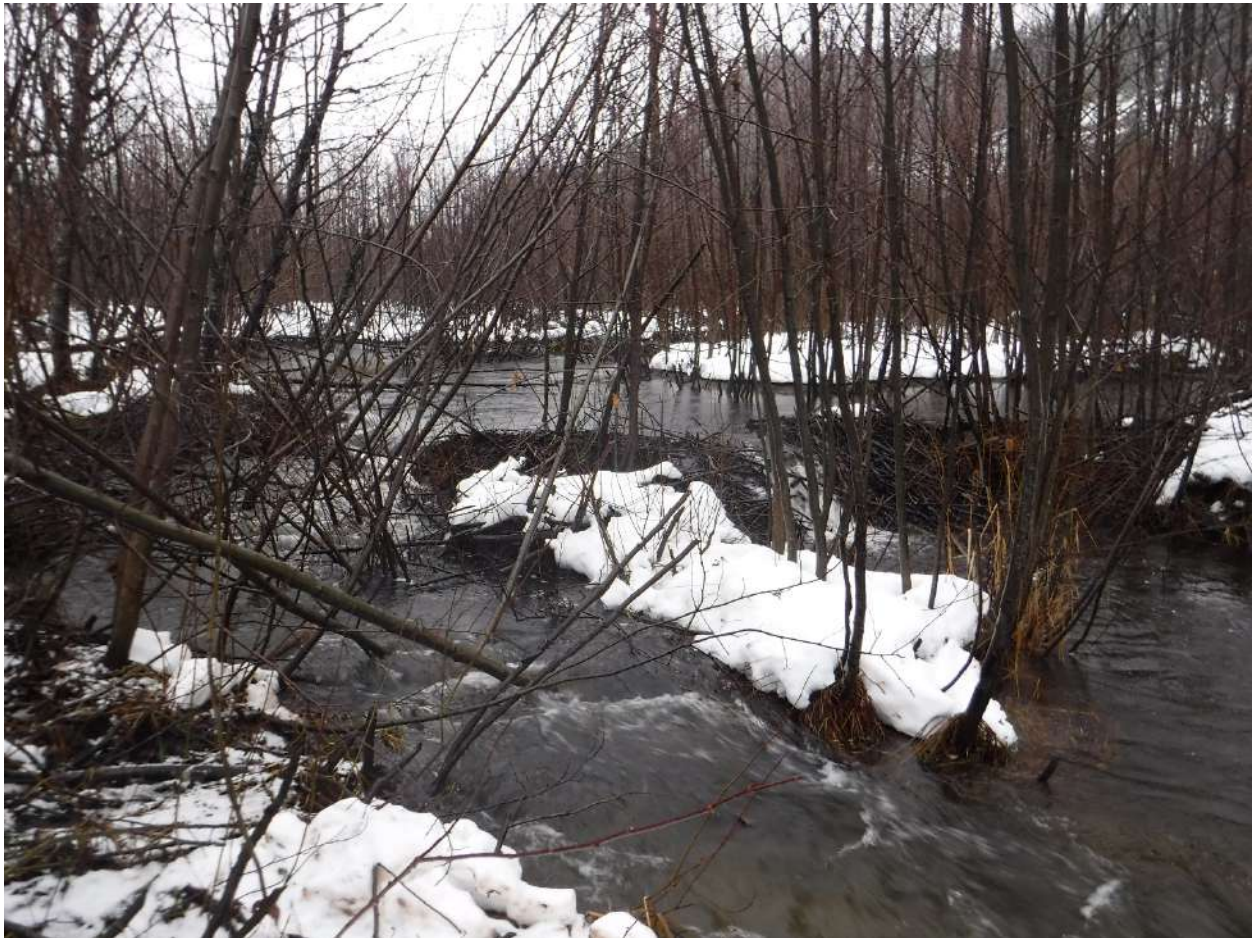
Figure 33. Looking upstream at the primary dam 100 m upstream of Reach 1 showing the formation of a new channel on river right (photo left) on November 26, 2017.

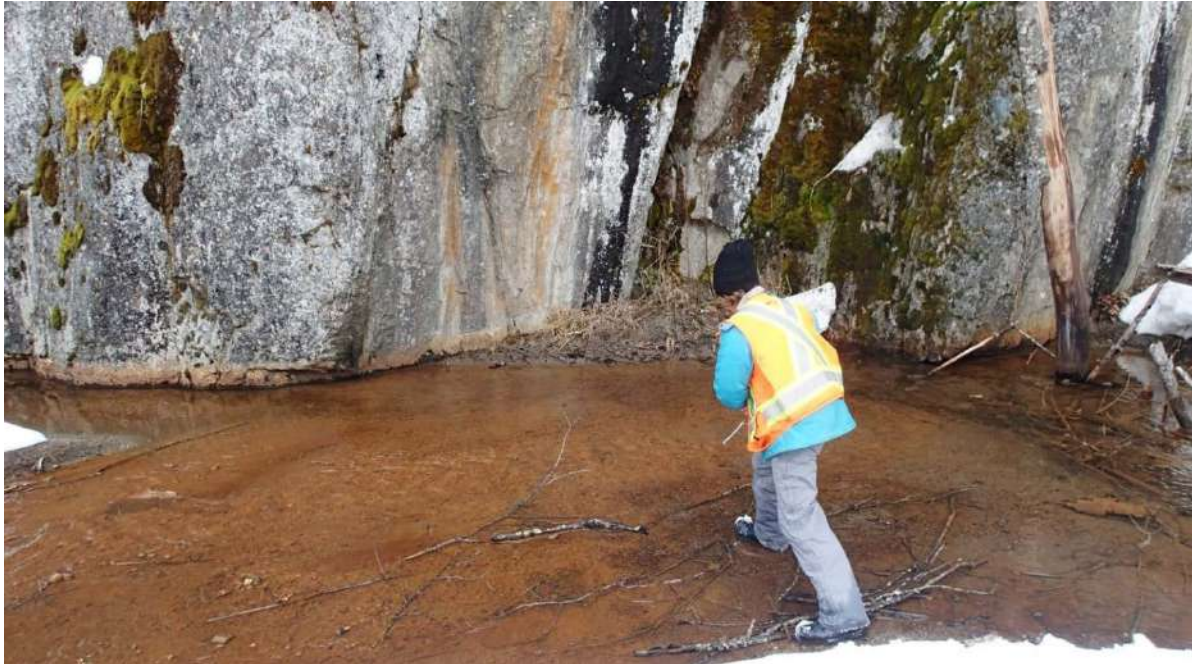
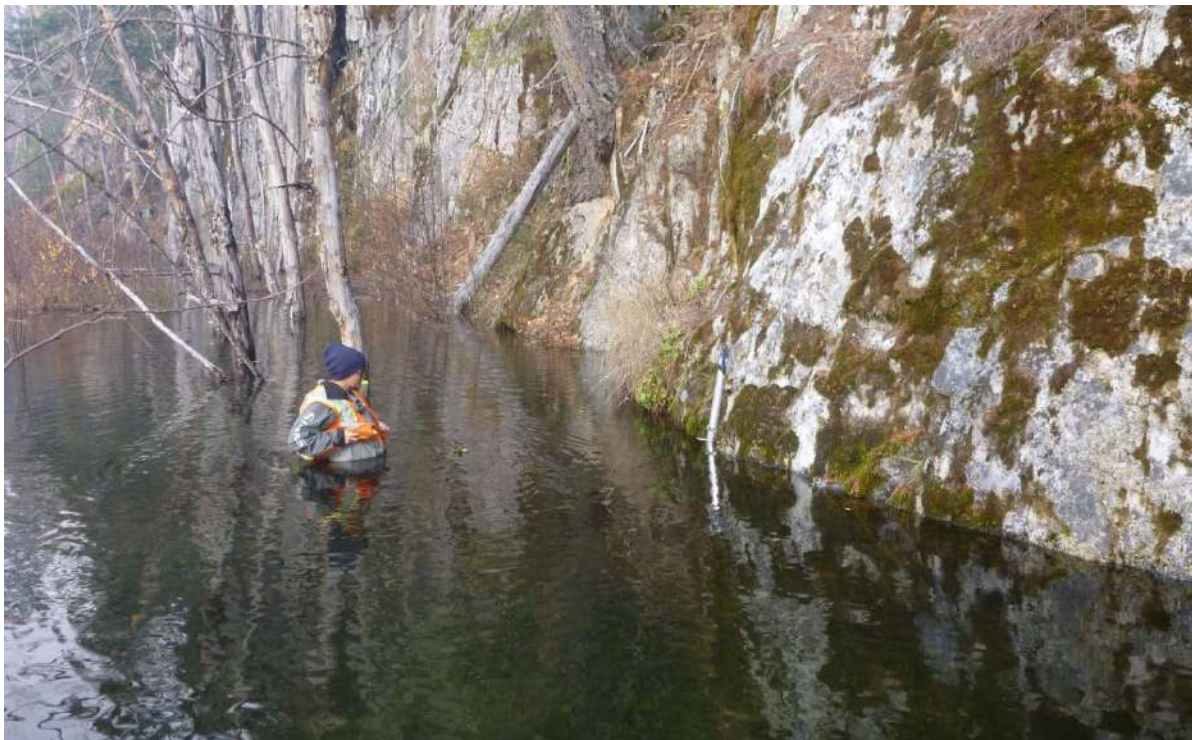
Figure 34. Comparison of water levels at ALE-MT05 site on a) February 27, 2014 and b) November 10, 2017.

In 2017, beaver activity upstream of the enhancement work in Reach 4 increased drastically (see large pool in Map 2). A series of large dams ranging from approximately 20-70 m in length, and of various heights, were constructed creating significant areas of backwater (Figure 34). Extensive damming was constructed approximately every 50 m. Beaver activity resulted in a significant increase in the amount of rearing habitat available through the creation of extensive backwater areas and side channels. This increase in habitat availability, in conjunction with the creation of 668 m² of new instream habitat in Reach 3 as part of the FHEP, is likely a contributory factor to the lower catch and CPUE at ALE-MT05 in 2017 as a similar number of fish dispersed over a larger area will result in lower CPUE.

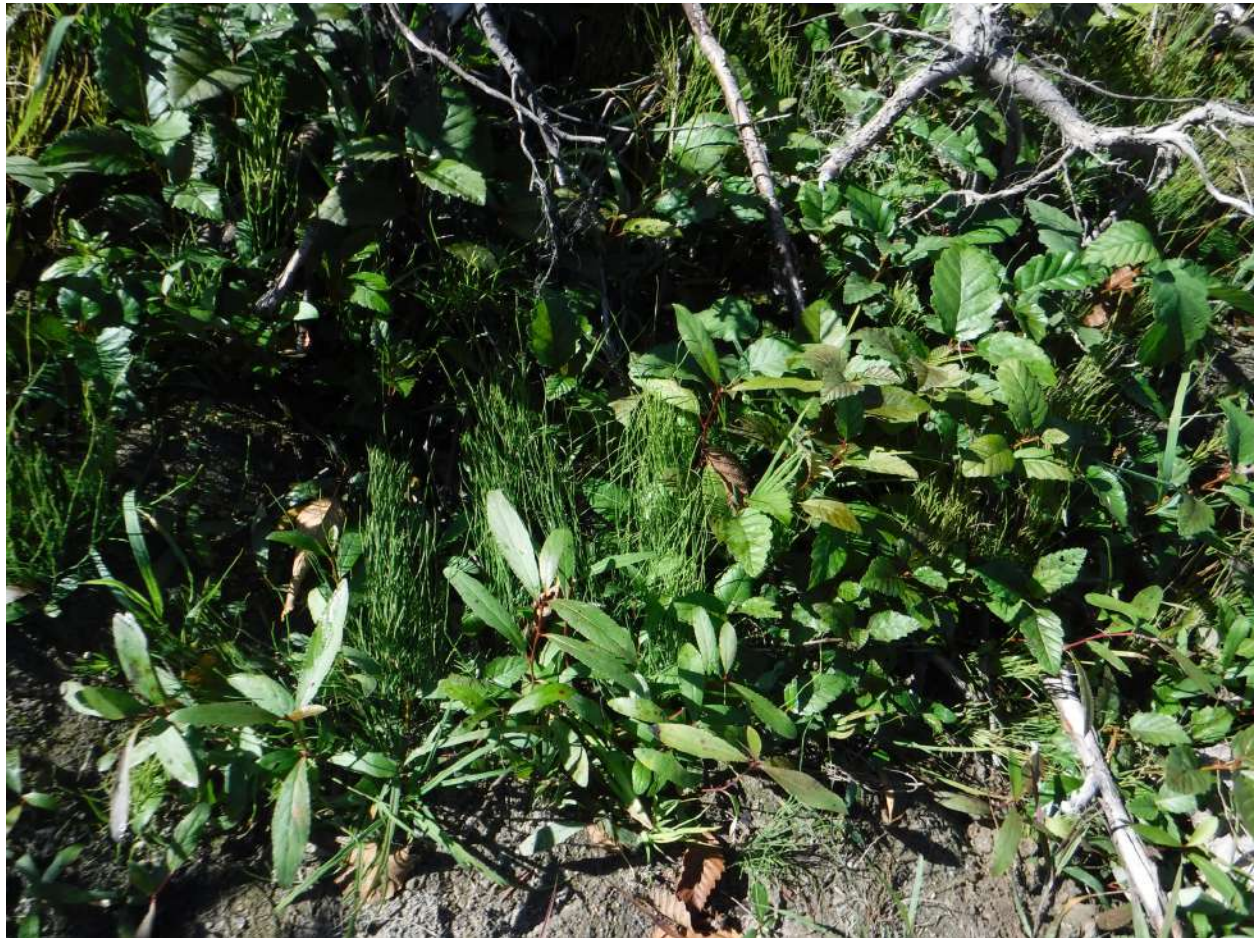
Between 2016 and 2017, vigorous regeneration of black cottonwood and red alder was observed (Figure 35). These floodplain pioneer species, with high initial growth rates, rapidly recolonized and infilling the compensation area (Figure 35, Figure 36, Appendix J). The estimated density for the four monitoring plots increased to $43,200 \pm 36,210$ stems/ha, with 90% certainty that the density of trees and shrubs ranges from 6,900 to 79,410 stems/ha (Table 36, Table 38). The DFO and MELP (1998) guided revegetation effectiveness target of 2,309 stems/ha was exceeded within all four permanent vegetation monitoring plots in 2016 and 2017 (Table 36).

Figure 35. Natural regeneration observed at ALE-PRM07. Photo is representative of vigorous re-establishment of red alder and black cottonwood, within the Alena Creek FHEP, on October 5, 2017.

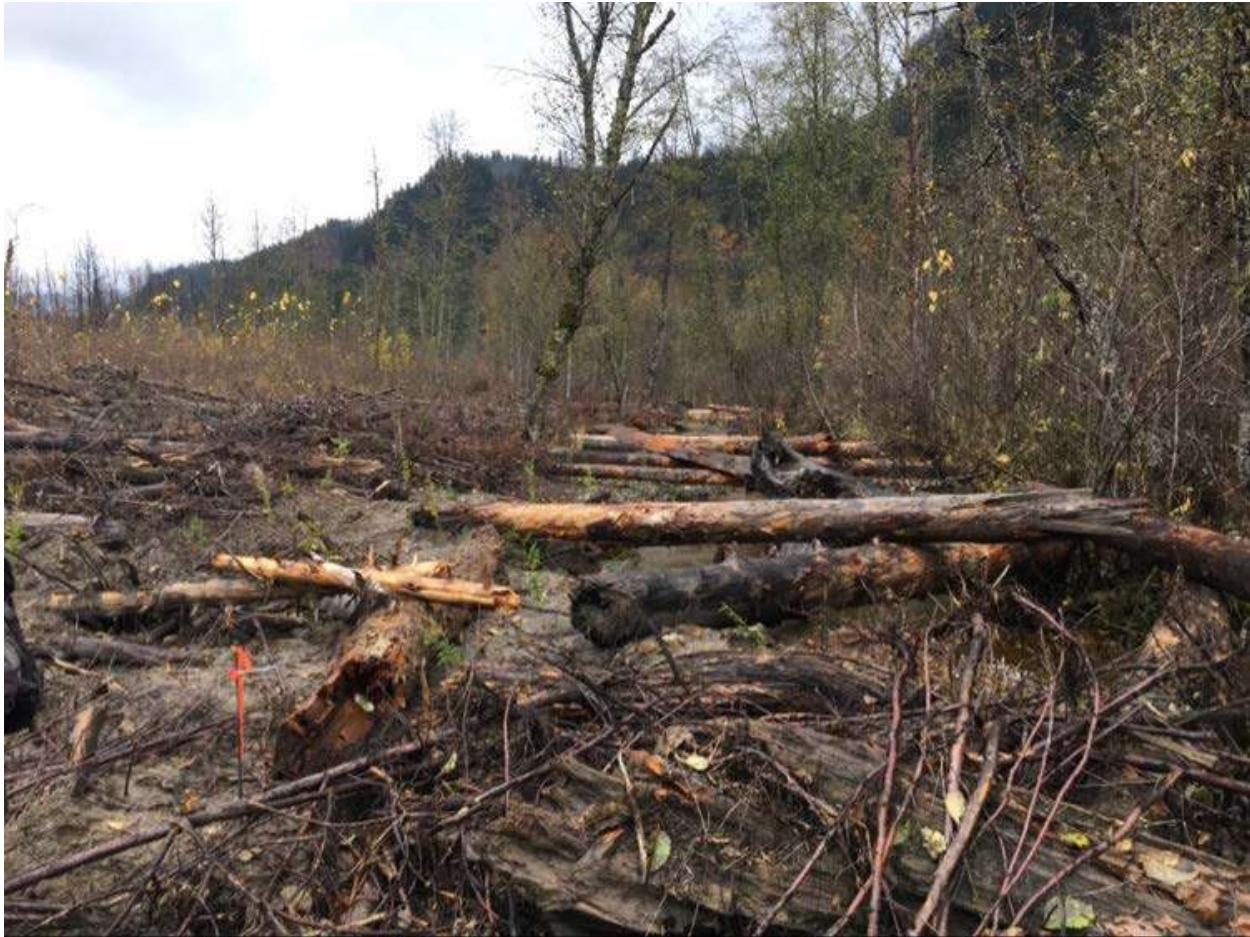
Figure 36. Photo of ALE-PRM07 after the implementation of riparian restoration works, on October 25, 2016.

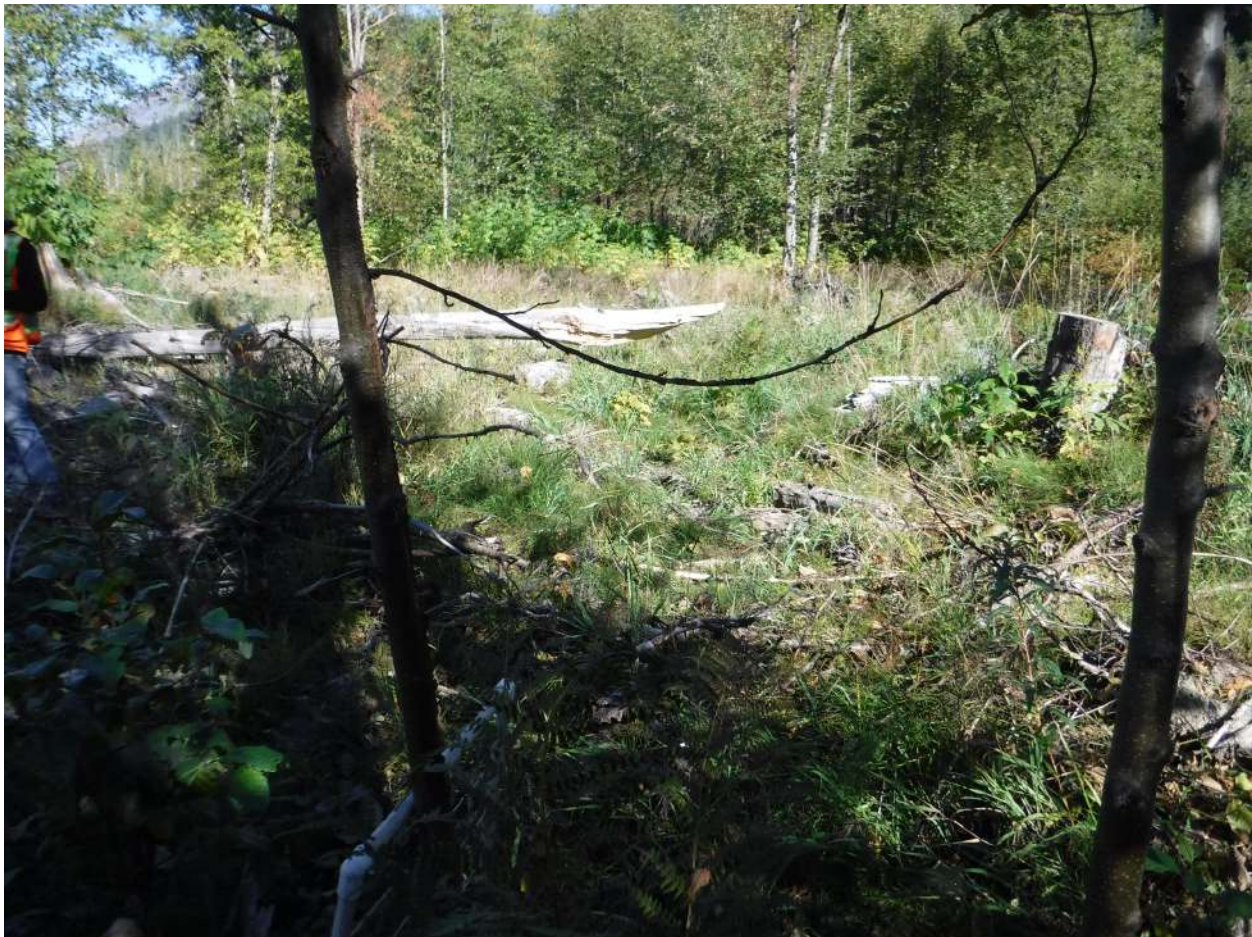
In 2017, vegetation cover was relatively high at three of the four sites surrounding the permanent vegetation monitoring plots. Vegetation cover ranged from 37% to 80%, with an average of 61% cover across all sites (Table 36). Vegetation cover was highest around the plot at ALE-PRM03 (Figure 37), where the substrate is dominated by native soils, and lowest around the plot at

Figure 37. Higher percent vegetation cover (80%), primarily horsetail, grass and ferns, at ALE-PRM03, October 5, 2017.

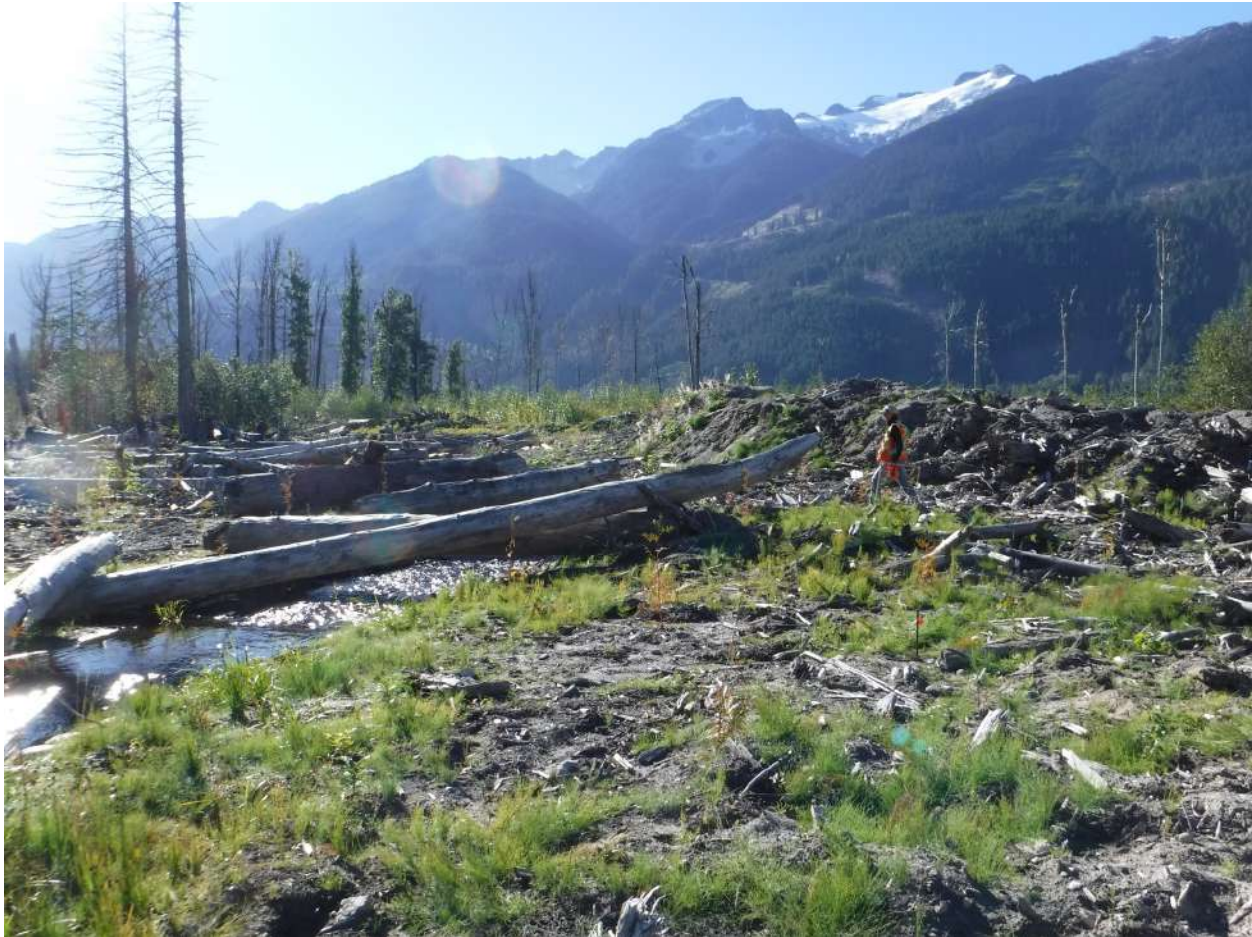
Figure 38. Lower percent vegetation cover (37%), primarily horsetail, at ALE-PRM05 located within the Meager Creek slide path, October 5, 2017.

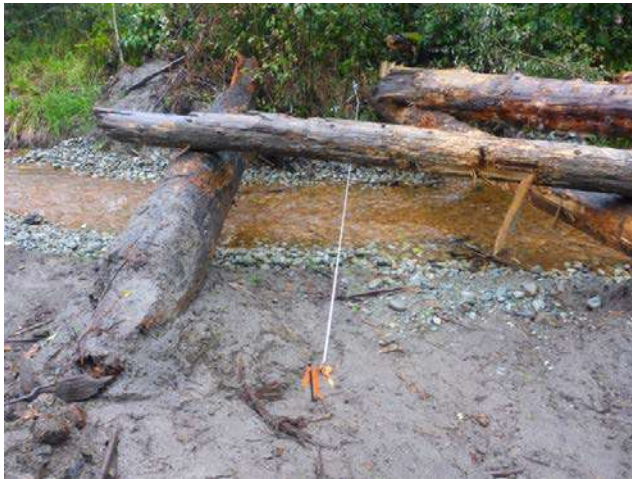
Figure 5. Looking from river right to river left at ALE-XS1 on September 19, 2016.

Reach 1 is the most downstream reach of Alena Creek and was enhanced under the FHEP and starts at the Lillooet River Forest Service Road (FSR, Map 4) bridge. In 2016, thirteen riffles and more than 120 pieces of large woody debris were installed in Reach 1 with total creation of 1,387 m² of enhanced fish habitat. The stream channel at ALE-XS1 has widened slightly with wetted access to the constructed floodplain on river left, as seen in 2017 and as intended in the design (Figure 5 to Figure 7). There were no other significant changes along Reach 1.

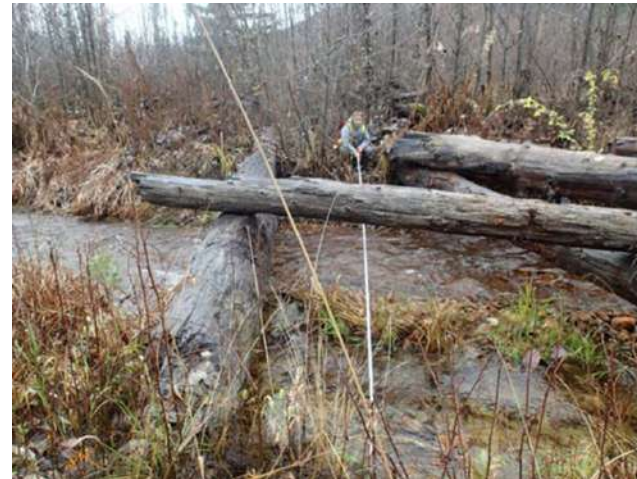
Figure 7. Looking from river left to river right at ALE-XS1 on November 5, 2018.

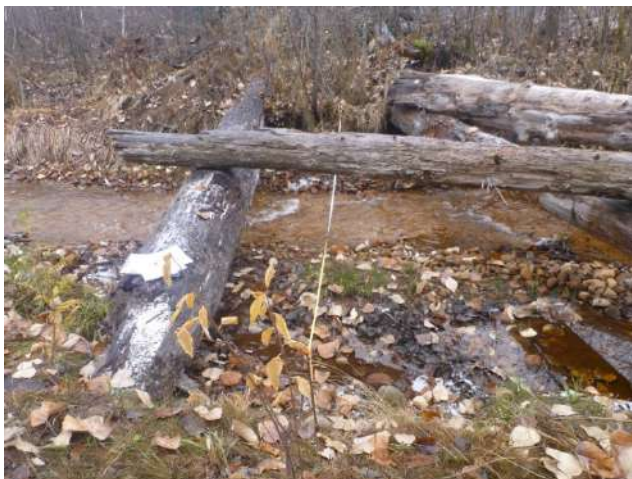
Figure 6. Looking from river left to river right at ALE-XS1 on November 10, 2017.

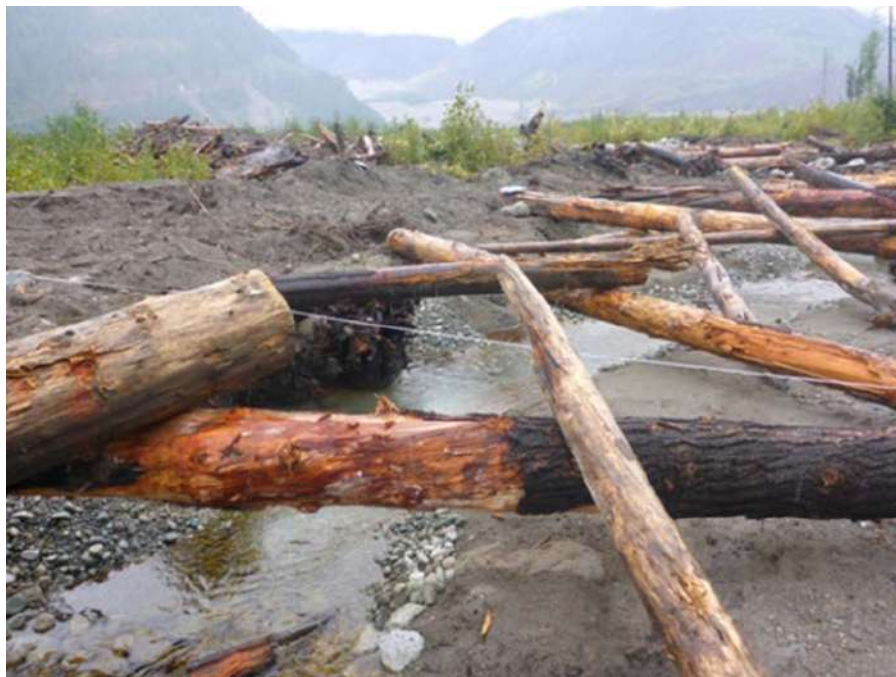
Figure 8. Looking upstream at ALE-XS6 on November 10, 2016.

A total of 668 m² of new instream habitat and 1,139 m² of floodplain was created in Reach 3 in 2016. Twelve cobble riffles and over 100 pieces of large woody debris were installed in this reach as under the FHEP. However, a mid-channel bar formed in 2017 just upstream of the ALE-XS6 as the result of erosion along the right bank (Figure 8 to Figure 10). In 2018, the mid-channel bar was still present but did not appear to impede flows or limit the potential fish habitat. Bank erosion has also caused channel widening and down-cutting in section at the riffle-crest downstream of ALE-XS5 (Figure 11). Repairs are recommended in Section 5.3.

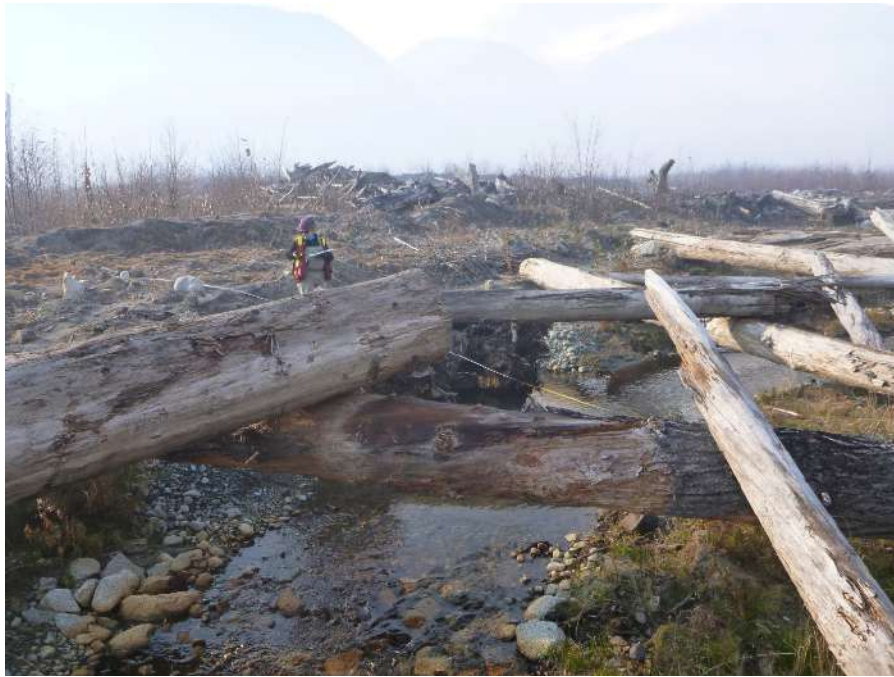
Figure 9. Looking upstream at ALE-XS6 on November 10, 2017

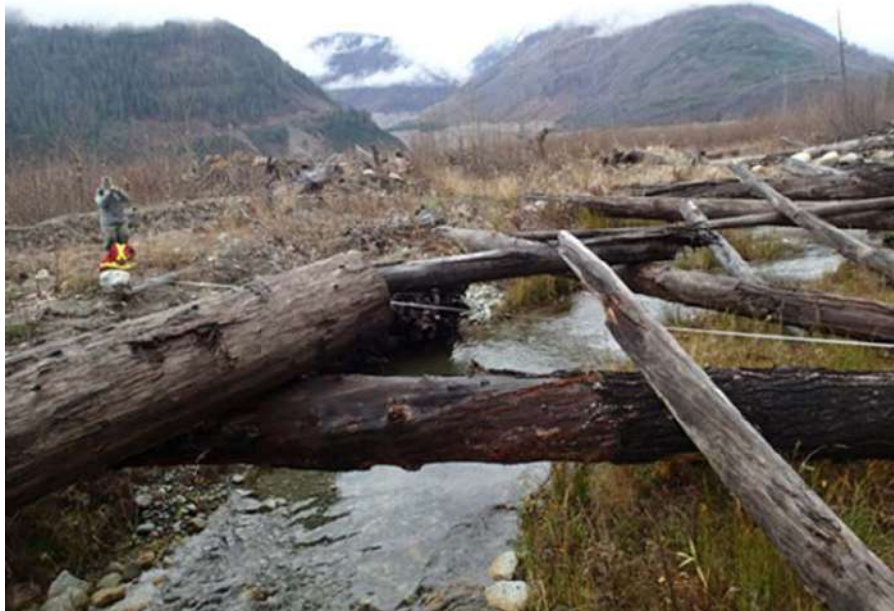
Figure 10. Looking upstream of ALE-XS6 on November 5, 2018.

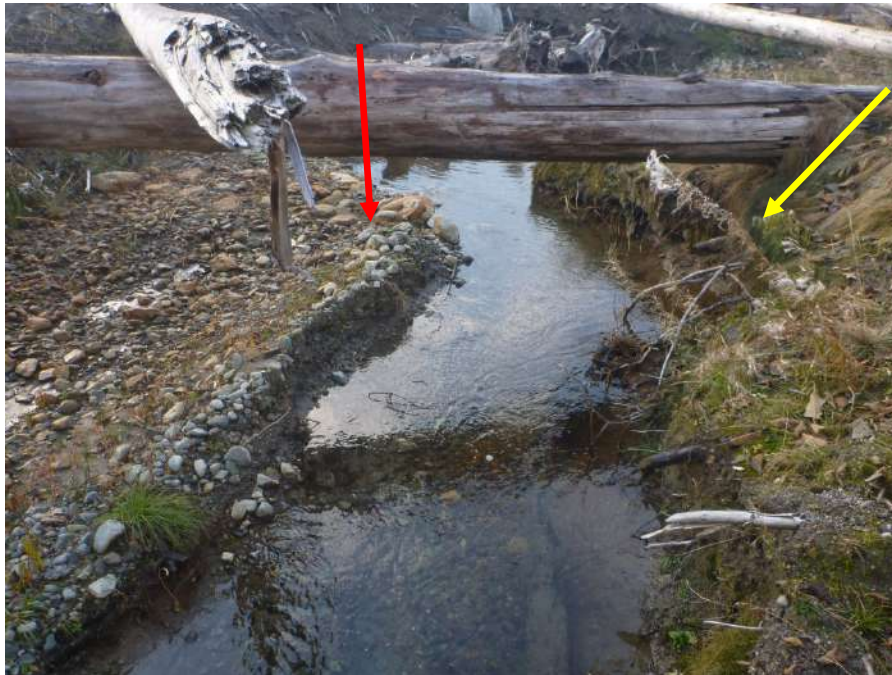
Figure 11. Looking upstream at the riffle crest located downstream of ALE-XS5 showing band erosion (yellow arrow) and down-cutting. The red arrow shows dewatered riffle crest. November 10, 2017.

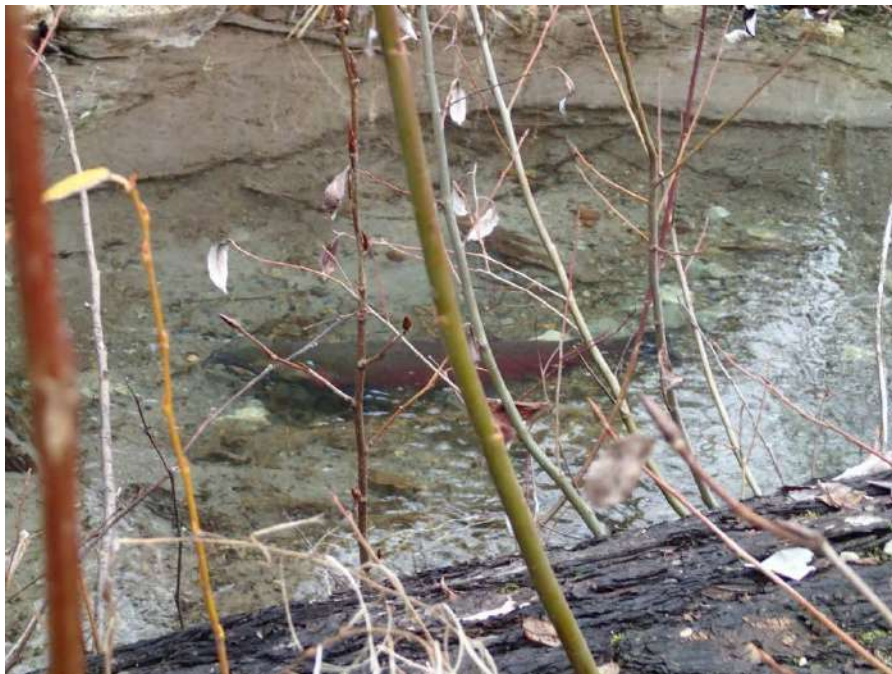
Figure 12. Spawning Coho Salmon observed in the enhanced habitat in Reach 1 on November 5, 2018.

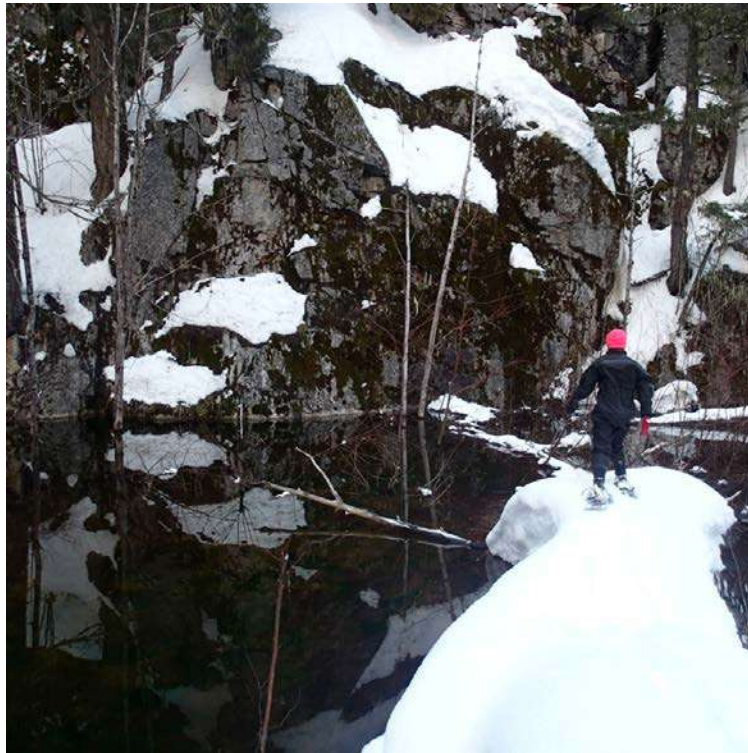
Figure 1. Looking RR to RL at ALE-USWQ1 on January 30, 2019.

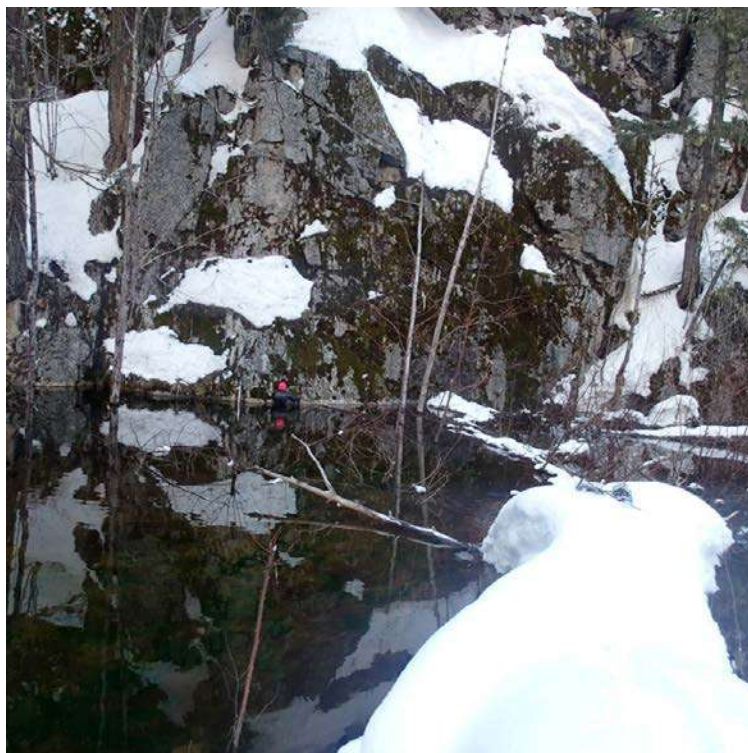
Figure 2. Looking RR to RL at ALE-USWQ1 on January 30, 2019.

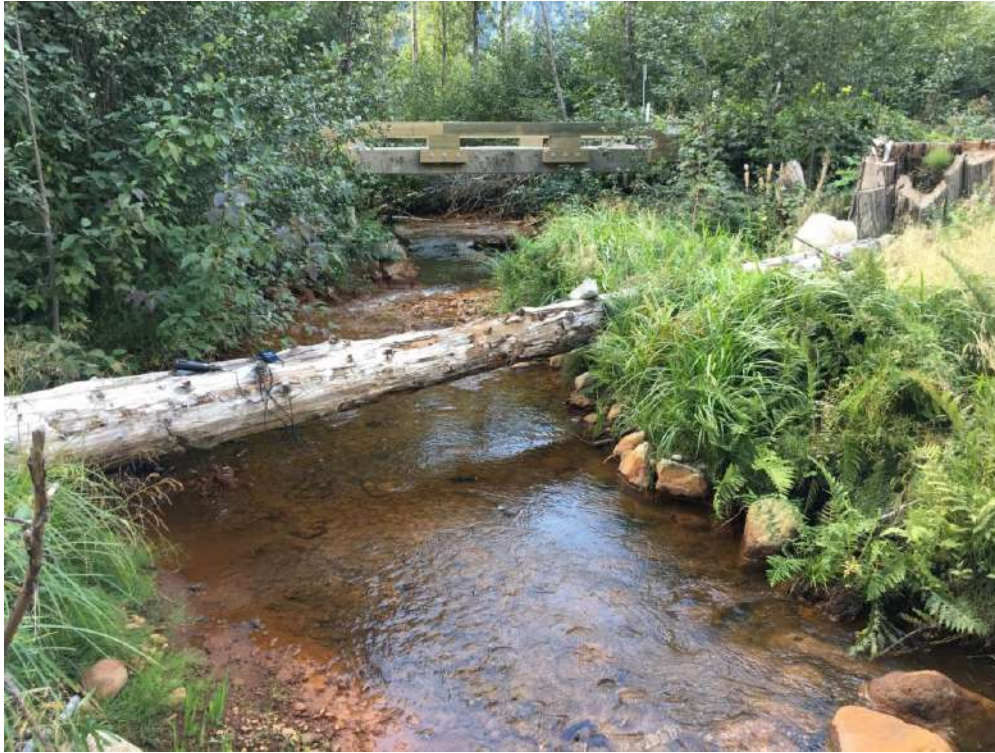
Figure 3. Looking downstream at ALE-BDGWQ on September 13, 2017.

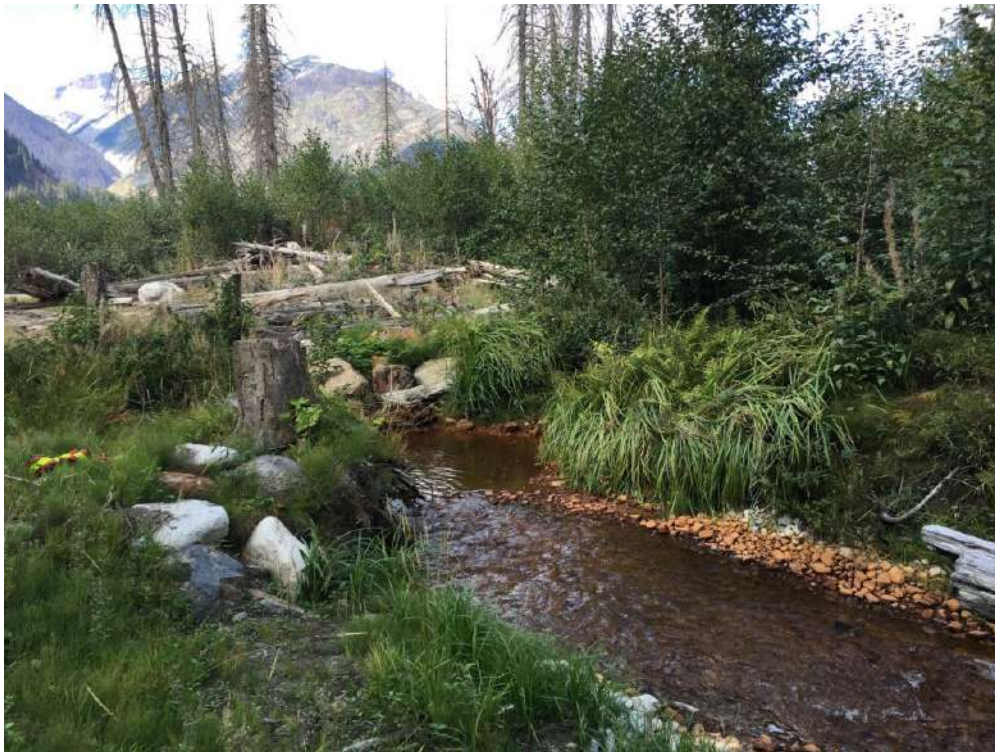
Figure 4. Looking upstream of ALE-BDGWQ on September 13, 2017.

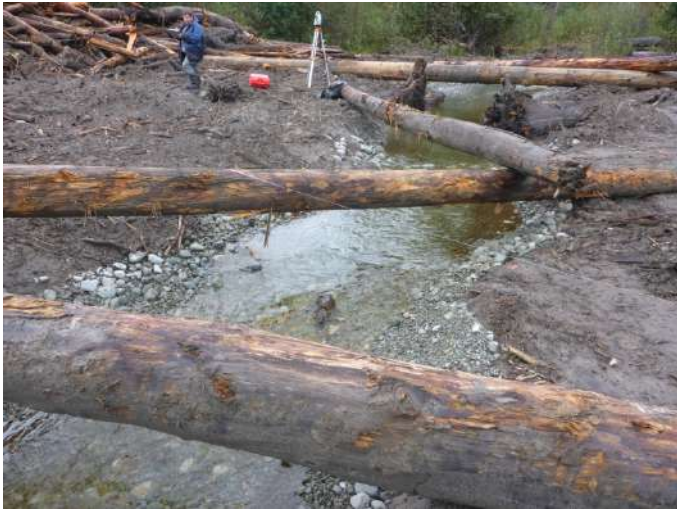
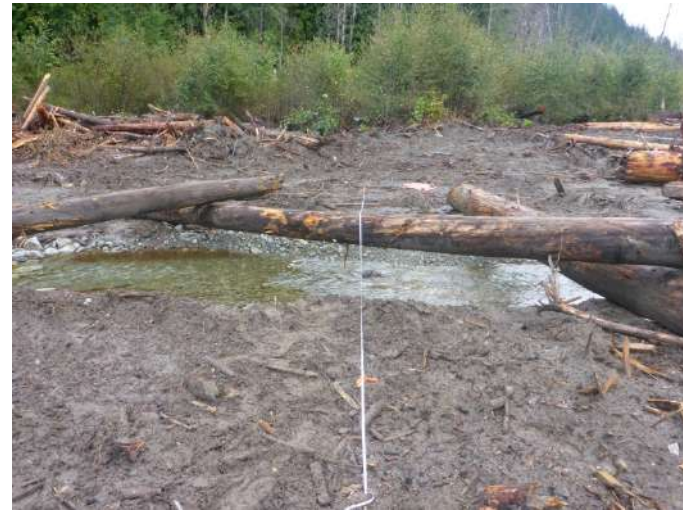
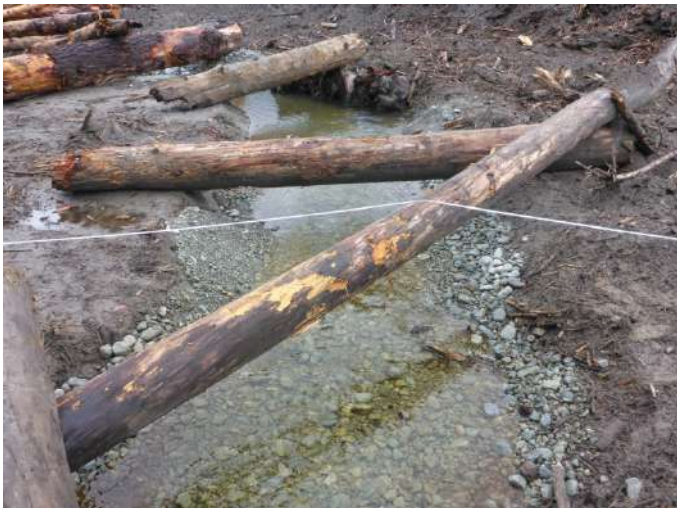
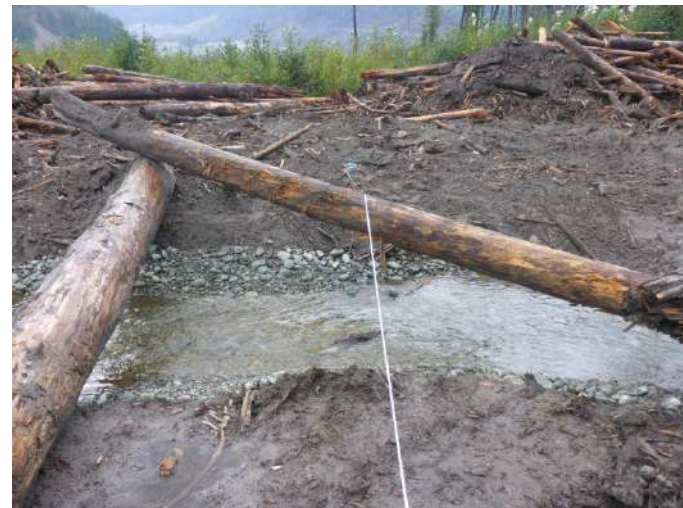
Figure 22. ALE-XS8 on September 19, 2016.

a) Looking upstream.

c) Looking from river right to river left.

b) Looking downstream.

d) Looking from river left to river right.

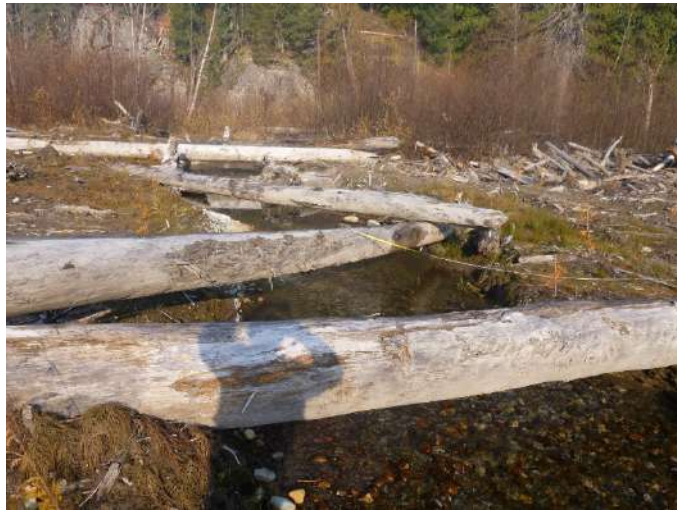
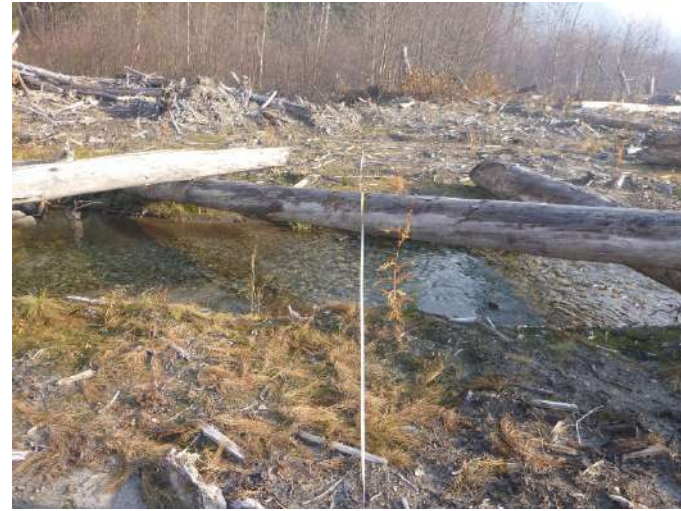
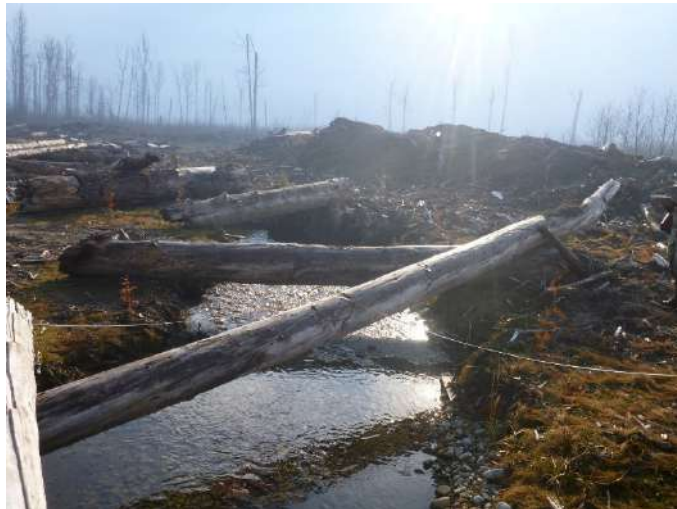
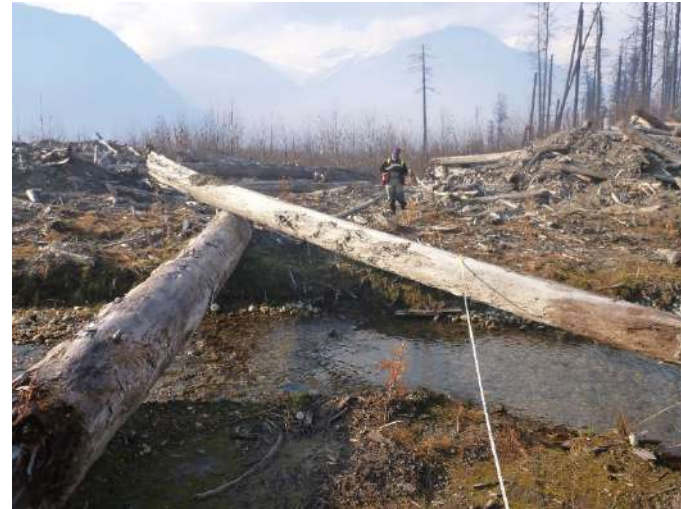
Figure 23. ALE-XS8 on November 10, 2017.

a) Looking upstream.

c) Looking from river right to river left.

b) Looking downstream.

d) Looking from river left to river right.

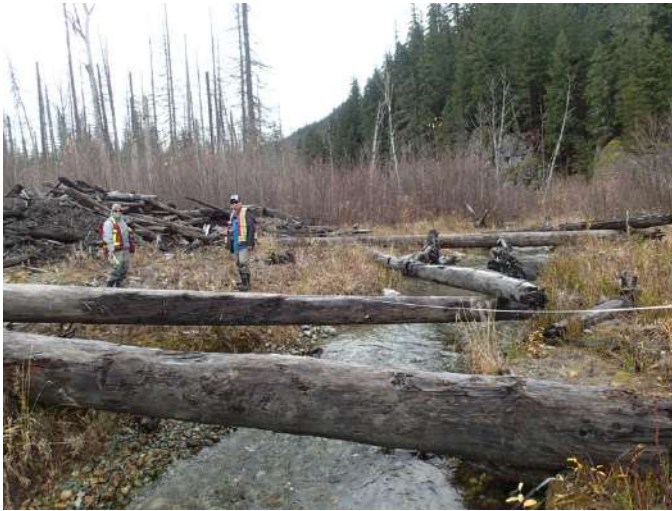
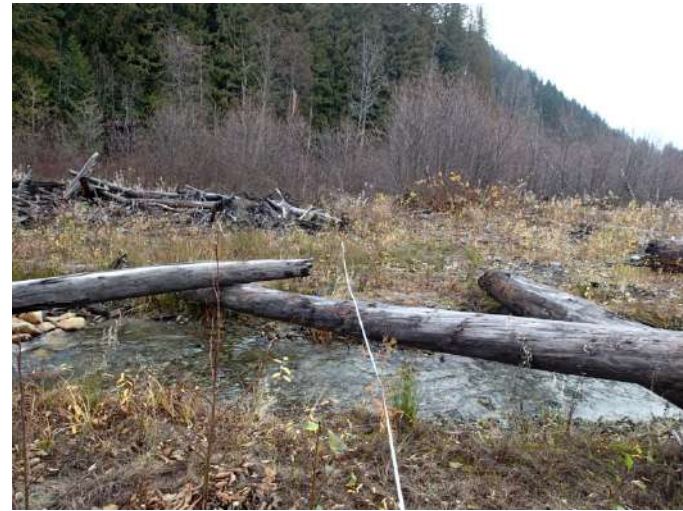
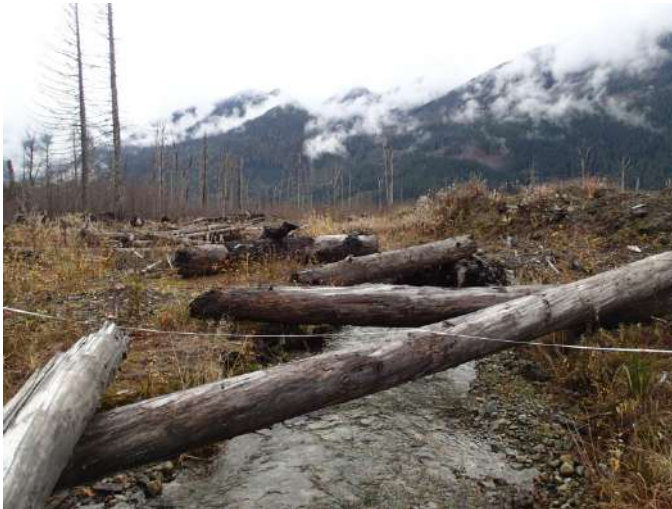
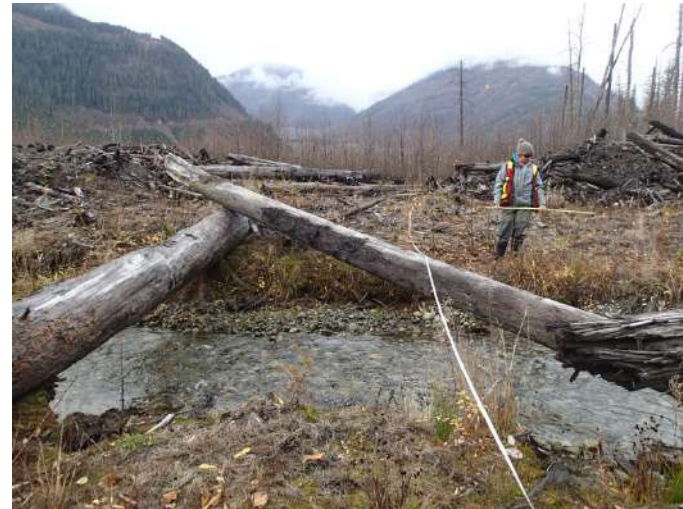
Figure 24. ALE-XS8 on November 05, 2018.

a) Looking upstream.

c) Looking from river right to river left.

b) Looking downstream.

d) Looking from river left to river right.
