Upper Lillooet Hydro Project

Operational Environmental Monitoring: Year 1

April 25, 2019

Ecofish Research Ltd.

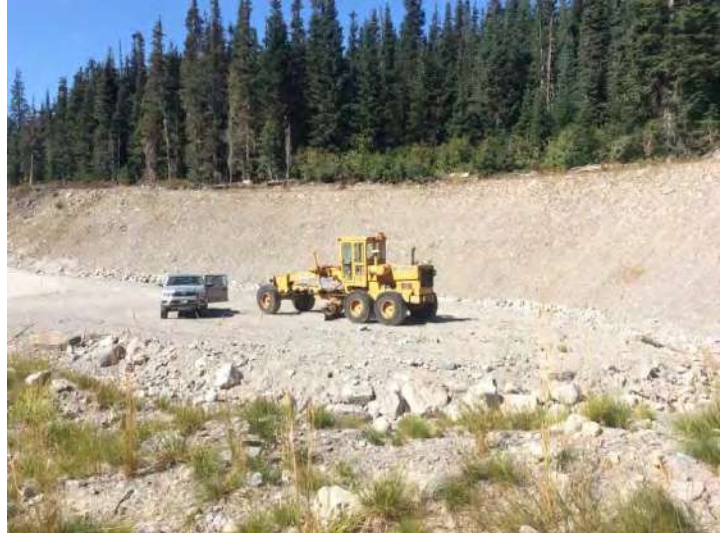
Card: Civil Works Stratum: Keyhole Laydown/Plot: 00/Comments Rest of site is not plantable. Sep 06, 2018 02.14.40 PM.jpg

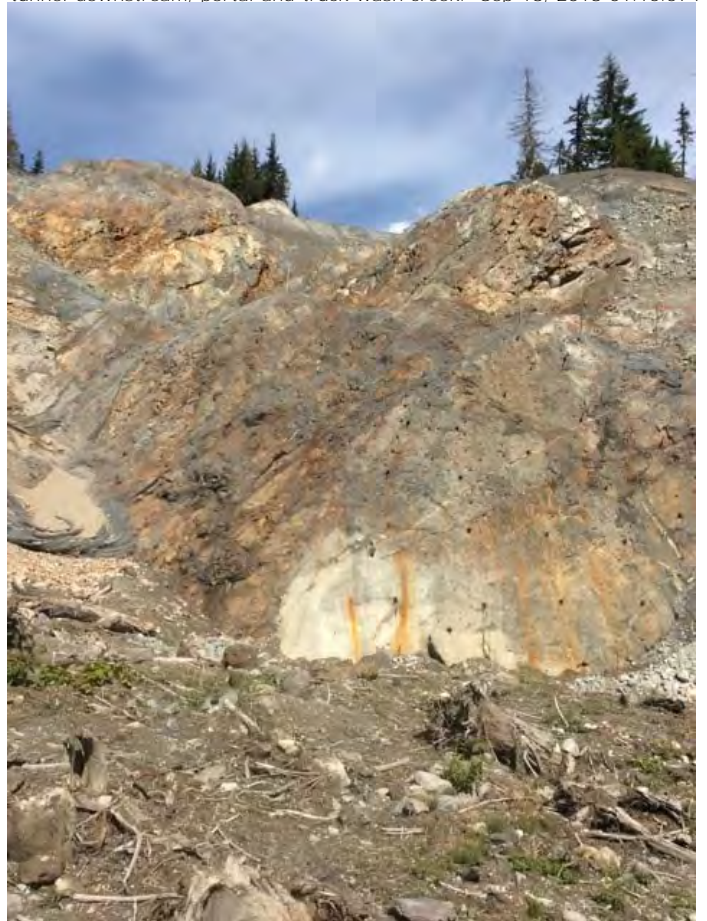
Card: Civil Works Stratum: Upper Lillooet Penstock/Plot: H/Comments UL
tunnel downstream, portal and truck wash creek. Sep 18, 2018 01.15.57 P

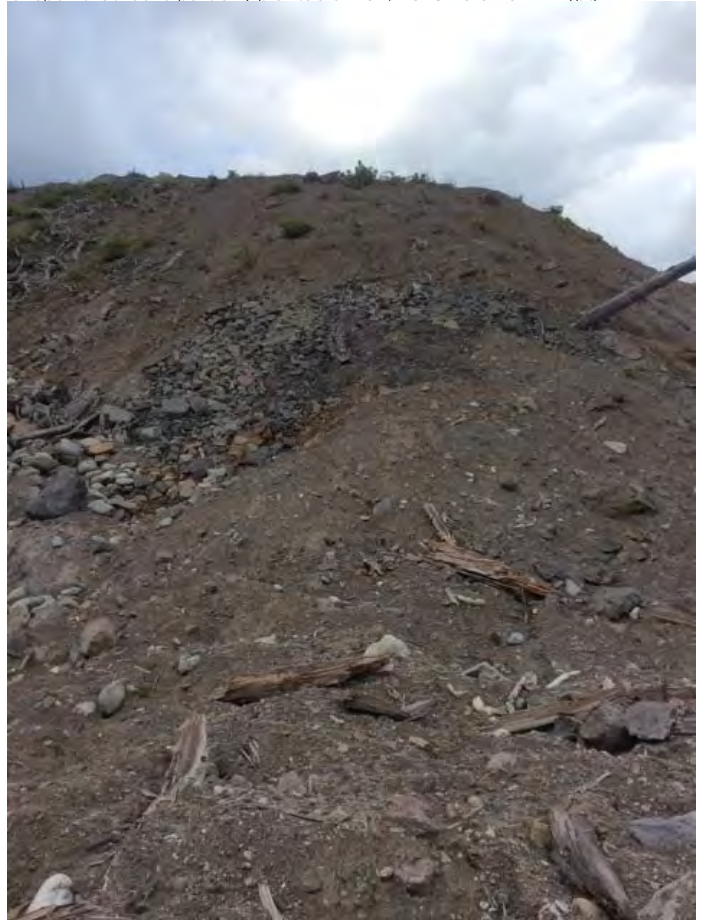
Card: Civil Works Stratam: Upper Spoil #1/Plot: 012/Comments Side slope of spoil that looks partially plantable. 07, 2018 10.31.01 AM.jpg

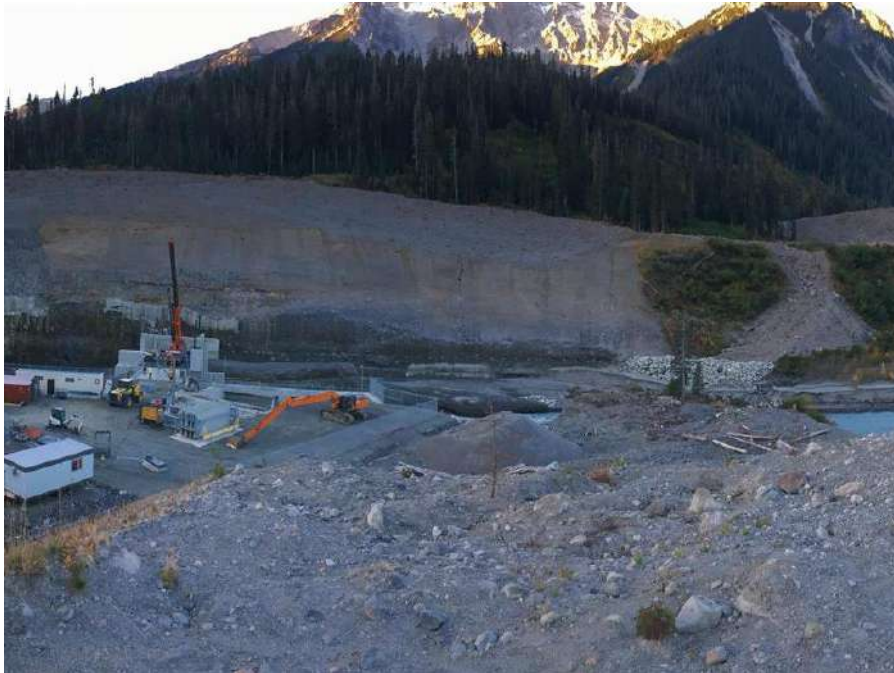
Figure 1. Upper Lillooet River HEF intake during the spring/summer of 2017, following revegetation planting.

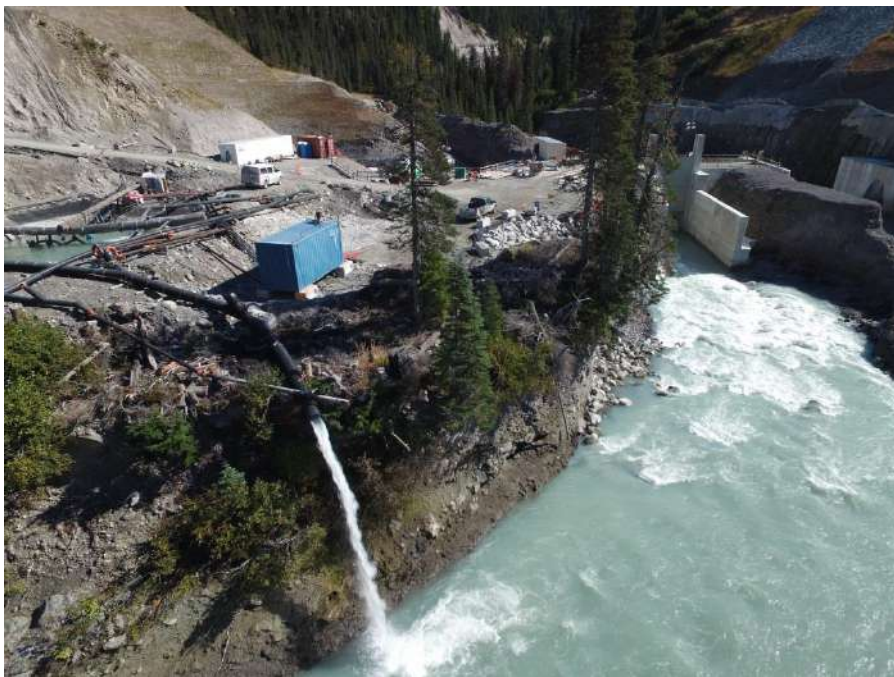
Figure 2. Upper Lillooet River HEF intake during construction, on September 22, 2016.

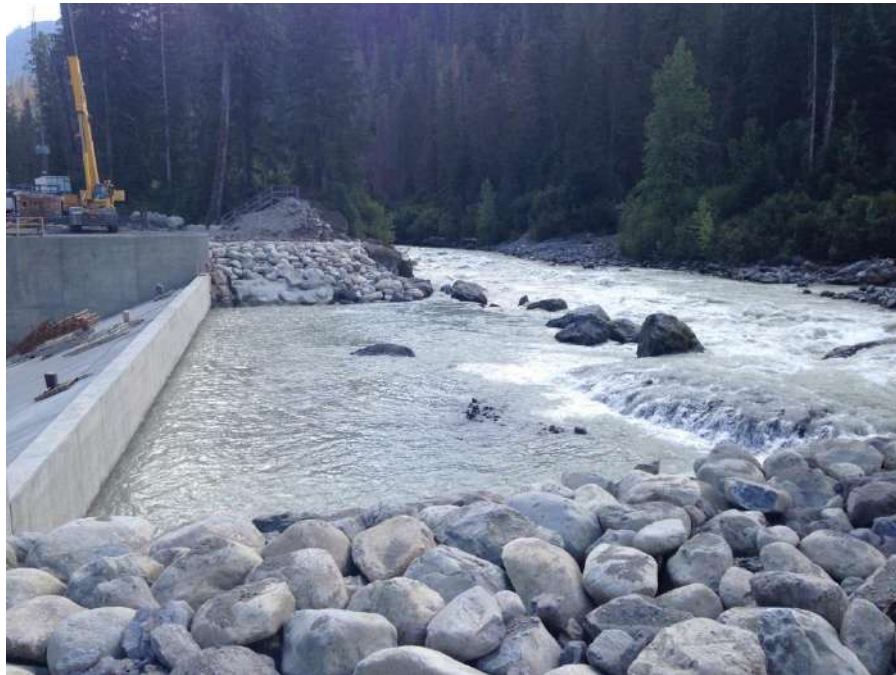
Figure 3. Upper Lillooet River HEF tailrace during the fall of 2016.

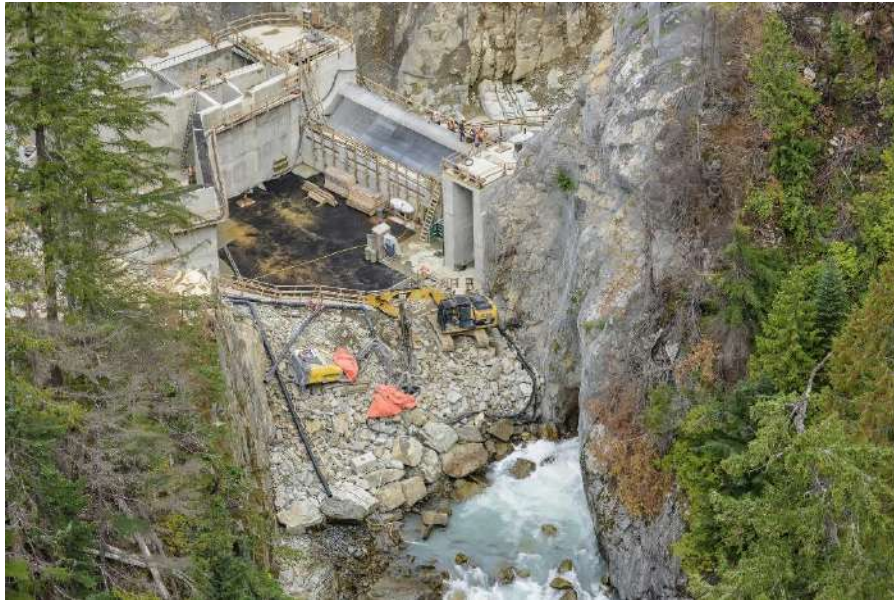
Figure 4. Boulder Creek HEF intake and diversion tunnel under construction, on September 7, 2016.

Pre-construction estimates and verified aquatic habitat loss for the Boulder Creek HEF are summarized in Table 7. The permanent aquatic footprint in the fish-bearing section of Boulder Creek was verified to be 39 m² and was associated with construction of the powerhouse and tailrace. The verified loss is 85 m² less than that predicted prior to construction (Buchanan *et al.* 2013b). The verified permanent loss of non-fish bearing habitat of 580 m² was associated with the Boulder Creek HEF intake and was 51 m² more than the pre-construction estimate; nevertheless, the total permanent aquatic habitat loss associated with the Boulder Creek HEF was 34 m² less than predicted prior to construction (Buchanan *et al.* 2013b). The overall reduction in the aquatic footprint is due to tailrace design changes. Figure 4, Figure 5, Figure 6 and Figure 7 illustrate the footprint of the Boulder Creek HEF during the construction period.

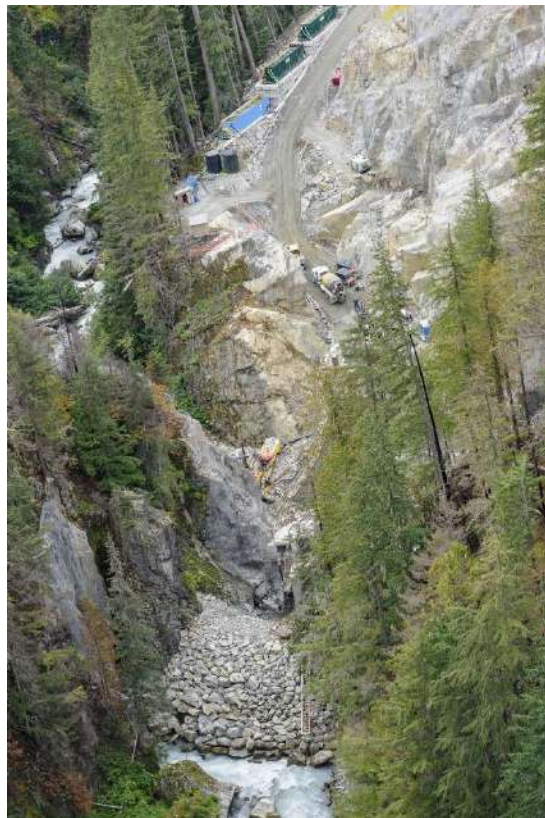
Figure 5. Boulder Creek HEF intake and access road, under construction on September 7, 2016.

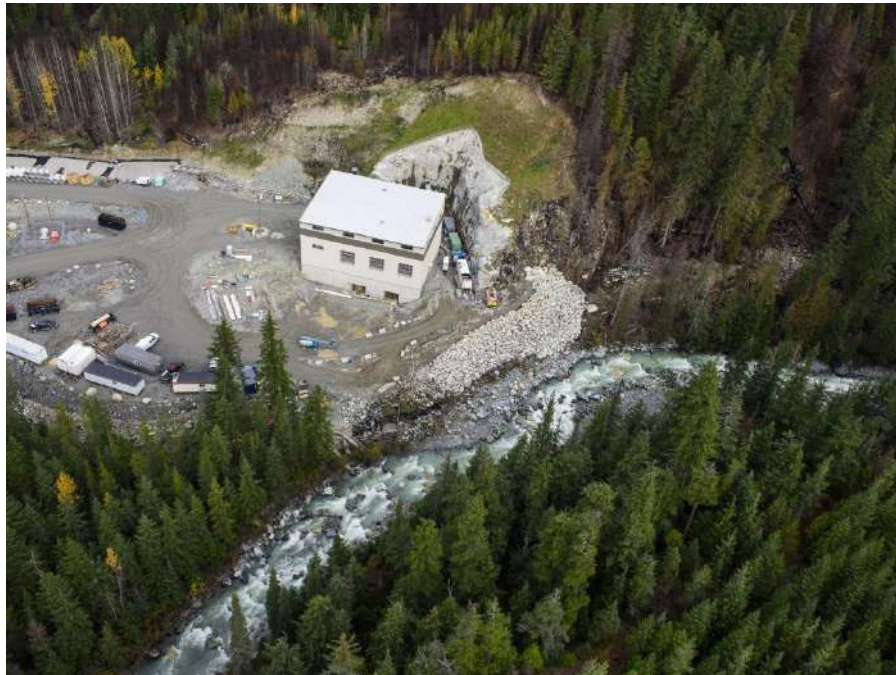
Figure 6. Boulder Creek powerhouse footprint during construction, on March 14, 2016.

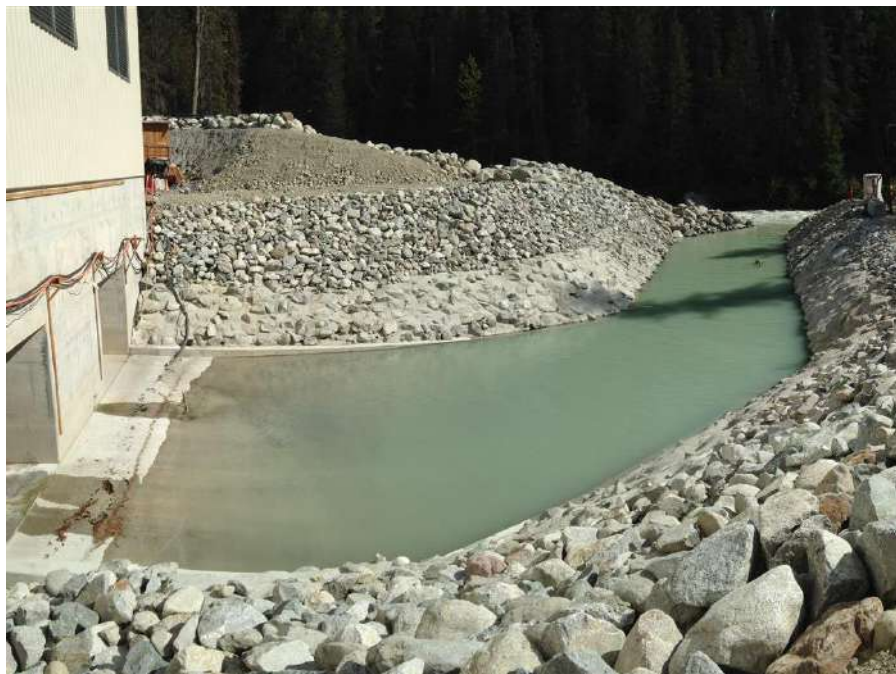
Figure 7. Boulder Creek HEF tailrace in the fall of 2016, after completion.

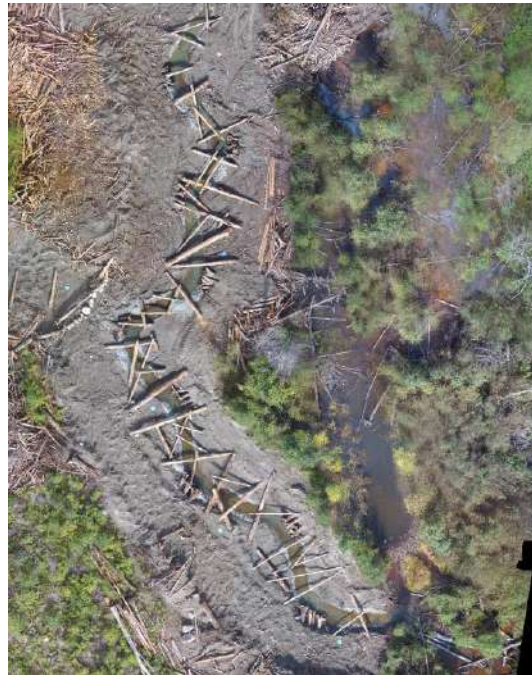
Figure 8. Aerial photo taken from the UAV showing the constructed channel for the Alena Creek FHEP on the left, and the retained beaver dam and pond on the right.

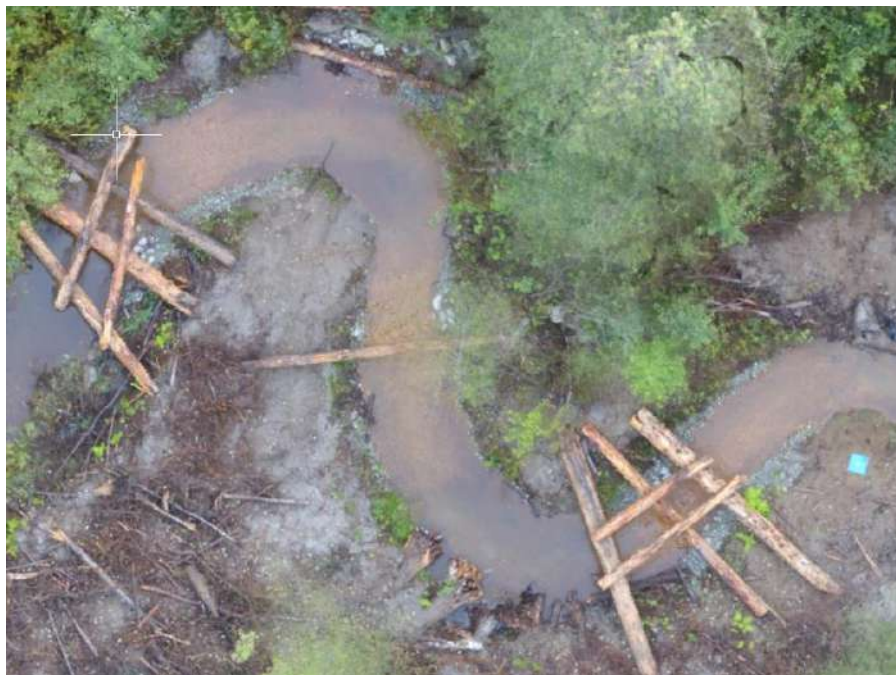
Figure 9. Sample screenshot from downstream (Reach 1) orthomosaic image showing riffle-pool sequence and habitat features for the Alena Creek FHEP.

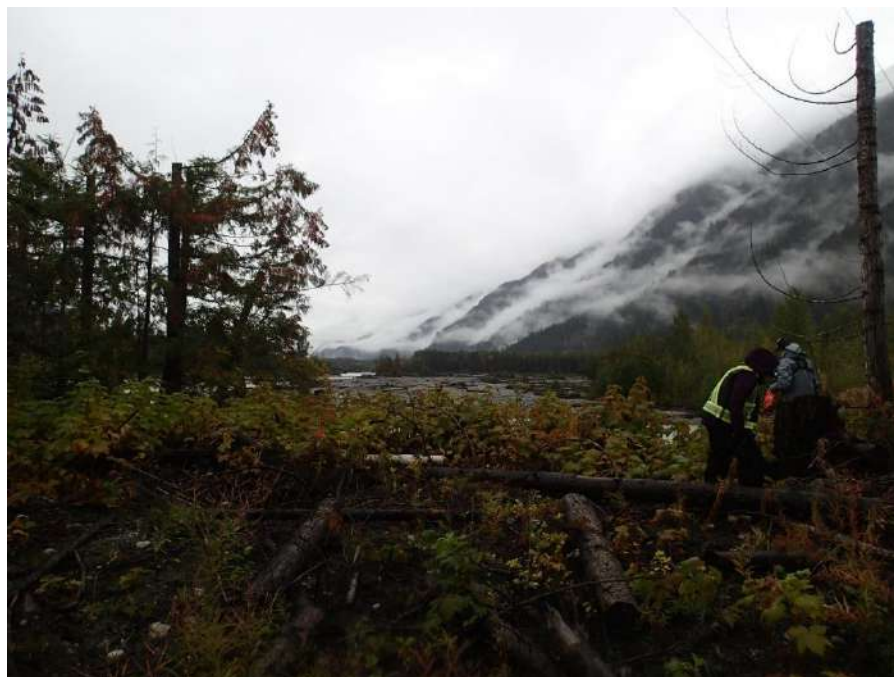
1. ULH-HADUCM01

Figure 1. Harlequin Duck riparian habitat on the north side of the Lillooet River at the transmission line crossing at ULH-HADUCM01, assessed on September 21, 2018.

General comment:	Good natural regeneration, plenty of coarse woody debris.
Clearing restricted to topping trees:	yes
Tree heights (m):	10, 4, 3
Average tree height (m):	6
Shrub heights (m):	1, 2, 1.5
Average shrub height (m):	2
Coarse woody debris present:	yes

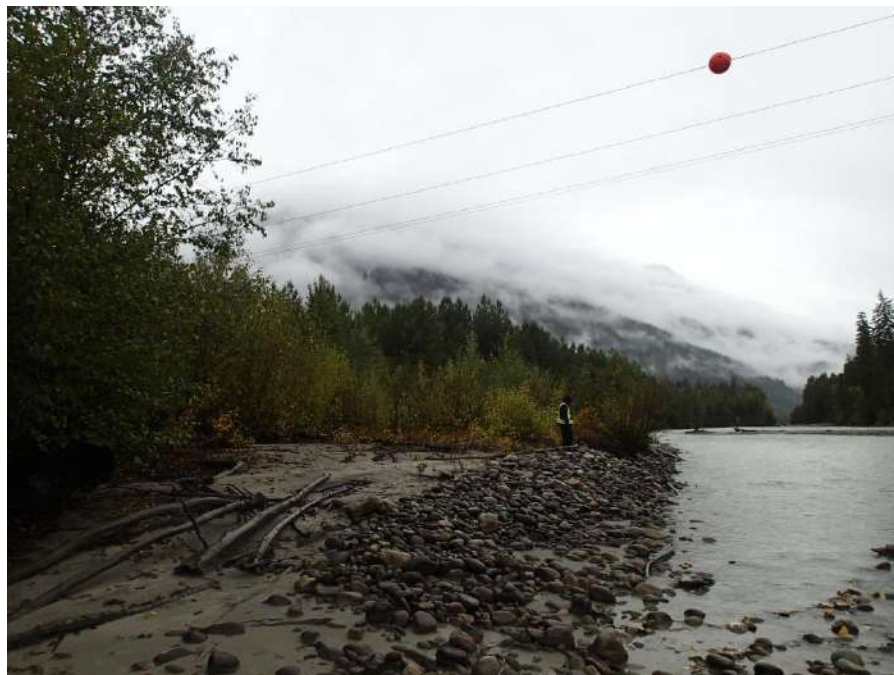
2. ULH-HADUCM02

Figure 2. Harlequin Duck riparian habitat on the south side of the Lillooet River at the transmission line crossing at ULH-HADUCM02, assessed on September 21, 2018.

General comment:	Young cottonwood and alders and good natural regeneration. Coarse woody debris deposits are natural. No trees were cleared within 30 m of the high-water mark.
Clearing restricted to topping trees:	topping was not necessary
Tree heights (m):	8, 3, 3
Average tree height (m):	5
Shrub heights (m):	3, 4, 3
Average shrub height (m):	3
Coarse woody debris present:	yes

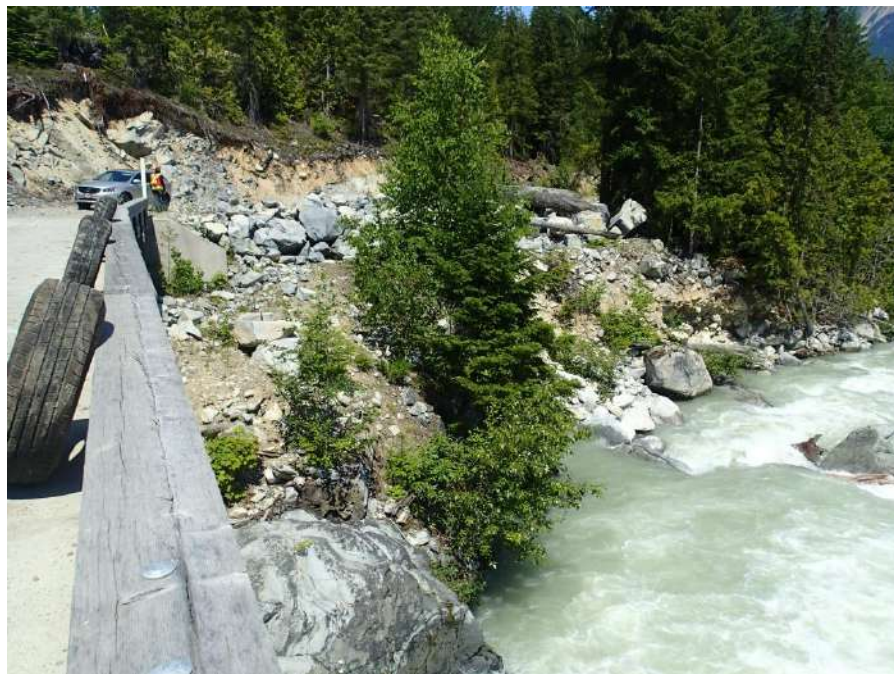
3. ULH-HADUCM03

Figure 3. Harlequin Duck riparian habitat on the north side of the Ryan River at the transmission line crossing at ULH-HADU03, assessed on June 19, 2018.

General comment:	The area is limited by the bridge abutment and road crossing. Coarse woody debris could not be placed safely unless anchored, which may create a potential hazard/log catchment at high flow.
Clearing restricted to topping trees:	yes
Tree heights (m):	3, 5, 8
Average tree height (m):	5
Shrub heights (m):	0.5, 1, 1
Average shrub height (m):	1
Coarse woody debris present:	no – not feasible

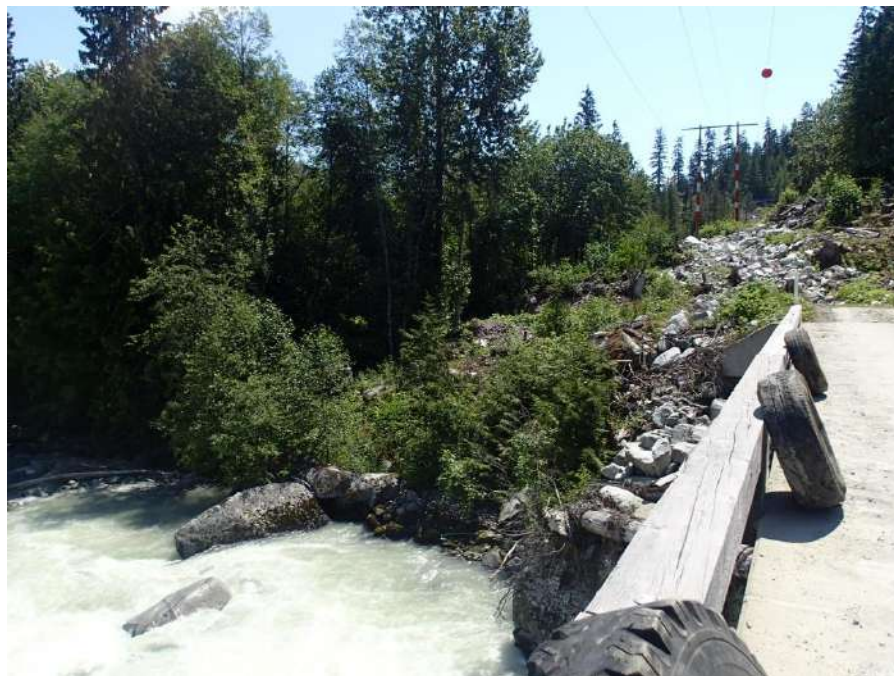
4. ULH-HADUCM04

Figure 4. Harlequin Duck riparian habitat on the south side of the Ryan River at the transmission line crossing at ULH-HADU04, assessed on June 19, 2018.

General comment:	Dense shrubs and small trees at water's edge, coarse woody debris left in place.
Clearing restricted to topping trees:	yes
Tree heights (m):	2, 4, 5
Average tree height (m):	4
Shrub heights (m):	1, 1, 1
Average shrub height (m):	1
Coarse woody debris present:	yes

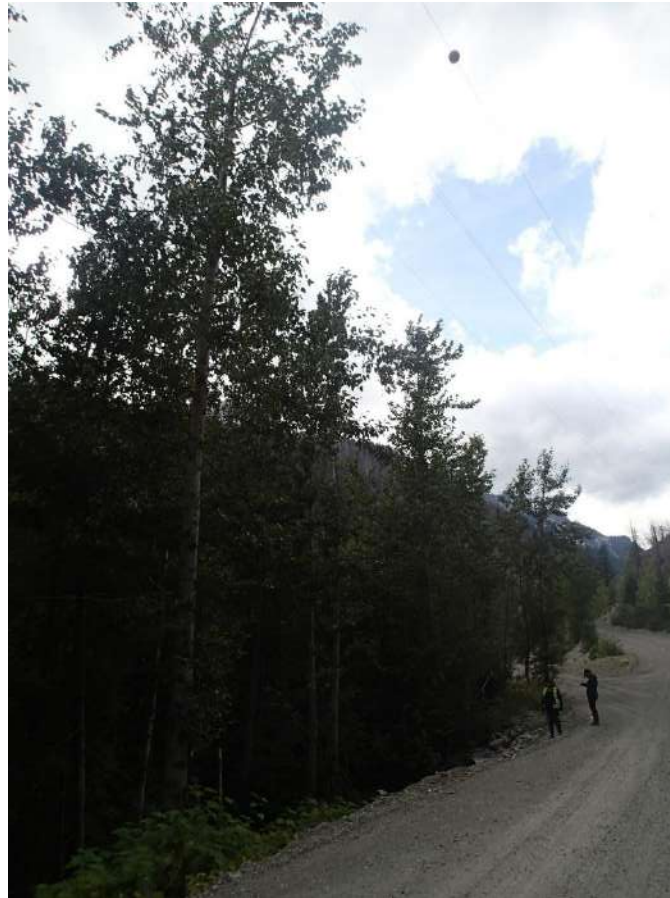
1. ULH-ASTRCM01

Figure 1. Coastal Tailed Frog stream crossed by the transmission line at ULH-ASTRCM01, assessed on August 31, 2018.

General comment:	No clearing required. The stream was dry at the time of the assessment
Clearing restricted to topping trees:	n/a
Effective sediment and erosion control:	yes
Cut wood left in place:	n/a

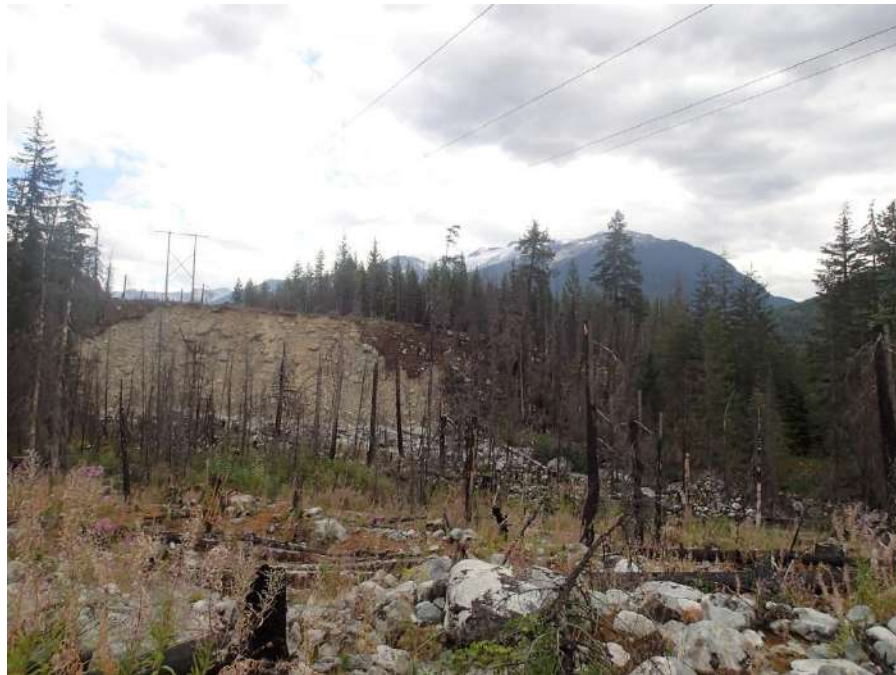
2. ULH-ASTRCM02

Figure 2. Coastal Tailed Frog stream crossed by the transmission line at ULH-ASTRCM02, assessed on August 31, 2018.

General comment:	Trees are burnt but still topped with cut wood left in place.
Clearing restricted to topping trees:	yes
Effective sediment and erosion control:	yes
Cut wood left in place:	yes

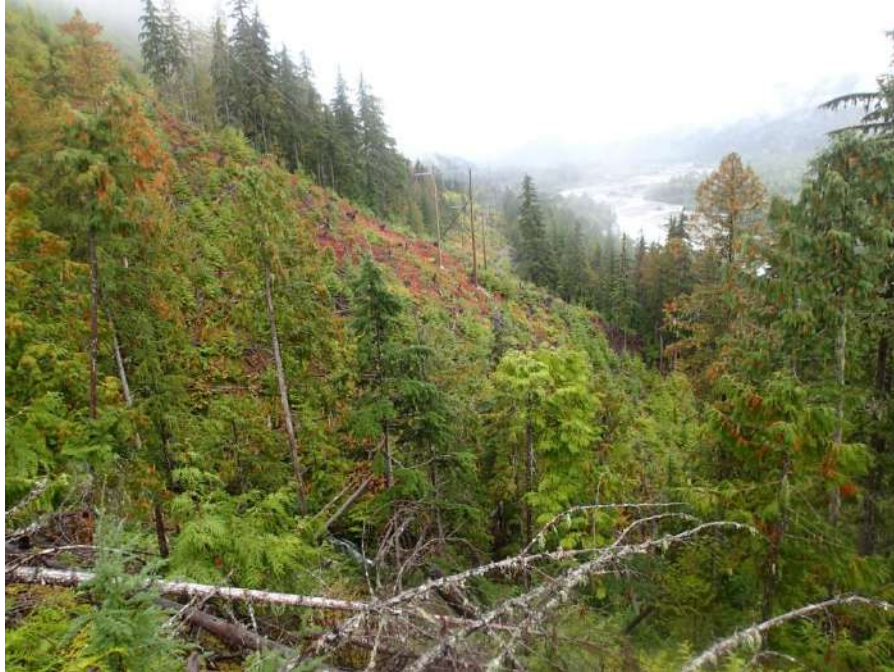
3. ULH-ASTRCM03

Figure 3. Coastal Tailed Frog stream crossed by the transmission line at ULH-ASTRCM03, assessed on September 21, 2018.

General comment:	River left of the stream appears to be an old clear cut. Cut wood placed over the creek.
Clearing restricted to topping trees:	yes
Effective sediment and erosion control:	yes
Cut wood left in place:	yes

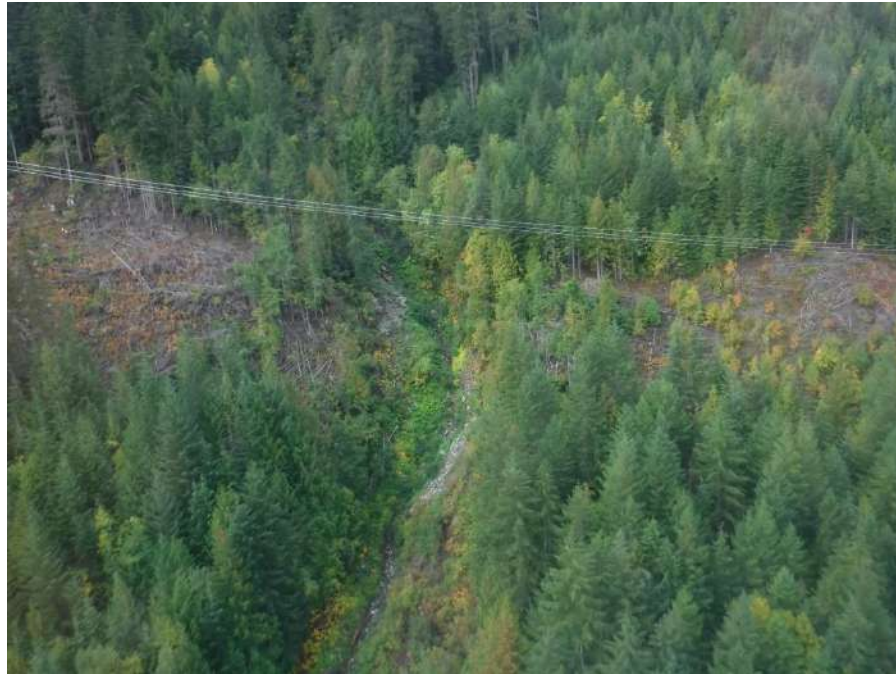
4. ULH-ASTRCM04

Figure 4. Coastal Tailed Frog stream crossed by the transmission line at ULH-ASTRCM04, assessed on September 24, 2018.

General comment:	Some topped trees visible, wood left in place, no erosion issues observed. Small patch of fallen trees on river right appear to be windfall.
Clearing restricted to topping trees:	yes
Effective sediment and erosion control:	yes
Cut wood left in place:	yes

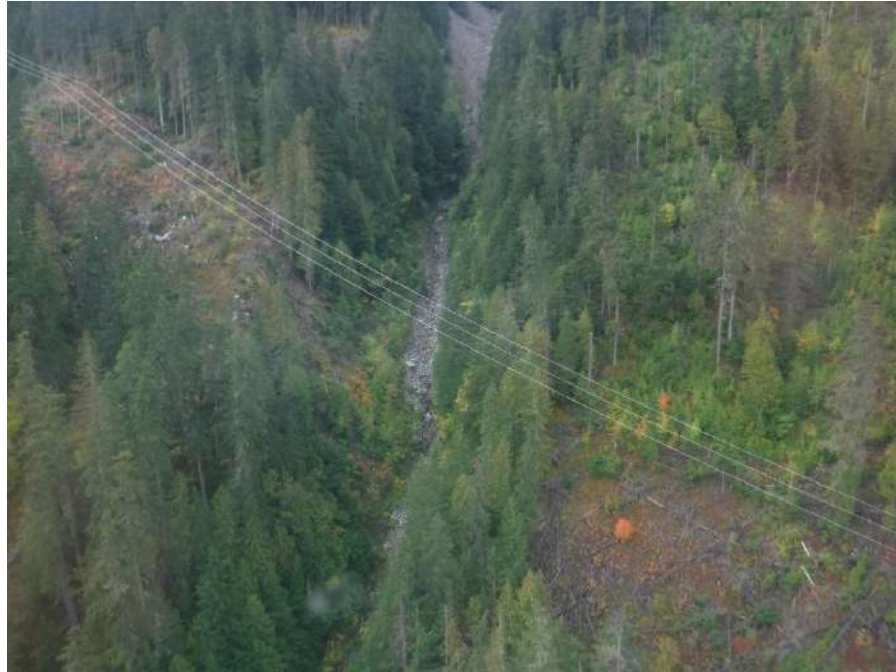
5. ULH-ASTRCM05

Figure 5. Coastal Tailed Frog stream crossed by the transmission line at ULH-ASTRCM05, assessed on September 24, 2018.

General comment:	Topped trees visible, wood left in place, no erosion issues observed near transmission line. Small slide observed upstream of transmission line is unrelated to the transmission line.
Clearing restricted to topping trees:	yes
Effective sediment and erosion control:	yes
Cut wood left in place:	yes

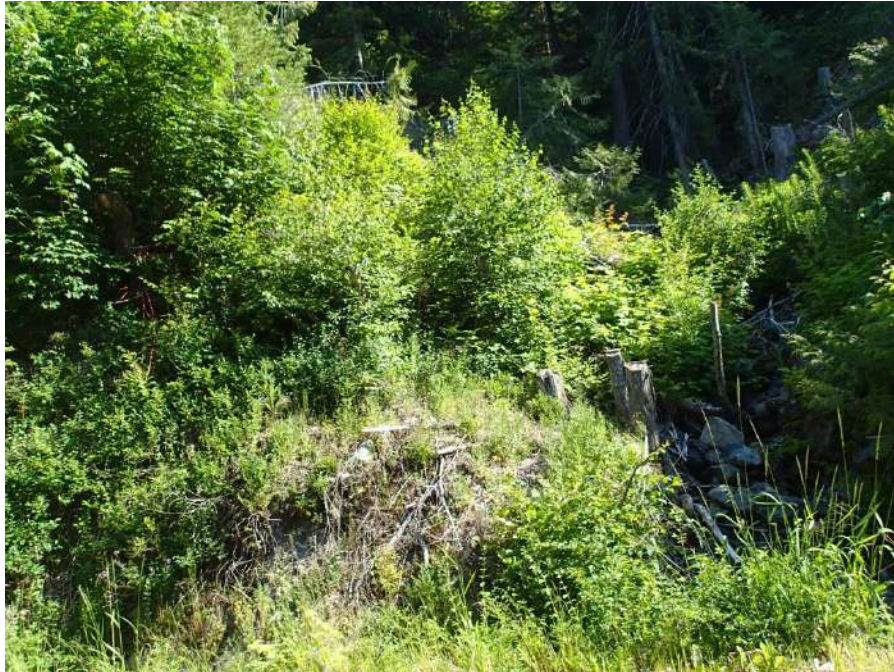
6. ULH-ASTRCM06

Figure 6. Coastal Tailed Frog stream crossed by the transmission line at ULH-ASTRCM06, assessed on June 19, 2018.

General comment:	Very little flow when assessed. It appears that a high flow deposited material upstream of the culvert but the culvert is still passable.
Clearing restricted to topping trees:	yes
Effective sediment and erosion control:	yes
Cut wood left in place:	yes

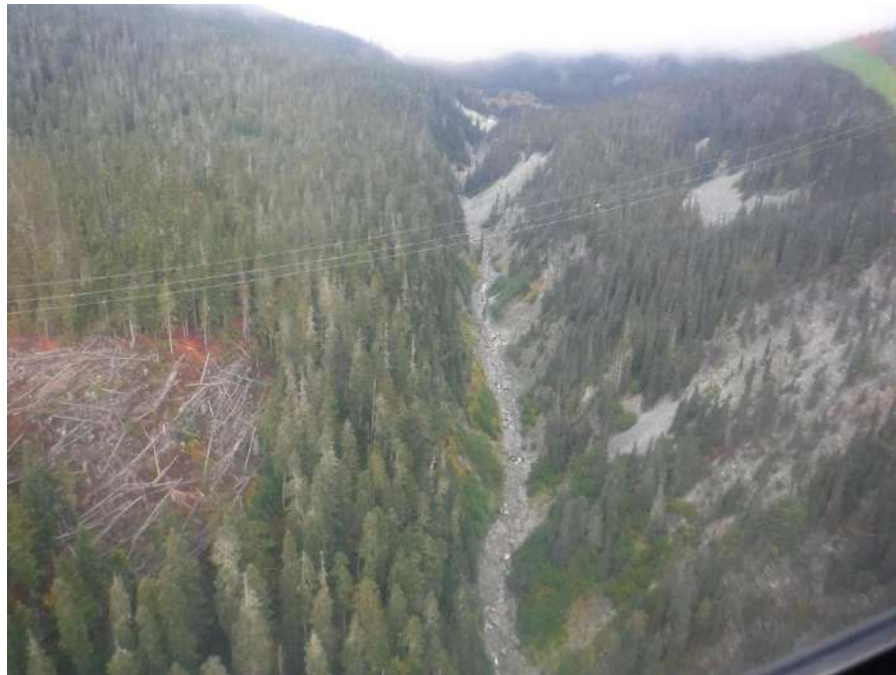
8. ULH-ASTRCM08

Figure 8. Coastal Tailed Frog stream crossed by the transmission line at ULH-ASTRCM08, assessed on September 24, 2018.

General comment:	The transmission line is high enough here that no topping or clearing was necessary.
Clearing restricted to topping trees:	n/a
Effective sediment and erosion control:	yes
Cut wood left in place:	n/a

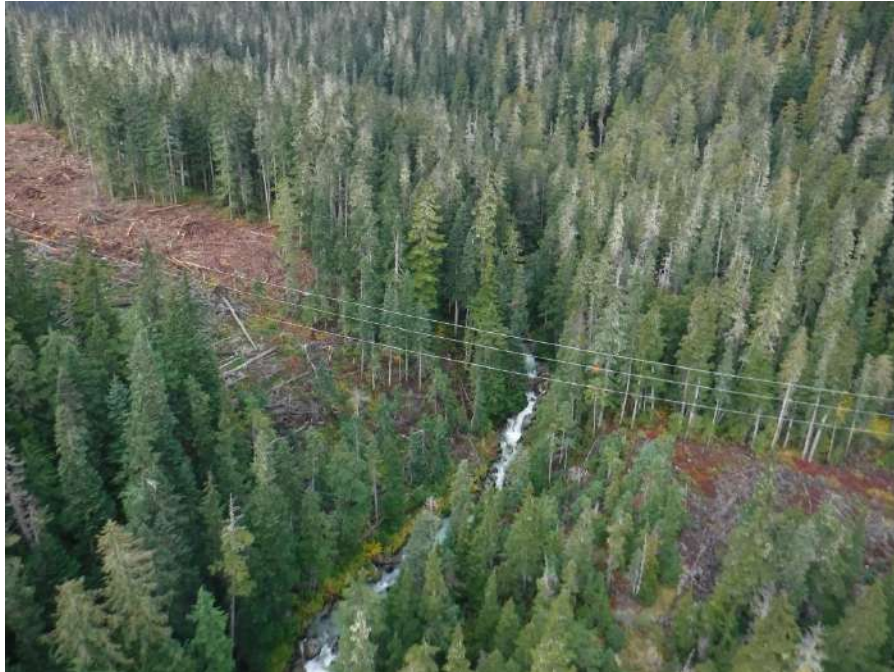
9. ULH-ASTRCM09

Figure 9. Coastal Tailed Frog stream crossed by the transmission line at ULH-ASTRCM09, assessed on September 24, 2018.

General comment:	Topped trees visible, wood left in place, no erosion issues observed.
Clearing restricted to topping trees:	yes
Effective sediment and erosion control:	yes
Cut wood left in place:	yes

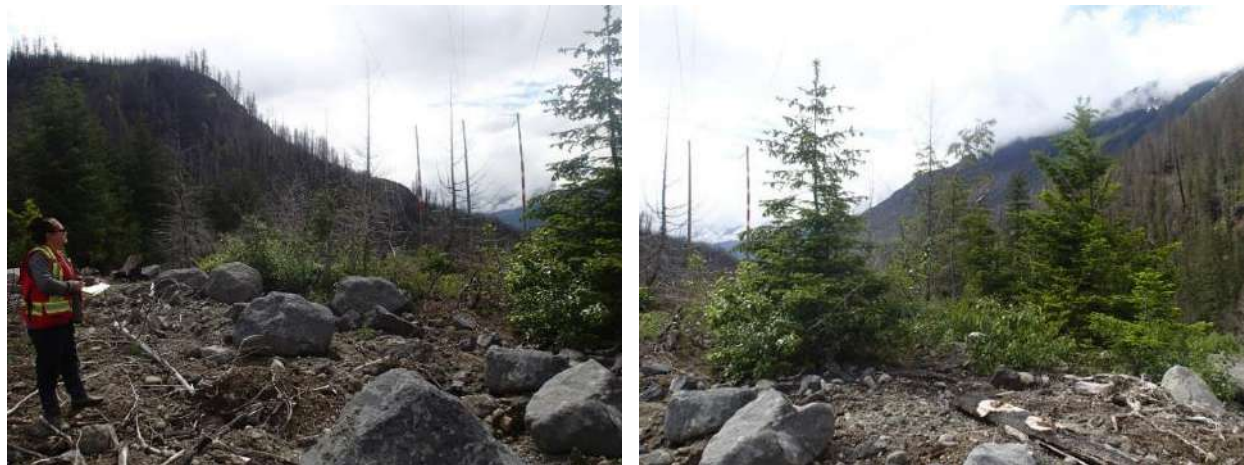
1. ULH-MAMCM01

Figure 1. Vegetated screen along the transmission line at ULH-MAMCM01, assessed on June 14, 2018.

General comment:	Site is partially burnt and will likely regenerate naturally but should be reassessed at a later date. Planting is not recommended at this time.
Species:	Grizzly Bear
Screen widths (m):	10, 5, 5
Average screen width (m):	7
Screen heights (m):	3, 6, 3
Average screen height (m):	4
% Screen coverages:	10, 20, 10
Average % screen coverage:	13
Percent stems preferred forage:	n/a, not within WHA 2-399

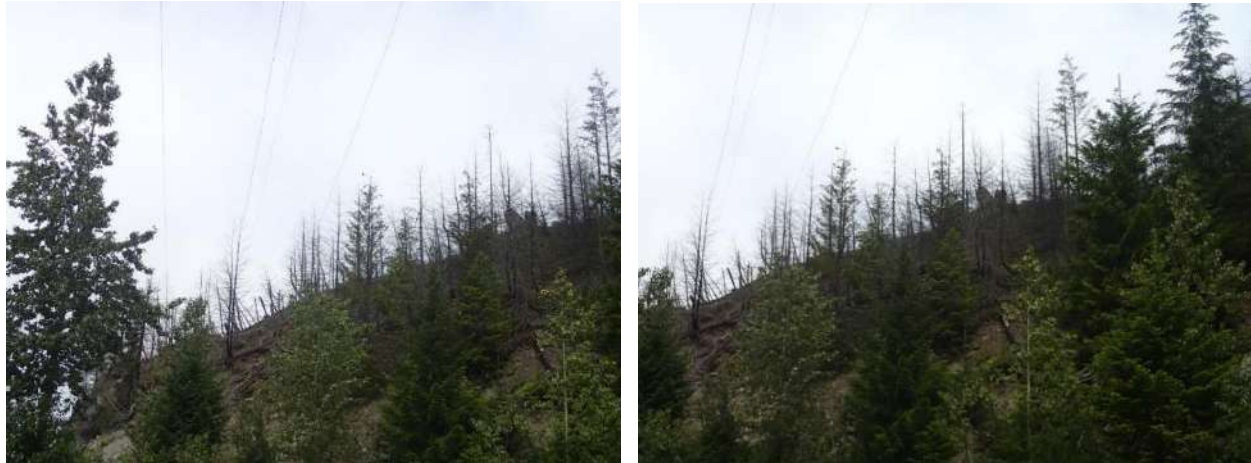
2. ULH-MAMCM02

Figure 2. Vegetated screen along the transmission line at ULH-MAMCM02 (at the top of the hill in the photo), assessed on June 14, 2018.

General comment:	The area is burnt and will likely regenerate naturally but should be reassessed at a later date. Planting is not recommended at this time.
Species:	Grizzly Bear
Average screen width (m):	n/a
Average screen height (m):	n/a
Average % coverage:	n/a
Percent stems preferred forage:	n/a, not within WHA 2-399

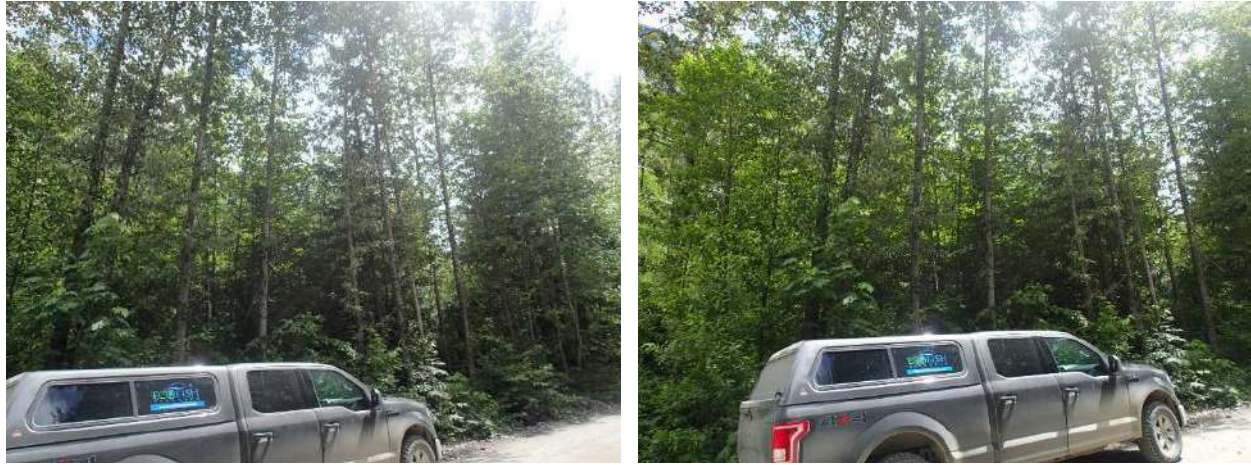
3. ULH-MAMCM03

Figure 3. Vegetated screen along the transmission line at ULH-MAMCM03, assessed on June 14, 2018.

General comment:	Mature vegetation was retained and site was not disturbed by construction.
Species:	Moose
Screen widths (m):	40, 20, 20
Average screen width (m):	27
Screen heights (m):	15, 8, 10
Average screen height (m):	11
% Screen coverages:	100, 100, 100
Average % screen coverage:	100

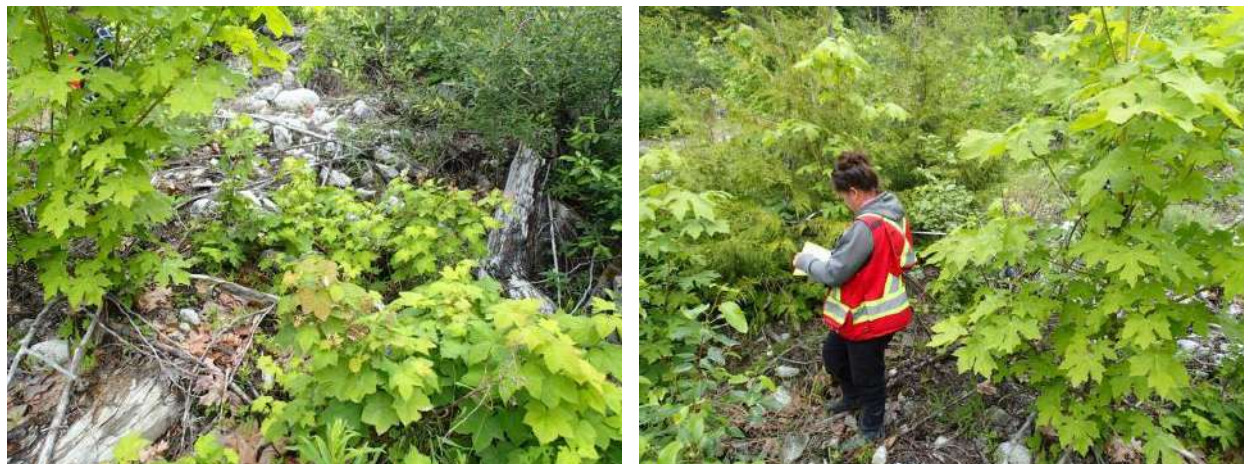
4. ULH-MAMCM04

Figure 4. Vegetated screen along the transmission line at ULH-MAMCM04A (river left of the creek), assessed on June 14, 2018.

General comment:	Screen was maintained on river left of the creek. The screen is expected to grow to a height of 5 m within two or three years.
Species:	Grizzly Bear
Screen widths (m):	20, 10, 12
Average screen width (m):	14
Screen heights (m):	4, 3, 5
Average screen height (m):	4
% Screen coverages:	100, 100, 100
Average % screen coverage:	100
Percent stems preferred forage:	n/a, not within WHA 2-399

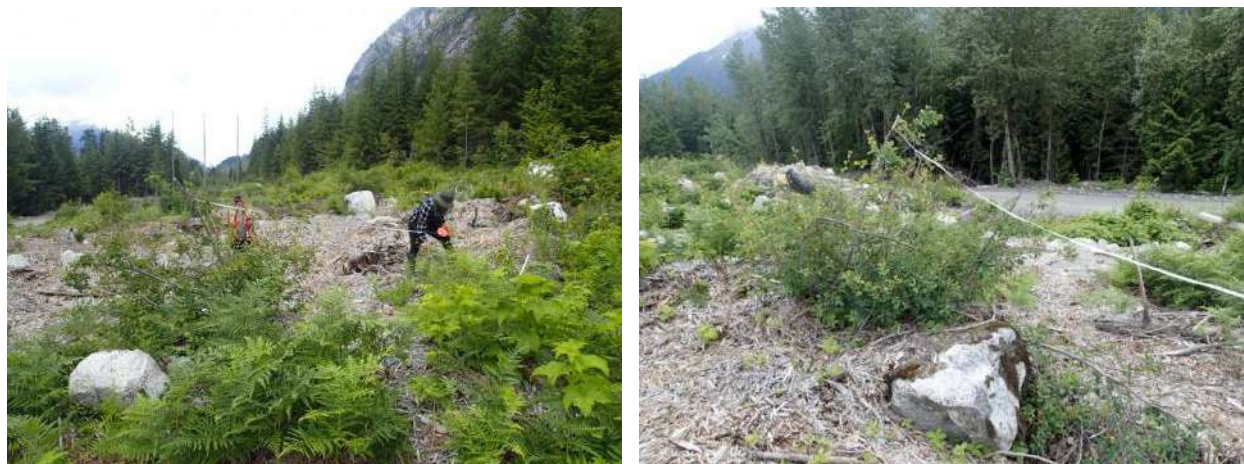
Figure 5. Vegetated screen along the transmission line at ULH-MAMCM04B (river right of the creek), assessed on on June 14, 2018.

General comment:	There is no screen on river right of the creek, but there is abundant immature revegetation that is expected to grow to a height of 5 m within five years.
Species:	Grizzly Bear
Average screen width (m):	n/a
Average screen height (m):	n/a
Average % coverage:	n/a
Percent stems preferred forage:	n/a, not within WHA 2-399

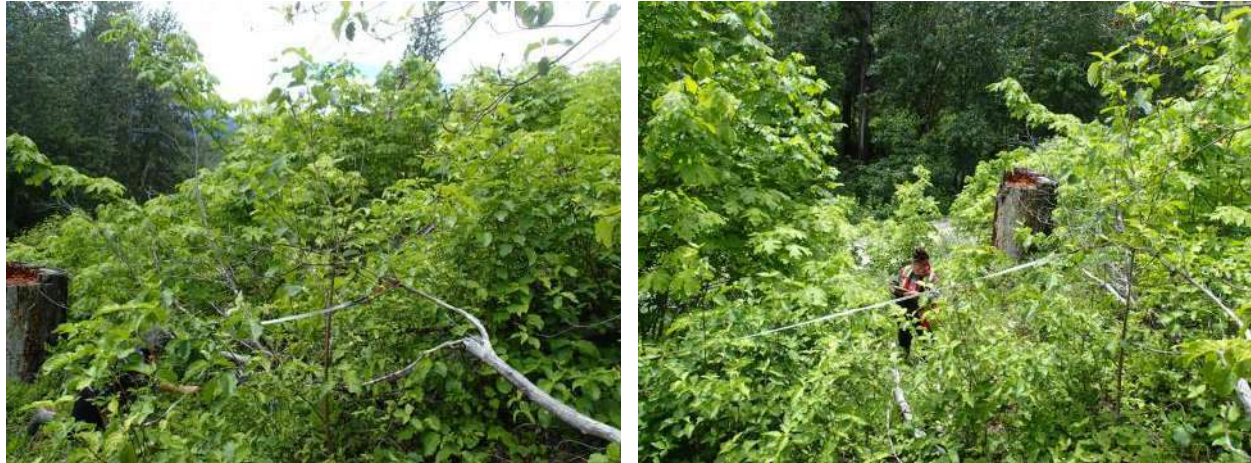
5. ULH-MAMCM05

Figure 6. Vegetated screen along the transmission line at ULH-MAMCM05, assessed on on June 14, 2018.

General comment:	Good shrub cover.
Species:	Grizzly Bear and Mule Deer
Screen widths (m):	20, 15, 15
Average screen width (m):	17
Screen heights (m):	5, 5, 5
Average screen height (m):	5
% Screen coverages:	80, 100, 100
Average % screen coverage:	93
Percent stems preferred forage:	Grizzly Bear – n/a, not within WHA 2-399

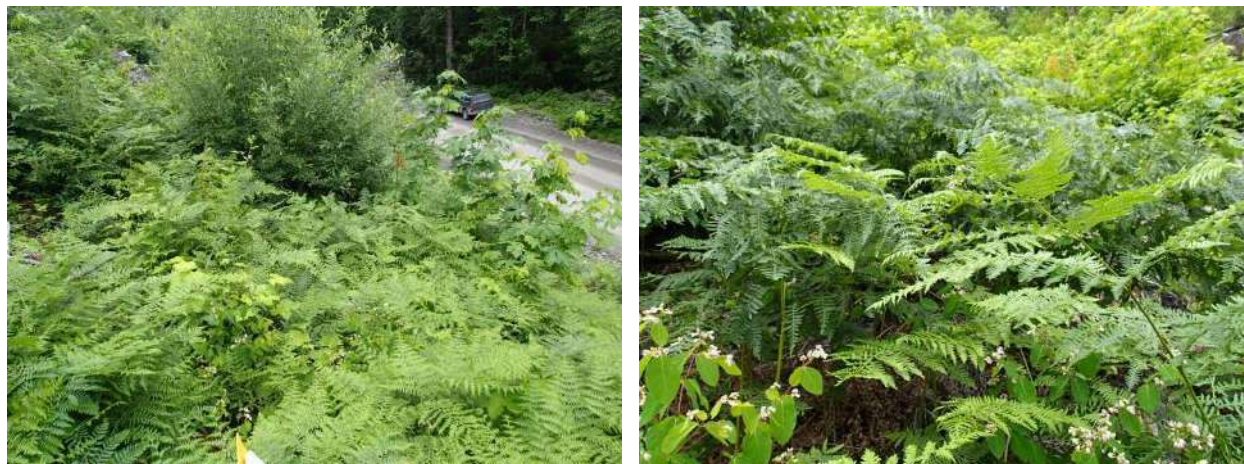
6. ULH-MAMCM06

Figure 7. Vegetated screen along the transmission line at ULH-MAMCM06, assessed on on June 14, 2018.

General comment:	Good dense shrub cover. Screen is expected to grow taller than 5 m within 2 or 3 years.
Species:	Grizzly Bear and Mule Deer
Screen widths (m):	20, 15, 15
Average screen width (m):	17
Screen heights (m):	3, 2, 2
Average screen height (m):	2
% Screen coverages:	20, 50, 20
Average % screen coverage:	30
Percent stems preferred forage:	Grizzly Bear – n/a, not within WHA 2-399

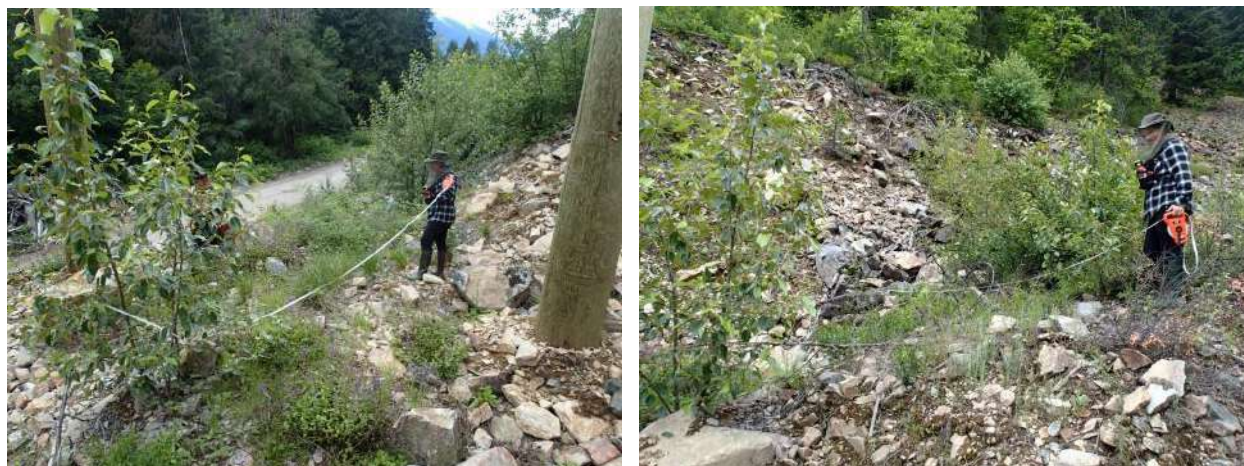
7. ULH-MAMCM07

Figure 8. Vegetated screen along the transmission line at ULH-MAMCM07, assessed on on June 14, 2018.

General comment:	Vegetation is regenerating naturally and expected to grow taller than 5 m, except within the 70 m wide scree slope where planting would not be feasible due to the substrate.
Species:	Grizzly Bear and Mule Deer
Screen widths (m):	2, 5, 2
Average screen width (m):	3
Screen heights (m):	3, 2, 1
Average screen height (m):	2
% Screen coverages:	20, 10, 0
Average % screen coverage:	10
Percent stems preferred forage:	Grizzly Bear – n/a, not within WHA 2-399

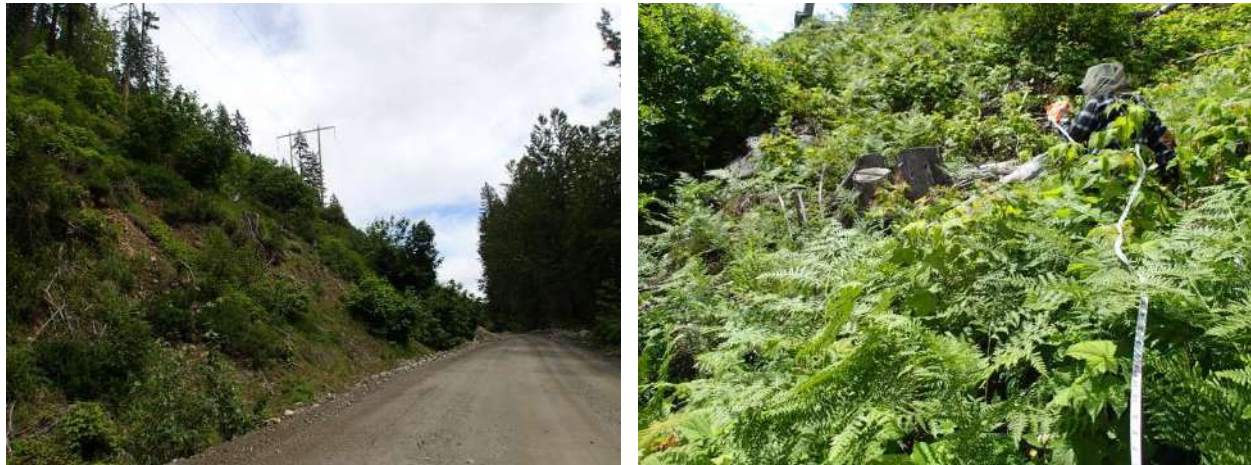
8. ULH-MAMCM08

Figure 9. Vegetated screen along the transmission line at ULH-MAMCM08, assessed on on June 14, 2018.

General comment:	A diversity of dense vegetation is regenerating naturally and expected to grow taller than 5 m.
Species:	Mule Deer
Screen widths (m):	15, 20, 15
Average screen width (m):	17
Screen heights (m):	2, 5, 3
Average screen height (m):	3
% Screen coverages:	40, 80, 20
Average % screen coverage:	47
