Upper Lillooet Hydro Project

Operational Environmental Monitoring: Year 1

April 25, 2019

Ecofish Research Ltd.

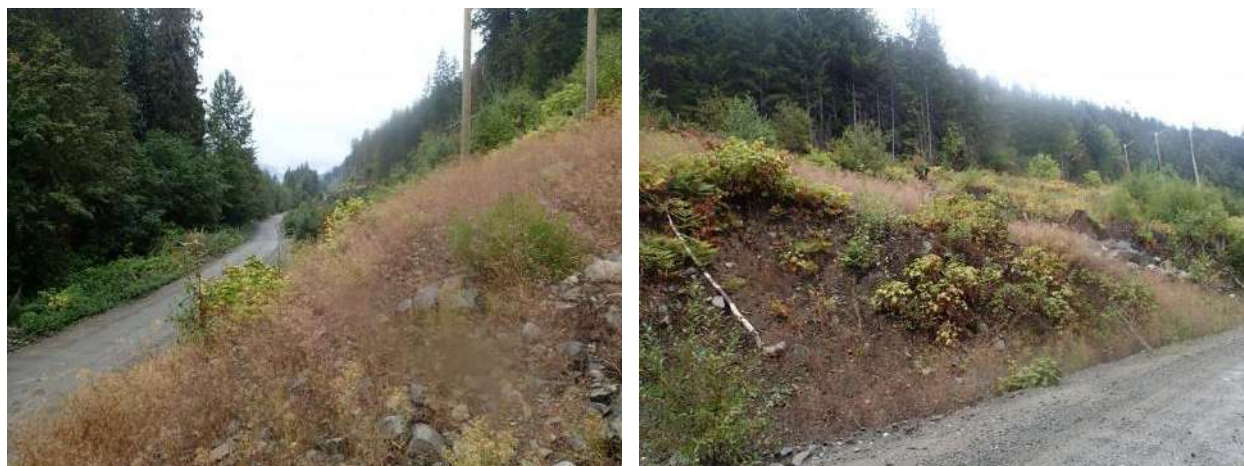
9. ULH-MAMCM09

Figure 10. Vegetated screen along the transmission line at ULH-MAMCM09, assessed on on June 14, 2018.

General comment:	Some vegetation will likely grow taller than 5 m over time but limited regeneration in some areas. Planting may be recommended in the future.
Species:	Grizzly Bear and Mule Deer
Screen widths (m):	1, 3, 2
Average screen width (m):	2
Screen heights (m):	1, 1, 1.5
Average screen height (m):	1
% Screen coverages:	5, 2, 5
Average % screen coverage:	4
Percent stems preferred forage:	Grizzly Bear – n/a, not within WHA 2-399

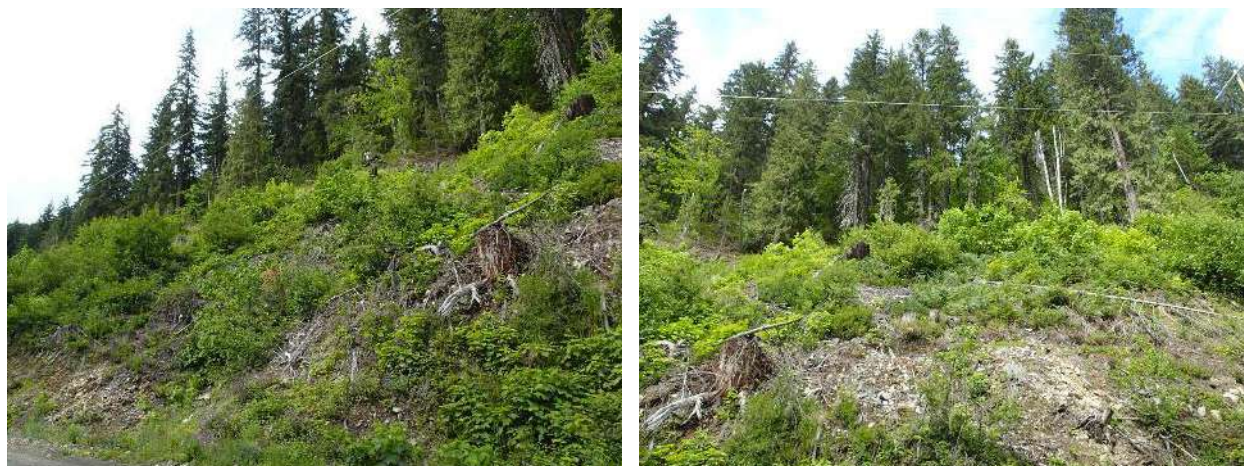
10. ULH-MAMCM10

Figure 11. Vegetated screen along the transmission line at ULH-MAMCM10, assessed on on June 14, 2018.

General comment:	Vegetation is expected to fill in and grow taller than 5 m.
Species:	Mule Deer
Screen widths (m):	8, 10, 10
Average screen width (m):	9
Screen heights (m):	1, 1, 1
Average screen height (m):	1
% Screen coverages:	10, 10, 10
Average % screen coverage:	10

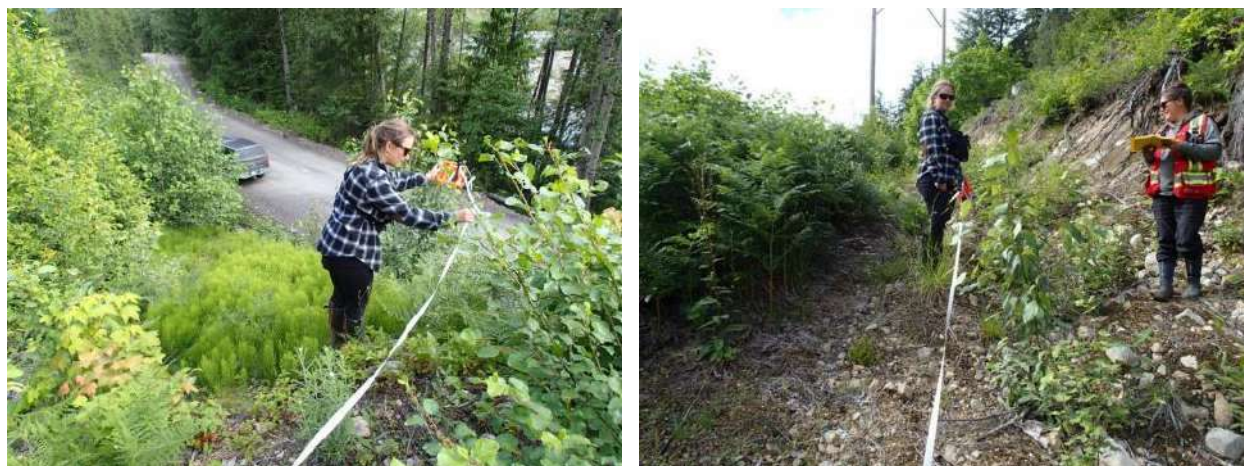
11. ULH-MAMCM11

Figure 12. Vegetated screen along the transmission line at ULH-MAMCM11, assessed on on June 14, 2018.

General comment:	Maintained screen includes some approximately 20 m tall conifers. Remaining vegetation is expected to grow taller than 5 m.
Species:	Mule Deer
Screen widths (m):	5, 10, 5
Average screen width (m):	7
Screen heights (m):	2, 1, 2
Average screen height (m):	2
% Screen coverages:	50, 30, 40
Average % screen coverage:	40

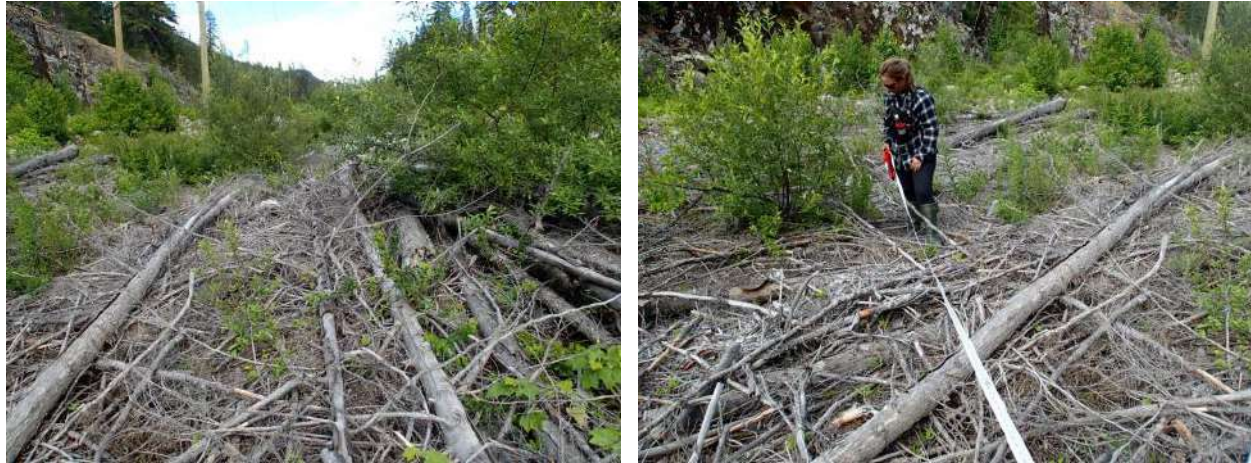
12. ULH-MAMCM12

Figure 13. Vegetated screen along the transmission line at ULH-MAMCM12, assessed on on June 14, 2018.

General comment:	Vegetation is expected to fill in and grow taller than 5 m.
Species:	Moose
Screen widths (m):	10, 5, 5
Average screen width (m):	7
Screen heights (m):	2, 1, 2
Average screen height (m):	2
% Screen coverages:	10, 10, 10
Average % screen coverage:	10

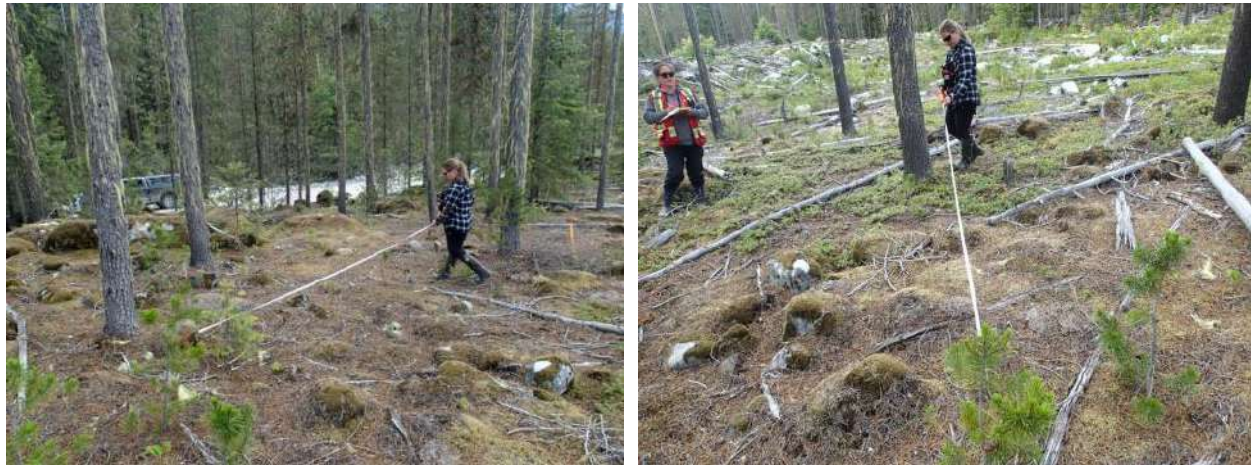
13. ULH-MAMCM13

Figure 14. Vegetated screen along the transmission line at ULH-MAMCM13, assessed on on June 14, 2018.

General comment:	Young and mature pine were retained.
Species:	Moose
Screen widths (m):	25, 25, 25
Average screen width (m):	25
Screen heights (m):	18, 20, 20
Average screen height (m):	19
% Screen coverages:	30, 30, 30
Average % screen coverage:	30

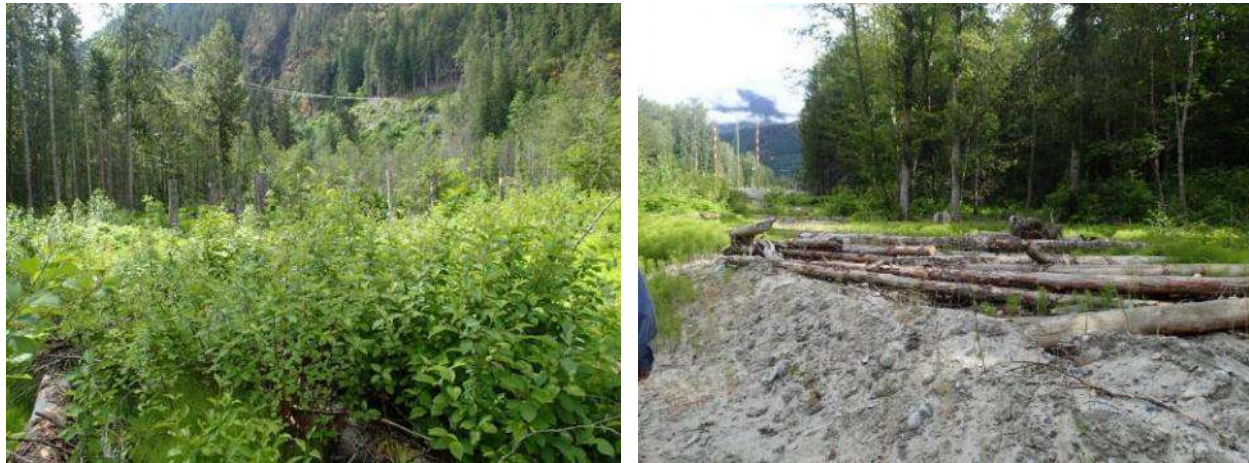
14. ULH-MAMCM14

Figure 15. Vegetated screen along the transmission line at ULH-MAMCM14, assessed on on June 6, 2018.

General comment:	Within WHA 2-399 the road was deactivated with the addition of coarse woody debris, and a vegetation screen was maintained. The screen consisted of maintained vegetation and no planting was observed. Vegetation is on a trajectory to grow taller than 5 m.
Species:	Grizzly Bear and Moose
Road deactivated:	Yes
Screen widths (m):	5, 10, 12
Average screen width (m):	9
Screen heights (m)	3, 2, 2.5
Average screen height (m):	3
% Screen coverages	100, 100, 100
Average % screen coverage:	100
Percent stems preferred forage:	Grizzly Bear – 67%

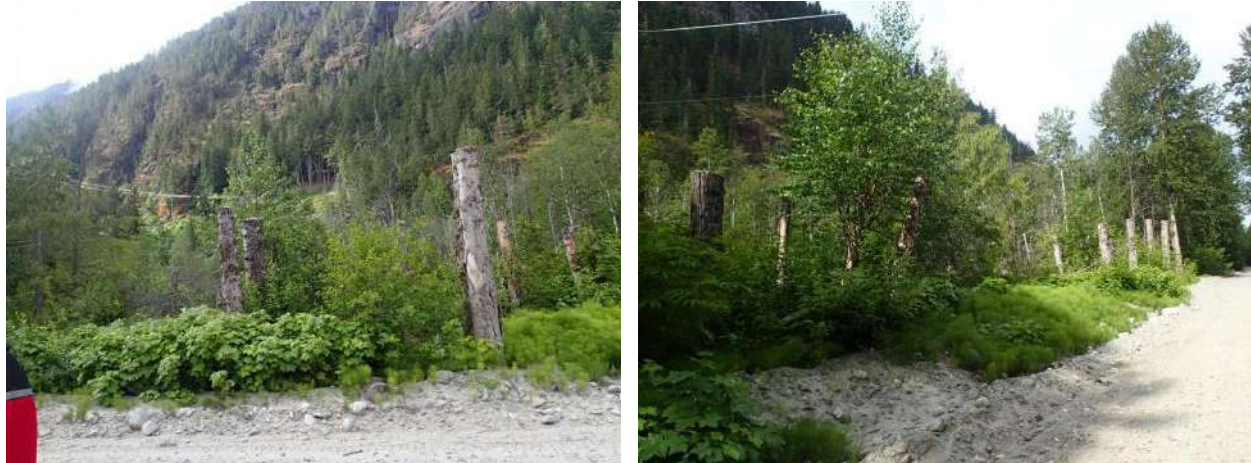
15. ULH-MAMCM15

Figure 16. Vegetated screen along the transmission line at ULH-MAMCM15, assessed on on June 6, 2018.

General comment:	Vegetation is expected to fill in and continue to grow taller.
Species:	Moose
Screen widths (m):	8, 15, 10
Average screen width (m):	11
Screen heights (m):	8, 3, 3
Average screen height (m):	5
% Screen coverages:	100, 100, 100
Average % screen coverage:	100

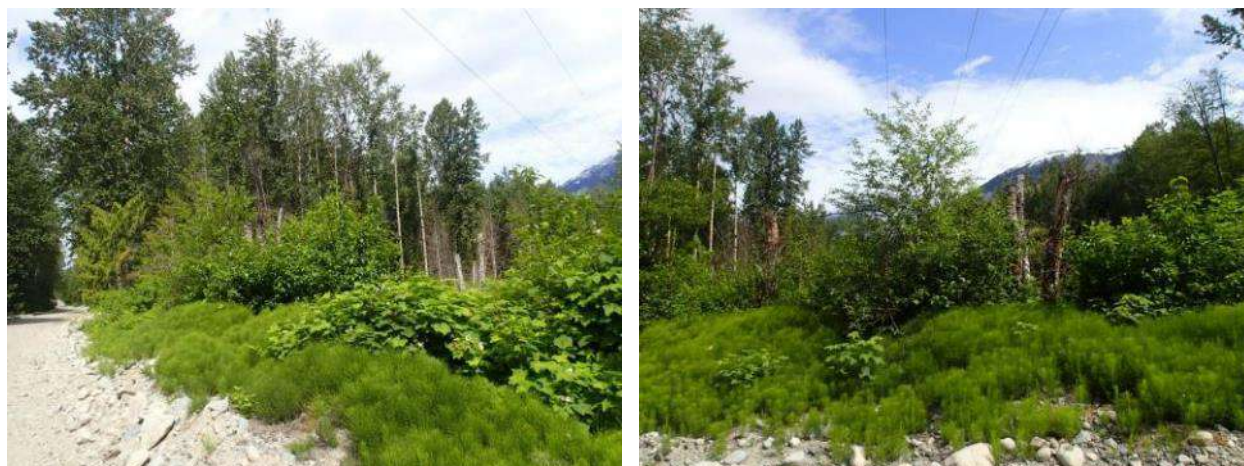
16. ULH-MAMCM16

Figure 17. Vegetated screen along the transmission line at ULH-MAMCM16, assessed on on June 6, 2018.

General comment:	Road deactivated and screen maintained within WHA 2-399. The South Creek debris flow that flowed into this area did not affect the maintained screen. The screen consisted of maintained vegetation and no planting was observed.
Species:	Grizzly Bear and Moose
Road deactivated:	Yes
Screen widths (m):	8, 10, 10
Average screen width (m):	9
Screen heights (m):	8, 2, 5
Average screen height (m):	5
% Screen coverages:	100, 30, 40
Average % screen coverage:	57
Percent stems preferred forage:	Grizzly Bear – 71%

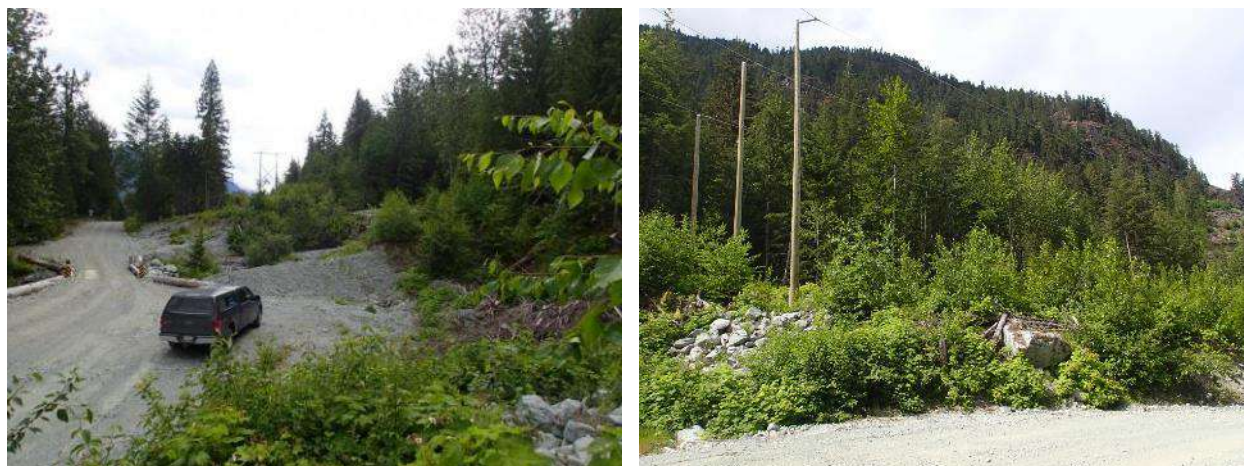
17. ULH-MAMCM17

Figure 18. Vegetated screen along the transmission line at ULH-MAMCM17, assessed on on June 6, 2018.

General comment:	There is a small gap in the screen at the transmission line pole but the gap is difficult to see through from the road. There is no screen on river right of the creek approximately 90 m along the road, but this is a result of Squamish Mills activity and isn't attributable to the Project.
Species:	Grizzly Bear
Screen widths (m):	8, 5, 10
Average screen width (m):	8
Screen heights (m):	3, 2, 3
Average screen height (m):	3
% Screen coverages:	80, 80, 100
Average % screen coverage:	87
Percent stems preferred forage:	n/a, not within WHA 2-399

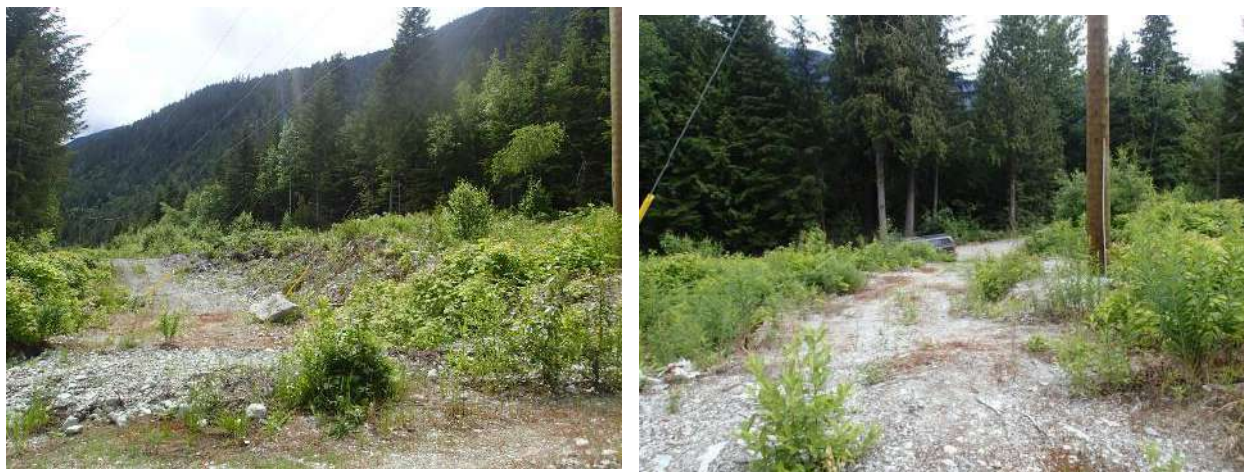
18. ULH-MAMCM18

Figure 19. Vegetated screen along the transmission line at ULH-MAMCM18, assessed on June 6, 2018.

General comment:	Easy road access and no screen maintained; however, natural regeneration is expected to grow taller and fill in.
Species:	Grizzly Bear
Screen widths (m):	20, 20, 20
Average screen width (m):	20
Screen heights (m):	1,2,2
Average screen height (m):	2
% Screen coverages:	0, 40, 50
Average % screen coverage:	30
Percent stems preferred forage:	n/a, not within WHA 2-399

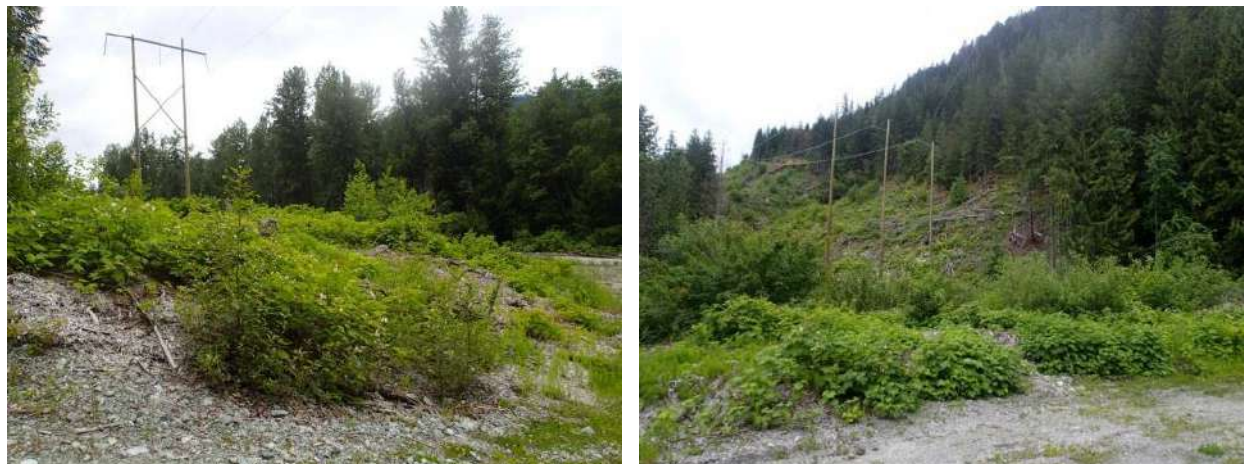
19. ULH-MAMCM19

Figure 20. Vegetated screen along the transmission line at ULH-MAMCM19, assessed on on June 6, 2018.

General comment:	Tower access road deactivated. Short maintained screen is expected to grow taller and fill in.
Species:	Grizzly Bear
Road deactivated:	Yes
Screen widths (m):	10, 10, 10
Average screen width (m):	10
Screen heights (m):	5, 3, 1
Average screen height (m):	3
% Screen coverages:	0, 30, 30
Average % screen coverage:	20
Percent stems preferred forage:	n/a, not within WHA 2-399

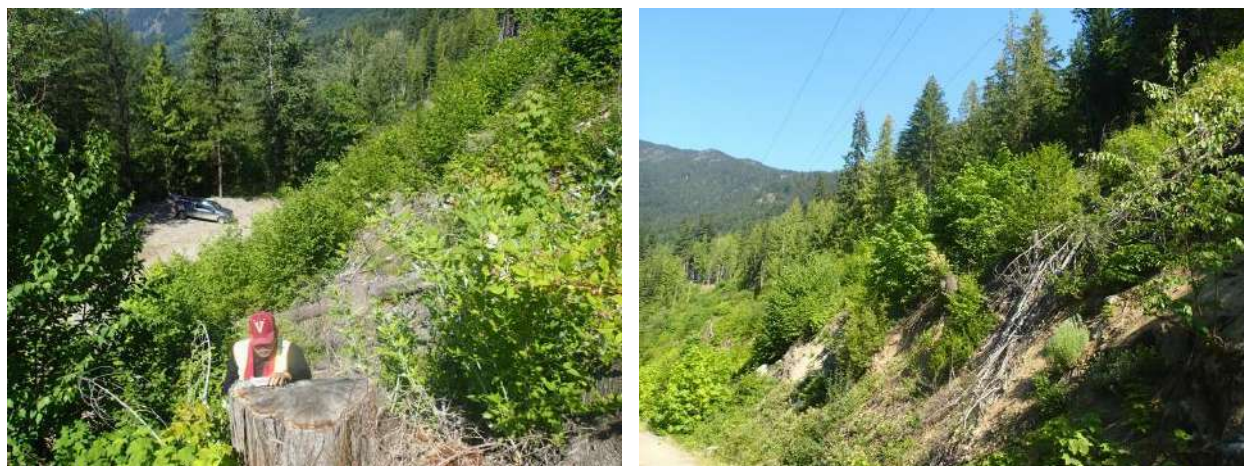
20. ULH-MAMCM20

Figure 21. Vegetated screen along the transmission line at ULH-MAMCM20, assessed on on June 19, 2018.

General comment:	Screen on this steep slope is expected to grow taller than 5 m and fill in.
Species:	Mule Deer
Screen widths (m):	15, 15, 12
Average screen width (m):	14
Screen heights (m):	5, 2, 5
Average screen height (m):	4
% Screen coverages:	25, 50, 50
Average % screen coverage:	42

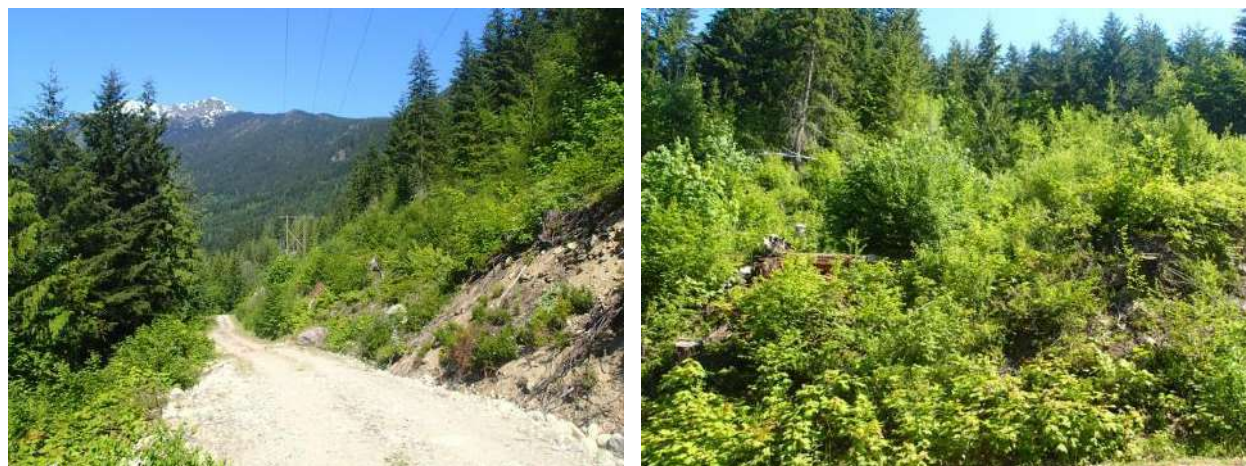
21. ULH-MAMCM21

Figure 22. Vegetated screen along the transmission line at ULH-MAMCM21, assessed on on June 19, 2018.

General comment:	Screen on this steep slope is expected to grow taller than 5 m and fill in. The transmission line is over the road in places here.
Species:	Grizzly Bear and Mule Deer
Screen widths (m):	5, 5, 2
Average screen width (m):	4
Screen heights (m):	5, 4, 3
Average screen height (m):	4
% Screen coverages:	50, 50, 60
Average % screen coverage:	53
Percent stems preferred forage:	Grizzly Bear - n/a, not within WHA 2-399

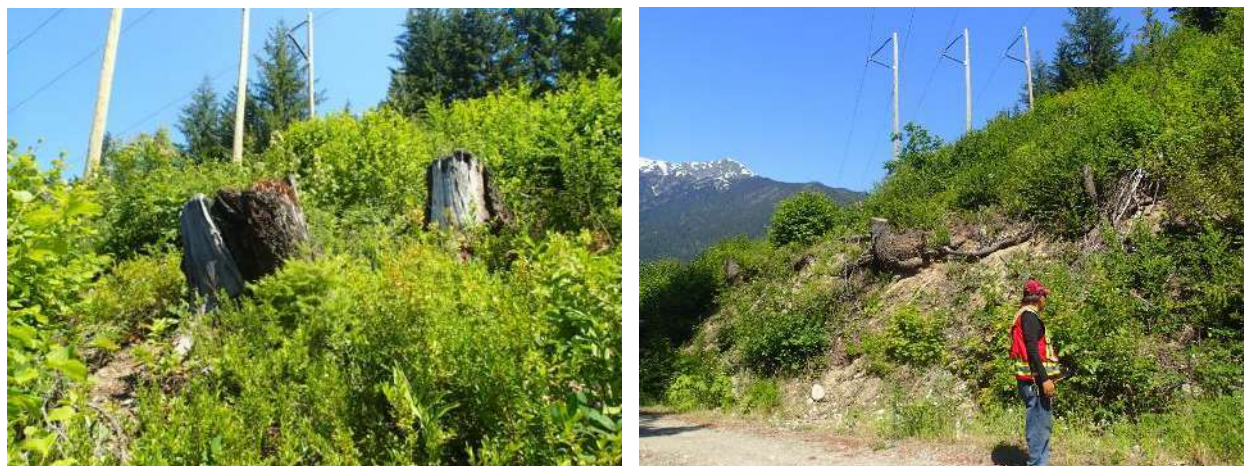
22. ULH-MAMCM22

Figure 23. Vegetated screen along the transmission line at ULH-MAMCM22, assessed on on June 19, 2018.

General comment:	Screen on this steep slope is expected to grow taller than 5 m and fill in. The transmission line is over the road in places here.
Species:	Grizzly Bear
Screen widths (m):	10, 8, 2
Average screen width (m):	7
Screen heights (m):	5, 2, 2
Average screen height (m):	3
% Screen coverages:	50, 50, 60
Average % screen coverage:	53
Percent stems preferred forage:	n/a, not within WHA 2-399

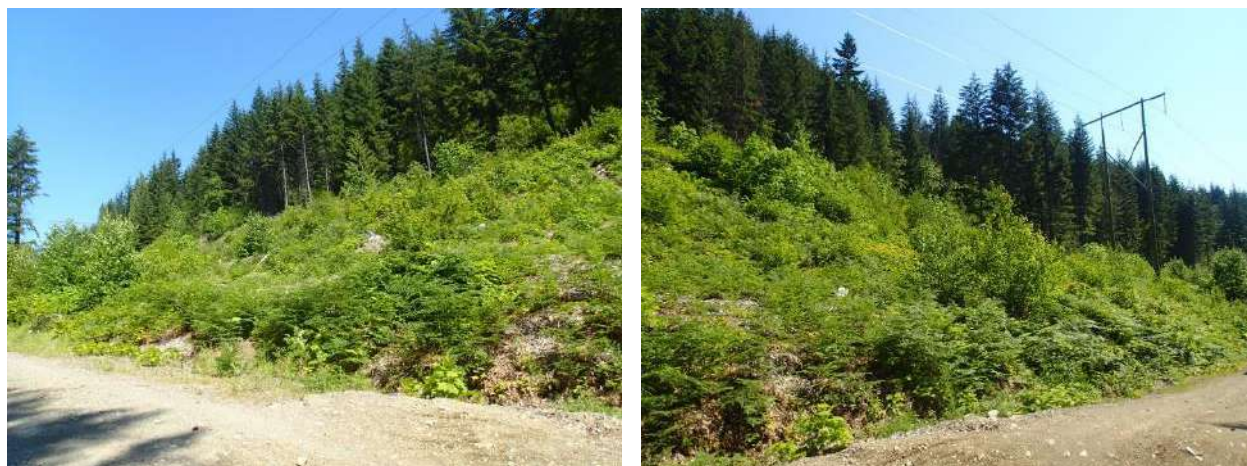
23. ULH-MAMCM23

Figure 24. Vegetated screen along the transmission line at ULH-MAMCM23, assessed on on June 19, 2018.

General comment:	Minimal screen at this site. Wood chips are restricting regeneration, but the vegetation is expected to fill in and grow taller than 5 m over time.
Species:	Grizzly Bear
Screen widths (m):	3, 10, 10
Average screen width (m):	8
Screen heights (m):	0.5, 2, 1
Average screen height (m):	1
% Screen coverages:	0, 0, 0
Average % screen coverage:	0
Percent stems preferred forage:	n/a, not within WHA 2-399

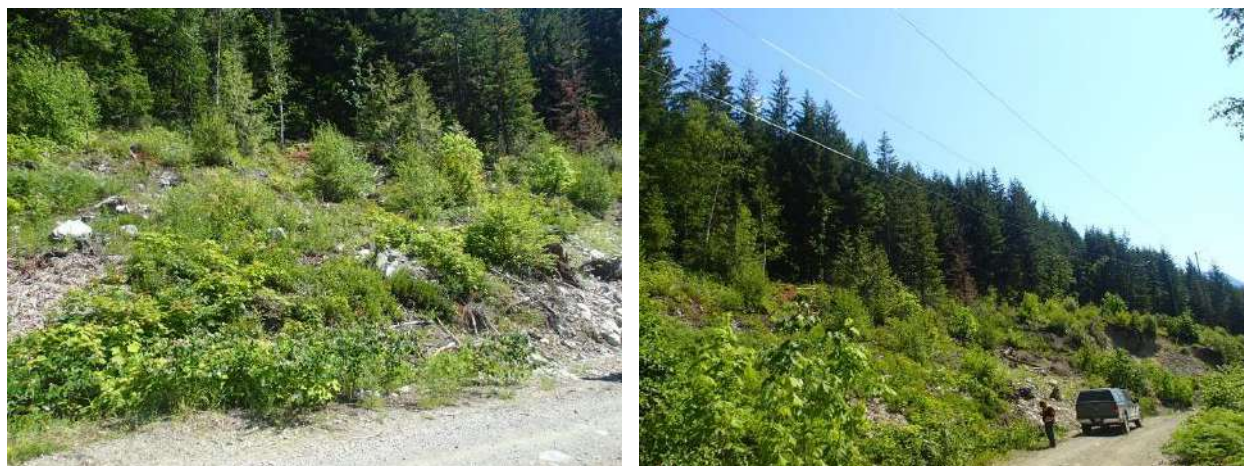
24. ULH-MAMCM24

Figure 25. Vegetated screen along the transmission line at ULH-MAMCM24, assessed on on June 19, 2018.

General comment:	The short vegetation along the road is expected to fill in and grow taller than 5 m, but the overall height will be limited by the transmission line above.
Species:	Grizzly Bear and Mule Deer
Screen widths (m):	n/a
Average screen width (m):	
Screen heights (m):	0.5, 0.5, 1
Average screen height (m):	1
% Screen coverages:	0, 0, 0
Average % screen coverage:	0
Percent stems preferred forage:	Grizzly Bear - n/a, not within WHA 2-399

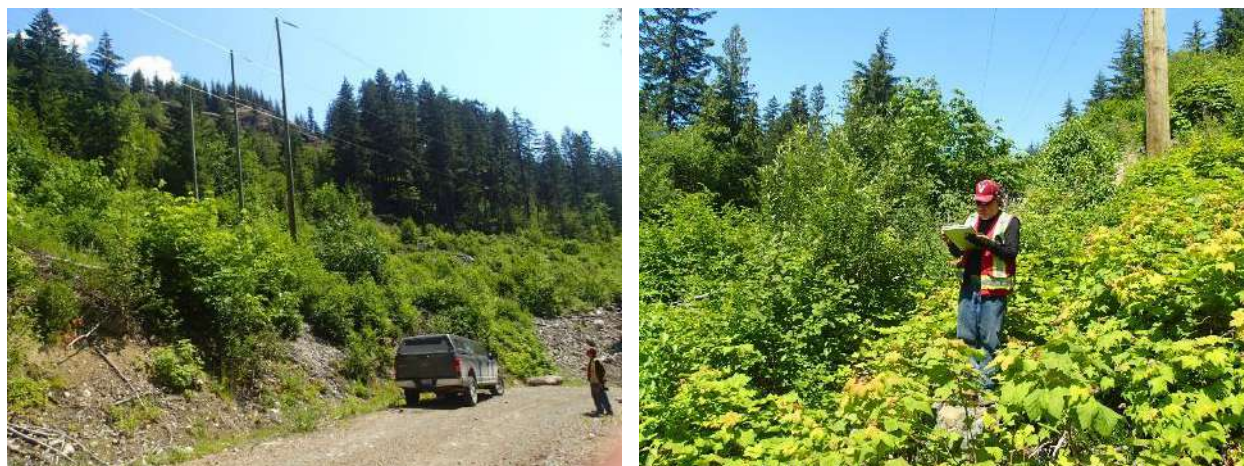
25. ULH-MAMCM25

Figure 26. Vegetated screen along the transmission line at ULH-MAMCM25, assessed on on June 19, 2018.

General comment:	The vegetated screen is expected to fill in and grow taller than 5 m.
Species:	Grizzly Bear and Mule Deer
Screen widths (m):	5, 10, 10
Average screen width (m):	8
Screen heights (m):	5, 3, 5
Average screen height (m):	4
% Screen coverages:	50, 80, 70
Average % screen coverage:	67
Percent stems preferred forage:	Grizzly Bear - n/a, not within WHA 2-399

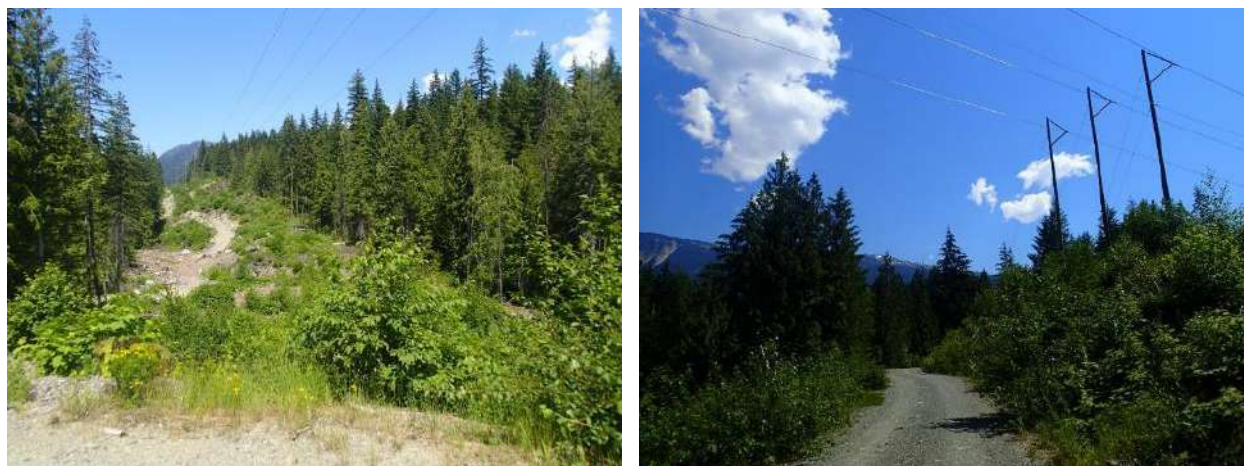
26. ULH-MAMCM26

Figure 27. Vegetated screen along the transmission line at ULH-MAMCM26, assessed on on June 19, 2018.

General comment:	The vegetated screen is expected to fill in and grow taller than 5 m.
Species:	Grizzly Bear and Mule Deer
Screen widths (m):	40, 40, 40
Average screen width (m):	40
Screen heights (m):	1, 2, 3
Average screen height (m):	2
% Screen coverages:	50, 50, 50
Average % screen coverage:	50
Percent stems preferred forage:	Grizzly Bear - n/a, not within WHA 2-399

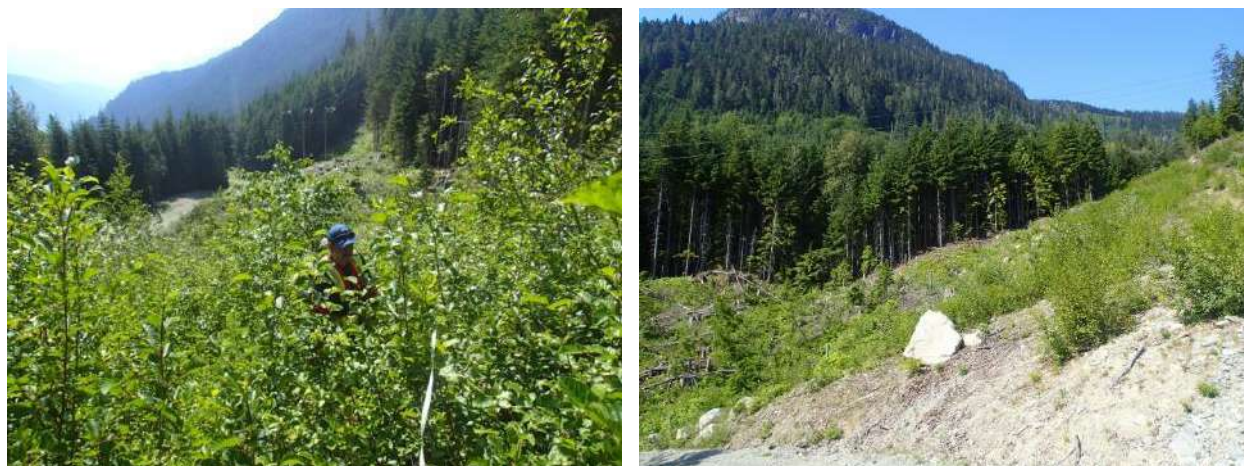
27. ULH-MAMCM27

Figure 28. Vegetated screen along the transmission line at ULH-MAMCM27, assessed on on June 21, 2018.

General comment:	Road deactivated and vegetated screen growing well. The screen is expected to grow taller than 5 m.
Species:	Grizzly Bear
Screen widths (m):	20, 50, 50
Average screen width (m):	40
Screen heights (m):	2, 3, 2
Average screen height (m):	2
% Screen coverages:	90, 81, 80
Average % screen coverage:	84
Percent stems preferred forage:	n/a, not within WHA 2-399

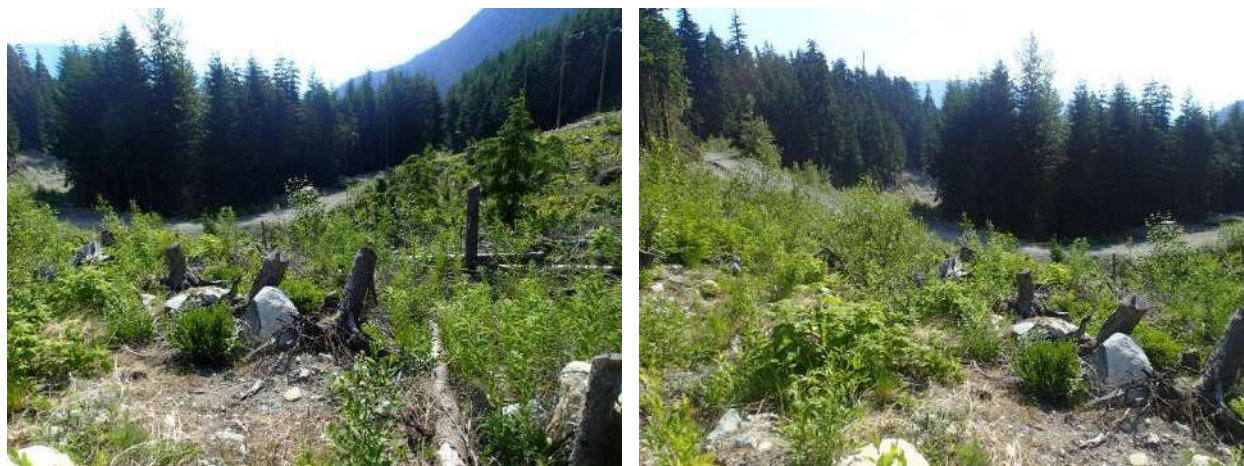
28. ULH-MAMCM28

Figure 29. Vegetated screen along the transmission line at ULH-MAMCM28, assessed on on June 21, 2018.

General comment:	Short vegetated screen is expected to fill in and become taller than 5 m.
Species:	Grizzly Bear
Screen widths (m):	30, 50, 40
Average screen width (m):	40
Screen heights (m):	0.3, 1, 1.5
Average screen height (m):	1
% Screen coverages:	0, 0, 10
Average % screen coverage:	3
Percent stems preferred forage:	n/a, not within WHA 2-399
