Upper Lillooet Hydro Project

Operational Environmental Monitoring: Year 2

April 29, 2020

Ecofish Research Ltd.

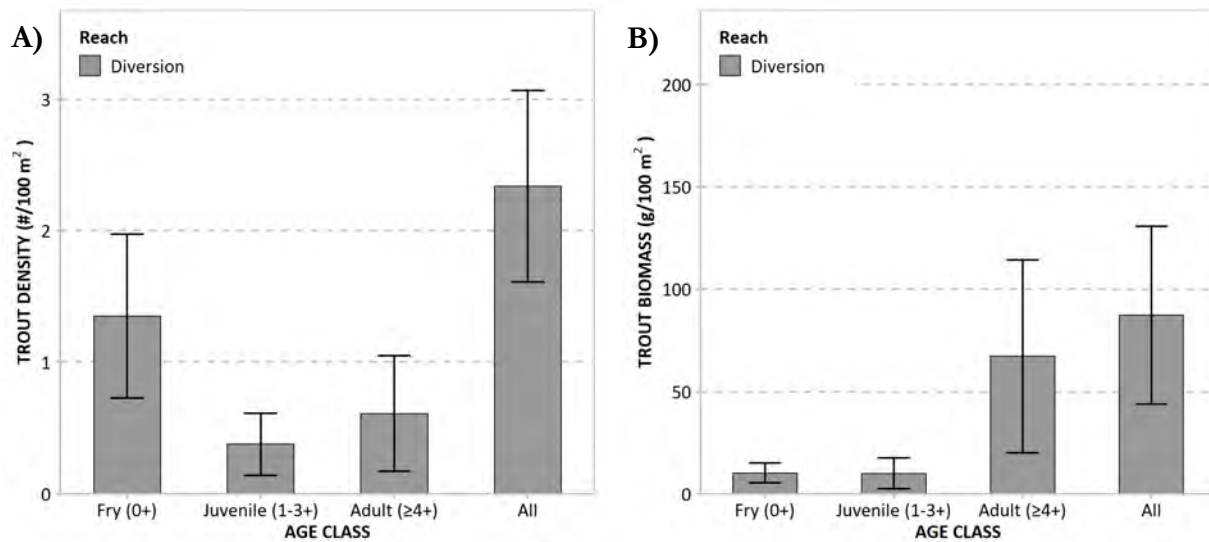
Figure 17. Average observed densities (\pm standard error) by age class of Bull Trout determined from closed-site electrofishing in the Upper Lillooet River diversion reach in 2019 presented as: A) fish density per 100 m² (FPUobs), and B) fish biomass per 100 m² (BPUobs). Bull Trout are not present in the upstream reach.

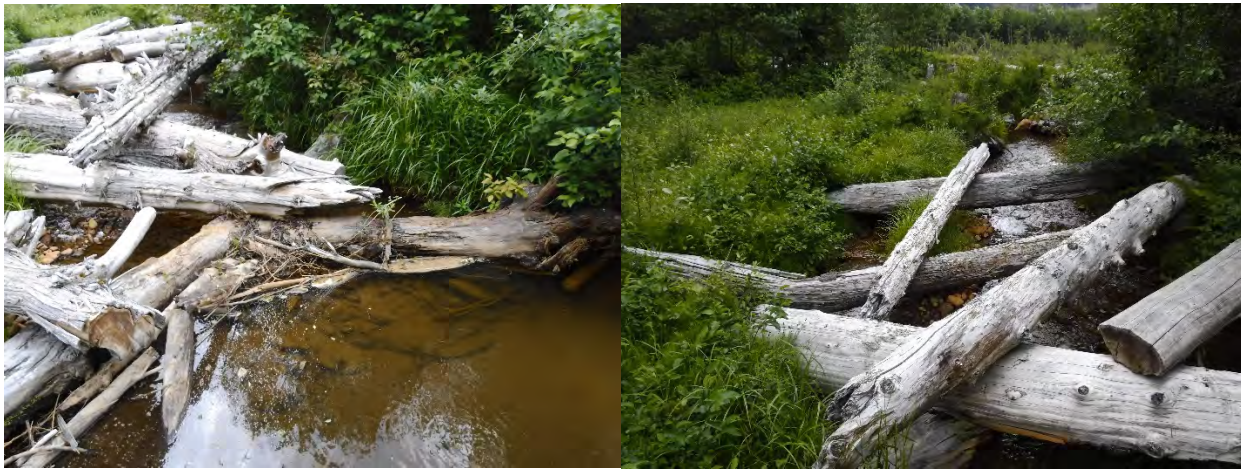
Figure 5. Log that has collapsed between ALE-XS1 and ALE-XS2 (left) causing moderate side-channel formation (right and shown in Figure 1 to Figure 4) and partial backwatering of a riffle. Photos taken on June 20, 2019.

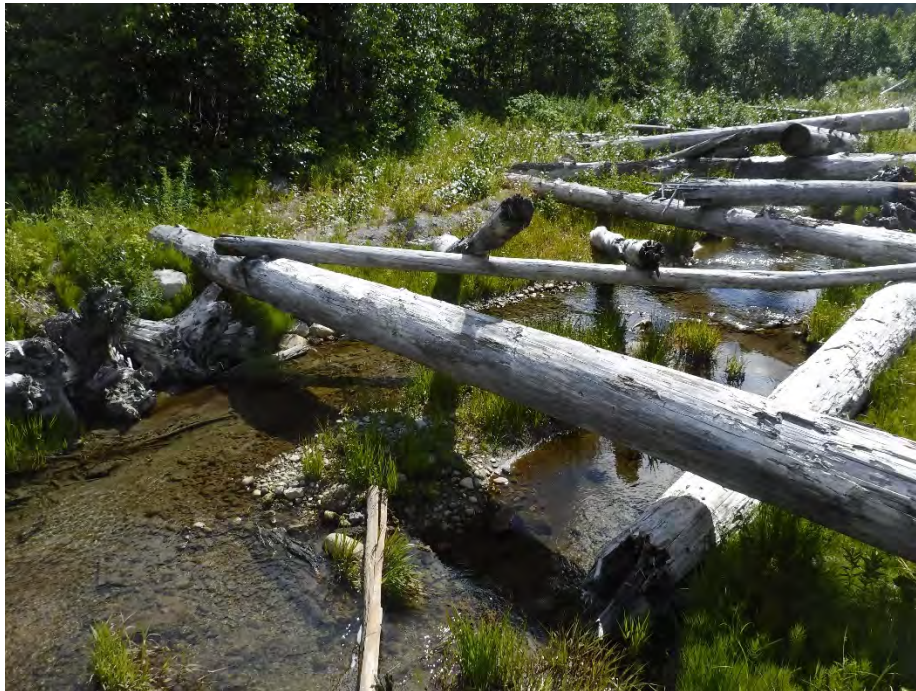
Figure 6. Mid-channel bar just upstream of ALE-XS6. Photo taken on June 20, 2019.

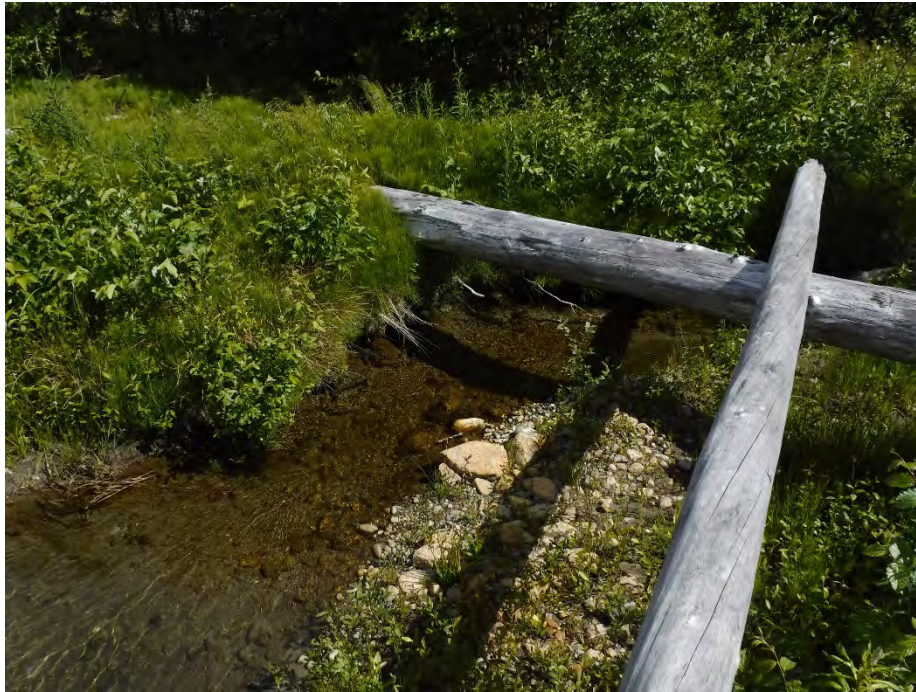
Figure 7. Bank erosion and channel down-cutting at ALE-XS5 requiring repair. Photo taken on June 20, 2019.

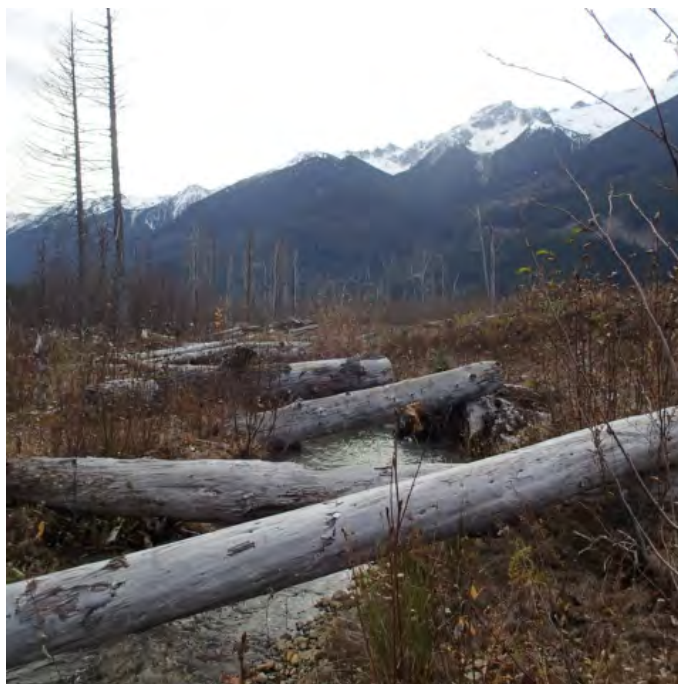
Figure 23. Overview of FHEP channel taken from ALE-PRM05, demonstrating revegetation success of trees and shrubs, on October 29, 2019.

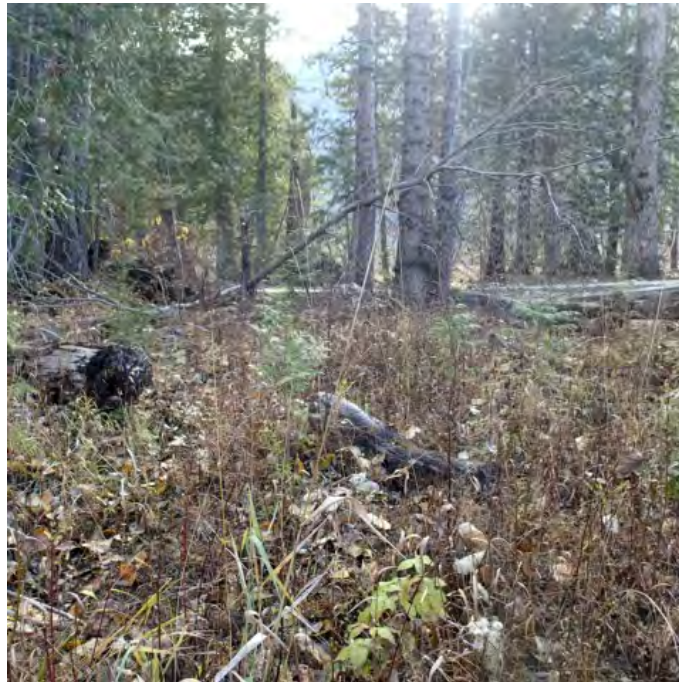
Figure 24. Revegetation success observed at ALE-PRM07. Photo is representative of western redcedar growth and the regeneration of other shrub and herb species, as well as the potential future condition in the background, on October 29, 2019.

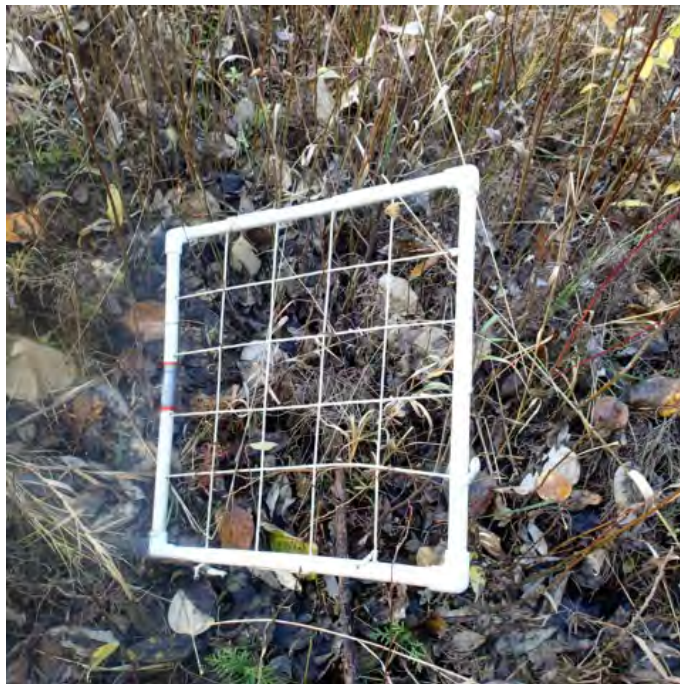
Figure 26. Relatively low percent vegetation cover in sampling quadrat at ALE-PRM06 October 29, 2019 due to abundance of leaf litter.
