Upper Lillooet Hydro Project

Operational Environmental Monitoring Year 4

April 29, 2022

Ecofish Research Ltd.

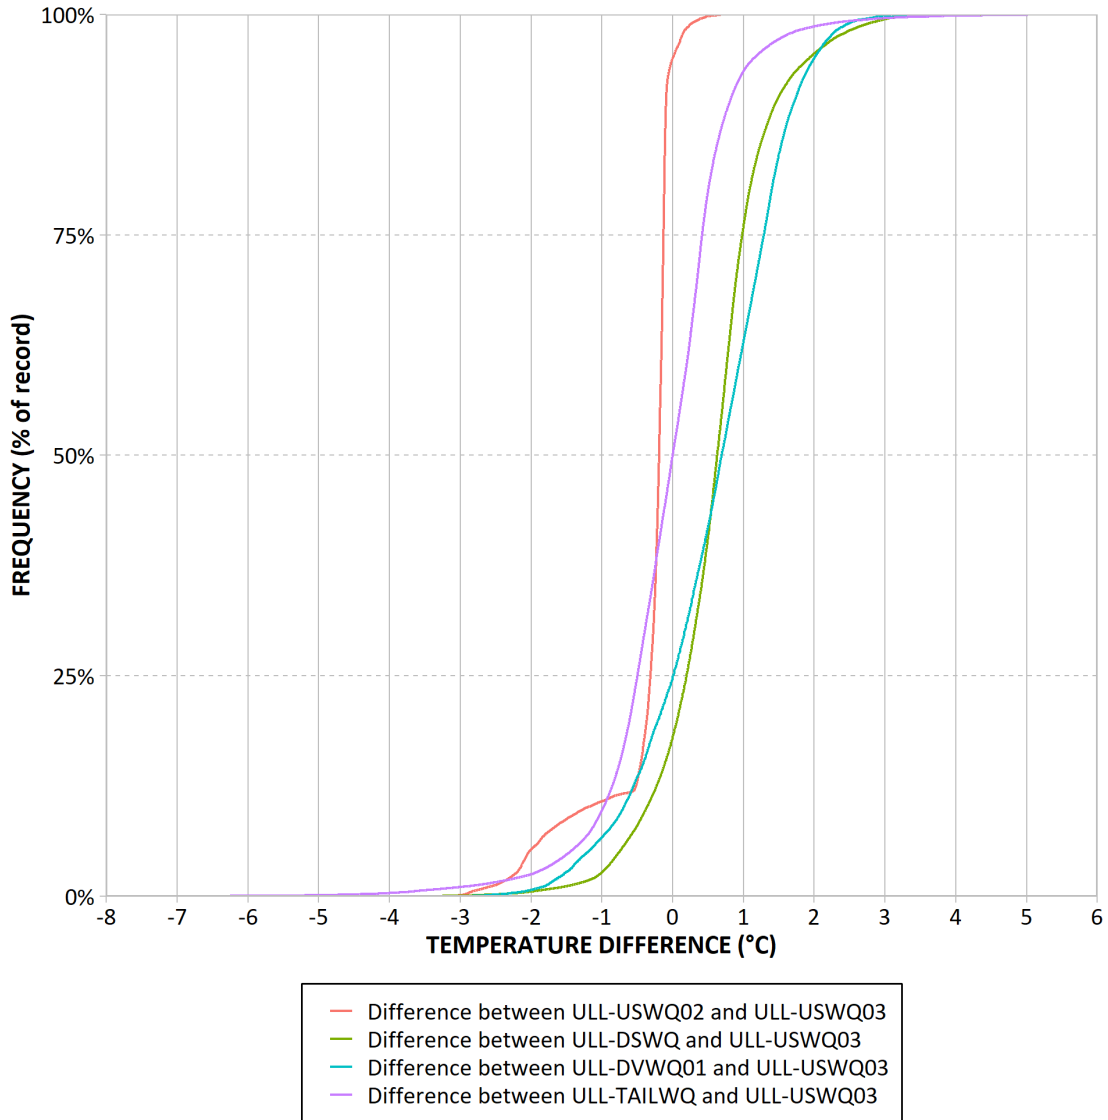
Figure 3. Cumulative frequency distribution of instantaneous water temperature differences between control and impact Upper Lillooet River sites and ULL-USWQ03 (the upstream control site established in Year 2) during operations (2018 to 2021). Positive values denote that water temperature at the site of interest was warmer than the upstream control site (ULL-USWQ03).

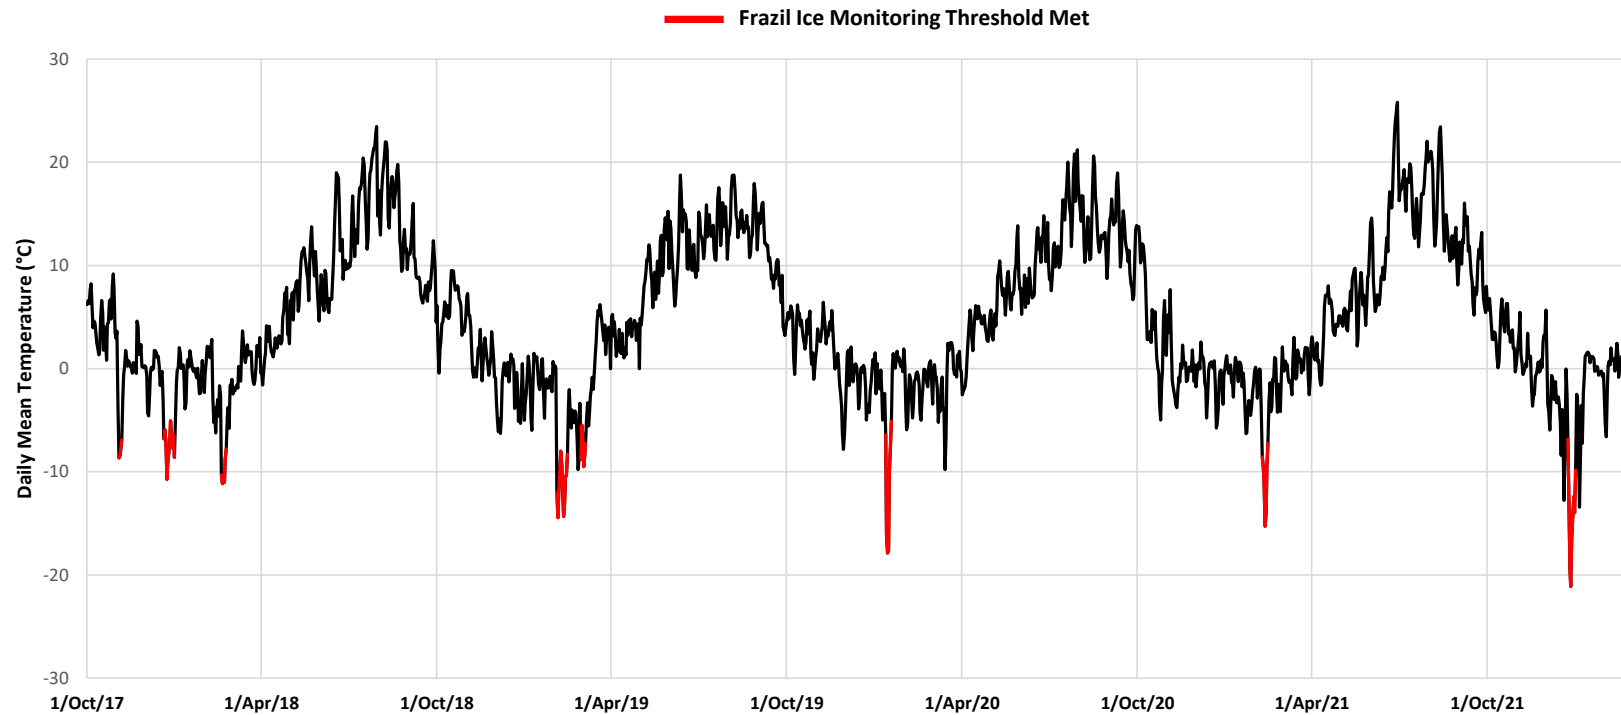
Figure 15. Average daily air temperature data from October 2017 to February 2022 at Callaghan Valley air temperature monitoring station. Note the threshold is met when air temperature are less than -5°C for at least three consecutive days. This figure is inclusive of those three days.

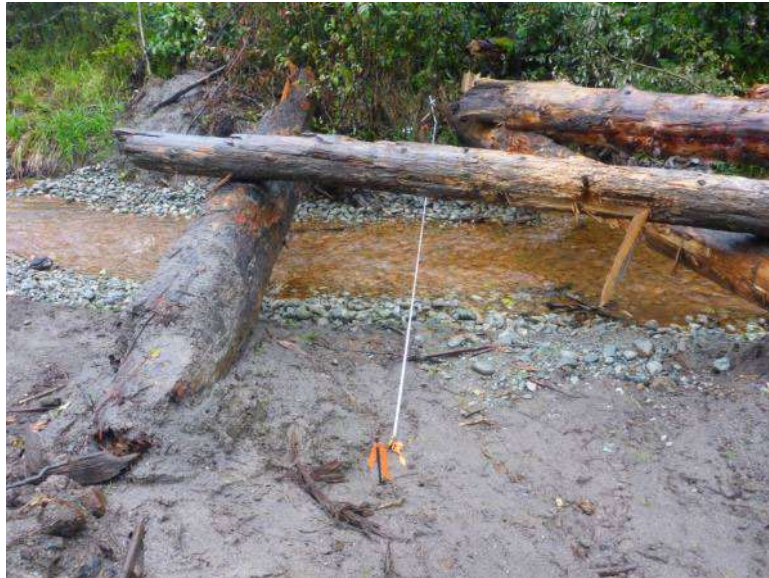
Figure 1. Looking from river left to river right at ALE-XS1 on September 19, 2016, showing a single channel.

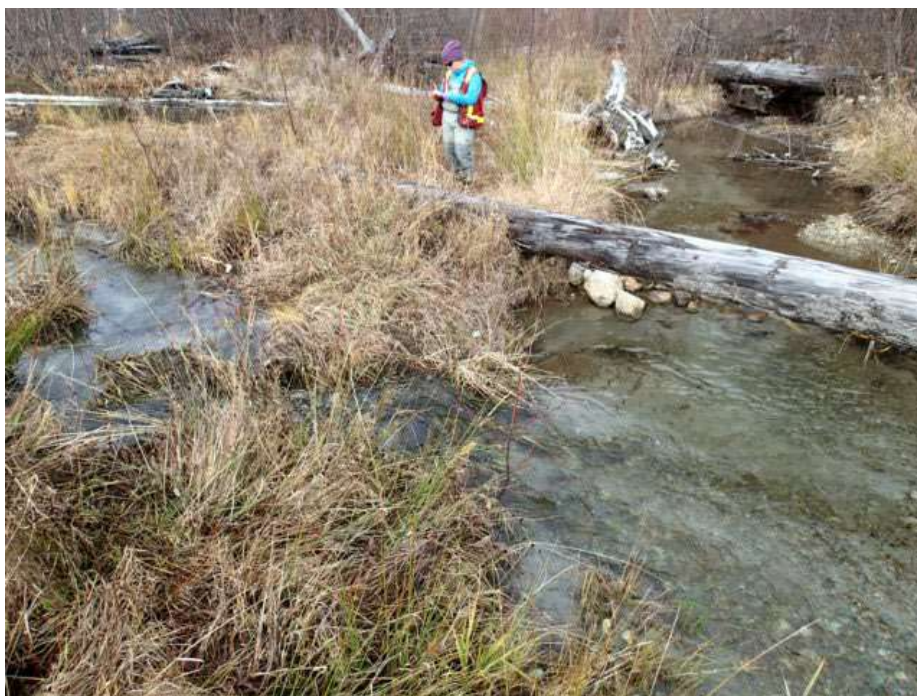
Figure 9. Confluence of overflow channel that formed during 2019 as a result of beaver activity upstream of Reach 3. Photo shows uppermost 20 m of Reach 3 (right) and overflow channel (left). Photo taken on November 13, 2019.

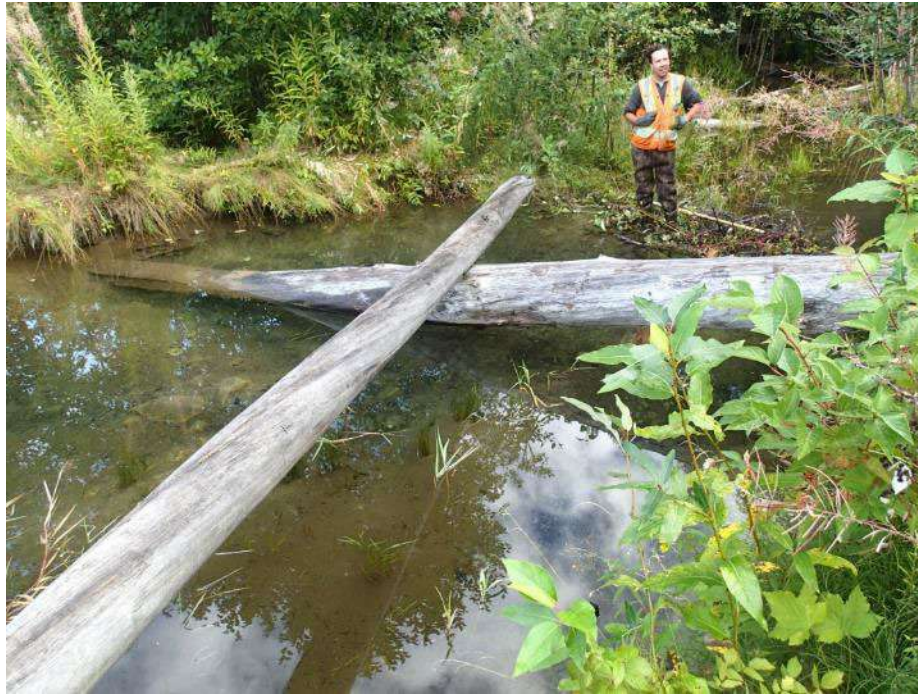
Figure 10. New reconstructed Beaver dam at the lower end of Reach 3 that was identified during fall 2021 and subsequently removed.

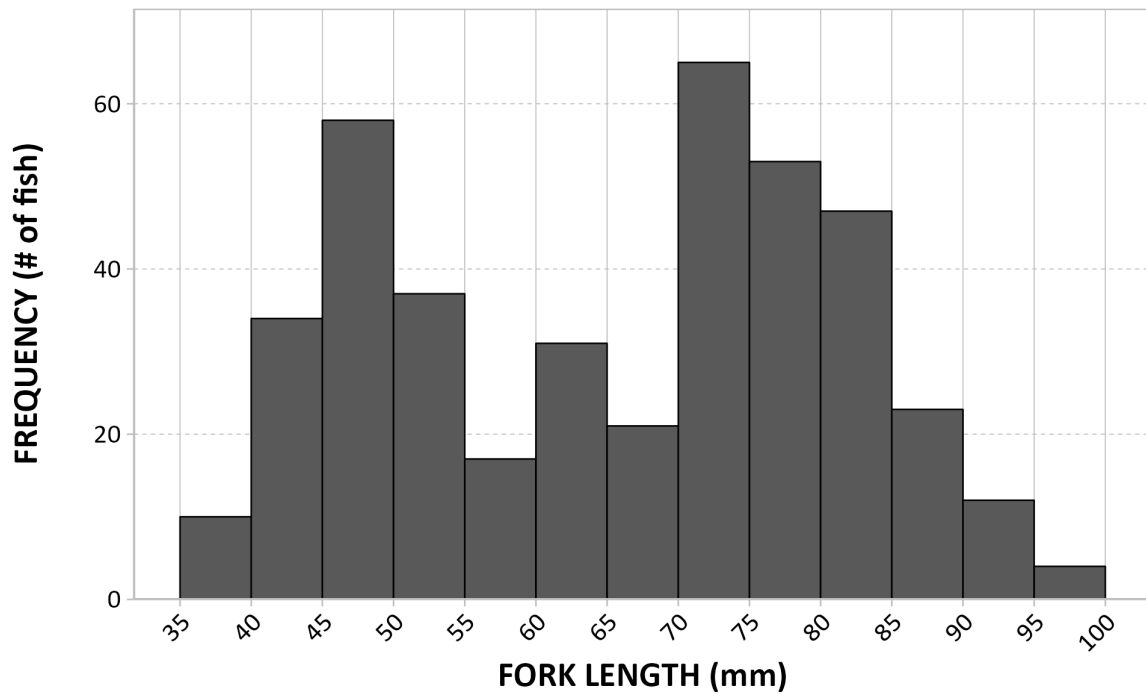
Figure 16. Fork length frequency for juvenile Coho Salmon captured (minnow trapping) in Alena Creek in 2021.
