Upper Lillooet Hydro Project

Weekly Environmental Monitoring Report #49

Reporting Period: November 23 – November 30, 2014

Cofferdam Construction Instream Works: Monitoring Report

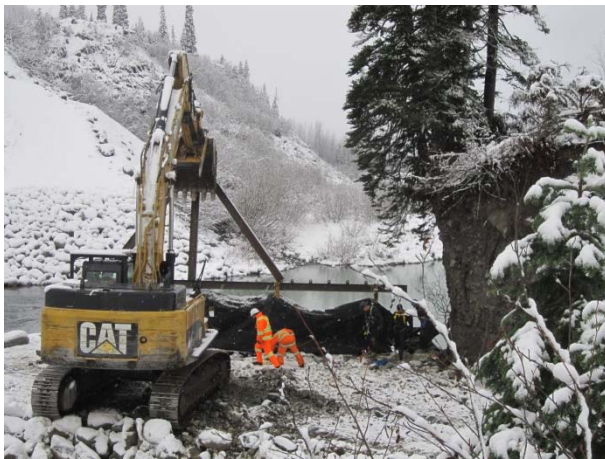
- Cofferdam Construction (Days 4 & 5) – CE installed additional layers of impermeable cofferdam liner (Photo 1) and 1 ton bags filled with crushed rock on the upstream side of the cofferdam (Photo 2), in order to reduce seepage through the cofferdam. The installation of additional cofferdam liner material proved to be marginally successful at further reducing seepage through the cofferdam. Once the liner installation was complete, CE reshaped the downstream side of the cofferdam (Photo 3) and installed geotextile fabric (Photo 4). CE also installed a wall of 1 ton bags filled with crushed rock ~50m downstream of the cofferdam (Photo 5; upstream of the diversion channel outlet) for the purpose of creating a sediment trap in the natural river channel and allowing CE to pump sediment laden water to the nearby upstream tunnel portal excavation. This additional mitigation strategy was developed to reduce the volume of sediment transported downstream during the placement of the 0-300mm material.

Photo 1 – Continued installation of cofferdam liner to the upstream cofferdam (November 23, 2014)

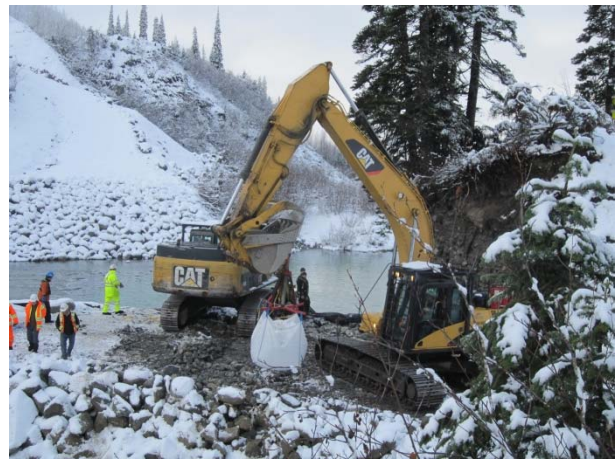
Photo 2 – Placing 1 ton bags of crushed rock on the upstream side of the cofferdam (November 23, 2014)

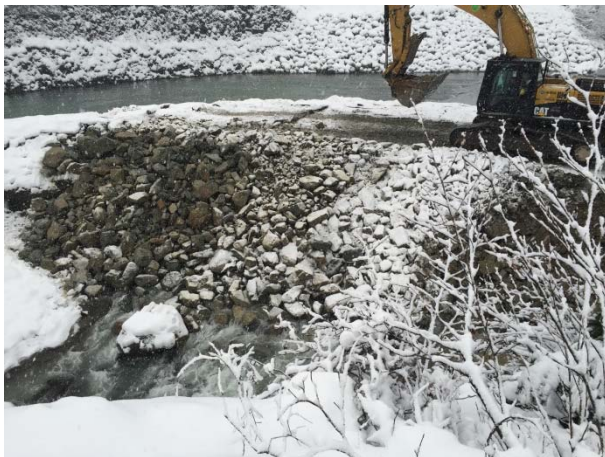
Photo 3 – Reshaping the downstream side of the cofferdam (November 24, 2014).

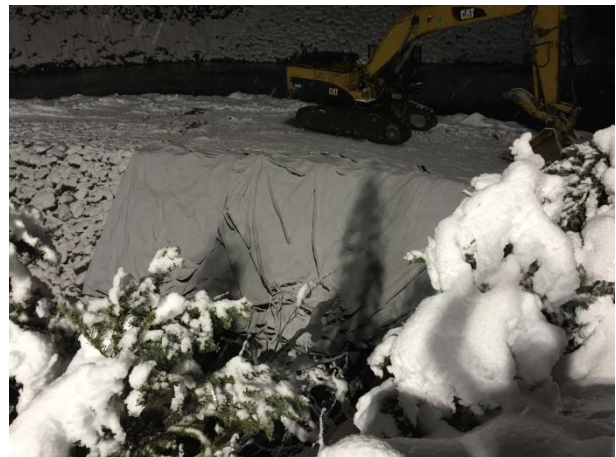
field conditions encountered onsite. The original design included the installation of impermeable key after the placement of the 0-300mm material. The impermeable key was replaced with the installation of a layer of geotextile fabric on the downstream side of the cofferdam between the 500-1500mm & 0 - 300mm interface (Photo 4).

Photo 4 – Installing geotextile on the downstream face of the cofferdam (November 24, 2014).

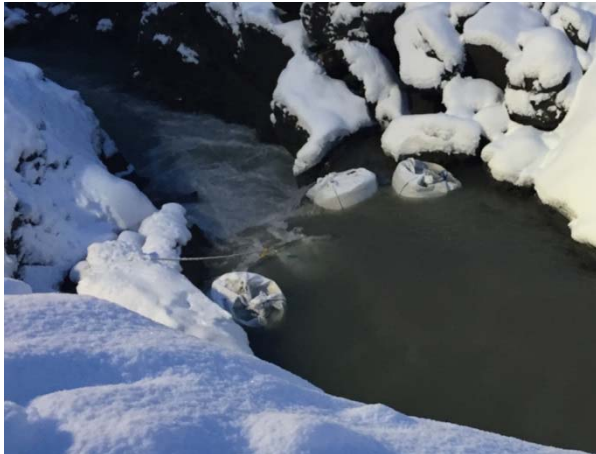
Photo 5 – One ton bags filled with crushed rock installed downstream of the cofferdam to create a sediment trap (November 25, 2014).

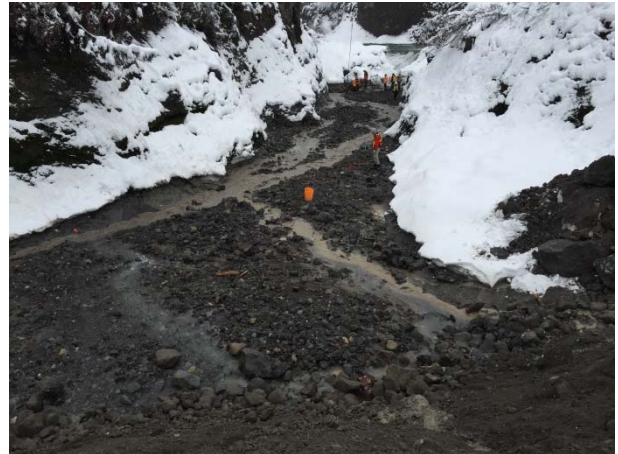
- Ecofish completed a fish salvage within the diversion reach once seepage through the cofferdam was sufficiently stemmed and conditions were safe to enter the diversion reach on foot. A fish stranding assessment was also completed in sensitive downstream reaches.

Photo 6 – Looking downstream at the diversion reach during the fish salvage works once the 0-300mm material sealed the majority of seepage (November 25, 2014).

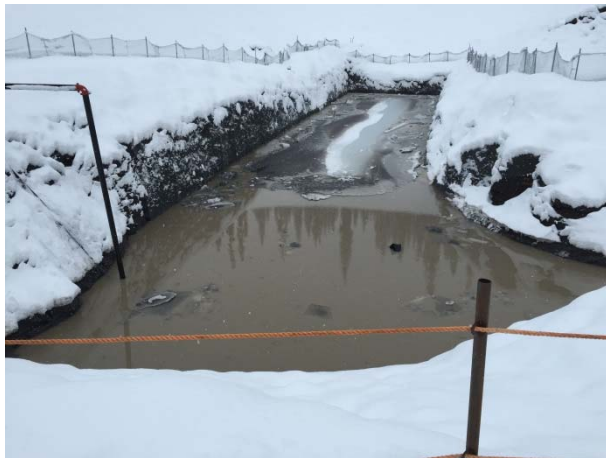
Photo 7 – ULRHEF upstream tunnel portion excavation filled with sediment laden water that was pumped during the cofferdam installation works. (November 25, 2014).

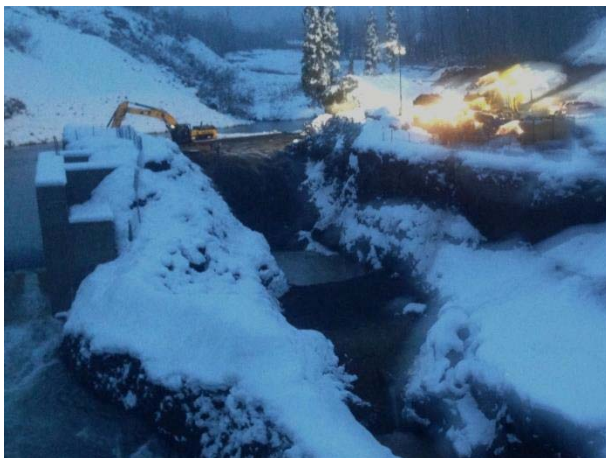
Photo 9 – Raising the height of the upstream cofferdam following completion of the downstream cofferdam works (November 26, 2014).

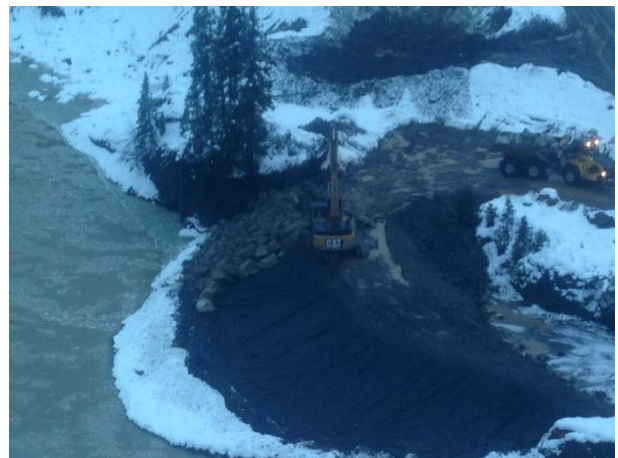
Photo 10 – Placement of riprap armouring on the front face of the upstream cofferdam once it was built to design height (November 27, 2014).

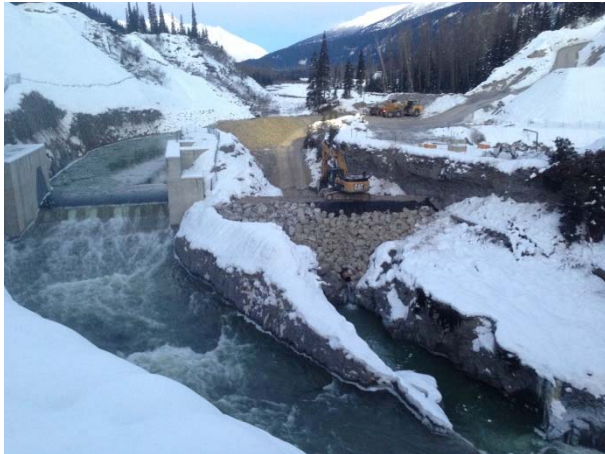
Photo 11 – Final riprap armoring of the downstream cofferdam (November 29, 2014)

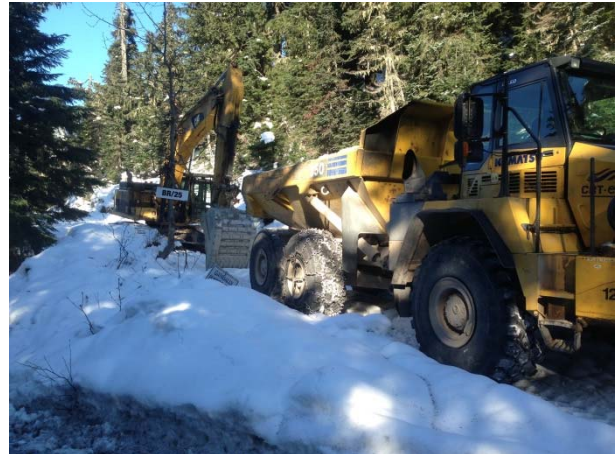
Photo 12 – Staging equipment in preparation for demobilization through the Mountain Goat Migration Corridor (November 29, 2014)

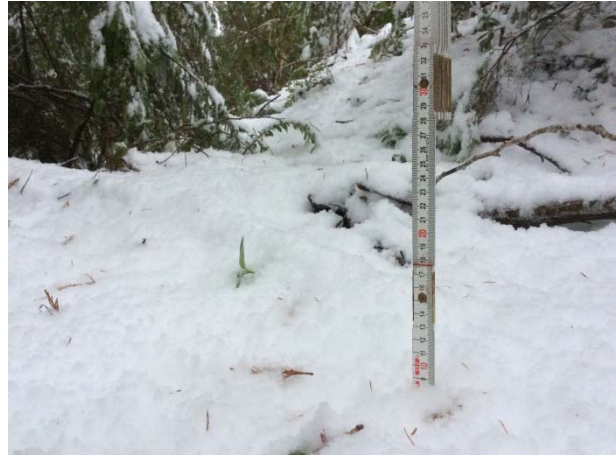
- The average snow depth measured within the forested Mountain Goat UWR near the BDRHEF intake on November 25 was 9.2cm (Photo 15). CE was advised that the forecasted overnight snowfall would likely result in exceedance of the 10cm snow threshold resulting in shutdown of construction activities at the intake work area, according to the conditions of the construction timing window extension approved by MFLNRO. On the morning of November 26, CE notified the IEM that all construction activities at the BDRHEF intake had been proactively suspended for the season and that site demobilization and winterization were underway.
- The IEM completed regular inspections of the BDRHEF intake diversion tunnel excavation on day shift and night shift throughout the active work period. Snow depth was monitored following new snowfalls within the forested Mountain Goat UWR near the intake area (Photo 15).

Photo 15 – Snow depth measured within the forested Mountain Goat UWR near the BRDHEF intake (November 25, 2014).

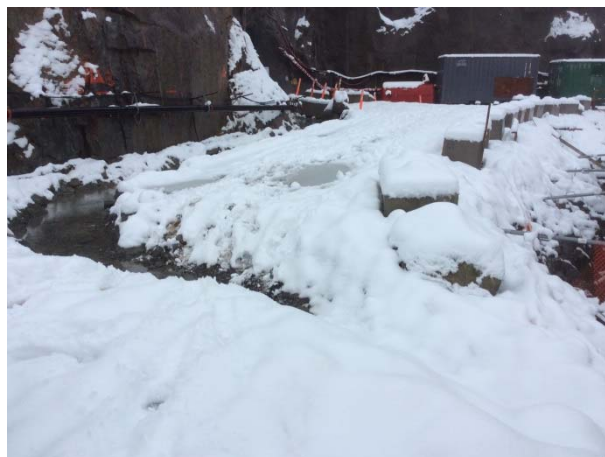
- As part of the winterization measures for the tunnel portal and powerhouse site, CE constructed a diversion ditch to direct all seepage emanating from the tunnel excavation to the powerhouse foundation excavation (Photo 17), which has been flooded. An outlet ditch has constructed to channel any overflow from the powerhouse excavation to a natural depression prior to reaching Boulder Creek.
- No environmental issues were observed during this reporting period at the BDRHEF powerhouse or downstream tunnel portal.

Photo 17 – A cut-off ditch installed to direct seepage from the tunnel excavation to the powerhouse excavation (November 26, 2014).

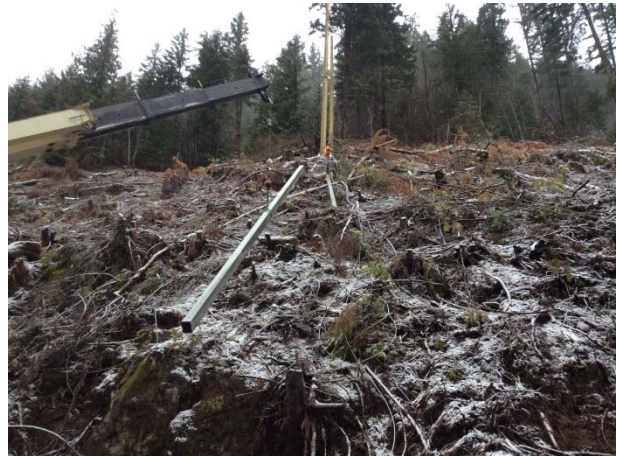
- On November 27 construction equipment in Segment 5 was demobilized to the laydown at 5km of the Lillooet River FSR.
- Foundation construction and structure framing works occurred in Segments 5 & 7 (Photo 19).

Photo 19 – Segment 5 pole dressing works (November 25, 2014).

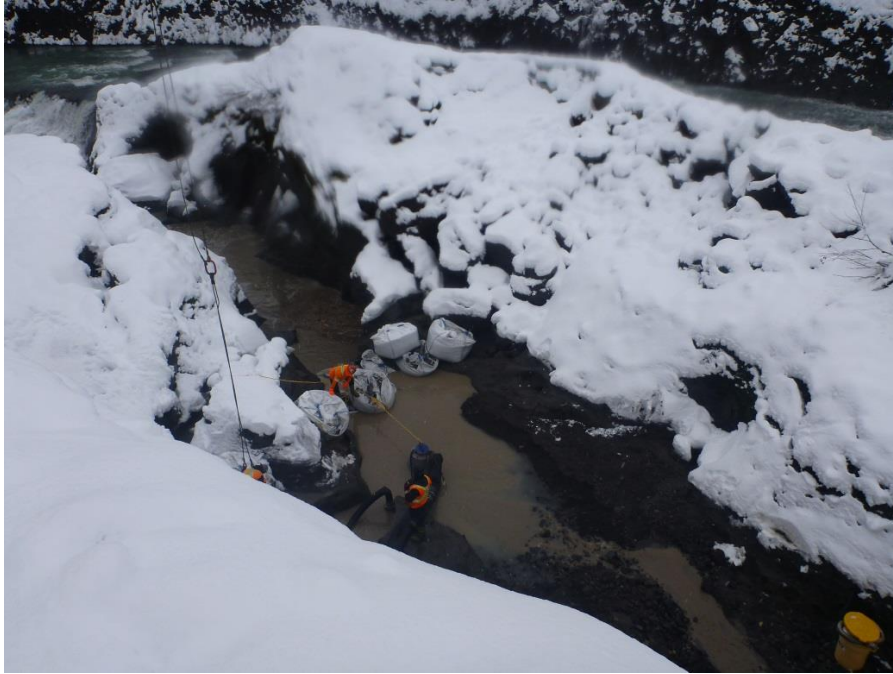
The nature of the construction works occurring during both peak turbidity events (November 20 and November 25) meant that it was not possible to delay or slow works phases, as this would have resulted in an extended duration and higher volumes of fine material being washed into the river. Achieving a choke in flows and then sealing the cofferdam were accomplished as quickly as possible to minimize the washout of fine material. Mitigation measures to reduce turbidity inputs were implemented as part of adaptive management actions when SEV values exceeded 4; with cognizance of the volume of material that was due to be deposited in the river during the fine material infill on November 25. In advance of this work activity a settlement pond was created below the cofferdam utilizing large bags filled with clear-crushed stone to create a temporary dam and settlement pond. Two pumps (10" and 6") were installed to extract water from this location and pump to the upstream tunnel portal excavation at the intake works site adjacent to the cofferdam works. This dual settlement pond and pumping effectively reduced the volume of fine material washed down the river, in addition to reducing the volume of turbid water discharged below the cofferdam during the works. Based on the pump capacity of the two pumps and the duration that they were operating, it is estimated that several thousand cubic meters of silt-laden water were prevented from flowing downstream (see Figure 3 and Figure 4).

Figure 3. View of the large bags of clear-crush stone used to create a settlement pond downstream of the upstream cofferdam, which effectively slowed flows during the installation of fine material and allowed for deposition.

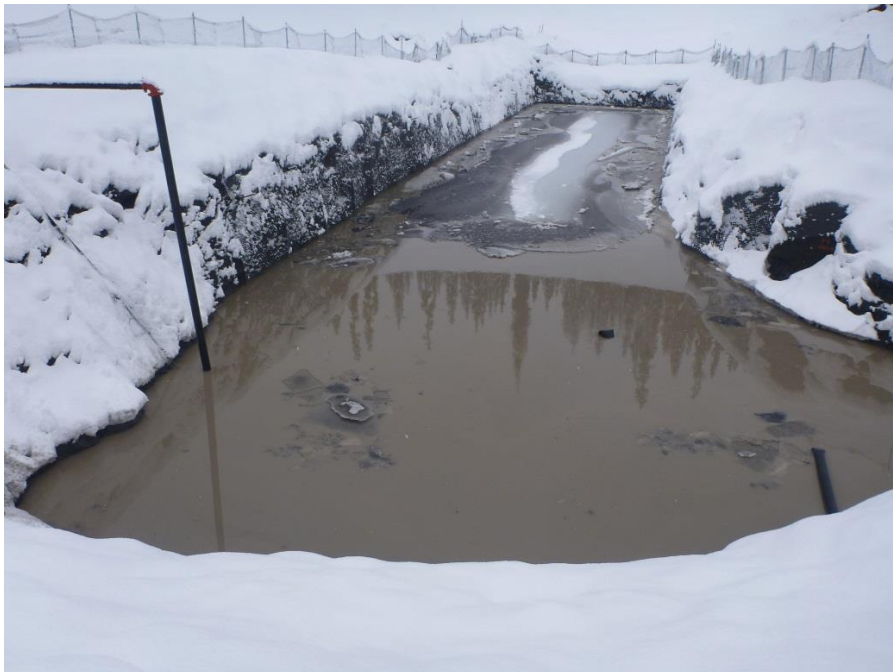
Figure 4. View of the upstream tunnel portal excavation into which sediment-laden water was pumped from the temporary settlement pond downstream of the upstream cofferdam.

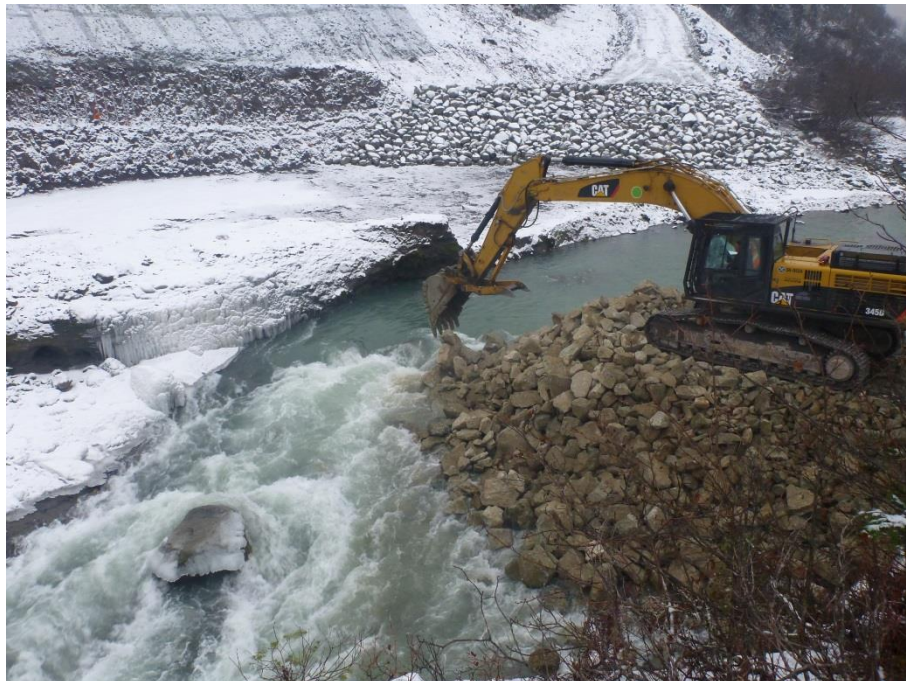
Figure 4. Building out first rock layer of cofferdam across the river channel. Water level rising upstream.

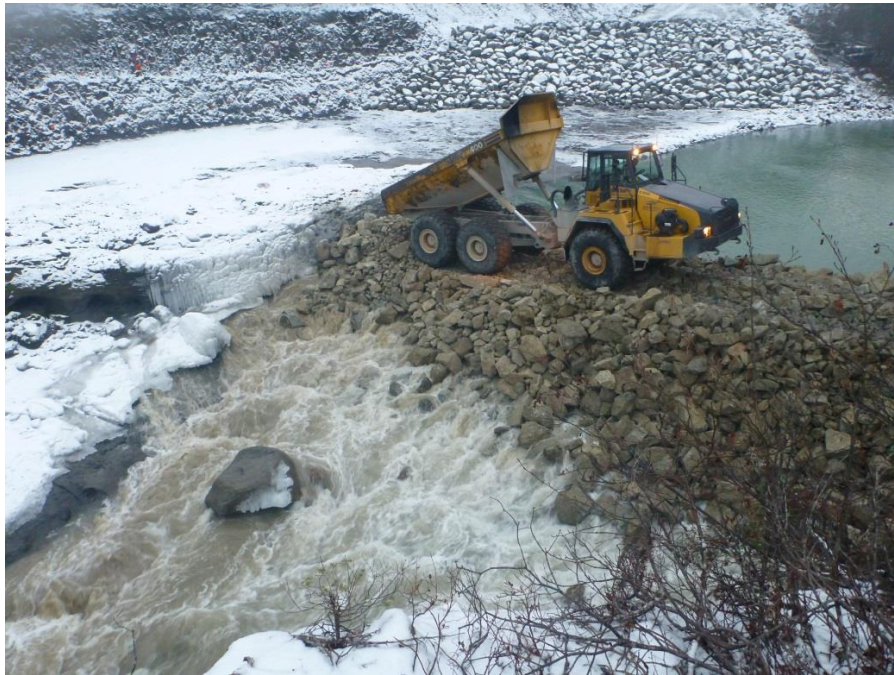
Figure 5. Closing the first rock layer across the river channel. This induced a significant rise in water level upstream, reaching the temporary diversion channel and switching flows.

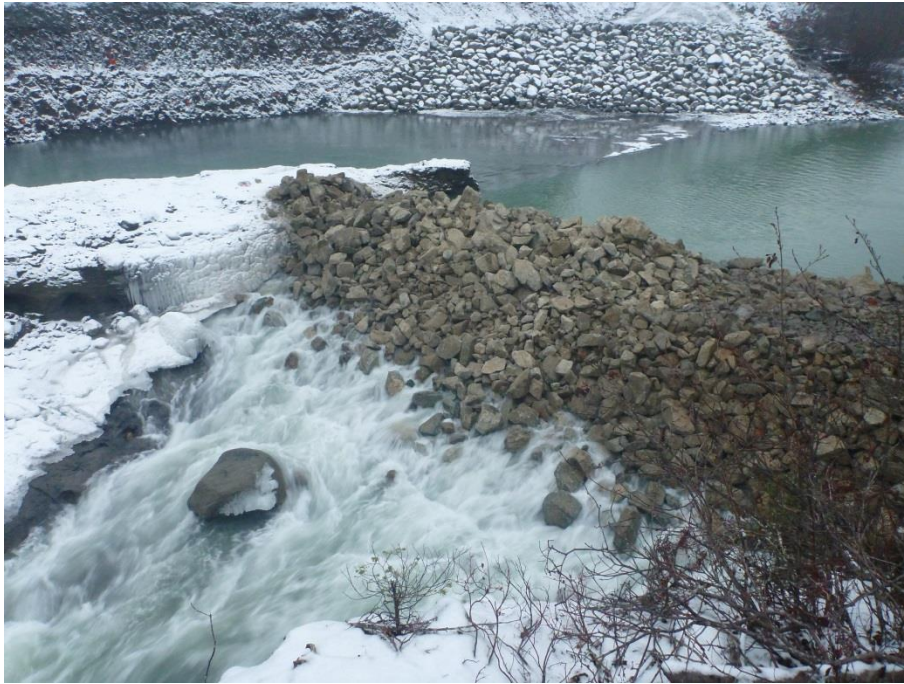
Figure 7. Once the initial flow diversion had taken place, turbidity in the river rapidly reverted to background values below the cofferdam.

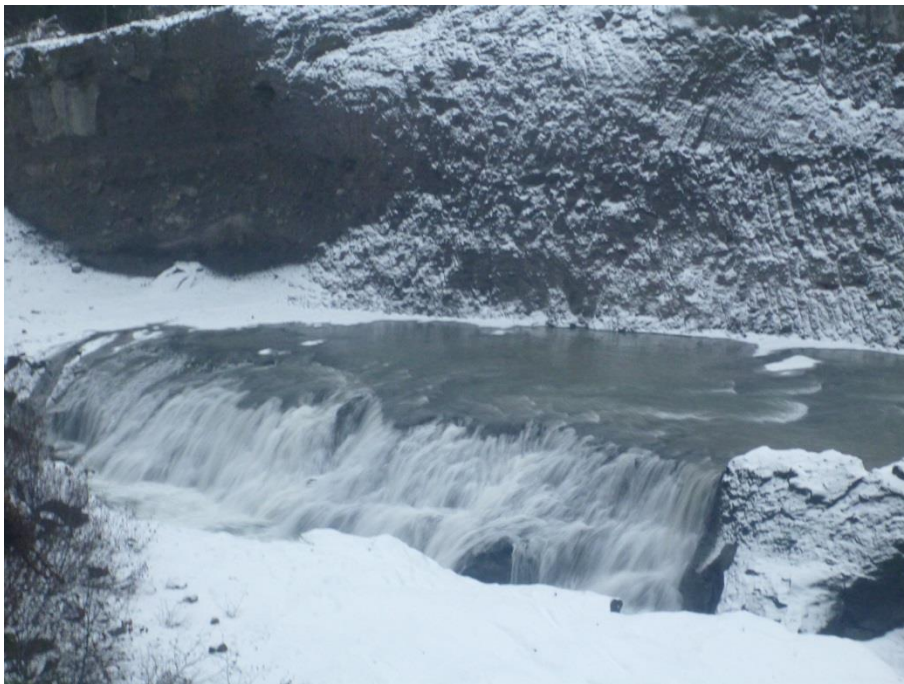
Figure 8. Similarly, following the initial flush, the flows in the temporary diversion channel also achieved background values.

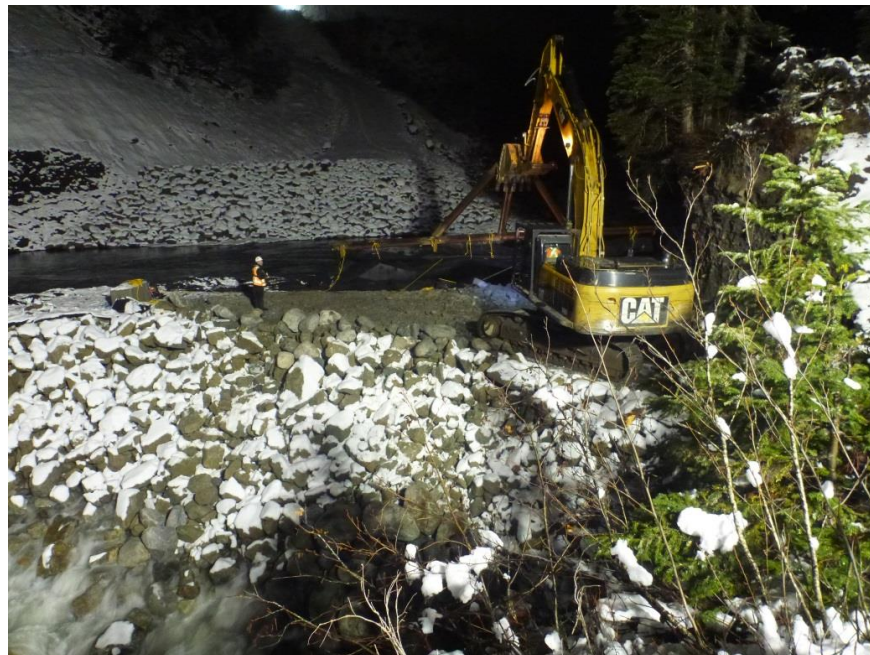
Figure 10. The geomembrane was installed along the upstream cofferdam face using a frame fabricated on site. This allowed the membrane to be placed close to the base of the cofferdam.

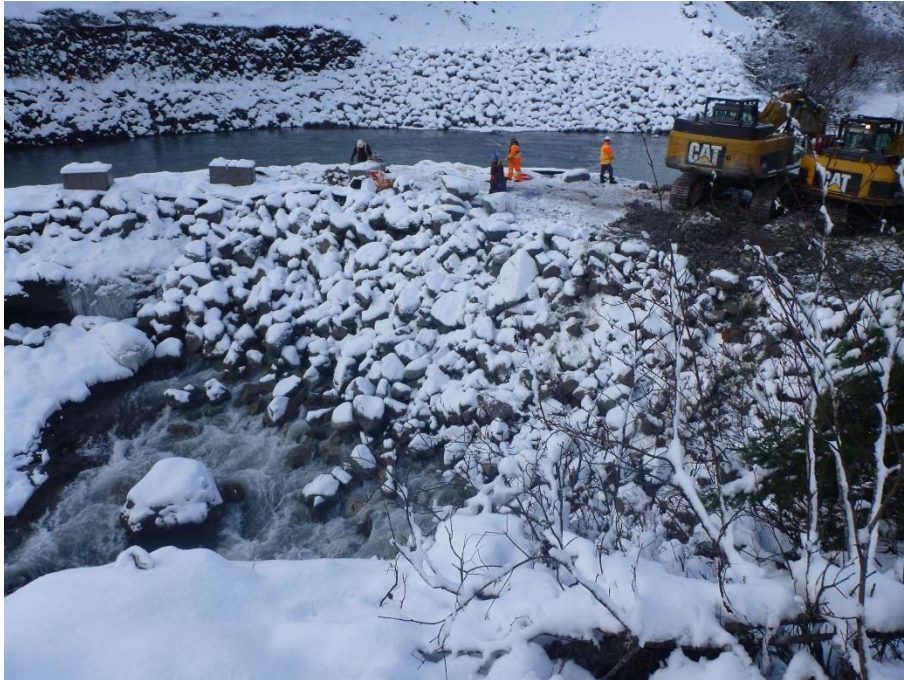
Figure 11. Additional rock fill material was placed on the toe of the cofferdam to seal the geomembrane to the base.

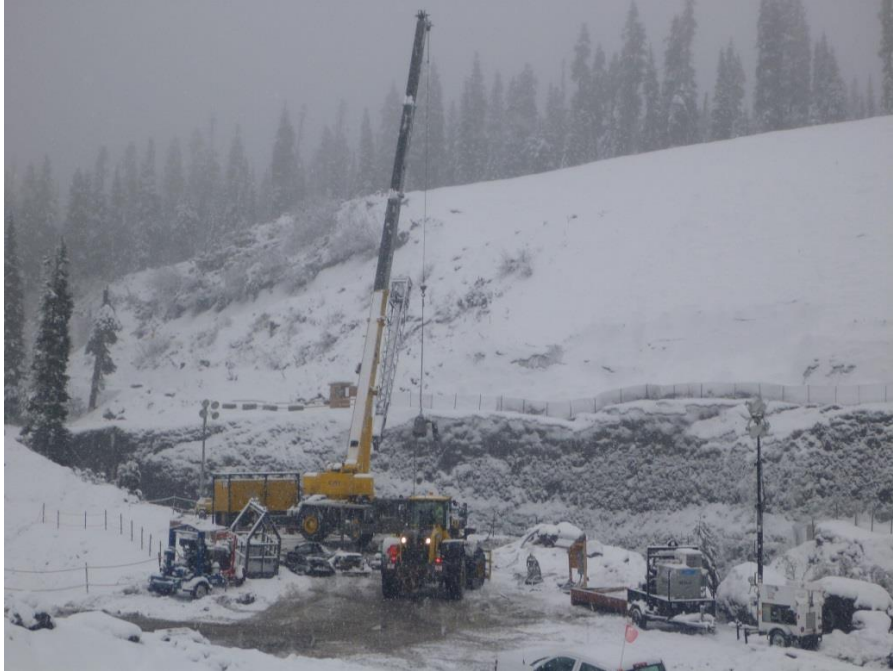
Figure 13. Two pumps (10” and 6”) were brought to the intake site to pump turbid water from below the cofferdam to the existing tunnel portal excavation which would act as a settlement pond. The crane was also in place to lower staff into the natural channel if fish salvage was required.

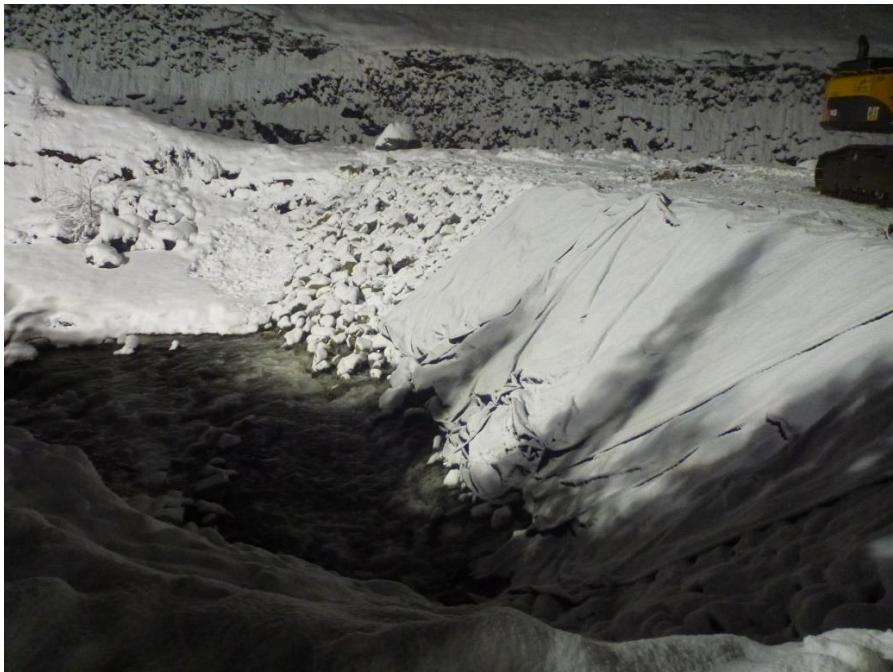
Figure 14. Additional geotextile was installed on the downstream side of the cofferdam, prior to fine material backfill.

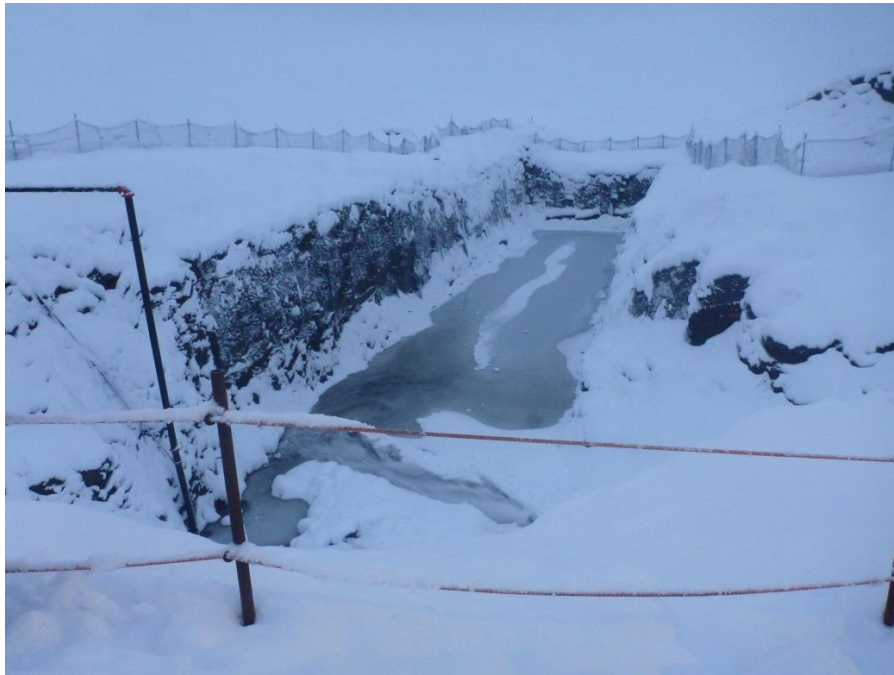
Figure 15. View of the tunnel portal excavation to be used as settlement pond.

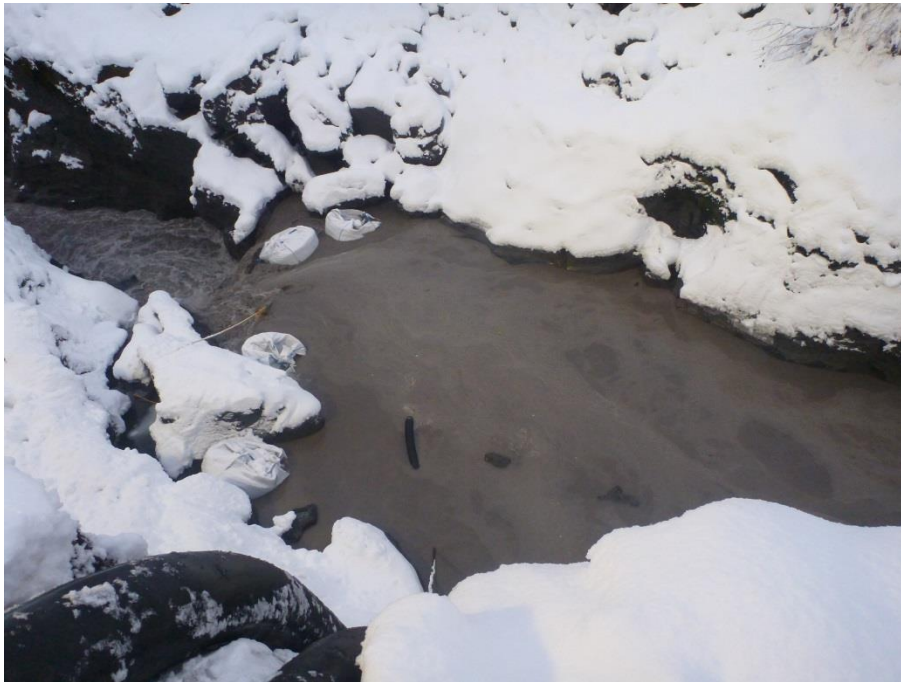
Figure 17. Large bags of crushed stone were in place downstream of the cofferdam to create a check in flow velocities. Two pumps were pumping out water to the upstream tunnel portal excavation.

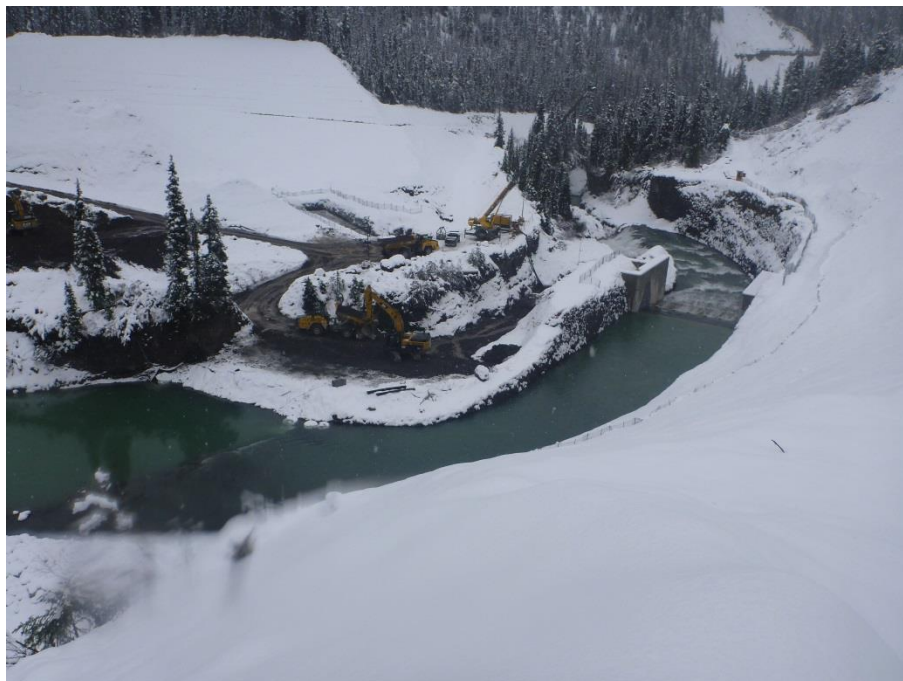
Figure 25. By the end of the day the level in the upstream tunnel portal excavation had lowered considerably, presumably discharging to groundwater. No long term elevation in turbidity downstream was noted.

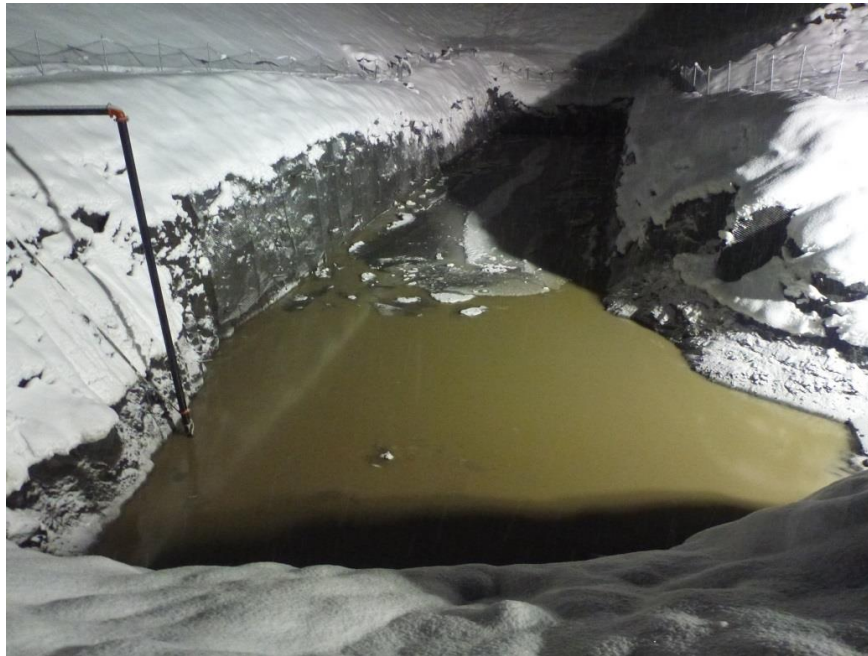
Figure 26. Infill material was placed at the downstream end of the dewatered river channel to form the downstream cofferdam. This was required to prevent backwatering from the temporary diversion channel in the event of high flows.

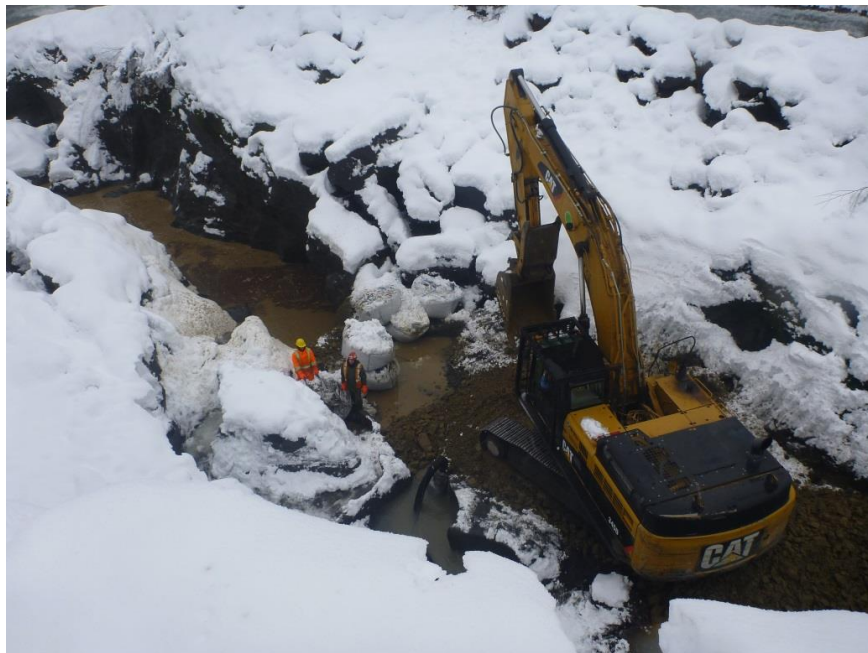
Figure 27. The downstream cofferdam was completed on a natural ledge, elevated above river level and included a steel culvert pipe to allow for drainage of the dewatered river channel. This comprised the final stage of instream works for the cofferdam project element.

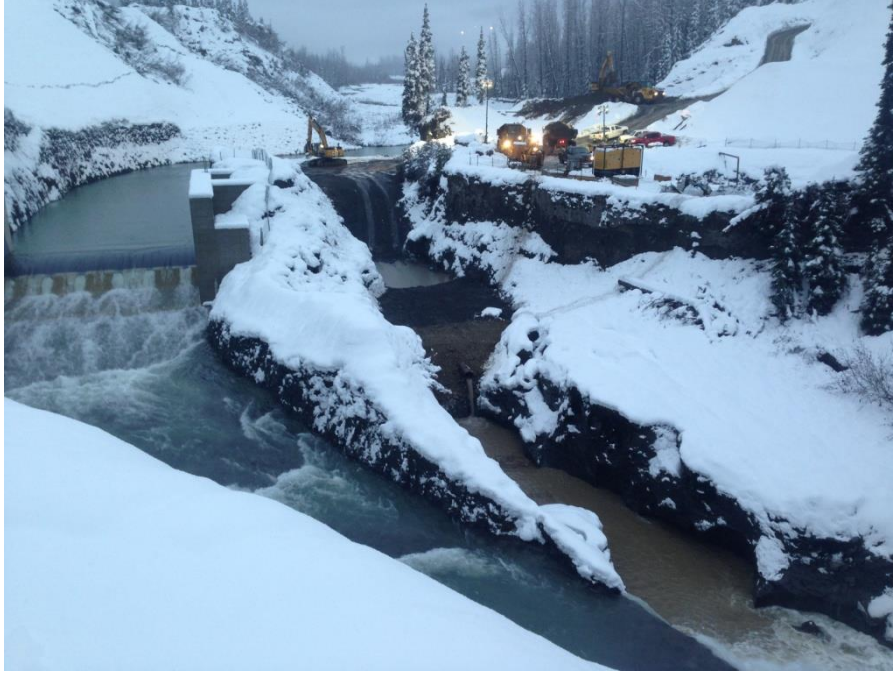
Figure 28. Final rock armouring and stone placement was completed in the dry, on the downstream face of the downstream cofferdam.

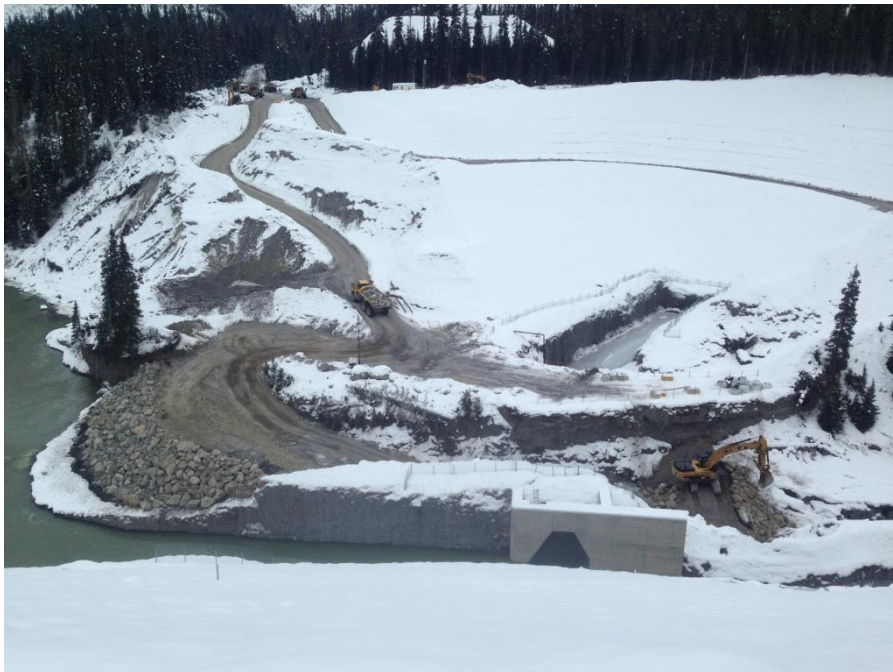
Figure 29. View of the completed cofferdams and dewatered river channel to the right of the image. The flows were successfully diverted through the temporary diversion channel, with the Obermeyer in place, to the left of the image.

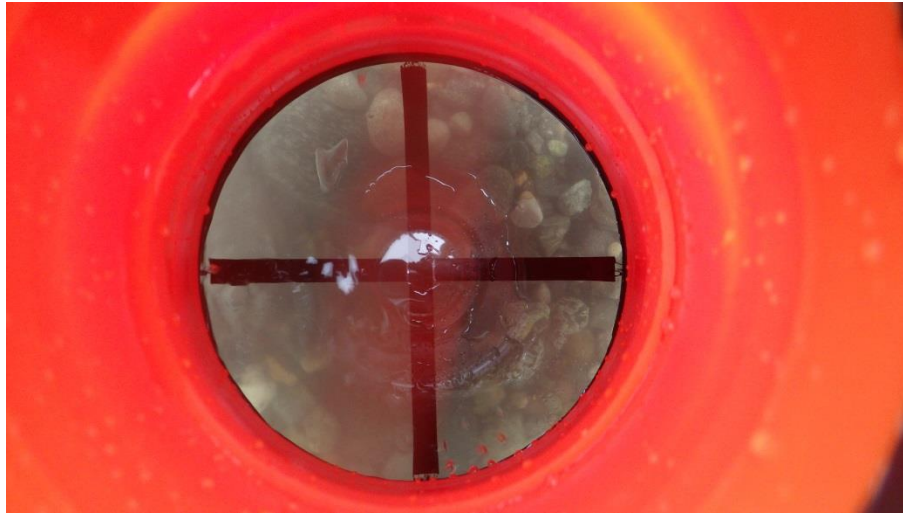
Figure 33. DSSM01 – Representative image through bathyscope viewer: after works. Rainfall-induced natural background turbidity event in the river impaired survey (November 27, 2014).

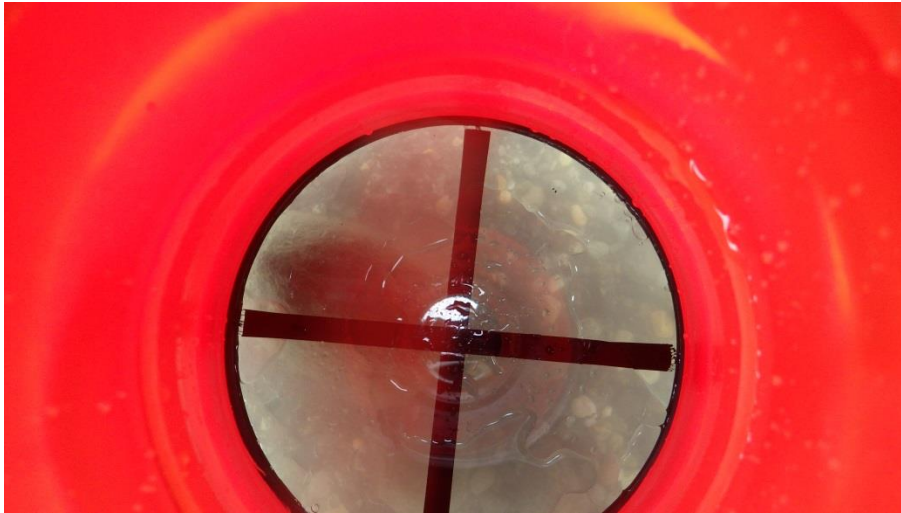
Figure 37. DSSM02 – Representative image through bathyscope viewer: after works. Rainfall-induced natural background turbidity event in the river impaired survey (November 27, 2014).

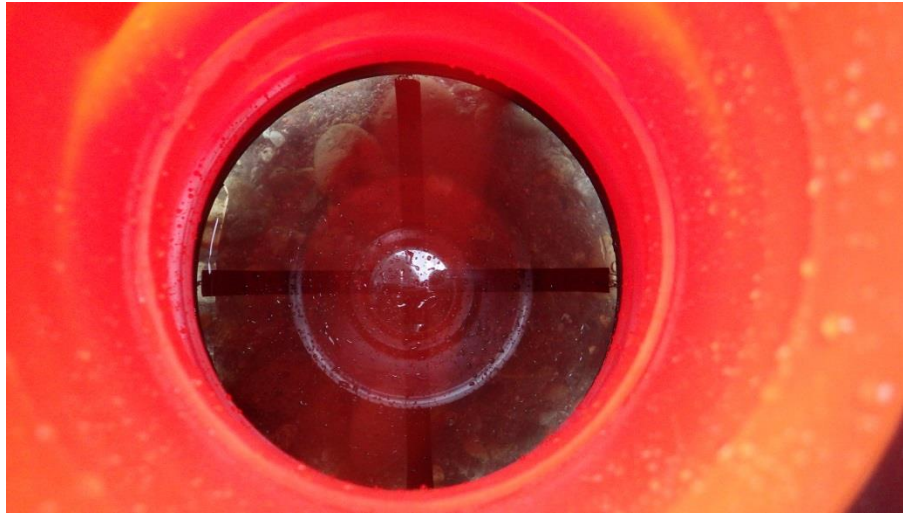
Figure 41. DSSM03 – Representative image through bathyscope viewer: after works. Rainfall-induced natural background turbidity event in the river impaired survey (November 27, 2014).

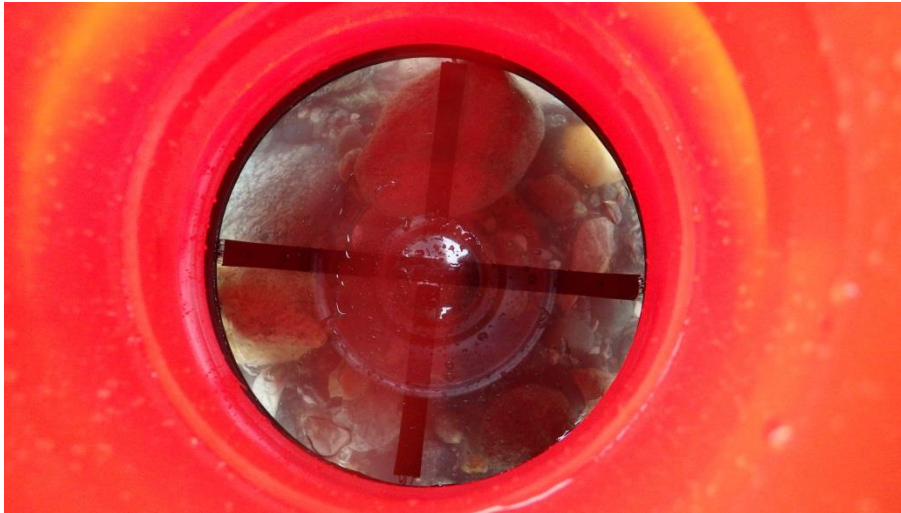
Figure 45. DSSM04 – Representative image through bathyscope viewer: after works. Rainfall-induced natural background turbidity event in the river impaired survey (November 27, 2014).

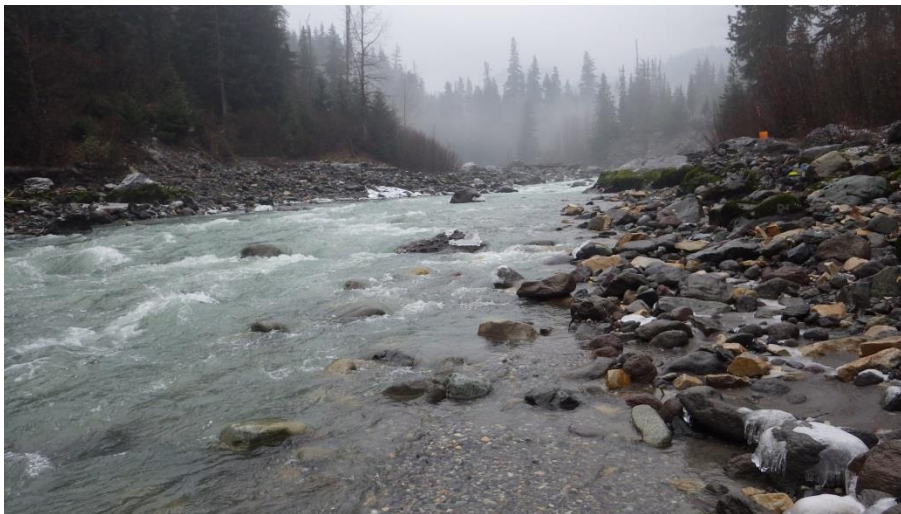
The stage change was recorded by the flow gauge at the powerhouse and was visually observed on the river bank by the Ecofish crew. The Ecofish crew stationed at this site conducted a stranding survey along the river left margin as flows receded. No fish were observed or recorded stranded.

Figure 48. DSSD03 – View of dewatered gravel habitats along the river margin at the bottom of the stage change, before flows started to rise.

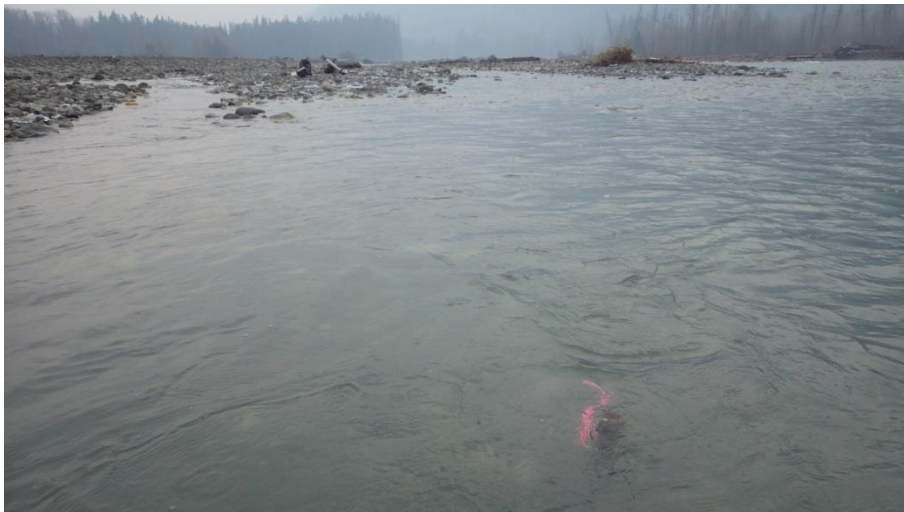
The Ecofish field crew moved downstream at 16:48 to the stranding sensitive habitat identified upstream of the Alena Creek (DSSD04) confluence on the main channel of the Upper Lillooet River. This section was prioritized due to the sensitivity of habitat at this location and the field observations at the DSSD01 site (Boulder Creek confluence), which identified limited stranding sensitive habitat under the flow conditions recorded. The change in water level was also observed by the Ecofish crew at site DSSD04. Areas of shallow cobble were dewatered during the stage change, but were found to be highly compacted and embedded. No fish were observed and or recorded stranded.

Figure 52. DSSD04 – View downstream to stranding-sensitive shallow cobble side channel during the low flow from the works-induced stage change.

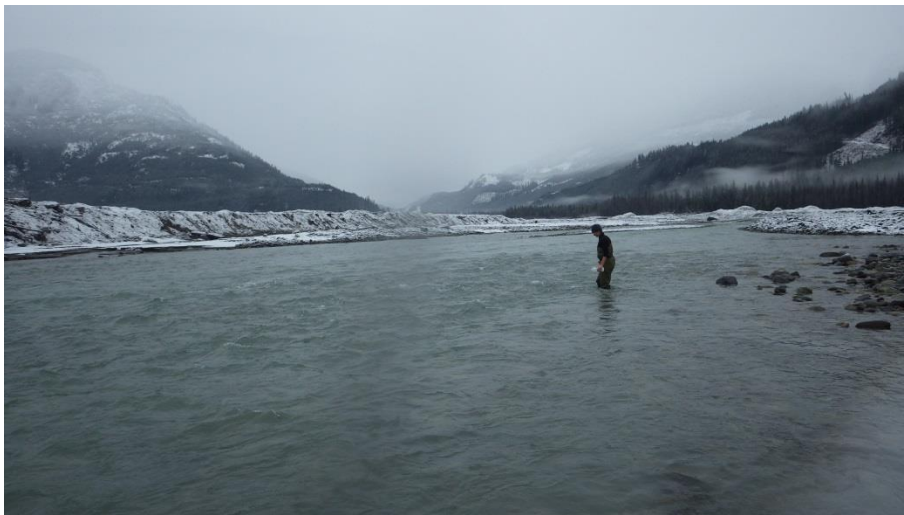
Figure 55. A water sample was also taken at site DSSD04, downstream of the Meager Creek confluence, calculated with lag-time to be during the peak of the turbidity event arising from works at the cofferdam upstream. No distinguishable change was observed.
