# **Upper Lillooet Hydro Project**

# Weekly Environmental Monitoring Report #19

Reporting Period: April 27<sup>th</sup> – May 3<sup>rd</sup>, 2014

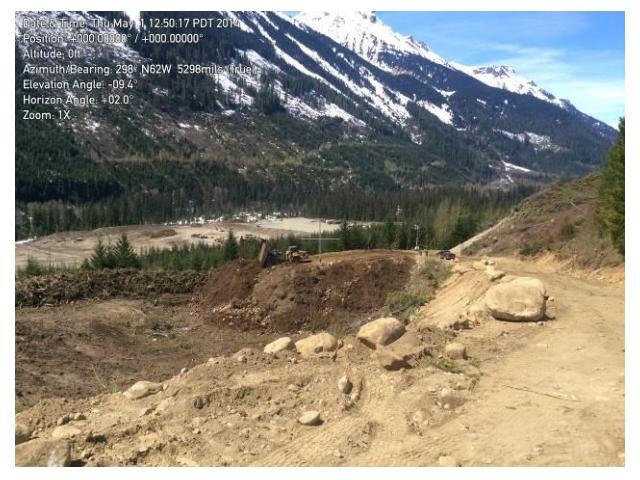
Photo 1. Stockpiling stripping and grubbing material from the Construction Camp work area. Note the separation of woody debris and organic soils (May 1, 2014).

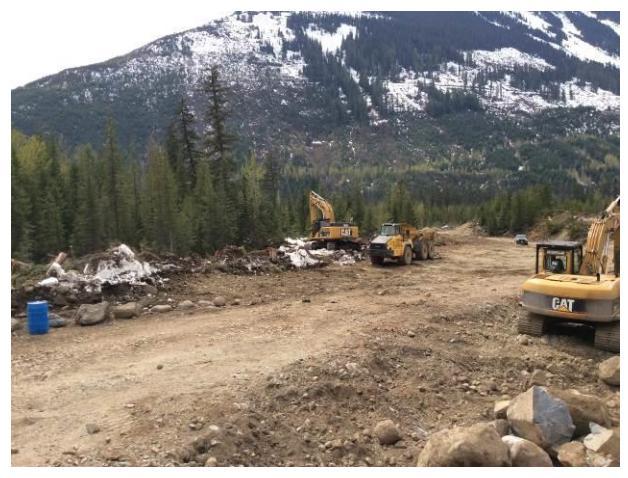
Photo 2. Stripping and grubbing activity at the BDRHEF powerhouse location. (May 3, 2014).

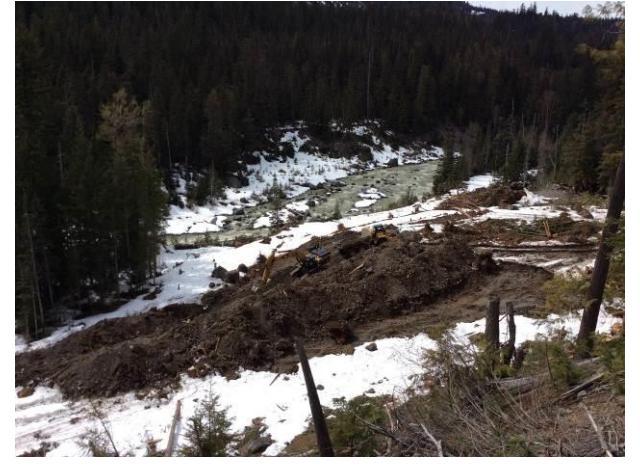
Photo 3. Stripping and grubbing material from the ULRHEF powerhouse work area. (May 3, 2014).

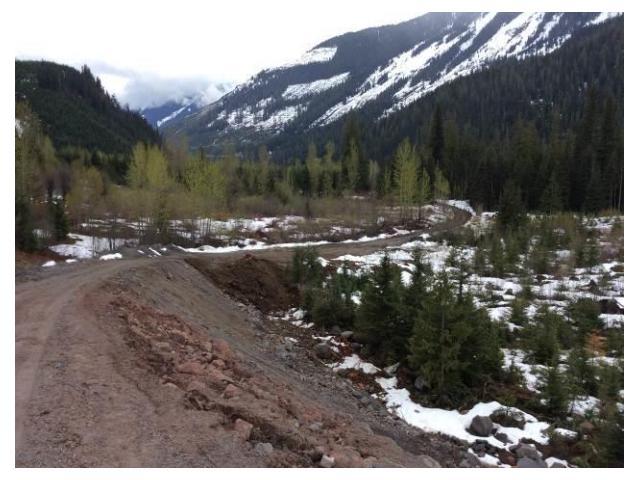
Photo 4. Stockpiling of organic material from the ULRHEF powerhouse at the base fill slope at the east heading of the Truckwash Creek realignment. (May 3, 2014).
